BAT, BARN OWL & NESTING BIRD SURVEY AT

Orchard Cottage, Fluke Hall Lane, Pilling

Author	Flora Whitehead	Date	24/5/23
Checked by	Andrew Gardner	Date	25/5/23
Report Version	1		
Field data entered	<input type="checkbox"/>		
Report Reference	6720

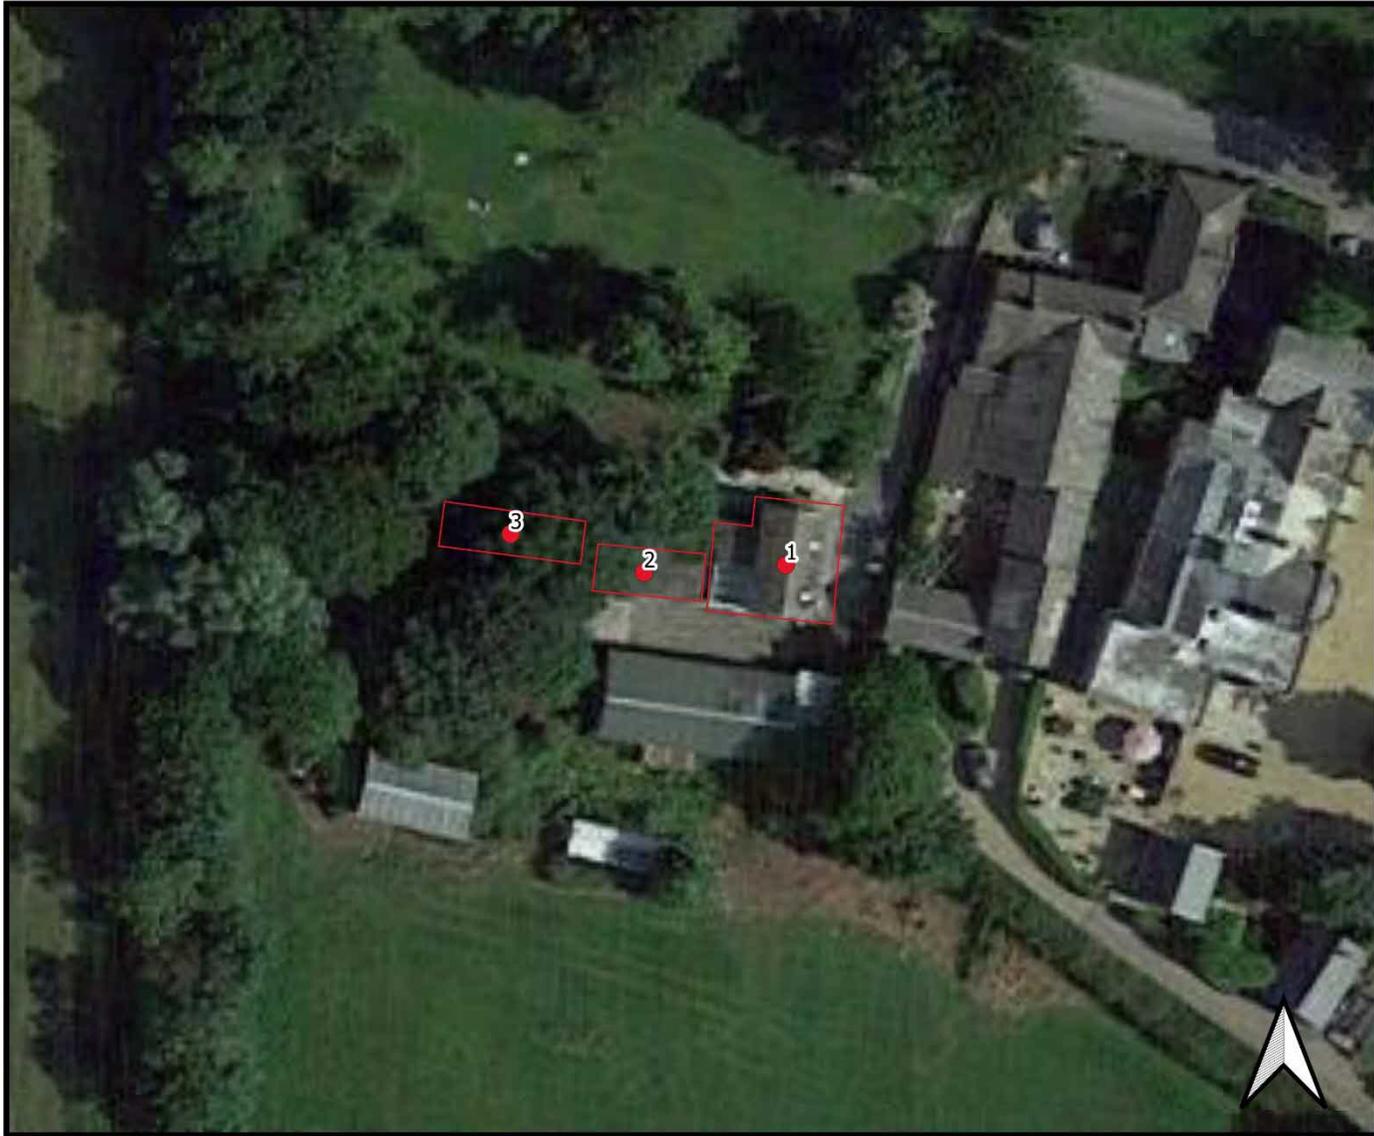
Figure 2
Site Boundary

- Site Boundary
- Building Number

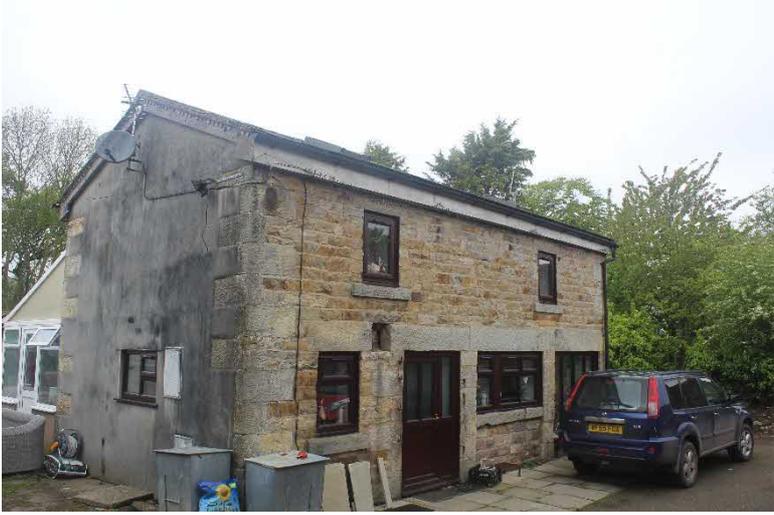
<p>Building 1</p>

The walls of the building are partially made from natural stone and partially rendered and are in excellent condition. There are no gaps or cracks, the pointing between the dressed stone is intact.

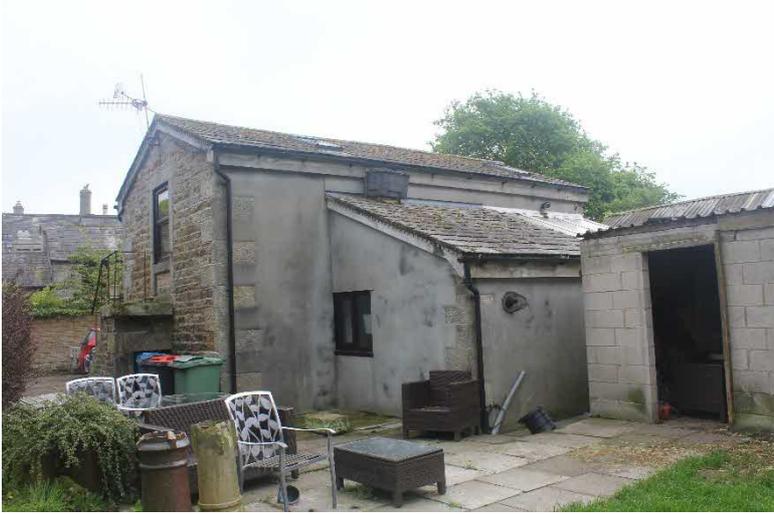
To summarise the building is of moderate size and the external walls are in excellent condition. The eaves lines are sealed with mesh grilles. The roof coverings were all in place and had patchy moss over them. There were no roof voids. Overall this building has low potential for use by bats, our categorisation would be 3. Further details of our categorisation can be found in Table 1.

<p>Walls and roof in good condition overall</p>

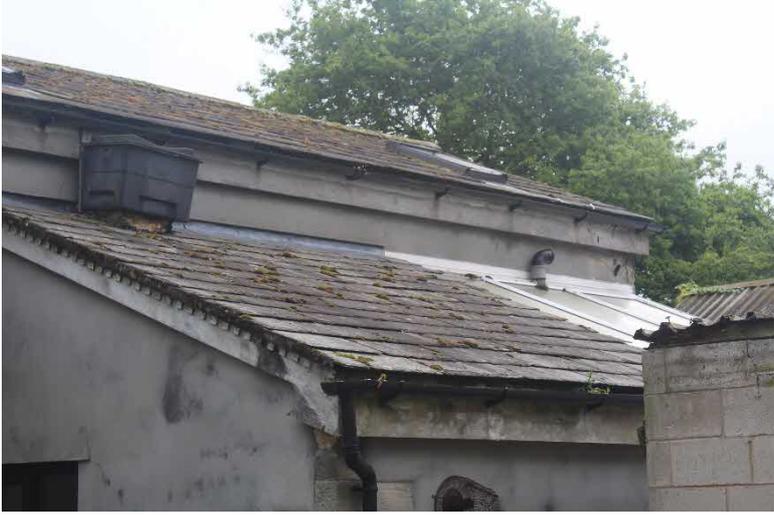
The roof of the building is made from stone slate. The slates are all in place, with very occasional minimal lifting. There is a patchy covering of moss particularly along the ridge, suggesting a cool dampness unattractive for bats. The single-storey extension to the west also has a slate roof with slates in place and partial sealed glass. The full extent of the roof could be seen from the ground with close focus binoculars and a 1,000,000 candle power torch. No indications of use by bats could be found.

<p>Slates in place with minimal lifting</p>

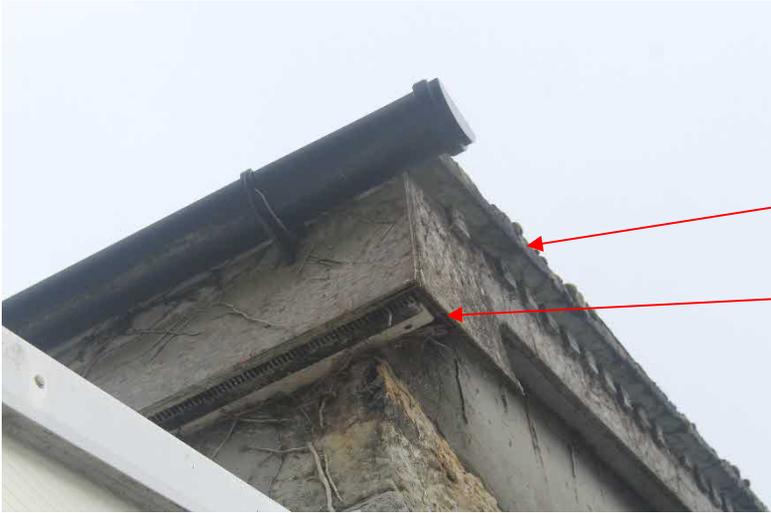
The eaves are sealed with mesh grilles behind the fascia boards. One small gap was noted where woodwork had degraded. There were no indications of roosting by bats in these areas.

Well sealed roof verge
Small gap in otherwise sealed eaves with mesh grille

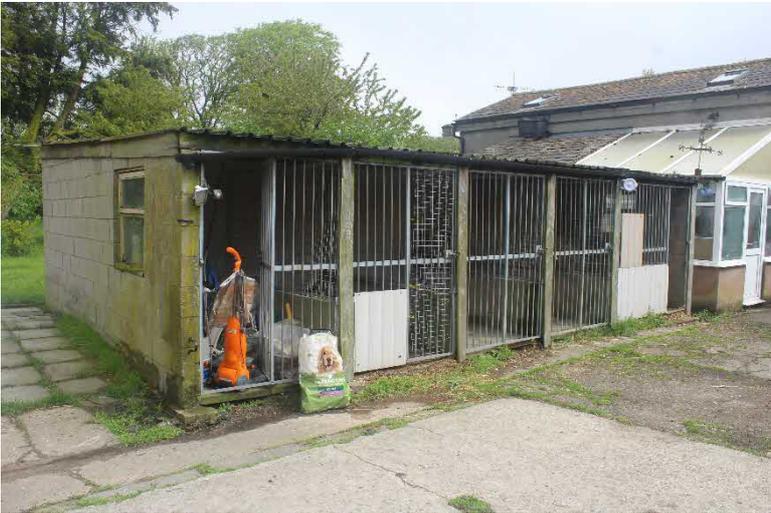
To summarise the building is of small size and the external walls are in good condition though there are crevices around wall tops/fascia boards. The roof and internal space have negligible suitability for use by bats. Overall this building has negligible potential for use by bats, our categorisation would be 2. Further details of our categorisation can be found in Table 1.

Building 2
Kennel has open doors and the blockwork is in generally good condition

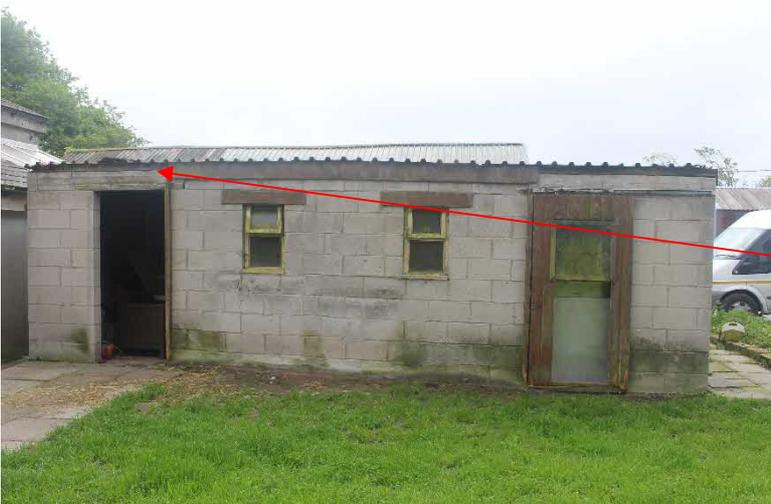
The walls of the building are made from concrete blockwork and are in good condition. Occasional cracks were noted over wall tops and where pointing was absent behind missing fascia boards. Other fascia boards also had cracks and were beginning to rot. The kennels had barred fronts which do allow internal access. There were no indications of roosting by bats in these areas, and the gaps are not thought to offer highly suitable roosting sites.

Small gaps at wall tops

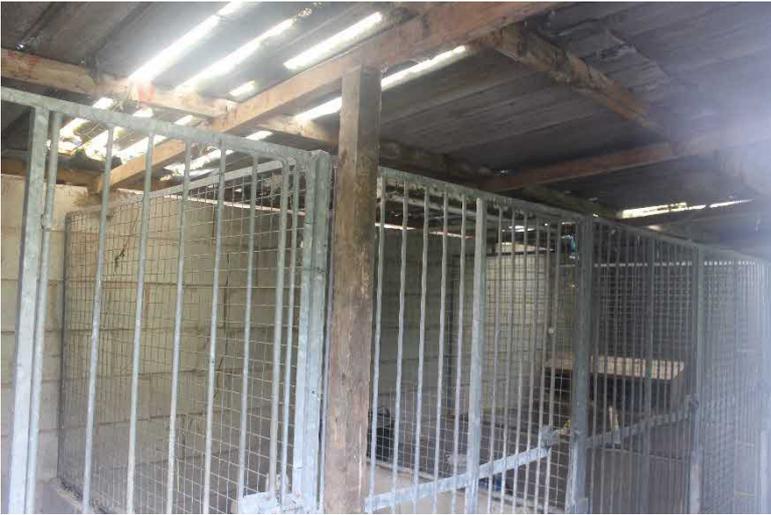
There were no roof voids. The timber rafters in the roof were found to be in excellent condition with no rot, splits or gaps suitable for roosting or hibernating bats. As mentioned above, the poor insulation makes the roof unsuitable for use by roosting bats. No indications of use by bats could be found.

Internal space poorly insulated offering negligible potential for use by bats

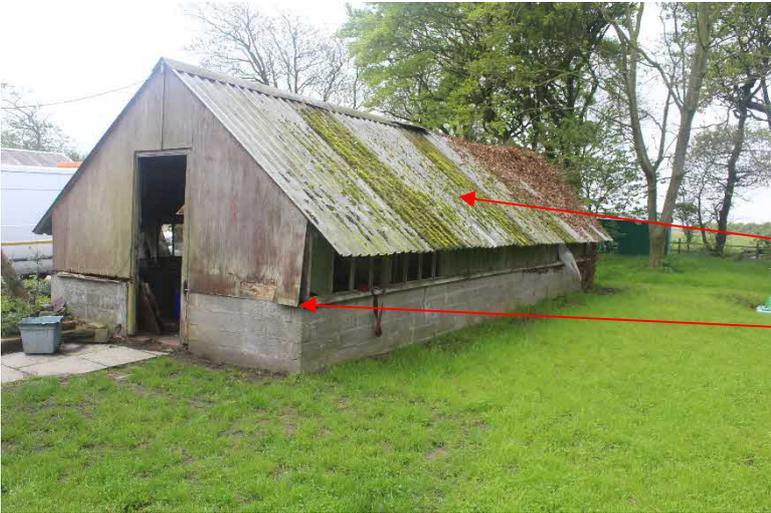
Building 3

The walls of the building are made from concrete blockwork and wood panels. There are numerous gaps in the woodwork and broken windows allowing internal access, though no gaps that offer highly suitable roost sites in the external walls. The eaves are very low due to the style of building with steeply pitched roof. There were no indications of roosting by bats in these areas.

The roof of the building is made from corrugated metal is unlined. Some panels were broken and/or covers in moss. Gaps under corrugations offered gaps, but the metal roof offers poor insulation and is therefore considered unsuitable for use by roosting bats. The full extent of the roof could be seen from the ground with close focus binoculars and a 1,000,000 candle power torch. No indications of use by bats could be found. As the roof is unlined any use of the roof would also result in droppings being deposited internally.

Metal roof damp

Gaps in woodwork and broken windows

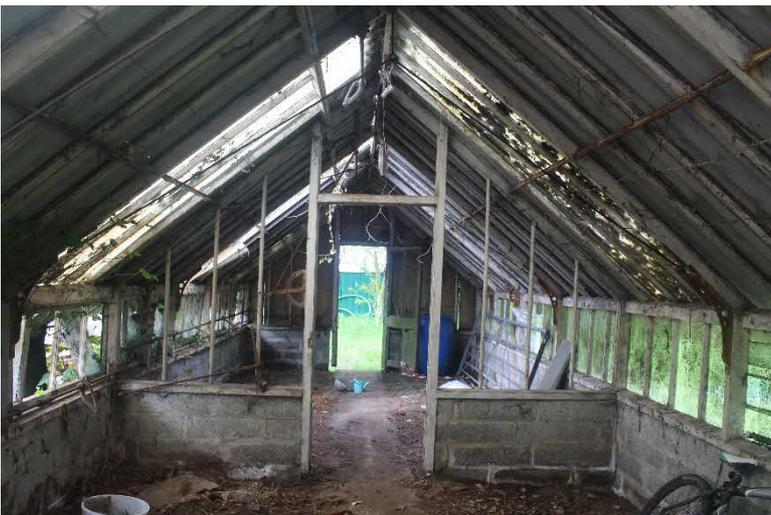
To summarise the building is of small size and the external walls and roof are gappy and poorly insulated. The roof and internal space have negligible suitability for use by bats. Overall this building has negligible potential for use by bats, our categorisation would be 2. Further details of our categorisation can be found in Table .

Internal space light, draughty poorly insulated offering negligible potential for use by bats
