Basement Impact Assessment and Ground Investigation Report

34 Belgrave Mews South London SW1X 8BT

On behalf of Leconfield Property Group

Report Reference: GWPR5680/GIR/December 2023			Status: Final
Issue	Prepared By	Checked By	Verified By
V1.01	 	 	 
	Aubyn Shortland BSc (Hons) FGS Senior Engineer	Miltiadis Mellios MSc(Eng) GMICE FGS MIEEnvSc Principal Engineer	Francis Williams MGeol (Hons) FGS CEnv CGeol Director

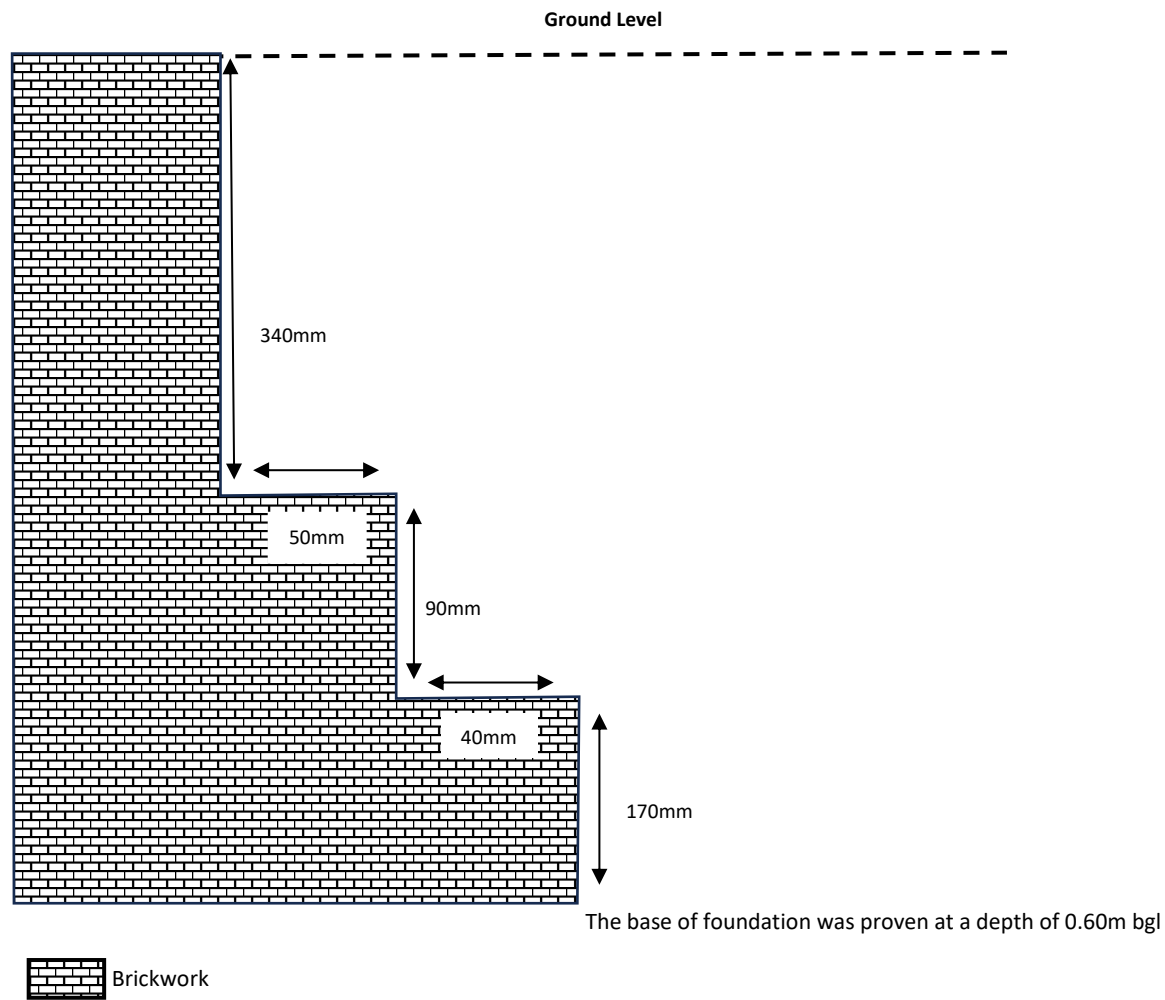
Figure 19: TP/FE02 (North-West Wall)

The base of foundation was proven at a depth of 0.50m bgl

The hand excavation of 2No. Foundation Exposures (TP/FE01 – TP/FE02) was undertaken across the site. A tabulated summary showing the depth and width of each foundation can be viewed below, as well as the bearing stratum. Diagrams of each foundation exposure can be viewed within Figures 17 – Figure 20.

Summary of Foundations Encountered			
Trial Hole	Depth of Foundation (m bgl)	Width at the Base of Foundation (mm)	Bearing Stratum
TP/FE01 (South-East Wall)	1.28	270	Kempton Park Gravel Member
TP/FE01 (South-West Wall)	0.90	60	Kempton Park Gravel Member
TP/FE02 (North-West Wall)	0.50	50	Kempton Park Gravel Member
TP/FE02 (North-East Wall)	0.60	90	Made Ground

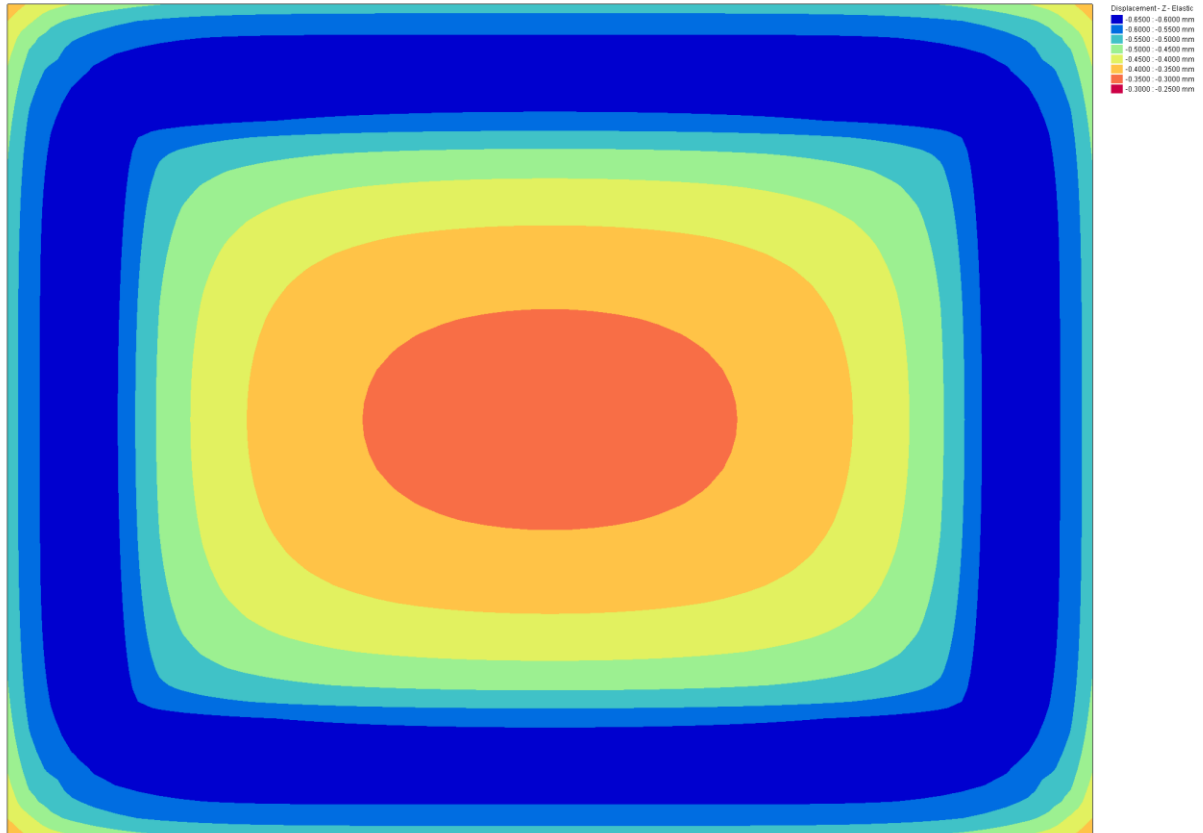
Vertical Displacement Contour Plot – Model 2

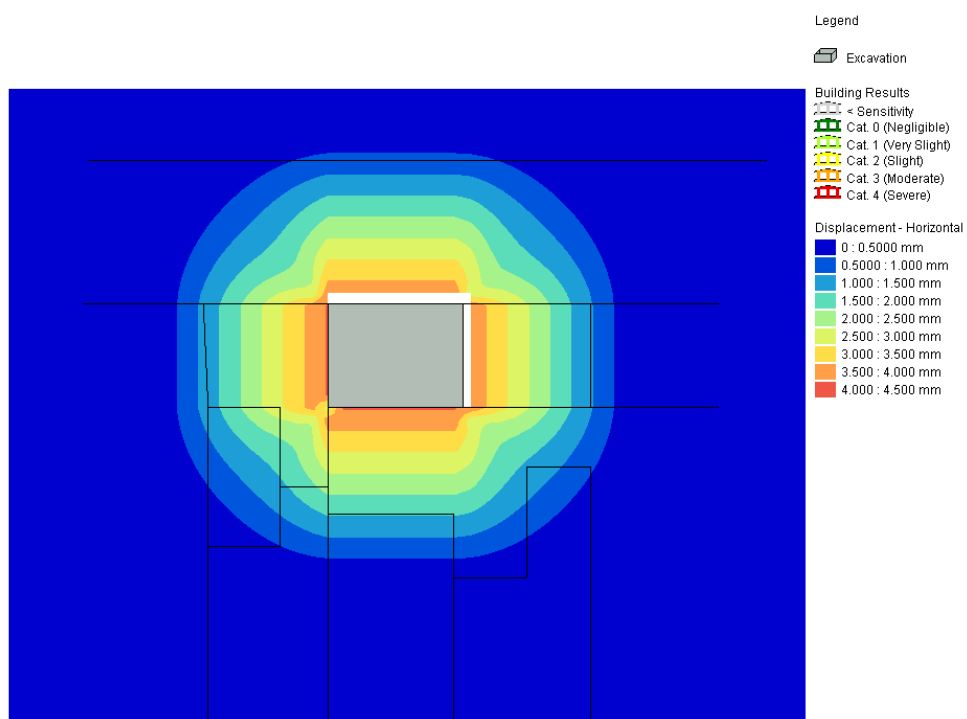
Model 2 Vertical Movement
