Arboricultural method statement to install a root barrier

CLIENT REFERENCE: SU2204195

OUR REFERENCE: OPT-7799

DATE: 11 September 2023

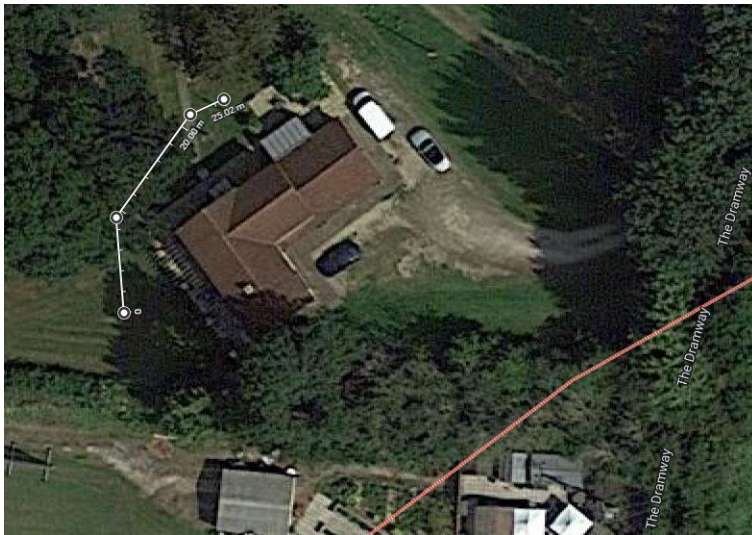
Figure 1 - Aerial plan indicating proposed length and alignment of barrier

Specifications of Barrier					
Barrier Type	Length (m)	Max Root Depth from SI (m)	Minimum depth to be achieved with barrier (m)	Shortest distance between vegetation and barrier (m)	Shortest distance between barrier and foundation (m)
Copper	25	N/A	3	8	2.5

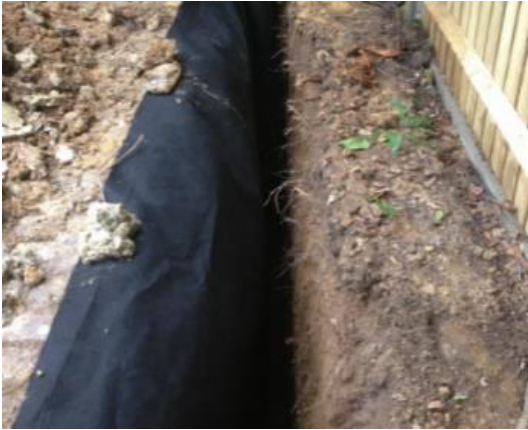
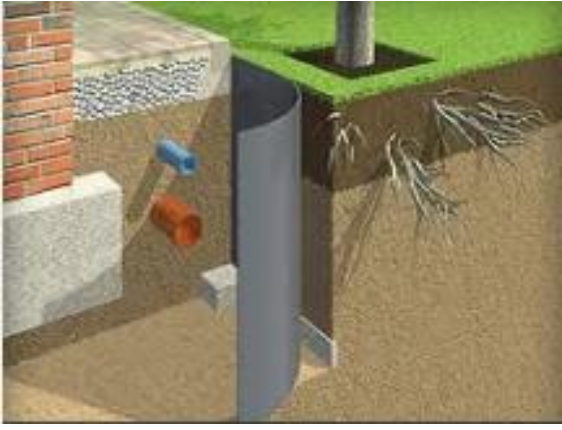
Following installation of the root barrier, the trench may be backfilled with 20mm single sized stone, alternatively, and dependent upon site conditions, backfilling could be done with as-dug material, which would be placed and compacted with a plate-compactor mounted on the excavator arm. In specific circumstances, we may also use no-fines concrete on the structure side of the shield.
