Site

119 The Drive,
Rickmansworth,

Zac Monro Architects

Arboricultural Impact Assessment AIA-27320-REV 0

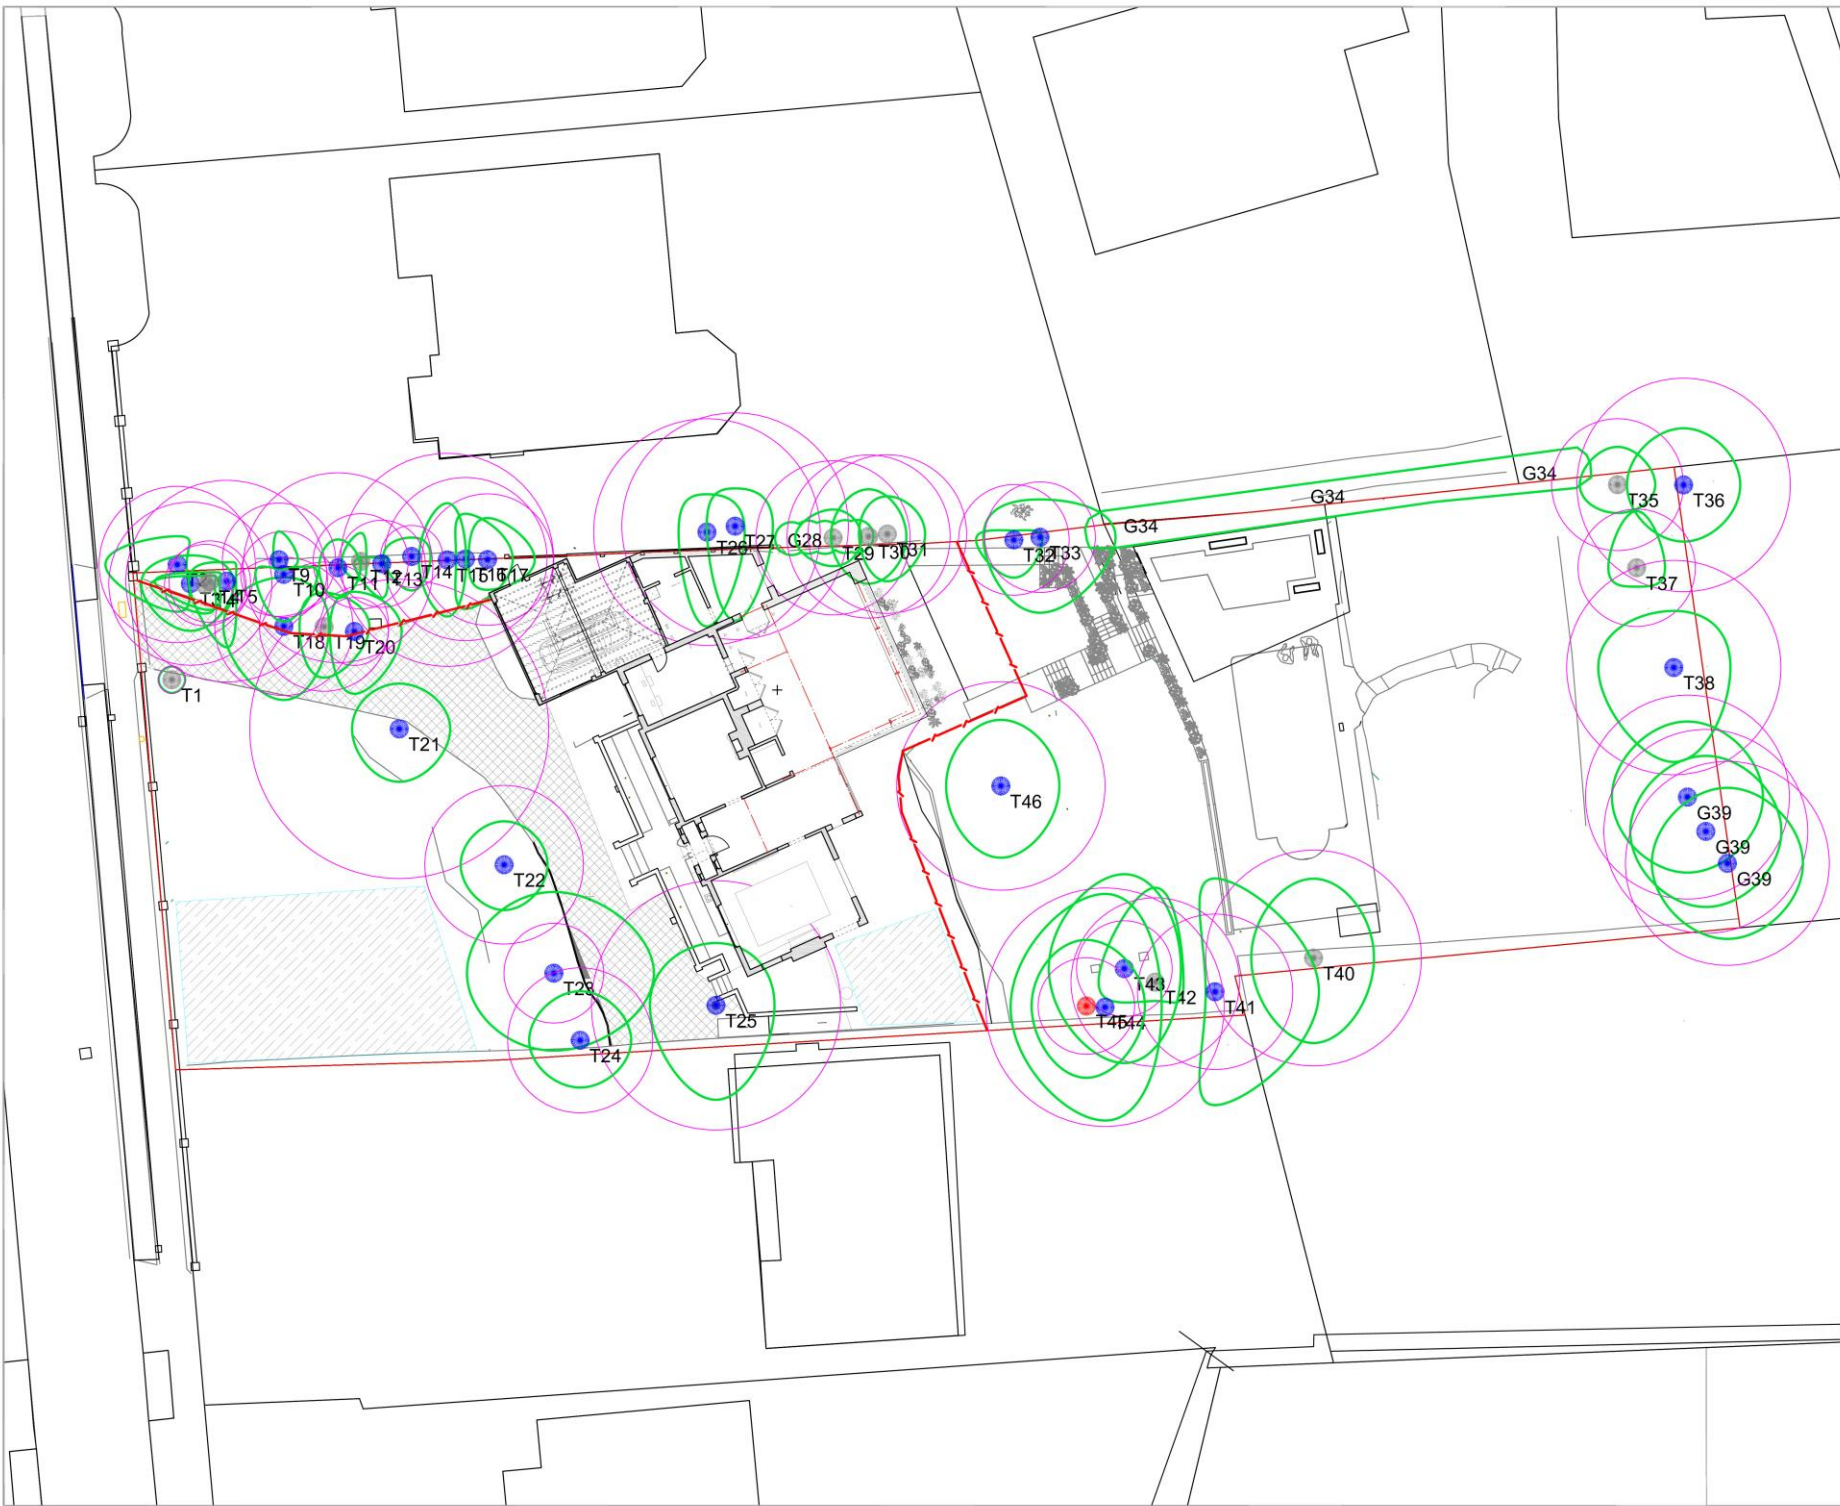
TITLE: Tree Protection Plan

- 6.1 The Tree Protection Plan (ATS-TPP-27320-02) and Tree Location Plan (ATS-TLP-27320-01) has been produced based on the provided topographical survey and proposed site plan. The tree protection plan should be used for tree issues only.

- 7.1.1 Retained trees shall be protected by tree protection barriers before any materials or machinery are brought onto the site and before any construction takes place. Tree protection barriers shall be installed around retained trees as indicated on the tree protection plan.

- 7.1.3 Access to the site is required along the driveway which is lined with trees either side. The trees along the northern boundary (T2-T20) can feasibly be protected by fencing.

- 7.1.4 Additionally, trees to the rear of the garden (T32-T46) that are not affected by the works can be 'closed off' with fencing running from north-south across the garden to prevent incursion into the root protection zones.

- Machinery (e.g. diggers) must not be tracked across unprotected soil within Root Protection Areas (RPA).
- Building materials must not be stored on unprotected soil within RPA.
- Any materials that have the potential to contaminate the soil (e.g., concrete mixing and diesel oil) must not be discharged within 15m of the tree trunk.
- The topography of the site must also be considered to avoid materials hazardous to the tree's health washings towards its rooting area.
- Fires must not be lit in close proximity to trees.
- Notice boards, telephone cables or other services should not be attached to any part of retained trees.
- Ground levels within RPAs must not be changed.
- Materials storage areas have been suggested on the tree protection plan, outside of the root protection zones.

Stage 1	Installation of tree protection barriers and ground protection in accordance with tree protection plan (ATS-TPP-27320-02)
Stage 2	Complete all construction works
Stage 3	Remove all machinery and materials from site
Stage 4	Remove tree protection barriers and ground protection
