PRELIMINARY BAT ROOST ASSESSMENT  
OF  
86 CAYTHORPE ROAD  
CAYTHORPE  
NOTTINGHAMSHIRE

**December 2023**

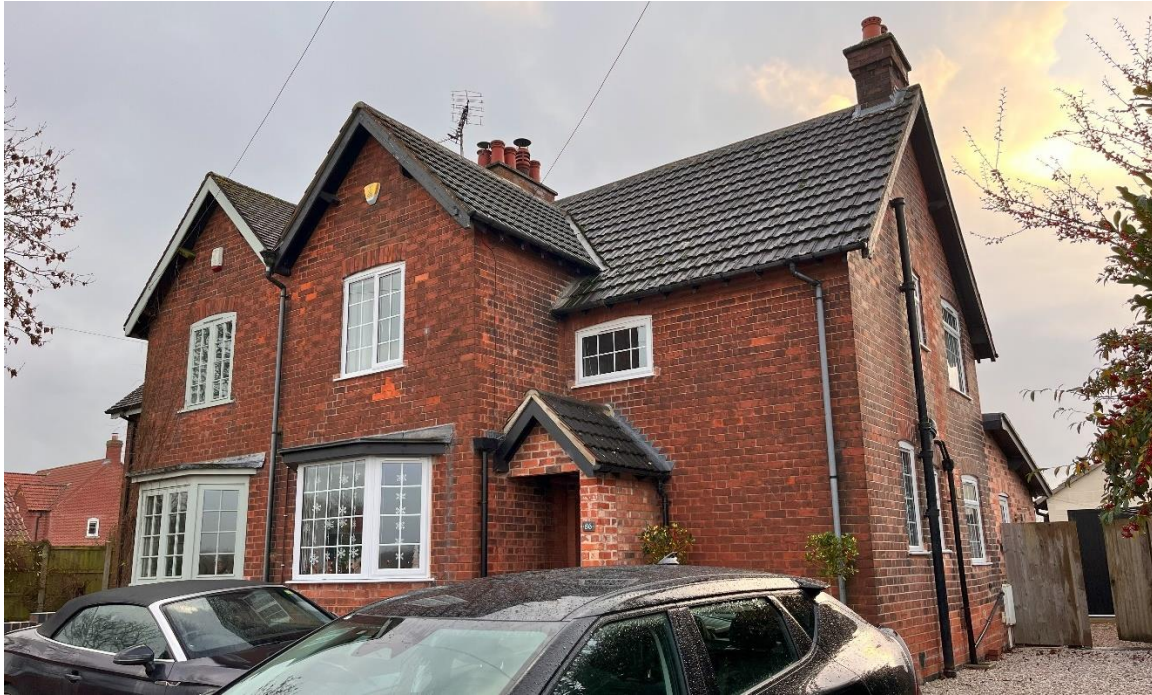
Photograph 1: 86 Caythorpe Road, taken from the north-west, showing the two-storey dwelling and its L-shaped footprint, along with the interlocking roof tile feature and exposed timbers on the gables and eaves.

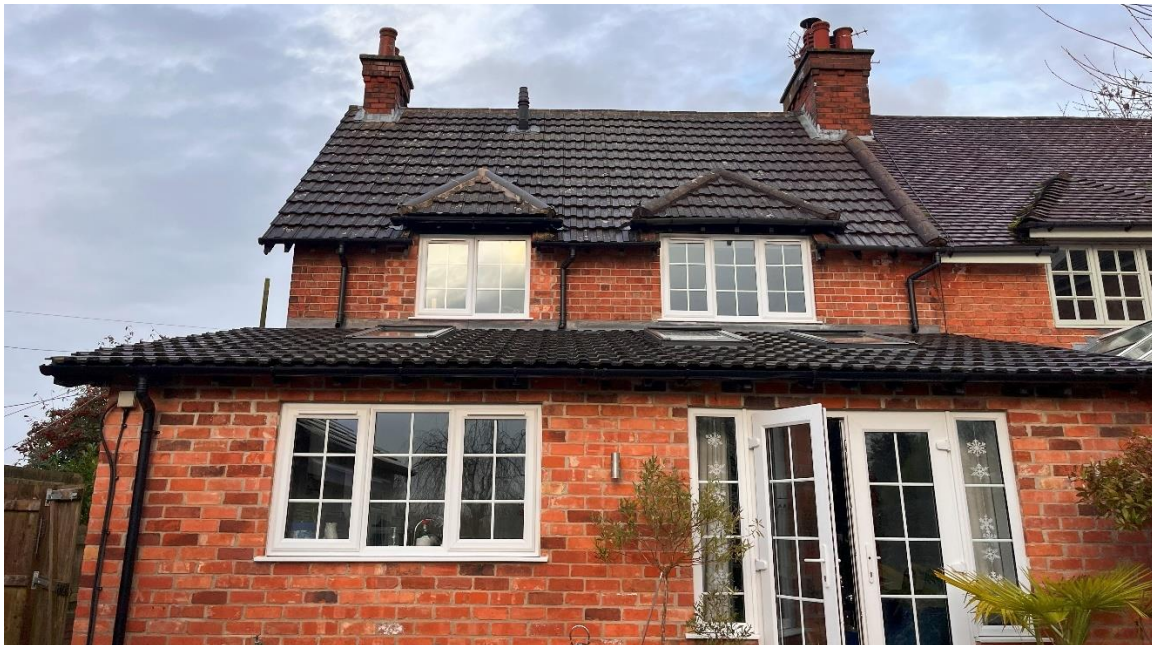
Photograph 2: 86 Caythorpe Road, taken from the south, showing the single-storey extension to the rear of the property.

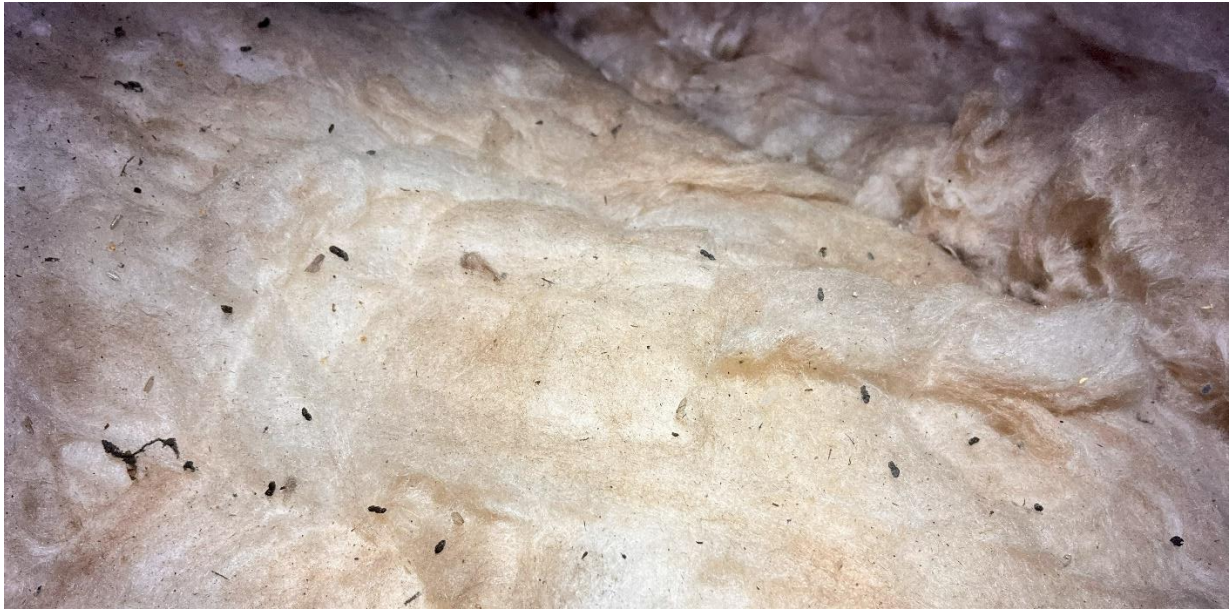
The internal search of the dwelling found evidence of bat roosting in the form of droppings, of the shape and size of those usually voided by one of the *Myotis* or *Plecotus* species of bat. These droppings were found largely to be scattered through the void, with a small aggregation located beneath some sagging bitumen felt along the ridge, approximately above where the ridge board of the north facing gable extends into the main pitch. This was considered the most likely access point into the roof space.

Photograph 3: Dropping evidence within the roof void.

As a result of this categorisation, there is a requirement for further phase II bat emergence and activity surveys in order to ascertain the status of the roost, as well as species present and to determine access points. These surveys must be undertaken within the active survey season for bats, which will be within the months of May-September, as seen in figure 2 below:

The current evidence is such that it is highly likely the development project will require the need to be covered by a European Protected Species Derogation Licence, to render it lawful. Given the limited extent of evidence, and that pointing to a roost of low conservation significance, it is considered likely that the project will qualify for the CL21 – Bat Low Impact Class Licence (Collins 2023).

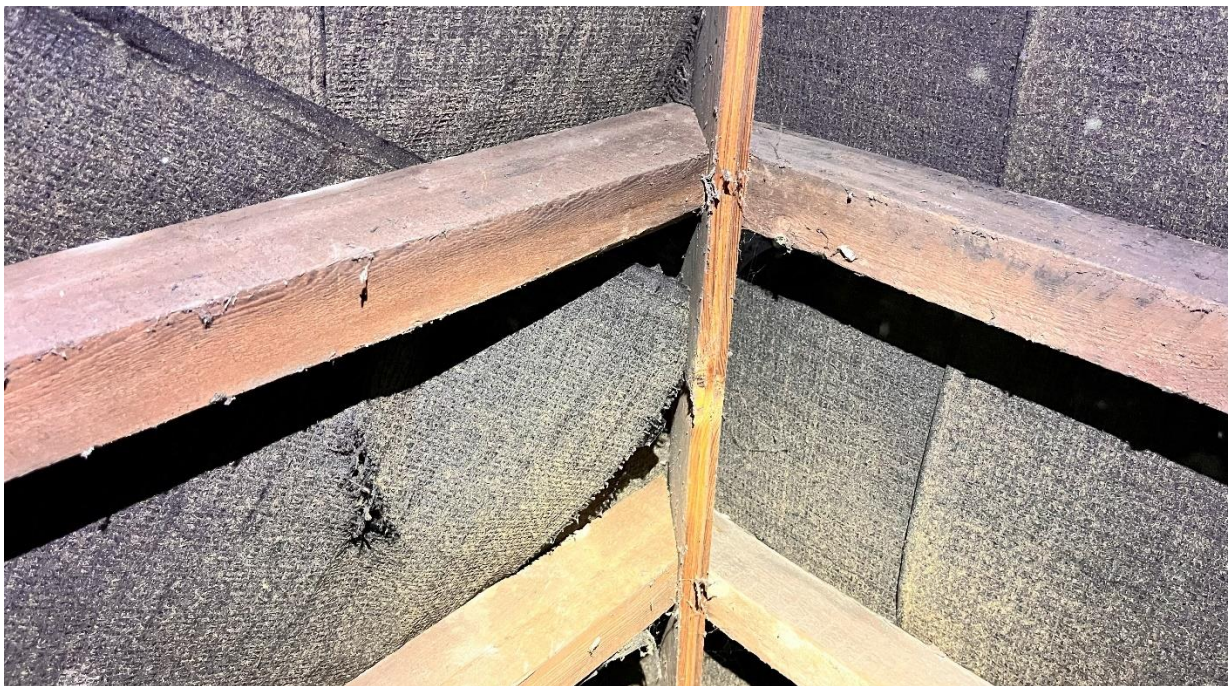
Photograph 4: The section of bitumen felt adjacent to the ridge board which has sagged, beneath which the aggregation of droppings were located.

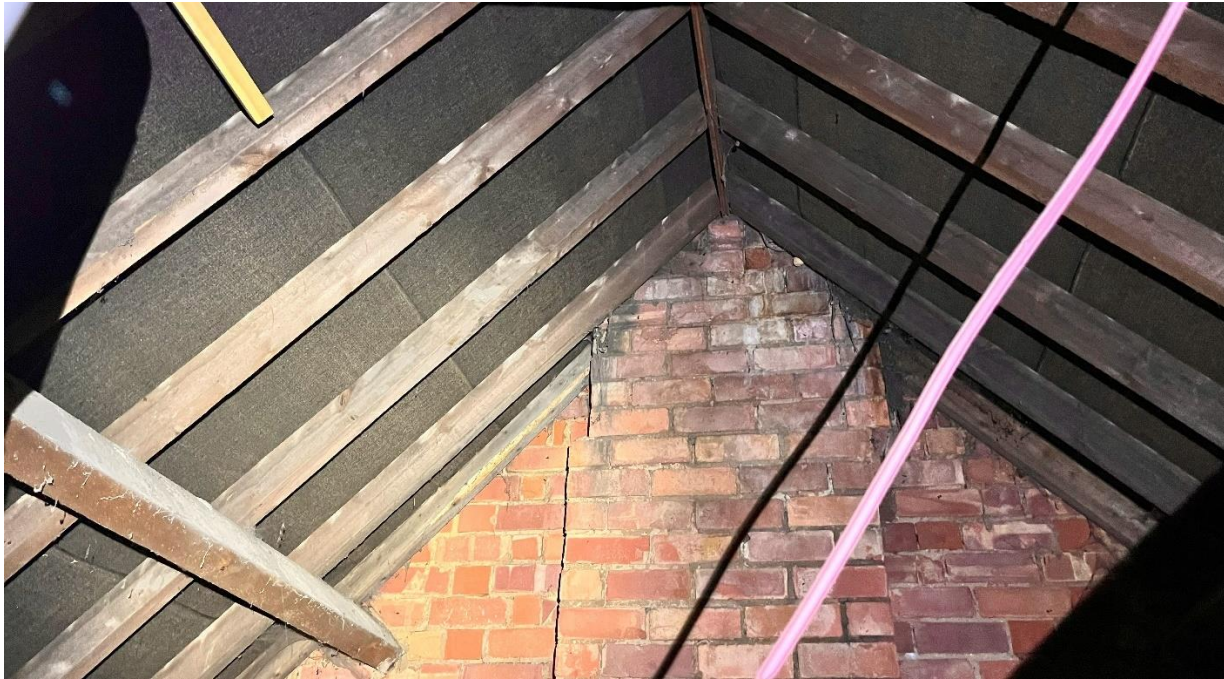
The roof space was an uncluttered void, free from heavy cobwebbing along the ridge board but heavily cobwebbed at the gable ends, with a general layer of detritus across the thick layer of insulation. Cobwebs at the gable ends were checked for evidence though none was found.

**Photograph 5: The roof void of the dwelling, pointing toward the western gable of the main pitch, showing the uncluttered space, the timber frame and the bitumen felt underlining. Note the relative lack of cobwebs along the ridge.**

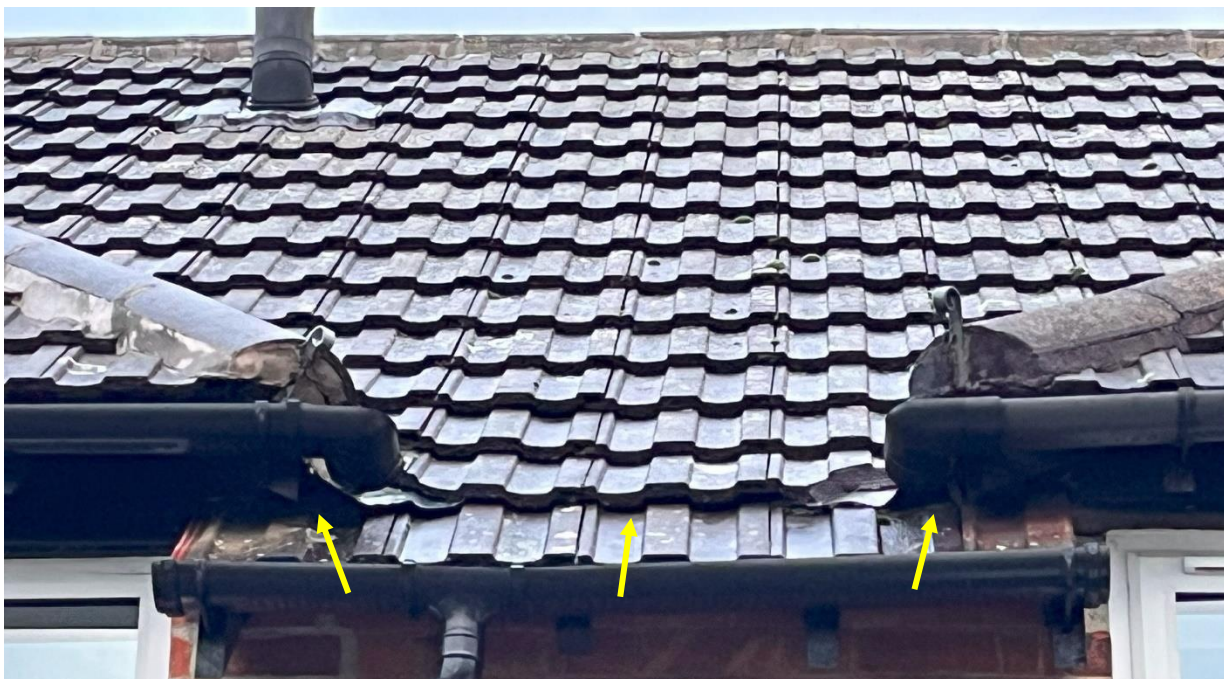
Features consisted of a space behind the lead flashing around the chimney breasts, gaps beneath roof tiles, potential space around the mini roofs above the bay windows, gaps around exposed timbers in the eaves of the south facing extension, and on both the west and north facing gables, and a section of missing bedding mortar on the gable verge of the north facing elevation.

**Photograph 6: Evidence of gaps beneath roof tiles and around the mini roof structures associated with the bay windows.**

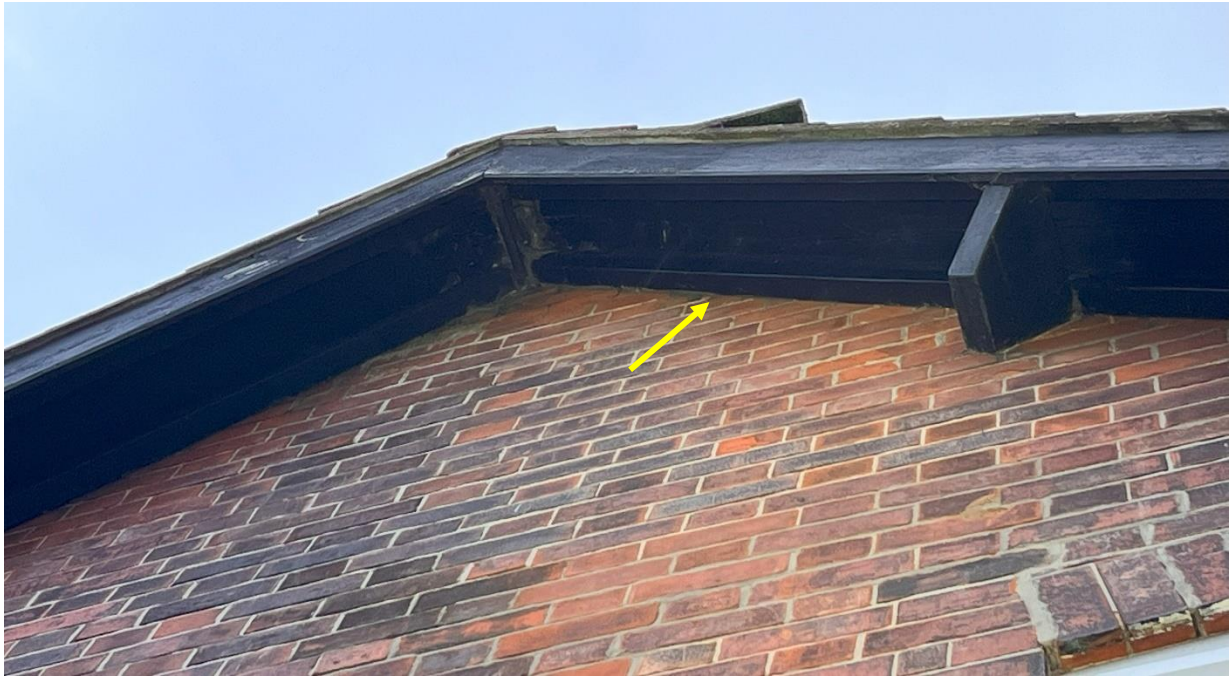
**Photograph 7:** Evidence of space behind exposed timber features on the gable ends and at the eaves. This image shows the western gable.

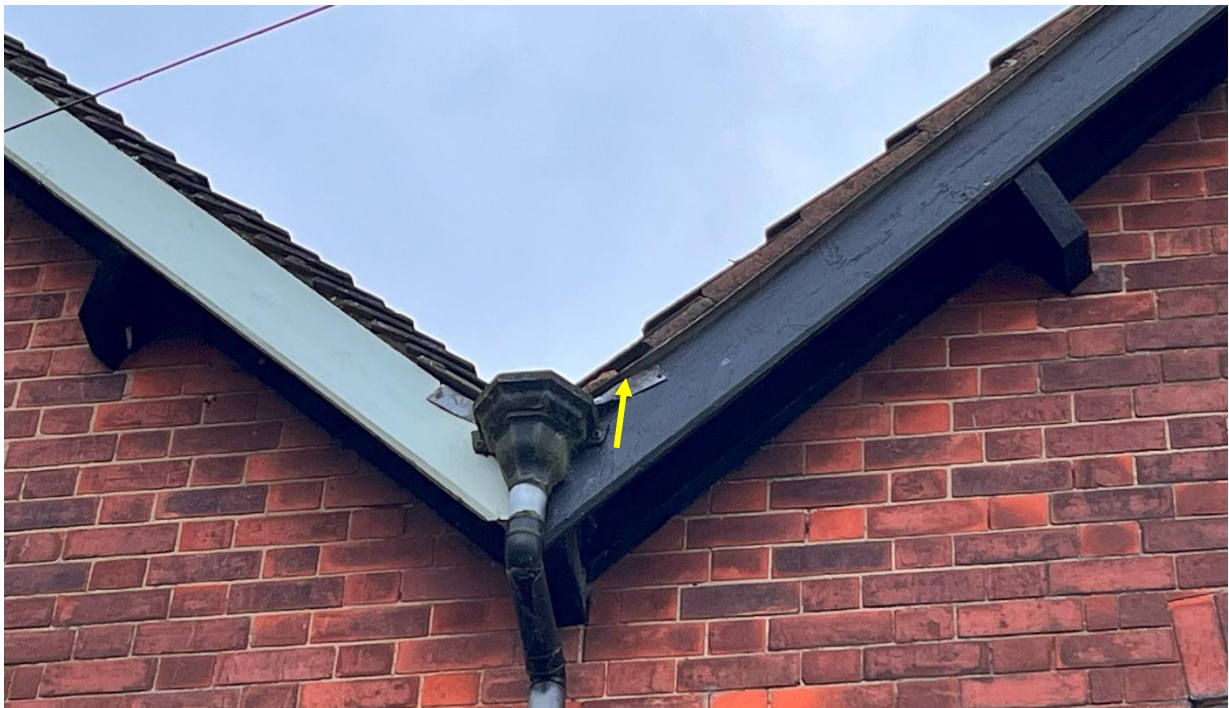
**Photograph 8:** Evidence of missing bedding mortar on the gable verge of the north facing extension.
