**T007 TAYLOR**

**SUPPORTING STATEMENT TO LISTED BUILDING CONSENT  
FOR  
INTERNAL ALTERATIONS  
AT  
AIRTHREY CROFT, 39 KENILWORTH ROAD, BRIDGE OF ALLAN, STIRLING FK9 4RP**

**12 DECEMBER 2023**

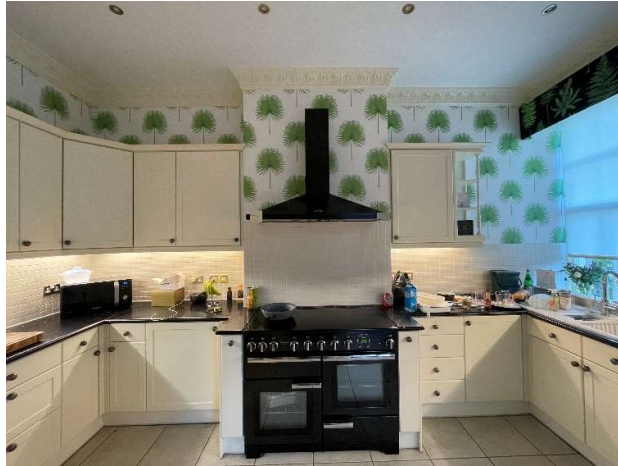
Figure 6 – Kitchen Elevation

- 4.2 The existing ceiling has been lowered to accommodate modern downlights and possibly ducting for the extract fan above the cooker. This ceiling height will be retained. It is possible the existing detailed cornice is above the false ceiling. The current cornice is clearly non-original.

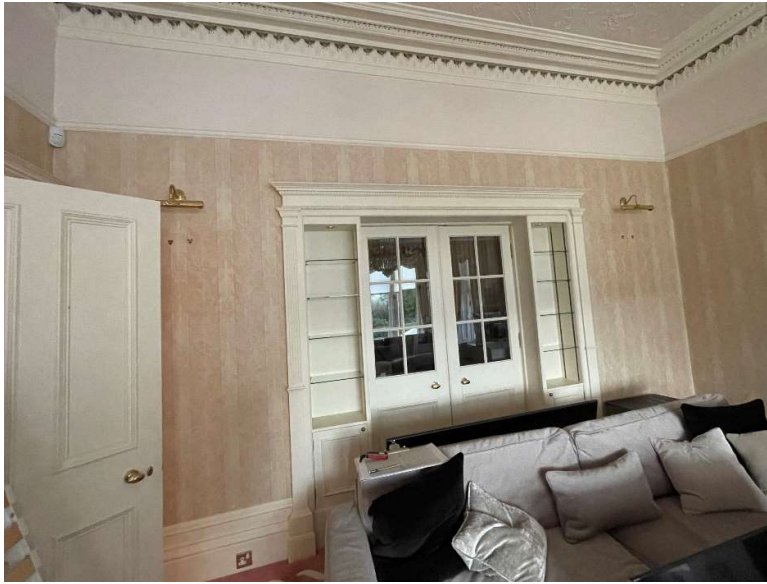
- 4.4 The double doors and side panels are not original features.

Figure 8 – Double doors and side panels as viewed from Drawing Room

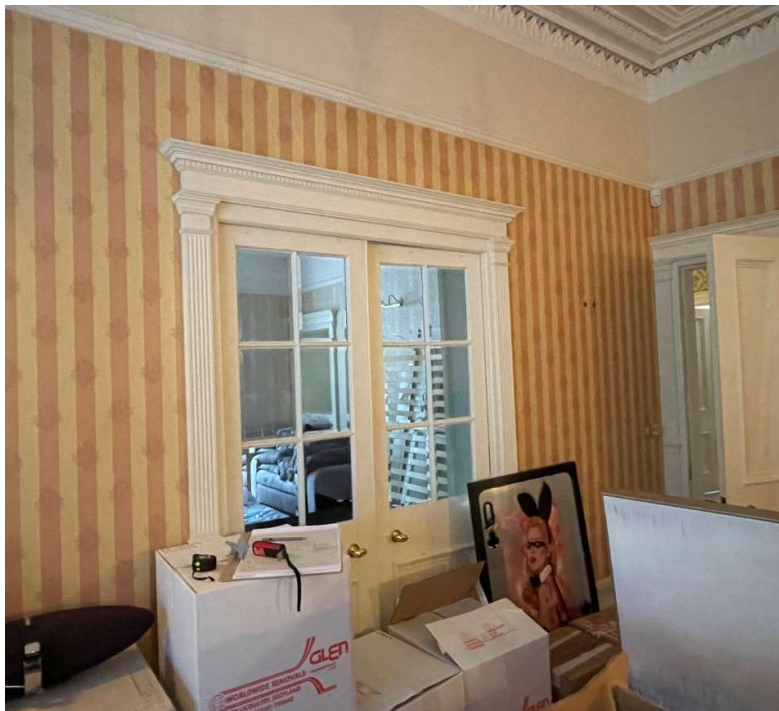
Figure 9 – Double doors as viewed from Dining Room

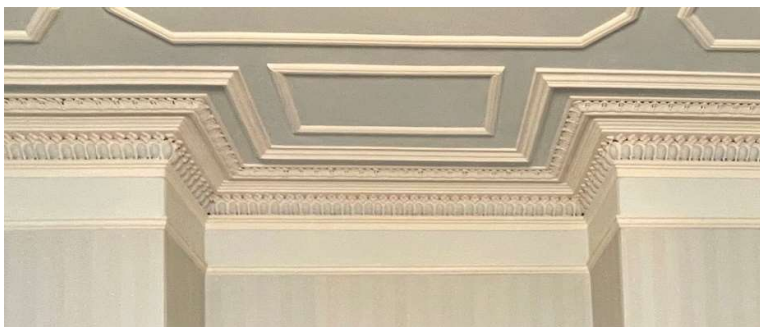
- 4.5 There is an existing picture rail which is at a height of 3045mm from the floor level to the underside of the picture rail.

4.6 The ornate cornice is located above this.

Figure 10 – Cornice and Picture Rail in Lounge
