London Institute of Healthcare Engineering

Verification Report

Land contamination risk management

Report Ref.	102228-PF-ZZ-XX-RP-GG-600004_P01 LIHE Verification Report					
File Path	\\rsbgukfs01\LONEngineering\1022--\102228 - London Institute of Healthcare\6 Documents\6.15 GG Geoen\01 Reports\102228-PF-ZZ-XX-RP-GG-600004_P01 LIHE Verification Report.docx					
Rev	Suit	Description	Date	Originator	Checker	Approver
P01	S2	Initial issue	20-Nov-2023	S Hyde/ A Tadayon	A Boucher	A Boucher
Ref. reference. Rev revision. Suit suitability (S2 – suitable for information)

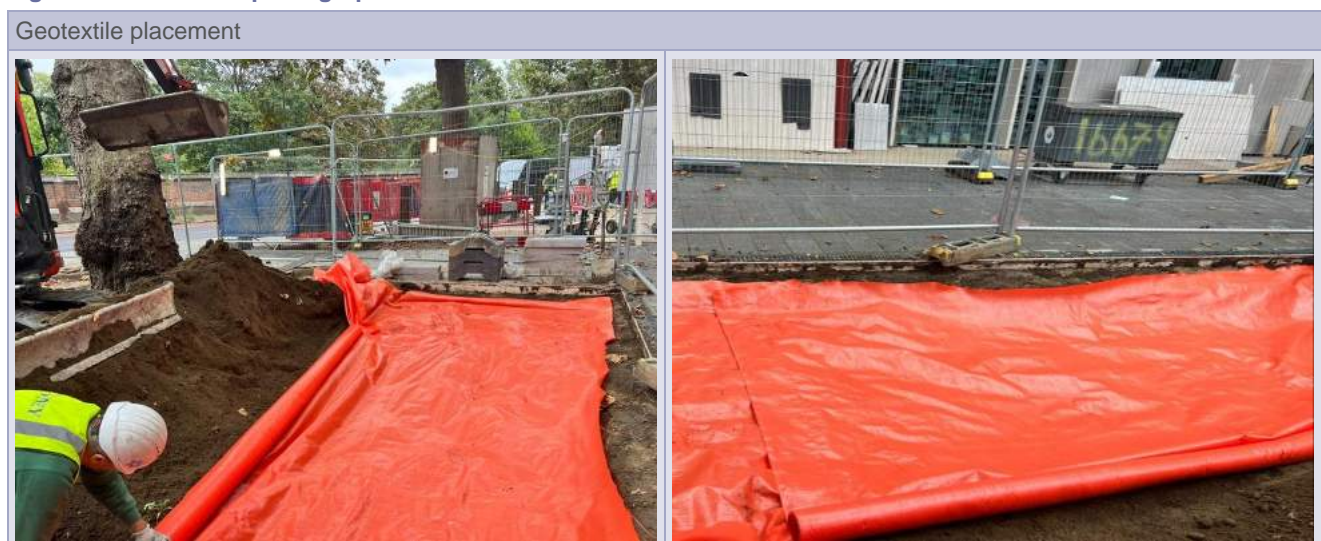
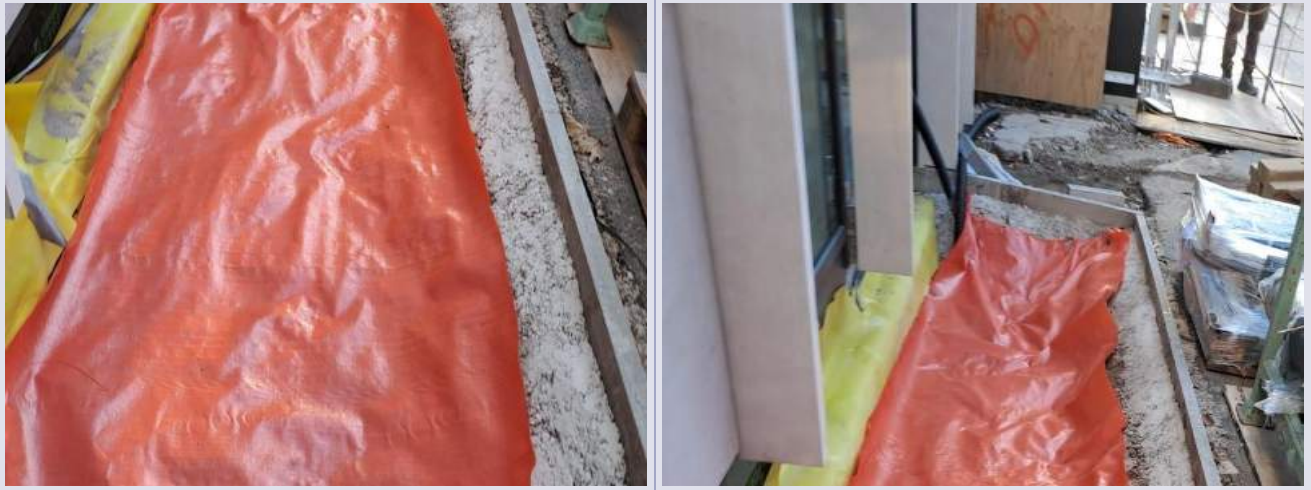
Figure 4-1 Geotextile photographs

The datasheet for the geotextile used onsite is presented in Appendix A. A non-woven geotextile was specified in the remediation strategy and a woven geotextile has been deployed onsite, however the geotextile used meets the tensile strength requirements so can be considered acceptable. Figure 4-1 includes a selection of photographs taken by the contractor during construction confirming the placement of the geotextile onsite.

Geotextile placement

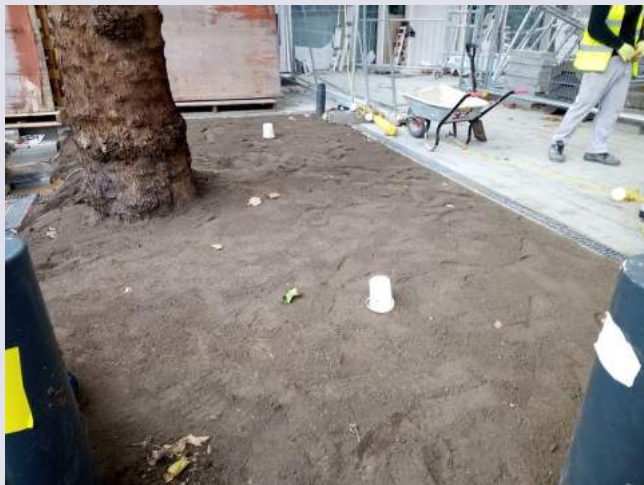
Soft landscaping area - ground level (V101- V102)

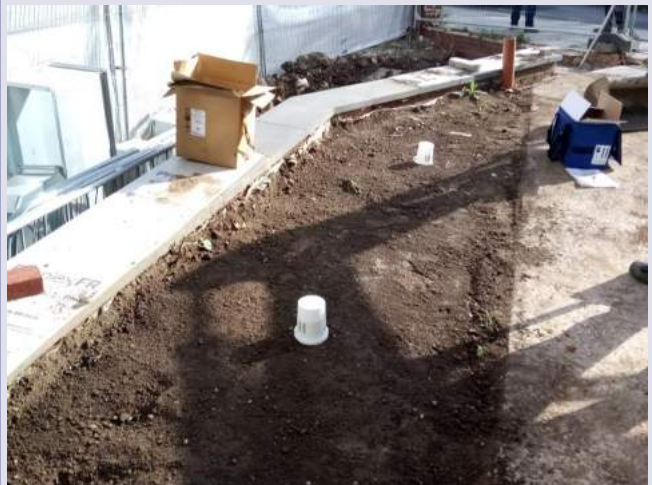
Soft landscaping area - ground level (V106 -V107)

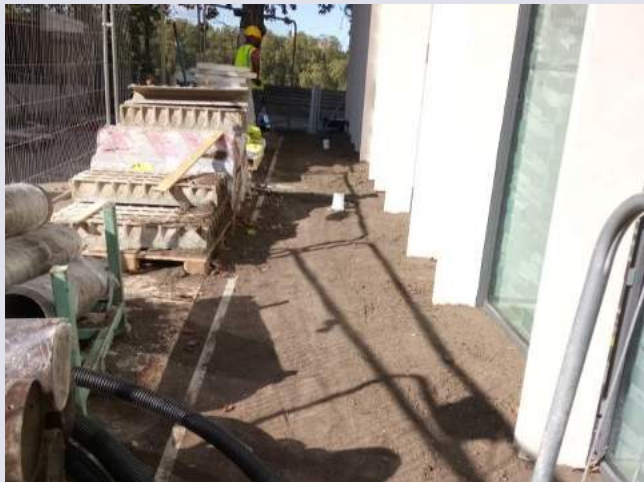
Soft landscaping area - ground level (V110 – V112)

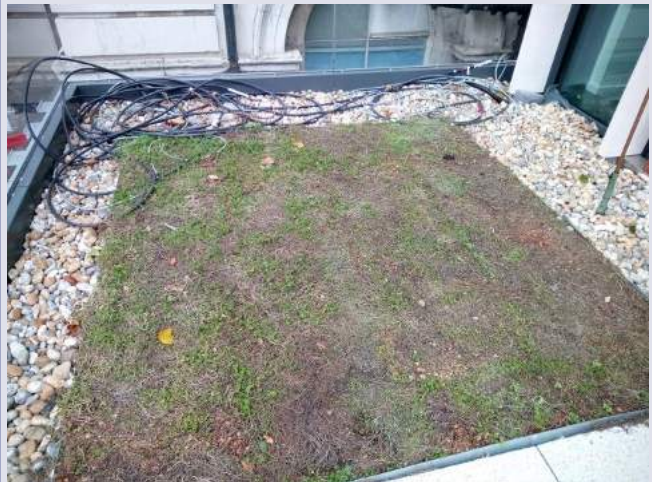
Rooftop terrace garden on Level 1

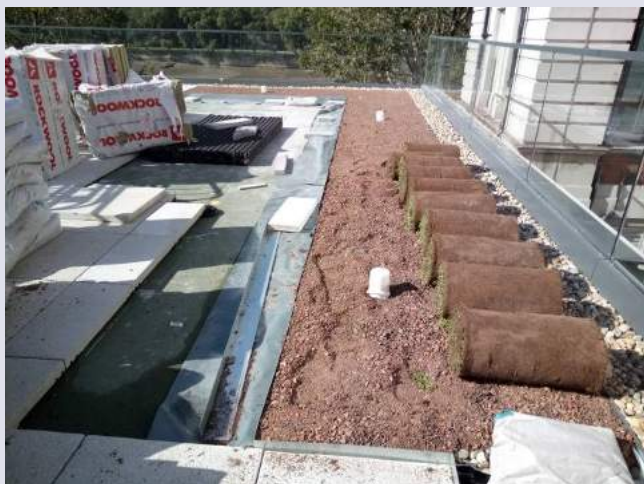
Rooftop terrace garden on Level 3

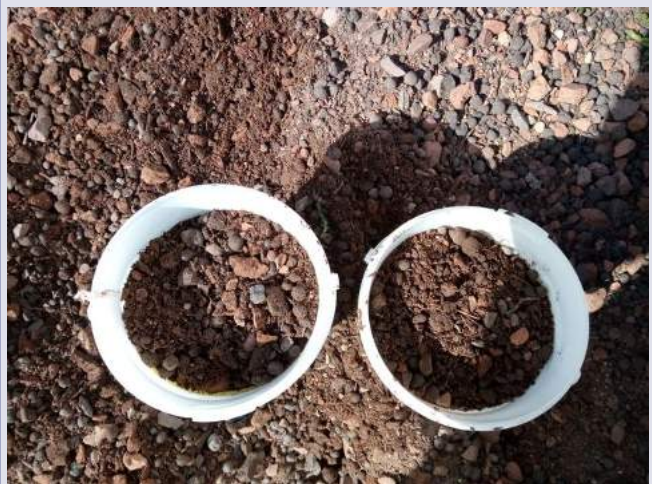
Imported topsoil – rooftop terrace garden

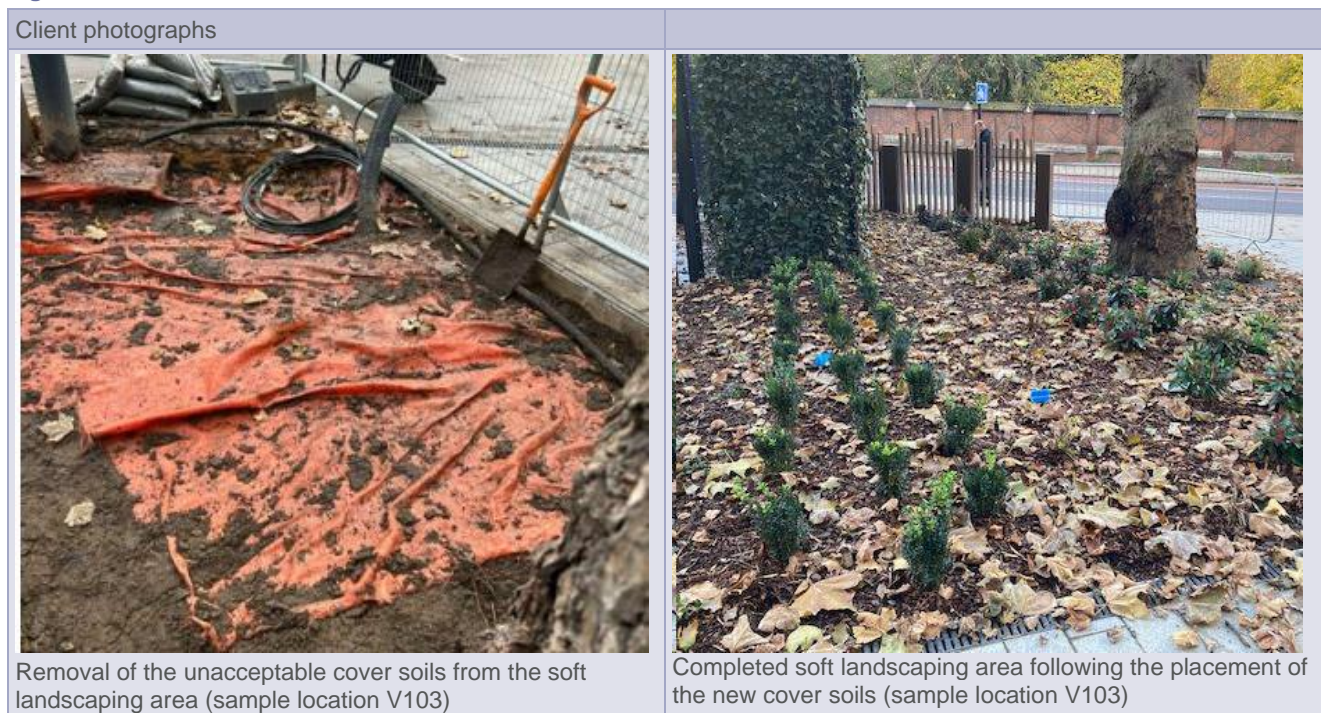
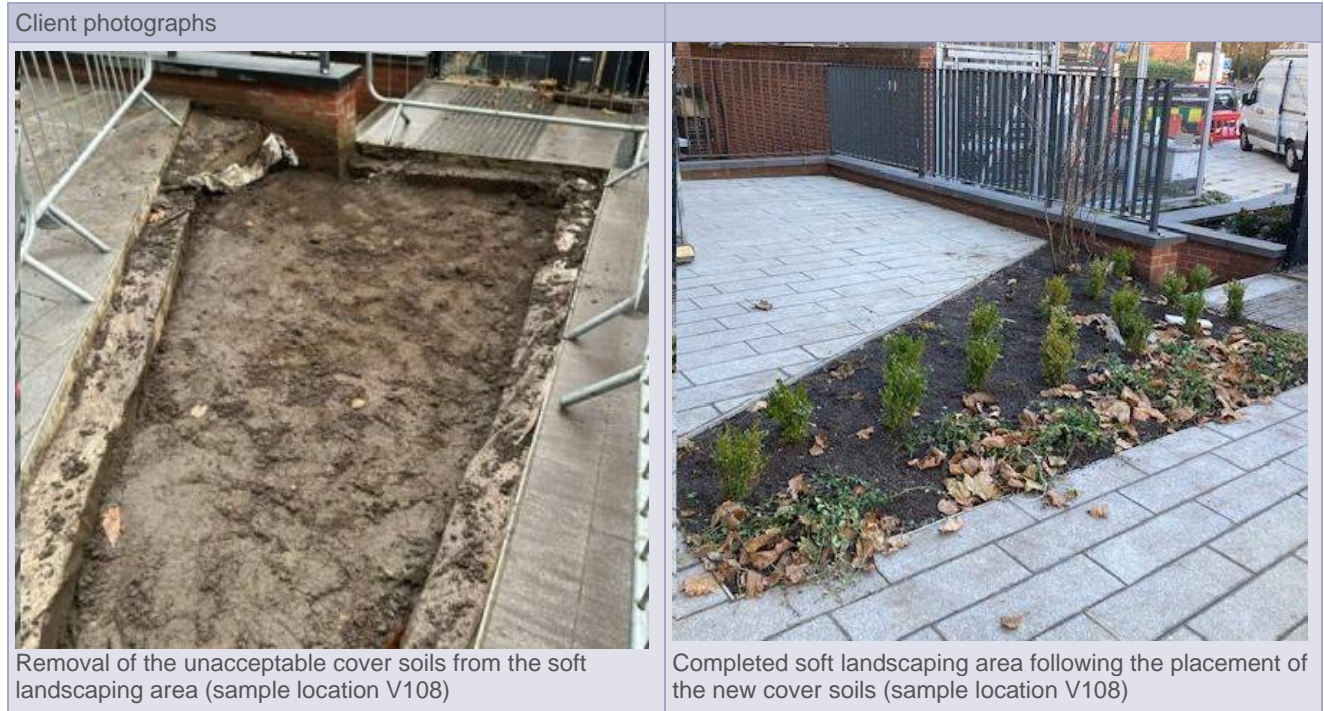
Figure 5-1 Remediation areas corrective actions

- Approximately 5m³ of soil was removed (down to the geotextile), circa 400mm deep.
- Soil was removed in stages and stored in covered stockpiled within the site compound for collection and offsite disposal.
- The newly imported replacement soils were used to reinstate the cover soils.
- Works were undertaken and completed on 10 November 2023.

- Approximately 3m³ of soil was removed, circa 400mm deep.
- Soil was removed in stages and stored in covered stockpiled within the site compound for collection and offsite disposal.
- The newly imported replacement soils were used to reinstate the cover soils.
- Works were undertaken and completed on 10 November 2023.

A plan showing the areas where soils were excavated, removed and replaced is included in the client email dated 15 November 2023 in Appendix E.

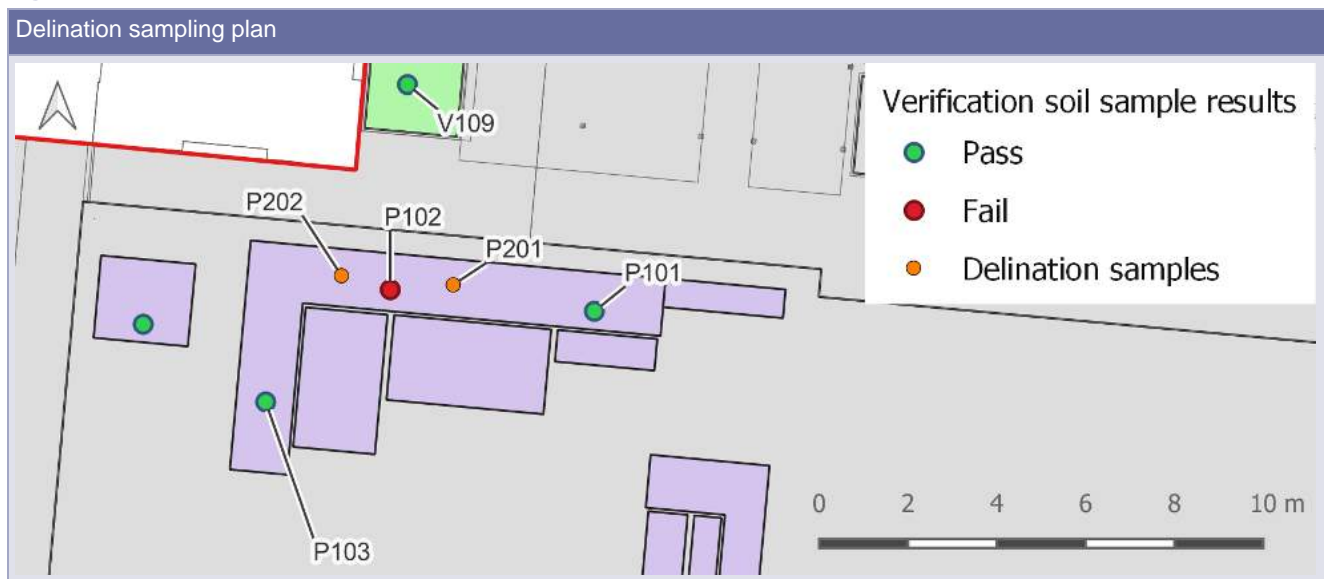
Figure 5-2 Delineation sample plan

- The geochemical analysis results for both soil samples pass the soil acceptability criteria (SAC),
- Asbestos in soils was not detected in the delineation samples (P201 and P202).

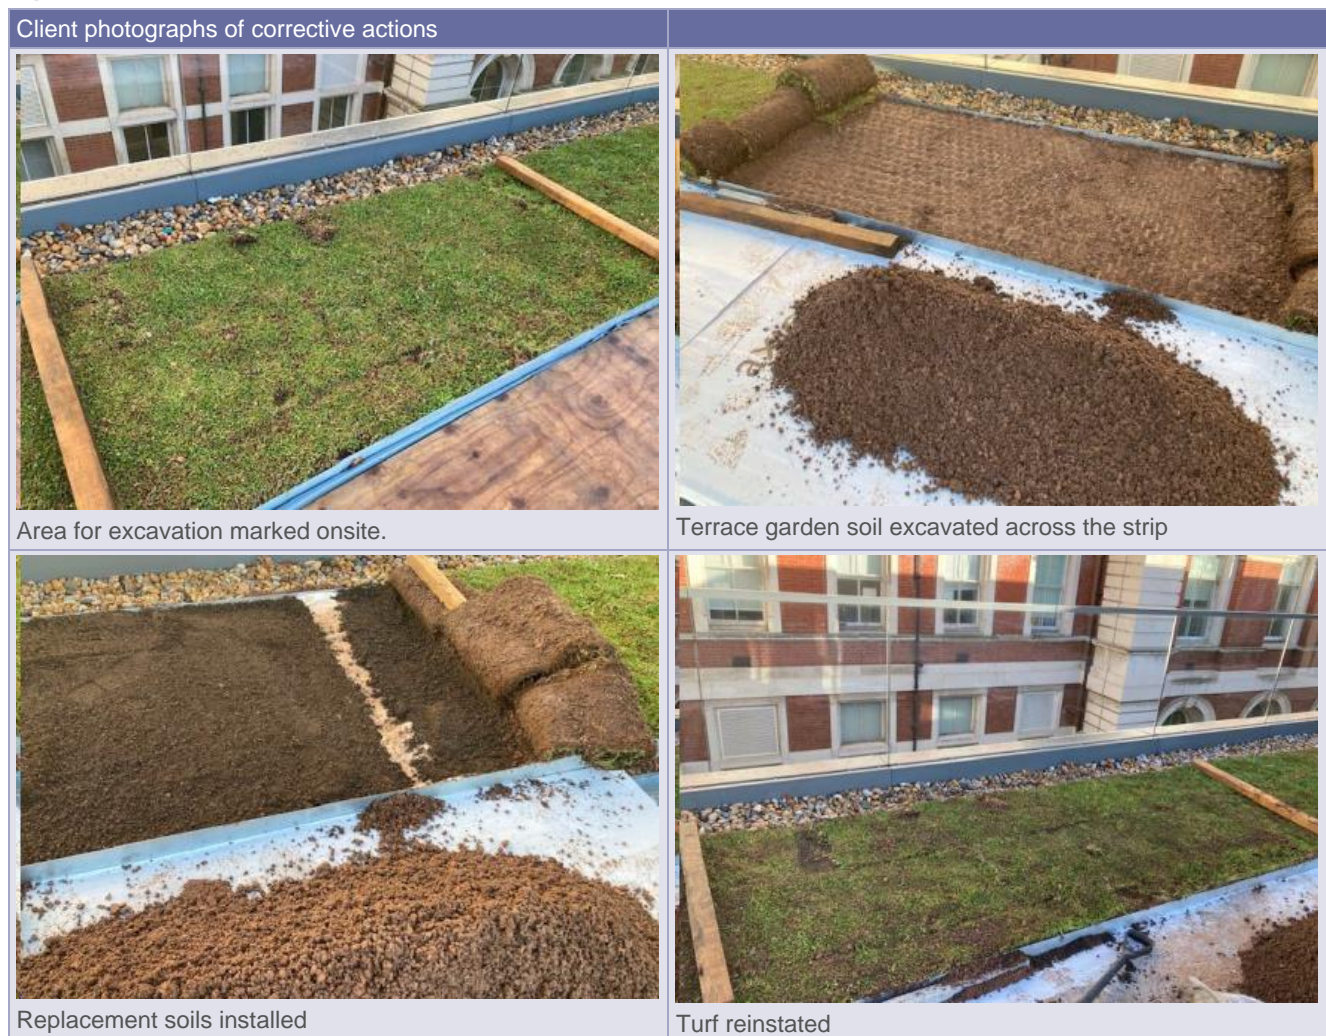
Figure 5-3 Corrective actions

- Due to the localised nature of the asbestos in soil, the terrace garden soil was excavated and removed from a 3.5m section centred around location P102.
- Approximately 0.3m³ of substrate and soil was removed down to the drainage board (black plastic crates).
- The soil and substrate were removed in stages and stored in a covered stockpile within the site compound for collection and offsite disposal.
- The newly imported replacement soil was used to restore this area.
- Works were undertaken and completed on 11 November 2023.

Photographs of showing the works being undertaken are included in Figure 5-3, overleaf and a plan showing the areas of 'corrective actions' is included in the client email dated 15 November 2023 included in Appendix E.

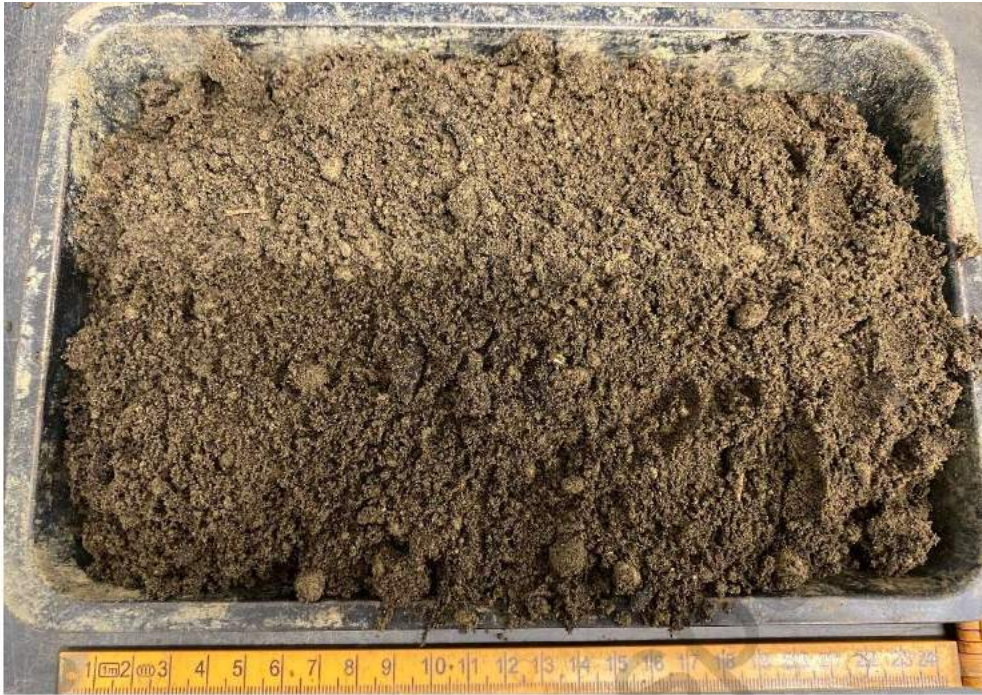
Plate 1: Topsoil 2: 65/35 Blend Sample

The sample was described as a brown (Munsell Colour 10YR 4/3), slightly moist, friable, slightly calcareous SANDY LOAM with a weakly developed, very fine to fine granular structure*. The sample was slightly stony and contained a high proportion of organic fines and occasional woody fragments. No unusual odours, deleterious materials, roots or rhizomes of pernicious weeds were observed.

The sample fell into the *sandy loam* texture class. However, further detailed particle size analysis revealed the sample to have a high proportion of particles in the *very fine* (0.05-0.15mm) fraction. Topsoils such as this are prone to self-compaction when initially placed in a landscape environment, which can lead to limited drainage and poor aeration, particularly if the soil does not display a well-defined structure. To reduce the risk of self-compaction, we recommend placing this soil to a maximum depth of 300mm, which is in line with BS3882:2015, section A.3.

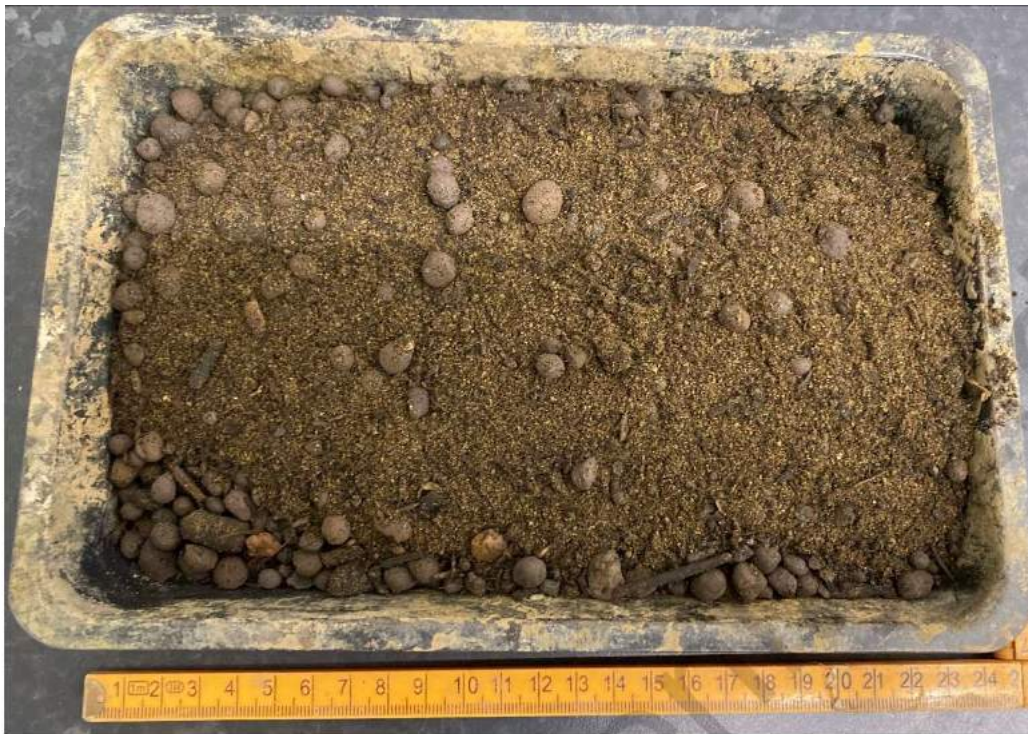
Plate 1: Lightweight Topsoil Sample

The sample was described as a very dark brown (Munsell Colour 10YR 2/2), slightly moist, friable, very slightly calcareous, LOAMY SAND with a single grain structure. The sample was very slightly stony, with the exception of frequent lightweight expanded clay aggregate particles (leca). The sample contained a moderate proportion of organic fines and occasional woody fragments. No deleterious materials, unusual odours, roots or rhizomes of pernicious weeds were observed.

The sample fell into the *loamy sand* texture class. Further detailed particle size analysis found the sample to have a predominance of *medium sand* (0.25-0.50mm) and smaller proportions of *coarse sand* (0.50-1.0mm). This is usually suitable for topsoil in rooftop or podium garden applications as reasonable porosity levels are generally maintained in a consolidated state and the risk of particle interpacking is reduced. The sample should therefore provide adequate drainage and aeration properties for these applications.
