Project: External and Internal Refurbishments,
Construction of Rear Conservatory &
Associated Works @ Gosallen, 2 Union
Place, Truro, Cornwall, TR1 1EP

Title: Existing Floor Plans & Elevations

Project No. 2478 Drawing: 003 Rev. H

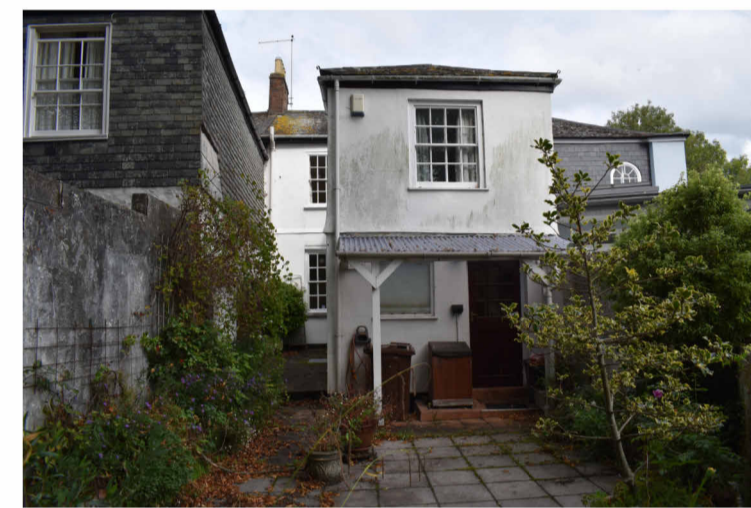
Existing Lean-to Roof (proposed to be removed) is of no historic or architectural merit.

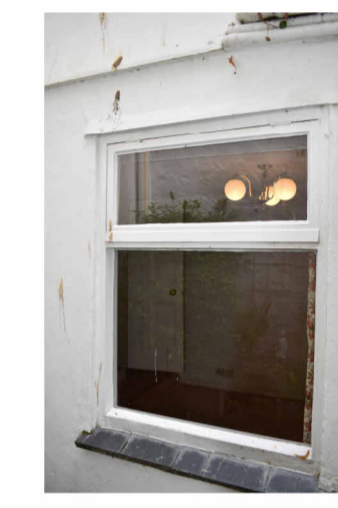
Existing Window WGF04. To be removed, no significant historic or architectural merit, frame compromised.
