Bat Survey Report Treverbyn, Polurrian Cliffs, Mullion, TR12 7EW

6 October 2023

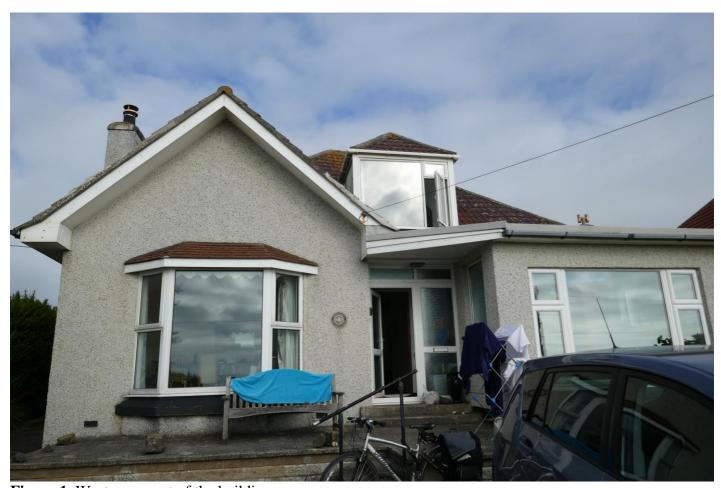
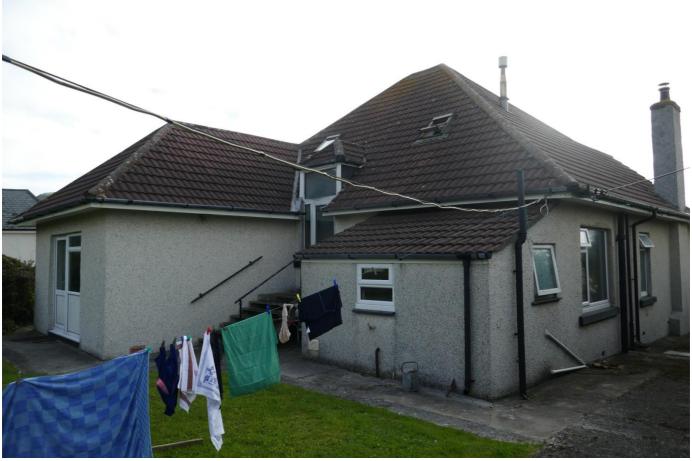
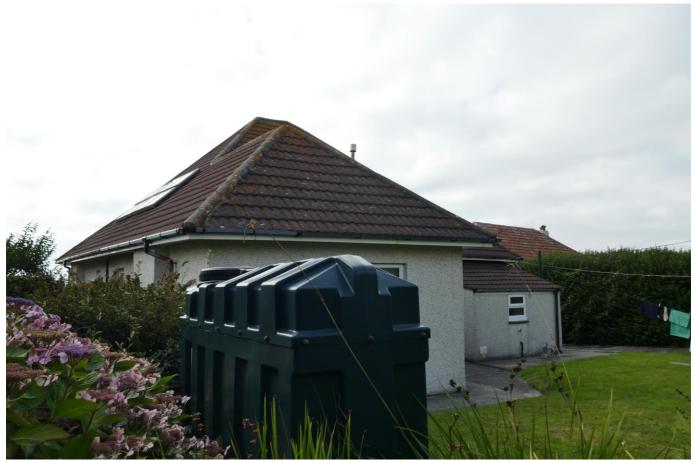
Figure 1. Western aspect of the building.

The detached dormer bungalow (Figures 1–3) was block built with a multiple hipped roof constructed of interlocking concrete tiles, some of which had gaps beneath suitable for roosting bats (Figure 4). The roof ridge was tightly cemented and did not provide any suitable gaps. Two small loft areas were present, of approximately 3m height, with wooden boarded floors; the roof was lined with bitumen felt, which was ripped in places and could allow bats to enter the roof void from gaps beneath tiles.

Figure 2. Northern and eastern aspect of the building.

Figure 3. Southern and eastern aspects of the building.

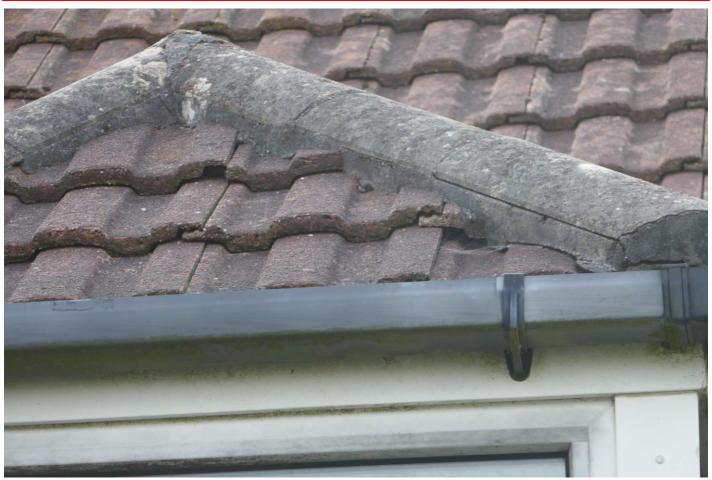
Figure 4. Gaps beneath roof tiles.

Whilst the development proposals are understood to leave the current loft areas intact, some roof tiles will be removed in fitting Velux windows, which has the potential to impact upon roosting bats.

- The relevant parts of the roof will be soft stripped by hand in the presence of a licensed bat ecologist with roof tiles removed with care and checked for bats underneath. Any other features identified by the ecologist as holding potential for roosting bats will also be removed under a watching brief.

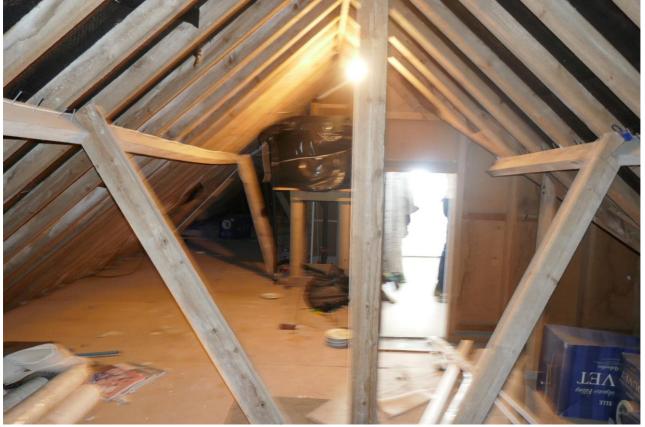
Figure 5. Roof void.

Approximately 12 bat droppings were found in the roof void, which were subsequently confirmed by DNA analysis to be from Common Pipistrelle *Pipistrellus pipistrellus*. No evidence of nesting birds was found.

- As there current roof voids will remain unchanged there is no requirement for additional bat mitigation.

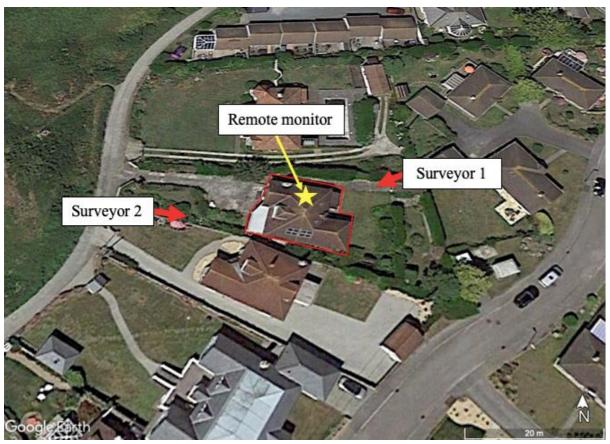
Two surveyors were present on each survey. Surveyor 1 was located in the back garden to the east of the property, viewing the northern and eastern aspects, with surveyor 2 positioned on the drive to the west observing the southern and western aspects. This strategy enabled all aspects of the building to be viewed. Table 1 summarises the personnel and equipment used, whilst Figure 6 shows the surveyor and equipment locations and Figure 7 shows the infrared illumination at the darkest point of the 26 August survey from surveyor 1's position.

Figure 6. Surveyor and equipment locations.

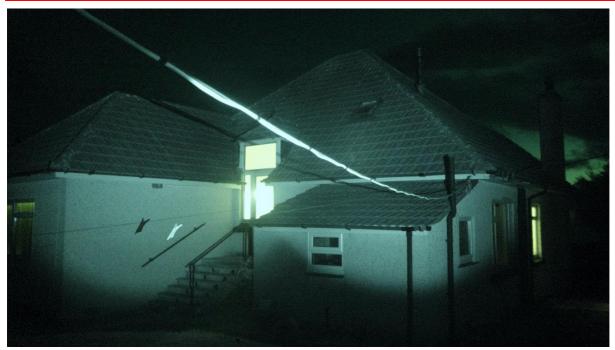
Figure 7. Infrared illumination. Surveyor 1, 26 August 2023.

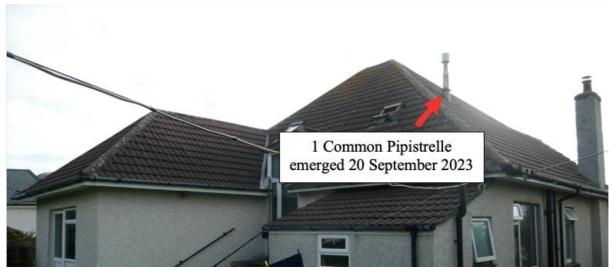
During the dusk emergence survey on 20 September a single **Common Pipistrelle** emerged from the northern roof pitch next to the boiler flue at 19.54 B.S.T. (see Figure 8). No other bat activity was observed during the survey.

Figure 8. Common Pipistrelle emergence location.

The surveys have shown that a single Common Pipistrelle is day-roosting beneath tiles on the northern aspect of the building; the presence of bat droppings from this species in the main roof void indicate that this bat is occasionally entering the void via the roof.

Before work can lawfully proceed the site must be registered by the ecologist under the Bat Mitigation Class Licence (WML-CL21). An appropriate mitigation strategy will need to be proposed as part of the licence application in order to maintain the favourable conservation status of the species roosting there. **Until the site has been confirmed as registered under the WML-CL21 class licence, no work must take place upon the building.** The following recommendations are made:

- Prior to work commencing a Schwegler 2F woodcrete bat box will be appropriately fitted to nearby trees, under the supervision of the bat ecologist. This box must be kept away from any forms of artificial lighting and kept in place for a minimum of five years. Any bats uncovered during work will be relocated by the ecologist to the box.
