## Grove Farm, Little Bealings, Suffolk

# Construction Environment Management Plan (Biodiversity)

**Ref:** 1870

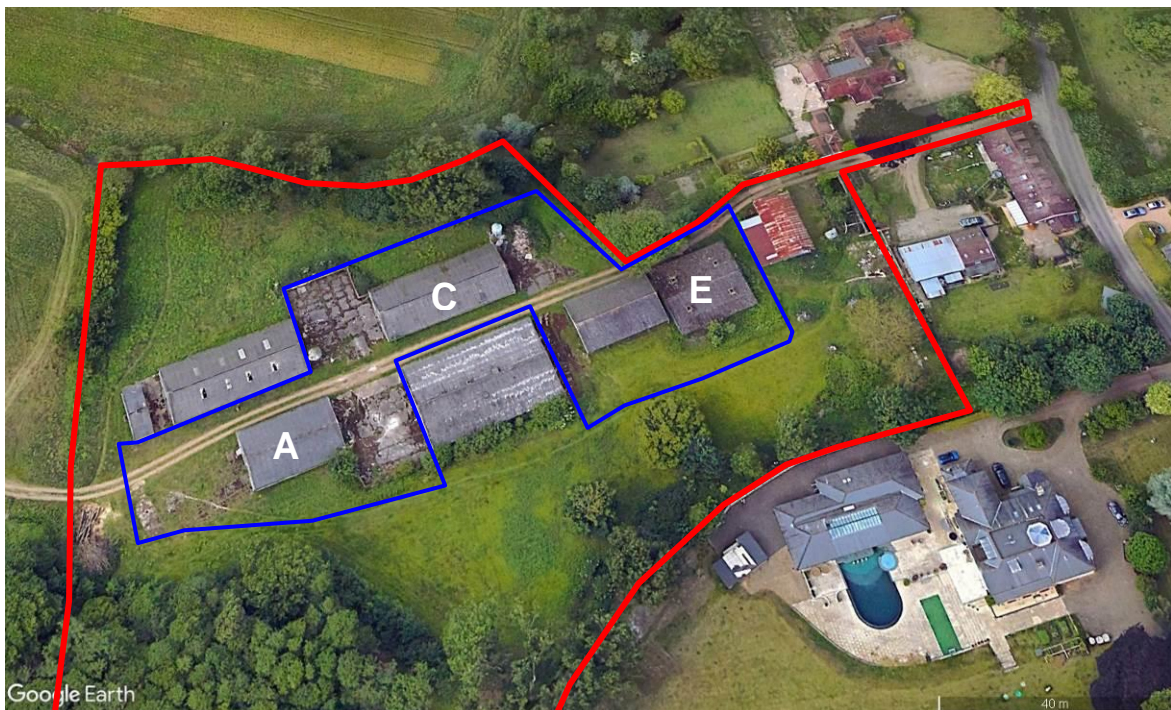
Fig 1: Aerial plan, with red line boundary outlined in red, and construction zone boundary (for buildings A, C and E) outlined in blue. Aerial photograph sourced from Google Earth Pro

- 3.3 An aerial location plan is provided below.

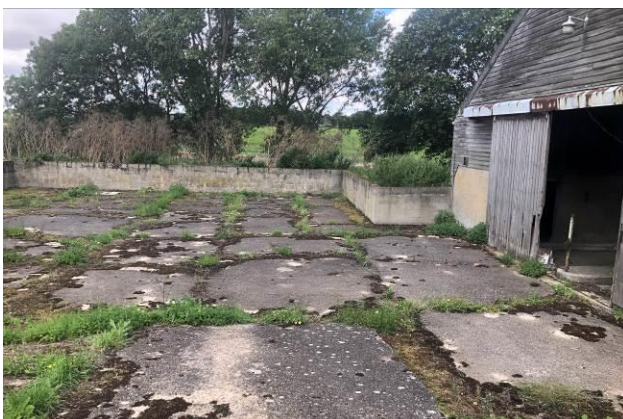
Figure 4: Existing concrete bunded area immediately west of Building C

- 4.11 Cement, fuel and other potentially harmful spillable products will be stored in one of the two existing bunded concrete pads only (see Figures 3 and 4, below), well away from the river. Fuels and oils will be used in association with appropriately sized drip trays to prevent any accidental spillages or leaks reaching the river.
- 4.12 Washing of concrete mixers or similar will take place on one of the two existing bunded concrete pads only.
- 4.13 No fires will take place on site.
- 4.14 Piles of soil or sand, particles of which are easily washed away during heavy rainfall, will either be stored on the southern side of the central access track only, well away from the river corridor, or in skips / containers to prevent runoff towards and into the river.

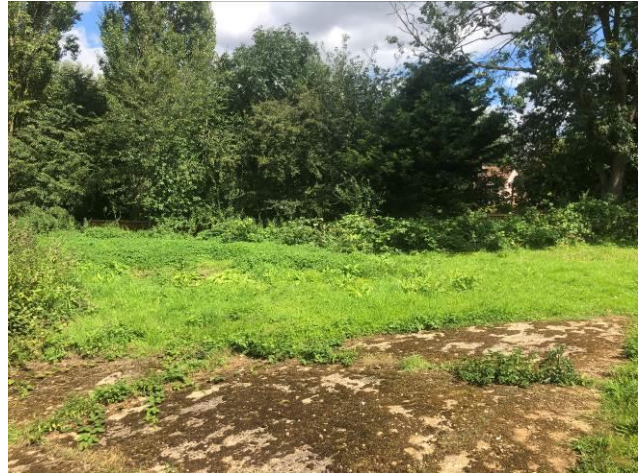
Photo 8: Scrub and trees to east of Building C, outside of construction zone
