219502- DOC- 001

3/20/1051/FUL

Condition 16 – preventing surface water discharging onto Hillside Lane and Pepper Hill.

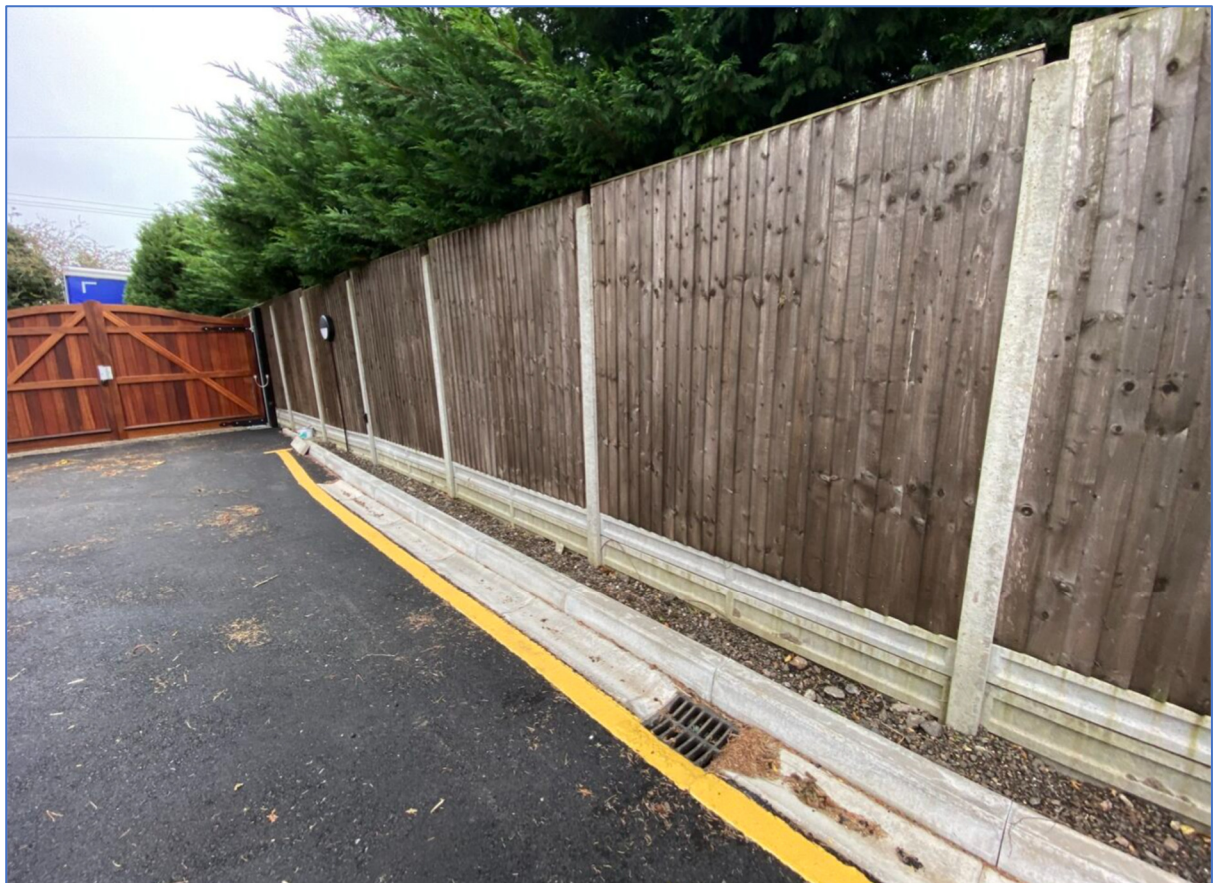
- A drainage gully has been installed which collects water into a drainage channel that runs along the south side of the access road and drains into a soakaway. Please see the photograph below.
- Please also refer to drawing ref 219502-PL-003
