**Bat Survey
of
Land adjoining Bourne Villa
Bakers End
Wareside**

**John Dobson B.Sc
Essex Mammal Surveys**

December 2023

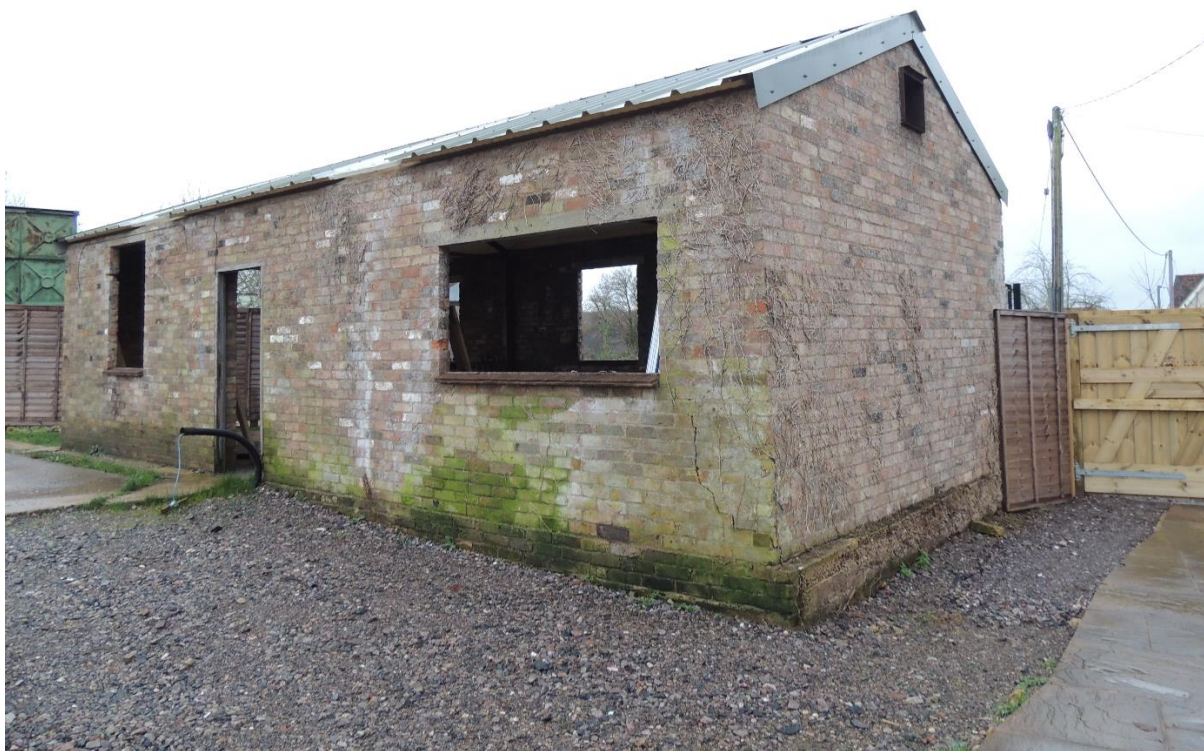
Photo 1: South-eastern (gabled) and south-western elevations

The survey building is a detached brick outbuilding with a metal sheet roof supported by a metal frame. The building is aligned NW-SE. The survey found that the interior was open to the roof, with no roof voids present that might offer potential roosting opportunities for bats. The interior also received daylight illumination (and draughts) via missing windows and doors, and also from two transparent panels in the roof. In such conditions, bats seek out dark areas or crevices in which to roost and the lack of such features meant the building was

unsuitable as a roosting place for bats. Externally, there were no cavities in the brickwork that might be occupied by bats.

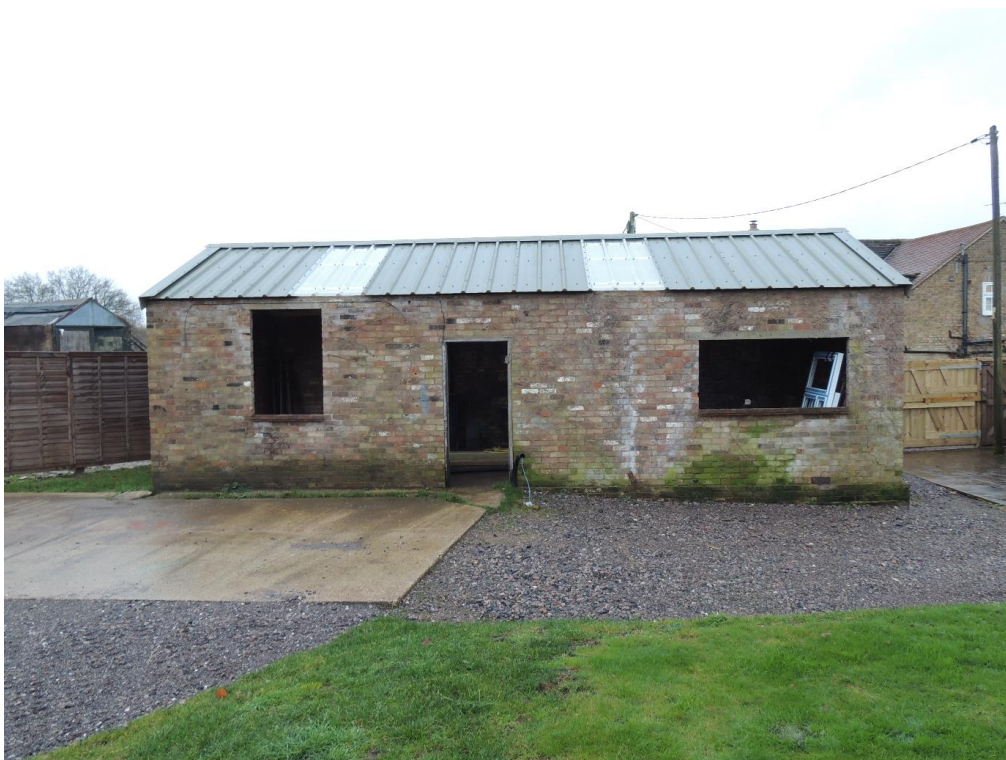
Photo 2: South-western elevation

The survey building is a detached brick outbuilding with a metal sheet roof supported by a metal frame. The building is aligned NW-SE. The survey found that the interior was open to the roof, with no roof voids present that might offer potential roosting opportunities for bats. The interior also received daylight illumination (and draughts) via missing windows and doors, and also from two transparent panels in the roof. In such conditions, bats seek out dark areas or crevices in which to roost and the lack of such features meant the building was unsuitable as a roosting place for bats. Externally, there were no cavities in the brickwork that might be occupied by bats.

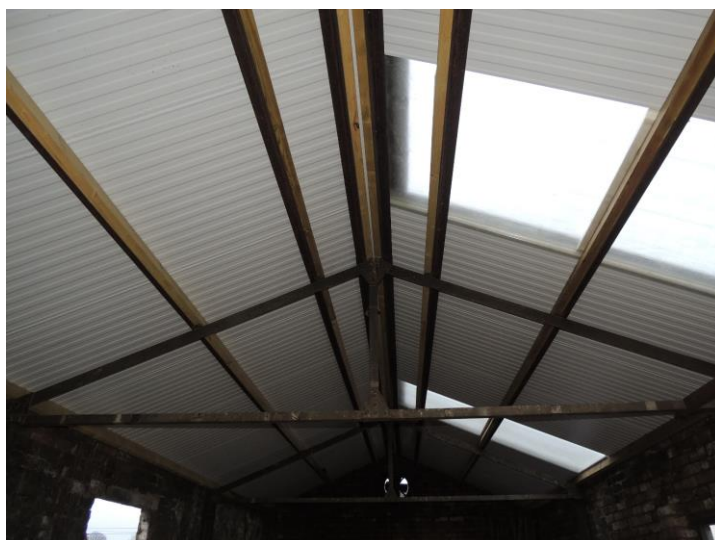
Photo 8: The roof had no features that might be occupied by bats

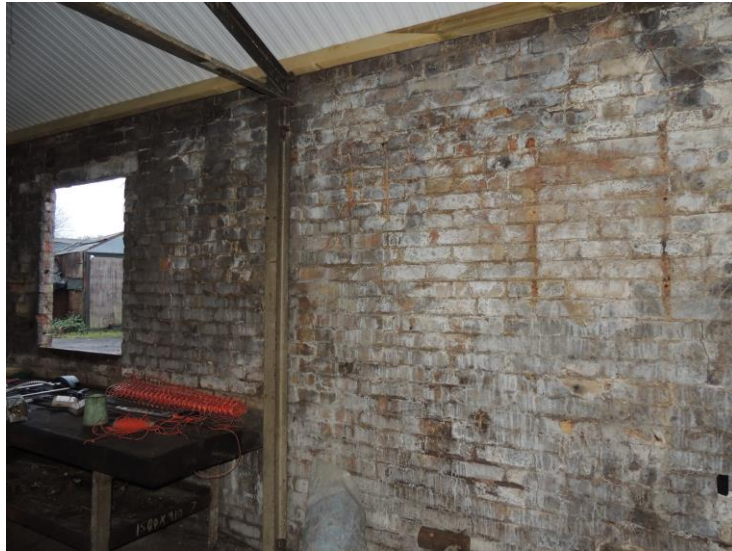
Photo 8: The brickwork had no features that might be occupied by bats

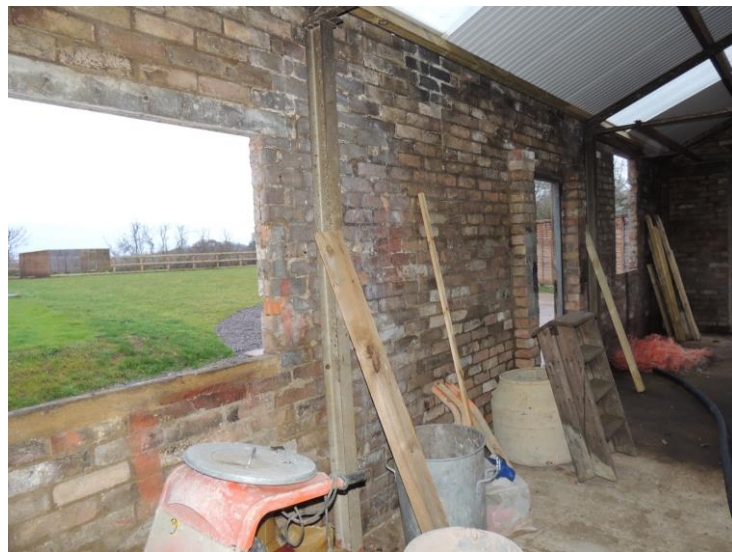
Photo 9: The brickwork had no features that might be occupied by bats

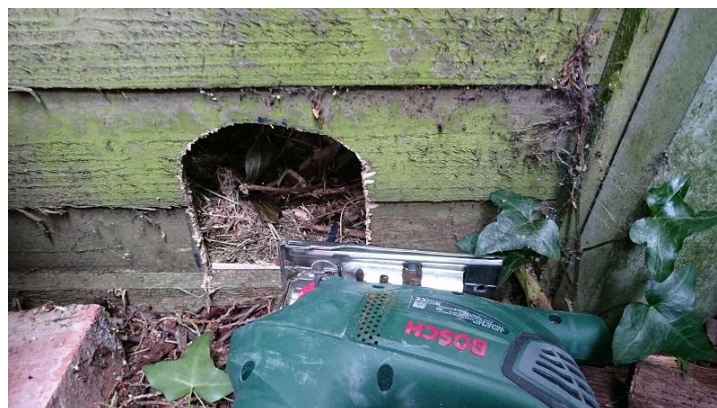
Photo 10: Hedgehog pathway at base of fence

A gap 13cm by 13cm is sufficient for any hedgehog to pass through. This will be too small for nearly all pets.

1: It is recommended that the existing gaps along the site boundaries are retained to allow hedgehogs and common toads to forage across the site as, potentially, at present. However if boundary fences are to be introduced, see below:

- Remove a brick from the bottom of the wall
- Cut a small hole in your fence if there are no gaps
- Dig a channel underneath your wall, fence or gate
