# DESK TOP STUDY REPORT

Site Address:	Monks Green Farm Mangrove Lane Brickendon Hertford, Herts SG13 8QL
Report Date:	November 2023
Project No.:	18625
Prepared for:	Monks Green Farm Ltd
Planning Application	East Herts Council

## **PRELIMINARY RISK ASSESSMENT – DESKTOP STUDY - PHASE 1 REPORT**

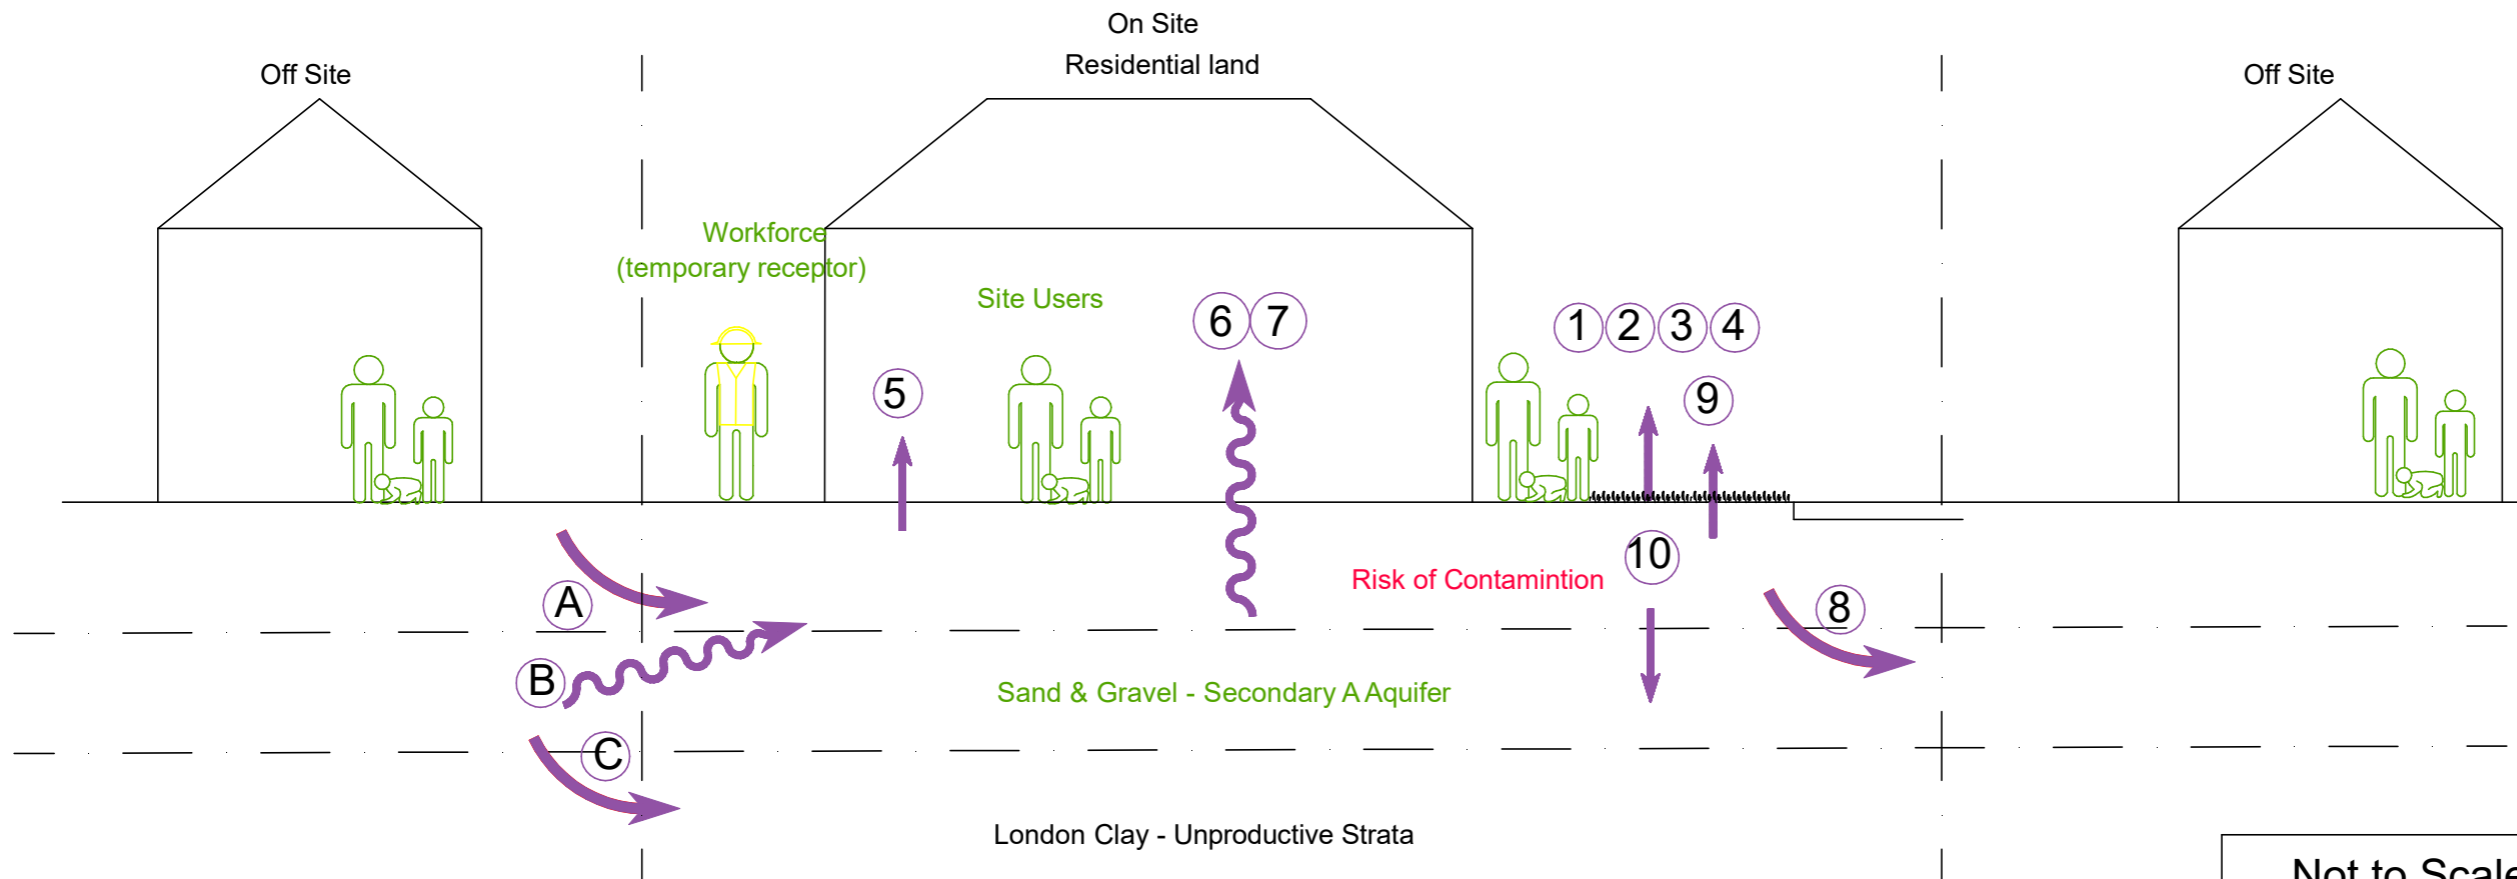
Not to Scale  
Sketch No. : DTS / 18625 / 01 / 01

- Purple =Possible pathways
- Green =Possible receptors
- Red =Possible sources
