# Bat Survey Report for 64a Acre End, Eynsham, Oxford, OX29 4PD

Cotswold Wildlife Surveys

23<sup>rd</sup> June & 11<sup>th</sup> and 25<sup>th</sup> July 2023

Report Number: 4545-CWS-01

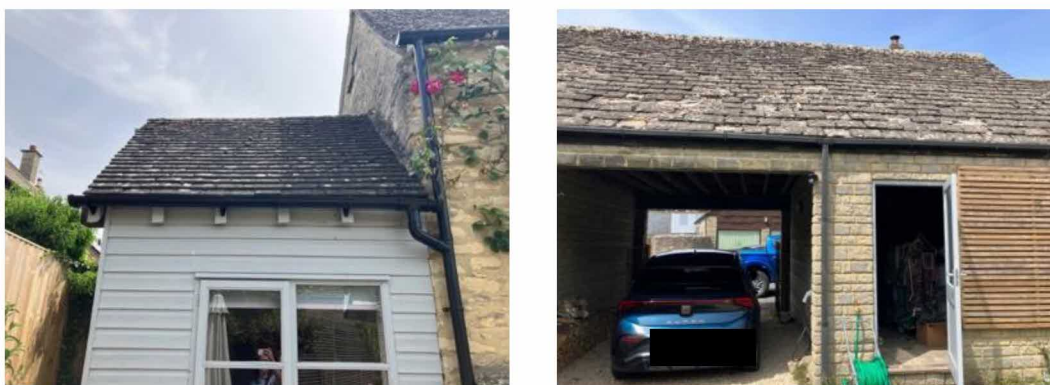
**Figs. 1 & 2 Northern end of the house (left) and garage (right)**

The survey site comprised the northern end of the house which consisted of a small extension and a separate garage (Figs. 1 and 2).

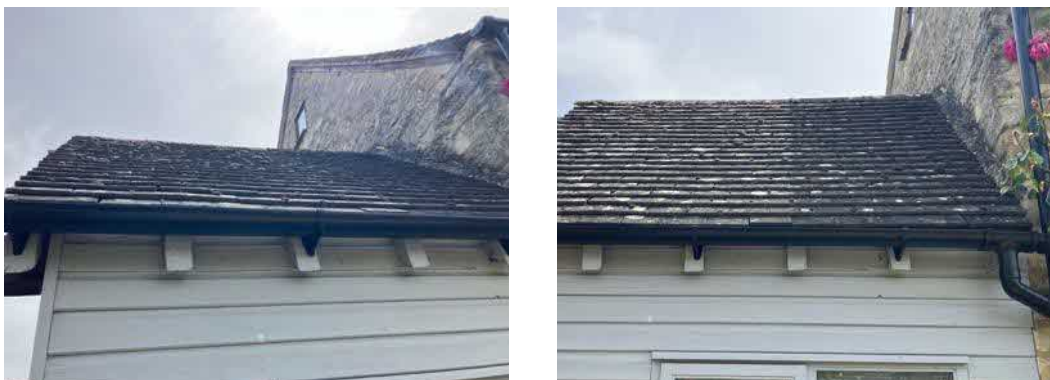
**Figs. 5 & 6 Ridge and roof tiles**

The north end of the house had a small, single storey extension with a pitched roof and clay roof tiles (Figs. 5 and 6). The ridge was intact and the roof tiles were tightly overlapping, with none raised, missing, broken or dislodged.

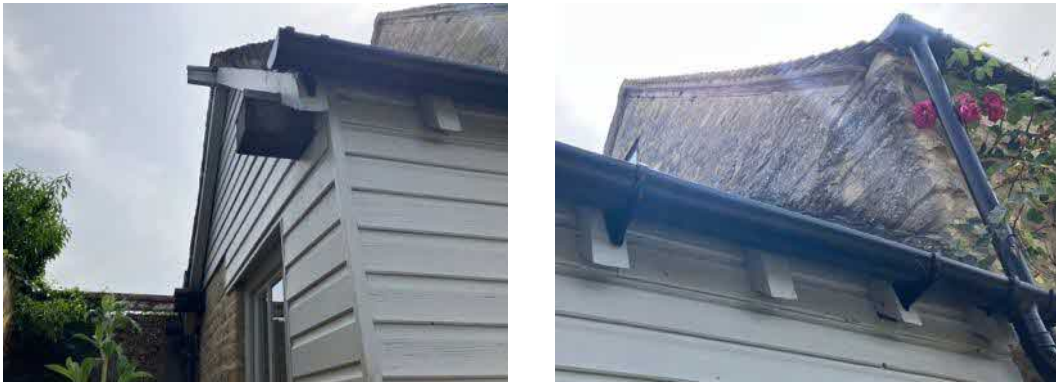
**Figs. 7 & 8 Gable ends**

The eaves were closed all round, whilst the gables of the house and extension were finished with the roof ends cement sealed (Figs. 7 and 8)

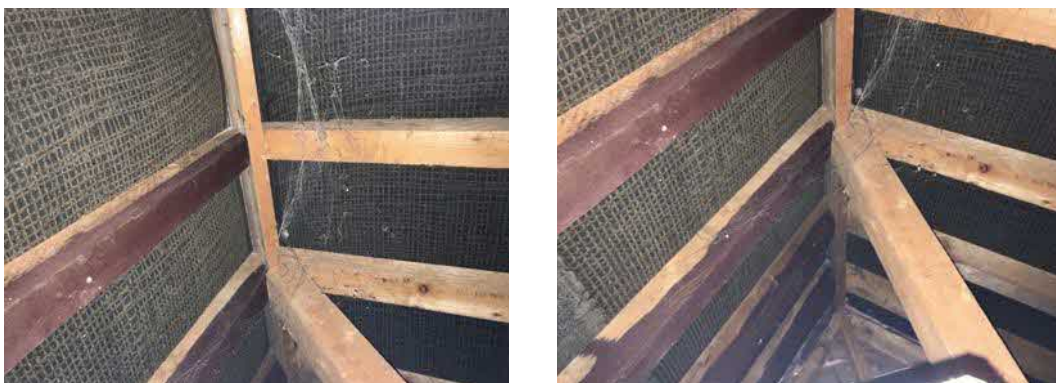
**Figs. 9 & 10 Roof void of extension**

Internally there was a single roof void inside the extension which measured approximately 0.5 metres high and ran the full length and width of the extension (Figs. 9 and 10).

The house had a vaulted ceiling and as such there was no roof void within the main part of the building.

No evidence of bat activity or occupation was found in or around the northern end of the house and it was considered to have negligible suitability for roosting bats.

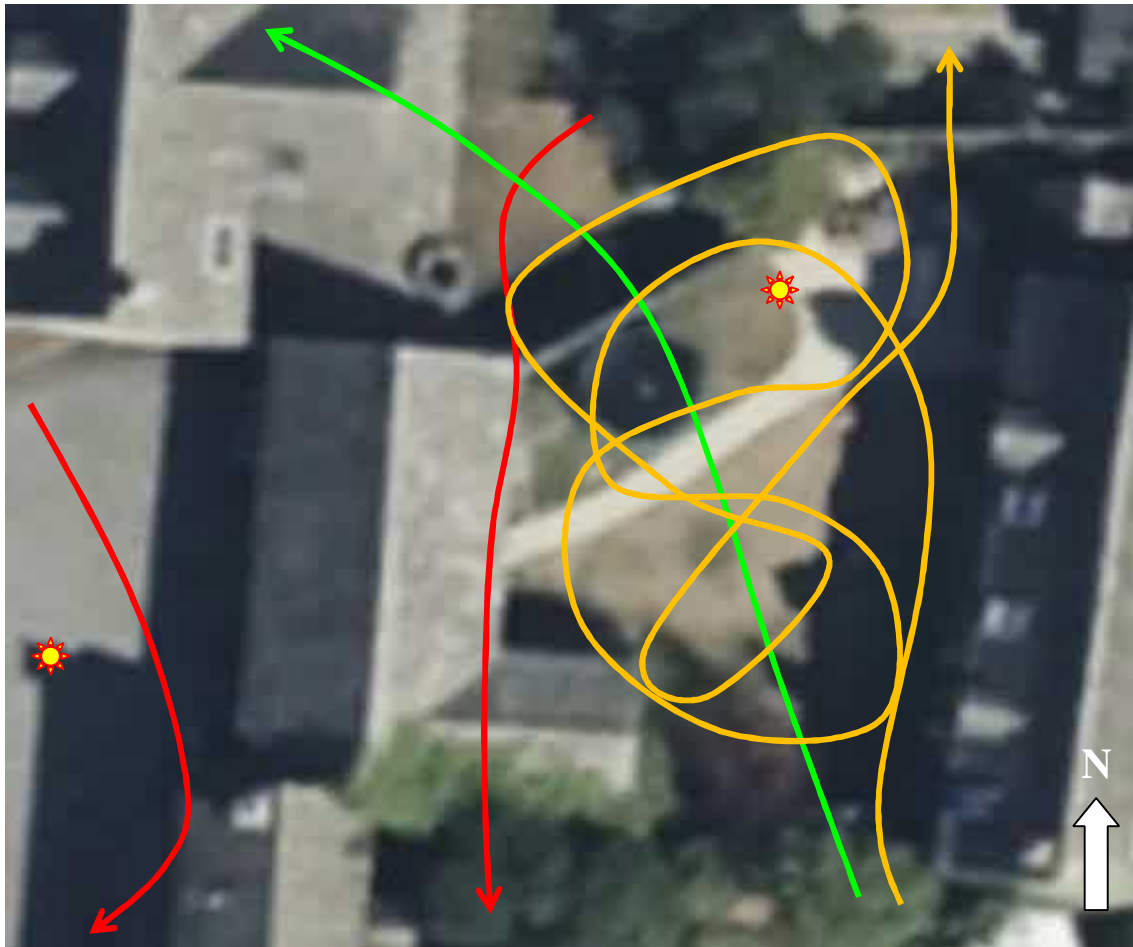
**Plan 1 Bat flight paths at emergence on 11<sup>th</sup> July 2023**

No bats emerged from the garage, but several species of bats were recorded as they passed over the site, including one or two Common Pipistrelles, a Noctule Bat flying overhead, with several Soprano Pipistrelles foraging throughout the duration of the survey within the garden of 64a Acre End.

Time	Observation
21:43	Noctule flew over the site
21:52	Soprano Pipistrelle (SP) foraging around the garden
21:53	Common Pipistrelle (CP) flew past
21:55	CP flew over the garden
22:05	SP foraging in the garden
22:19	SP still foraging in the garden
23:00	Intermittent SP foraging until survey ended

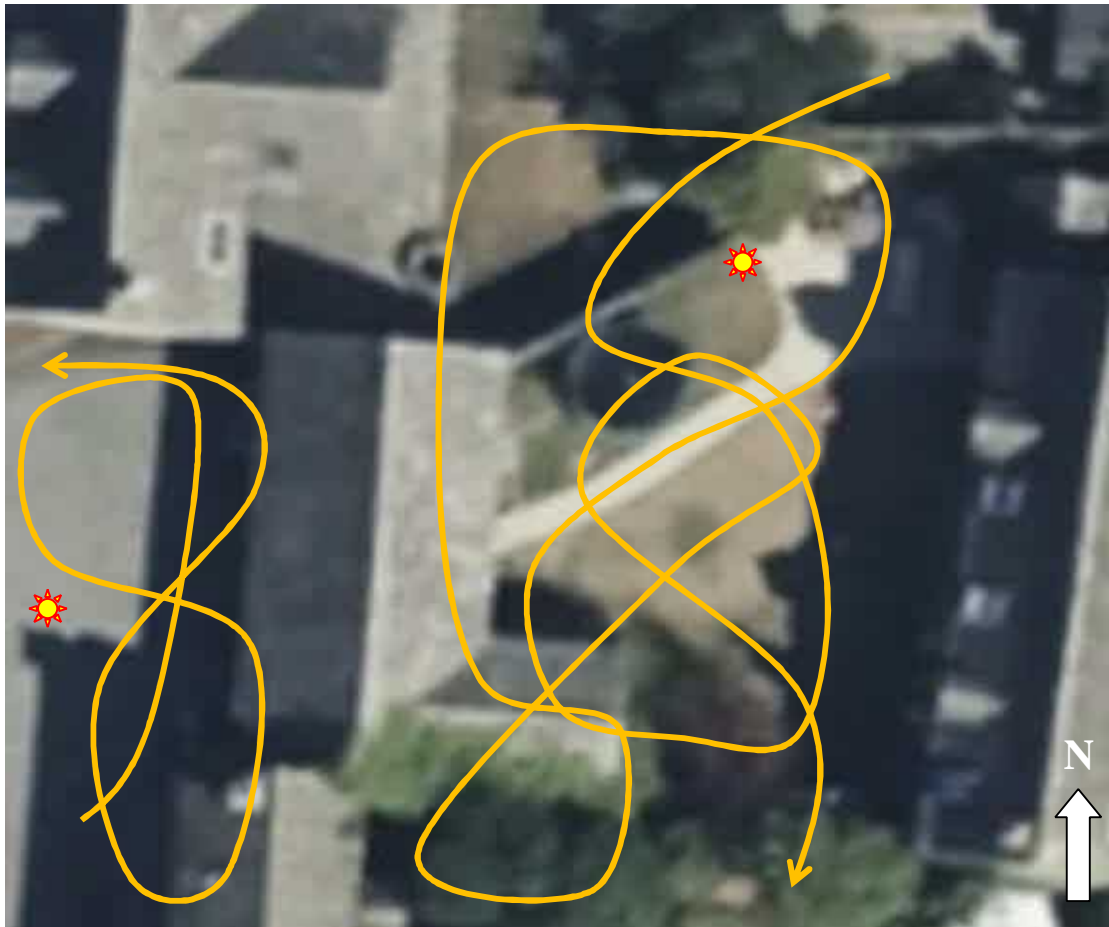
**Plan 2 Bat flight paths at emergence on 25<sup>th</sup> July 2023**

No bats emerged from the garage, but several Soprano Pipistrelles were recorded foraging throughout the duration of the survey within the garden of 64a Acre End.

Time	Observation
21:23	Soprano Pipistrelle (SP) flew past
21:29	SP foraging in the garden
21:35	SP still foraging in the garden
21:48	SP still foraging in the garden
22:40	Intermittent SP foraging until survey ended

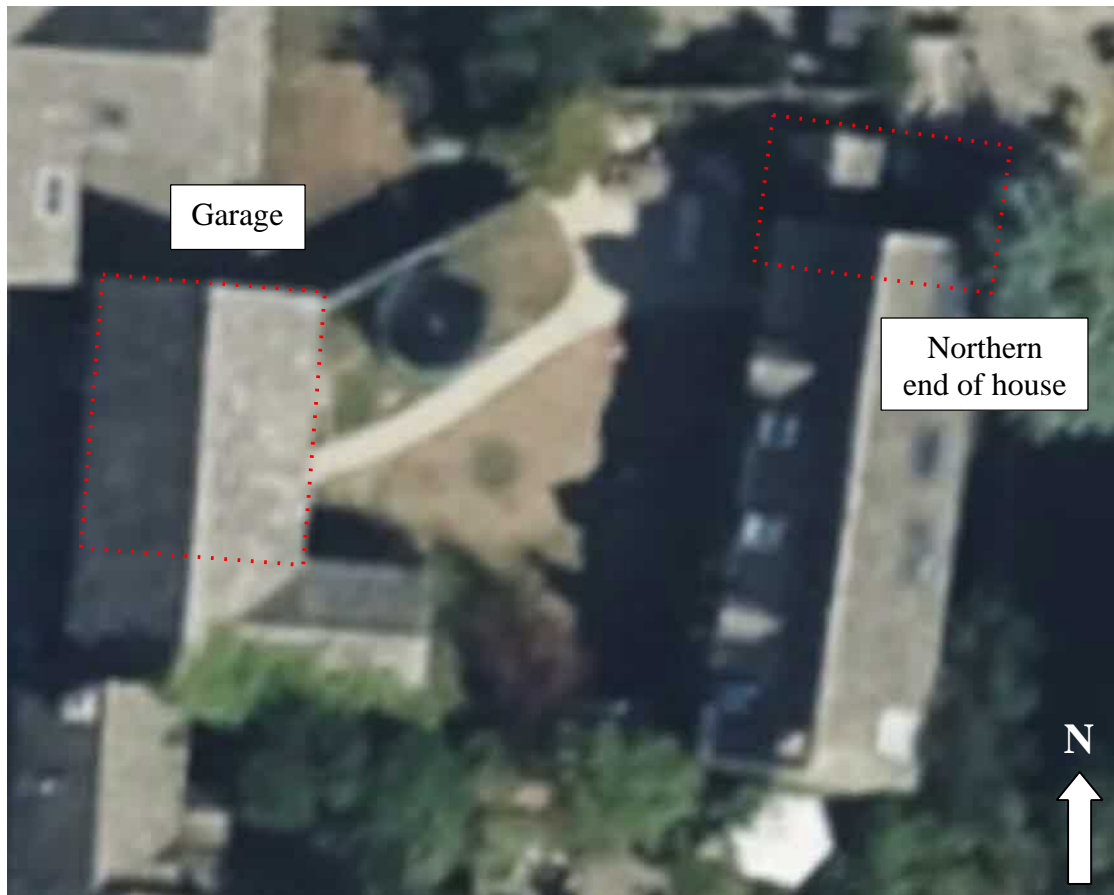
## Appendix 2: Site layout

The layout of the site is shown in the aerial photograph in Appendix 2.
