Vine Farm, Collingham

Protected Species Survey Report

November 2023

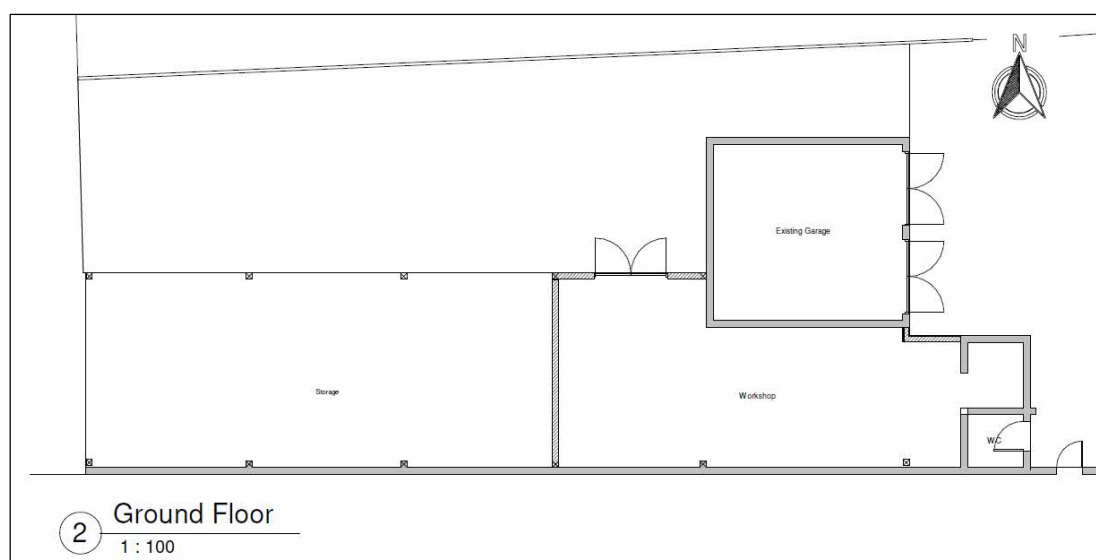
Figure 1.2.1: The surveyed buildings are shown above. Figure reproduced from drawings dated April 2023 provided by MO Architects, Collingham.

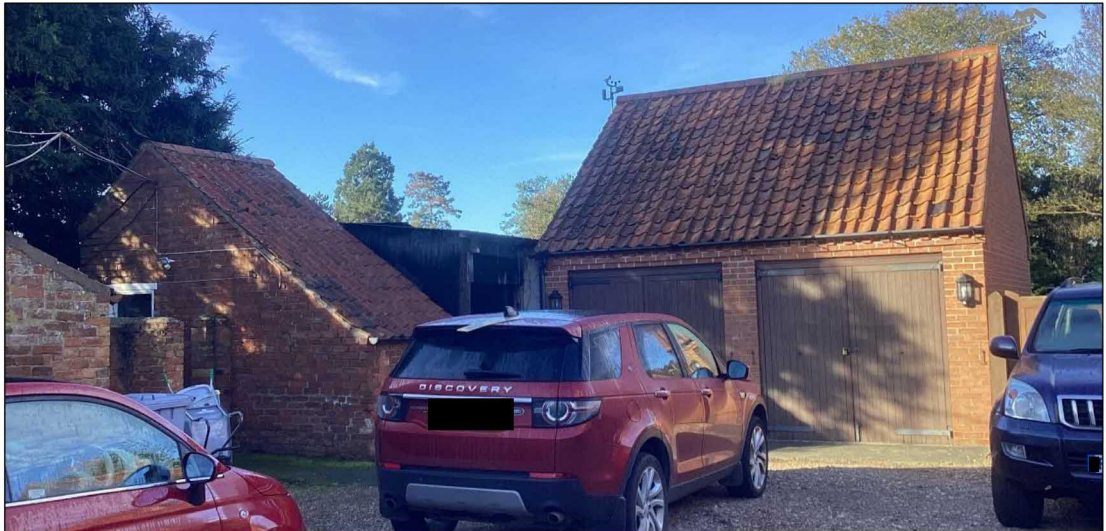
Photograph 1.3.1: View of the east elevation of Building 1 (the workshop and toilet) to the left (south) and the front west elevation of Building 3 (the garage) to the right (north).

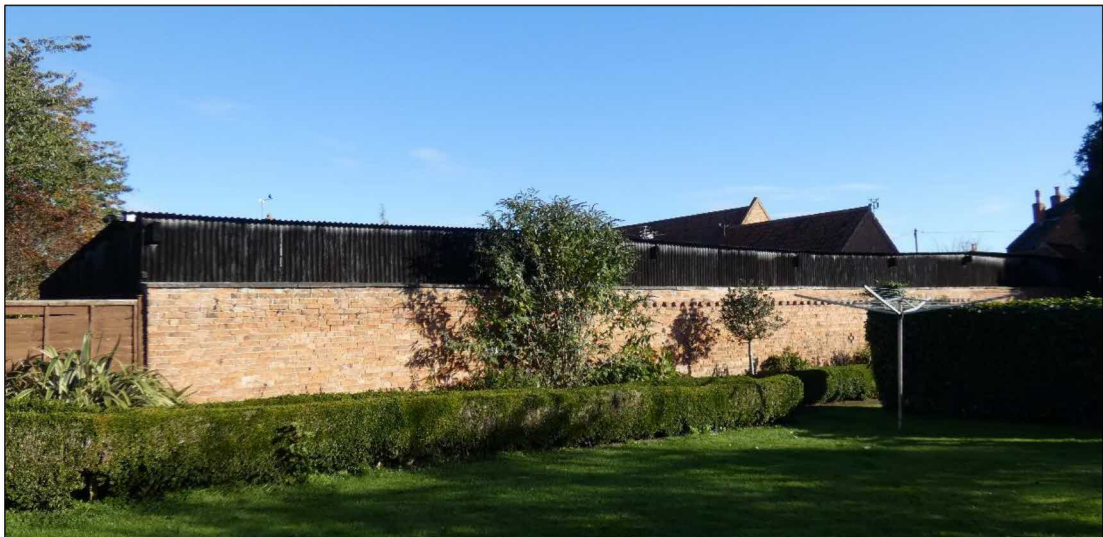
Photograph 1.3.2: View of the south elevations of Building 1 (the workshop) on the right (east) and Building 2 (the storage shed) to the left (west).

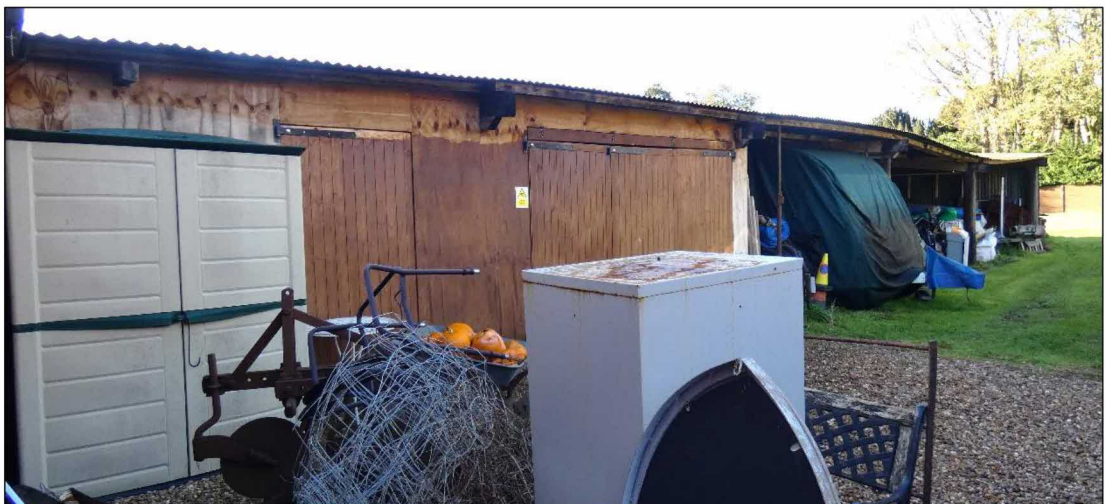
Photograph 1.3.3: View of part of the north elevation of Buildings 1 (the workshop) to the left (east) and the adjoining Building 2 (the storage shed) to the right (west).

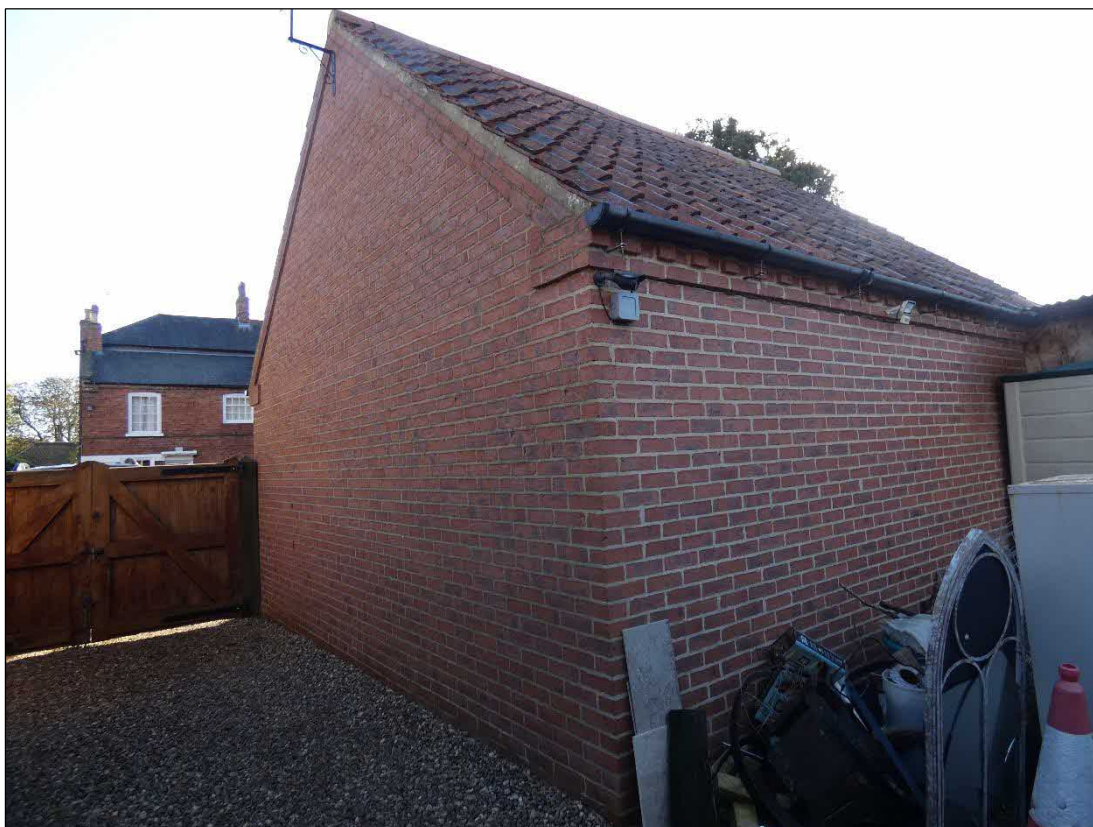
Photograph 1.3.4: View of the north and west elevations of Building 3 (the garage) from its north-west corner.

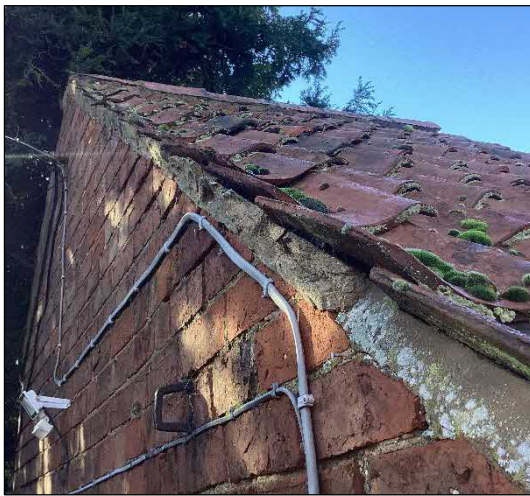
Photograph 4.2.1: Apertures between the verge mortar and tiles at the eastern end of Building 1.

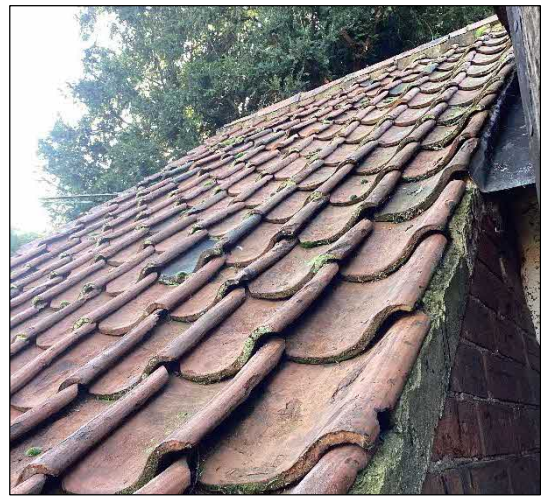
Photograph 4.2.2: Apertures beneath and between the clay tiles at the eastern end of Building 1.

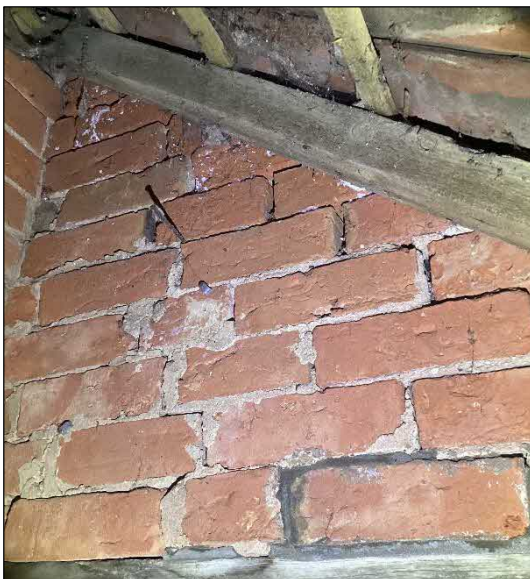
Narrow subsidence cracks within the internal brickwork of the room to the north of the toilet, and a narrow crevice between the wall and the doorframe of this room – see Photographs 4.2.3 and 4.2.4.

Photograph 4.2.3: View of one of the subsidence cracks within the internal brickwork of the small room to the north of the toilet within Building 1.

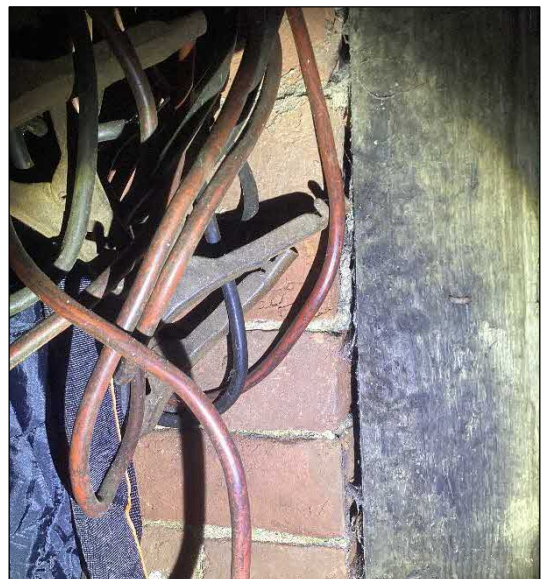
Photograph 4.2.4: View of the narrow gap between the brickwork and the doorframe of the small room to the north of the toilet within Building 1.

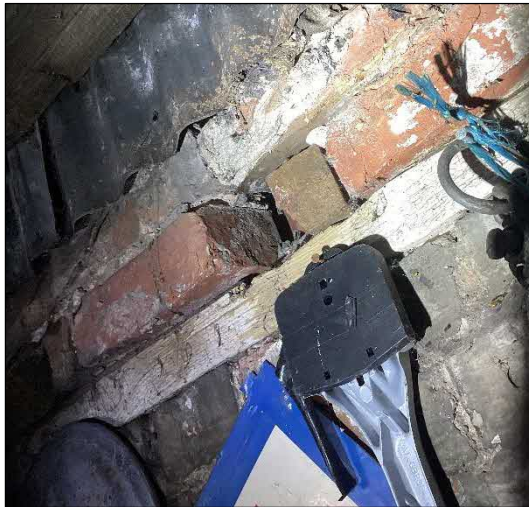
Some missing bricks within the lower internal wall of the south elevation, some of which provide a suitably sized recess for low numbers of bats within the wall cavity – see Photograph 4.2.5.

Photograph 4.2.5: View of two of the bricks missing from the interior wall of Building 1.

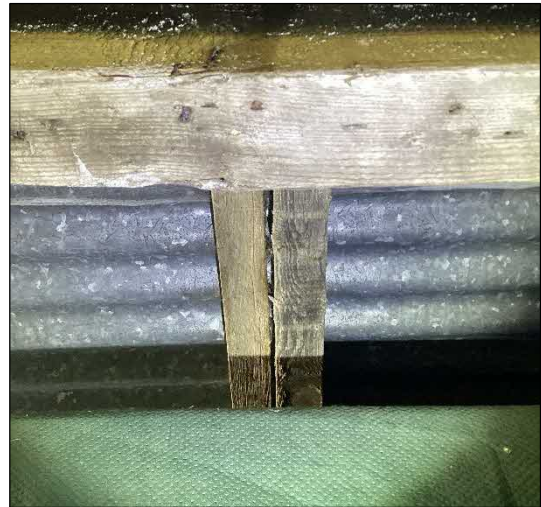
Photograph 4.2.6: A narrow crevice between two roof timbers within Building 2.

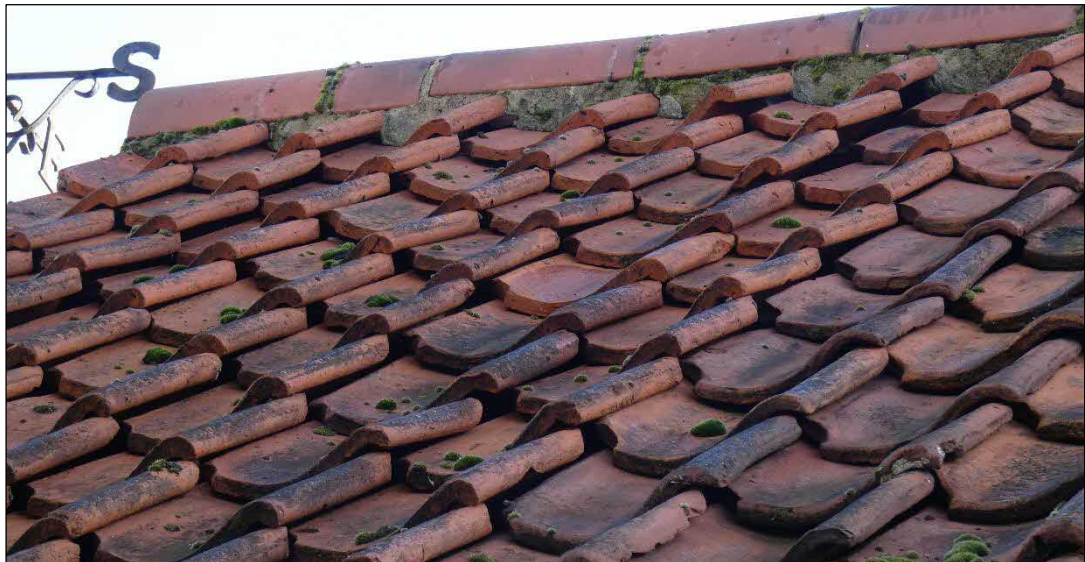
Photograph 4.2.7: The roof of Building 3. There are several apertures between and beneath the ridge and roof tiles of this roof that could potentially support low numbers of roosting bats.

Building 3 – ‘low suitability’ for roosting bats i.e., it is “a building with one or more potential roost sites that could be used by individual bats opportunistically at any time of year. However, these potential roost sites do not provide enough space, shelter, protection, appropriate conditions, and / or suitable surrounding habitat to be used on a regular basis or by larger numbers of bats”. The PRF within this building are all associated with the roof and ridge tiles.

5.2.5 It is understood that the proposals for the buildings do not involve any impacts on the roof of Building 3; if so, further bat surveys of the buildings are not recommended. If, however, the roof of Building 3 will be impacted then an evening emergence survey of this roof is recommended, to determine the presence or likely absence of roosting bats with more confidence, in keeping with current best practice guidelines (Collins (ed.), 2023) in respect of buildings with ‘low suitability’.

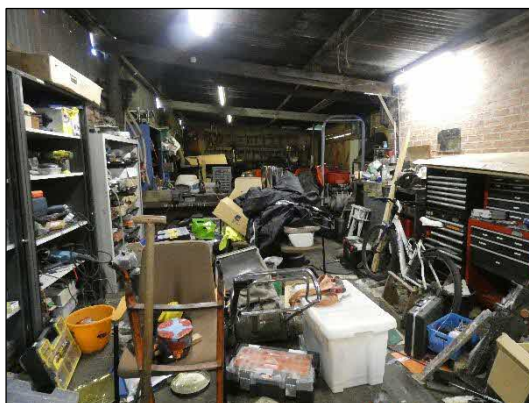
Photograph 4.2.8: View inside Building 1, facing west.

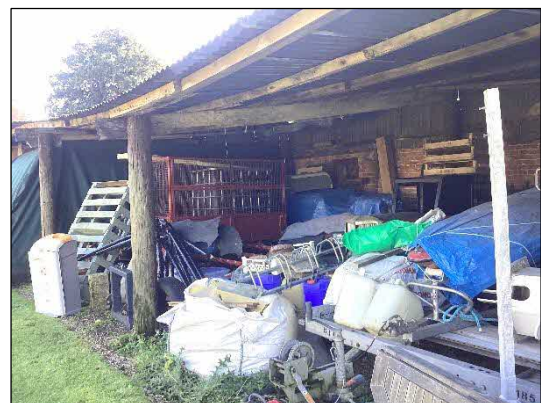
Photograph 4.2.9: View inside Building 2, from its north-west corner facing east. The feeding remains from the brown long-eared bat were found on the blue tarpaulin in the distance.

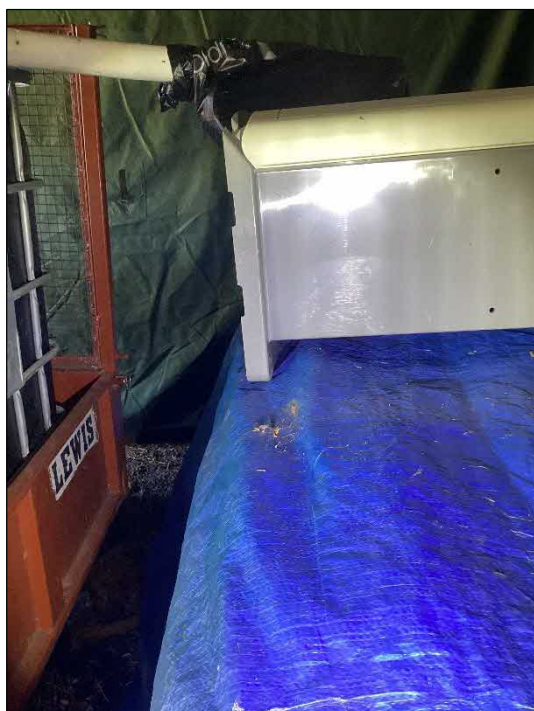
Photograph 4.2.10: The remains of the large yellow underwing moths found on the blue tarpaulin inside Building 2, which indicates feeding by a brown long-eared bat.

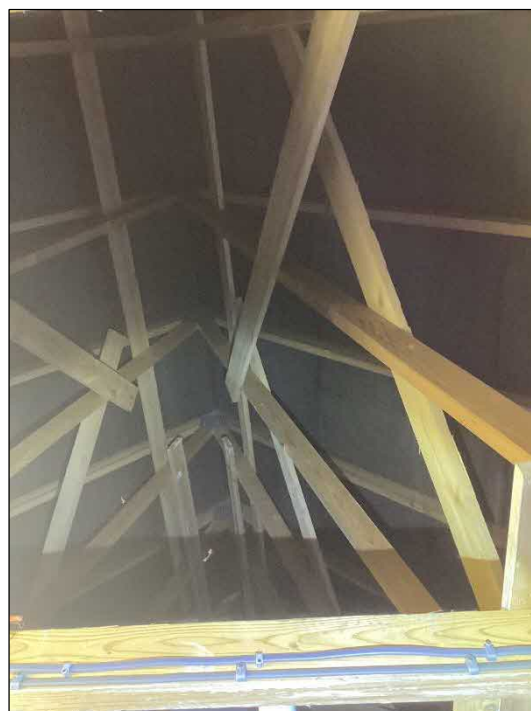
Photograph 4.2.11: View of the roof space of Building 3 (the garage).
