BAT, BARN OWL AND NESTING BIRD SURVEY

**CHY-AN-COOSE, HOLMAN PARK,
CAMBORNE, CORNWALL**

February 2022

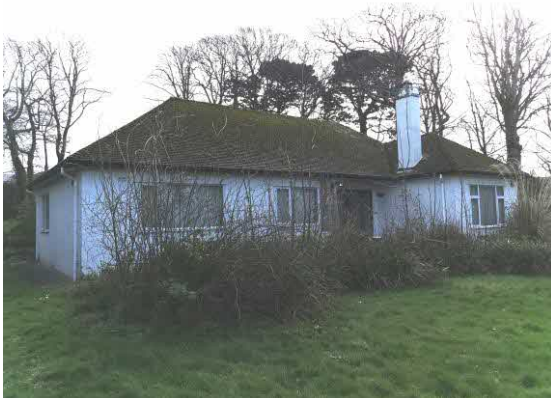
The building subject to this survey is a detached rectangular bungalow with a small projecting section on its south western corner which also contains a chimney. It is built from rendered blockwork and has a hipped roof covered with tiles, see photos 1, 2 and 3. It is located within the grounds of Rosewarne House in Holman Park which is an area of private wooded parkland close to the centre of Camborne in Mid Cornwall.

Photo 1. Showing the building from the north west

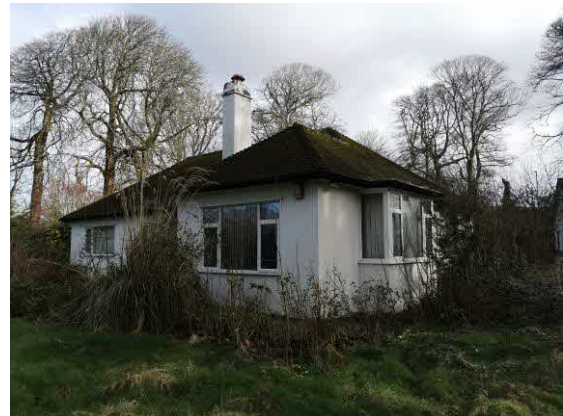
Photo 2. Showing the building from the south west

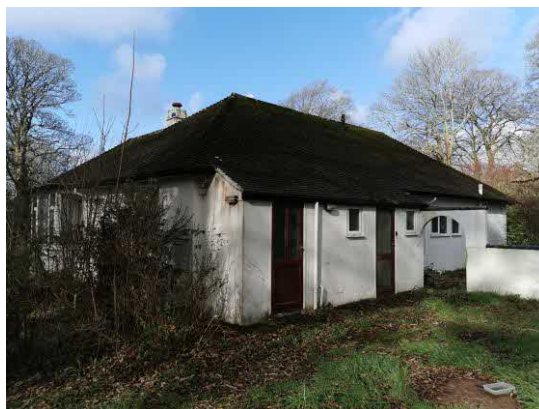
Photo 3. Showing the building from the south east

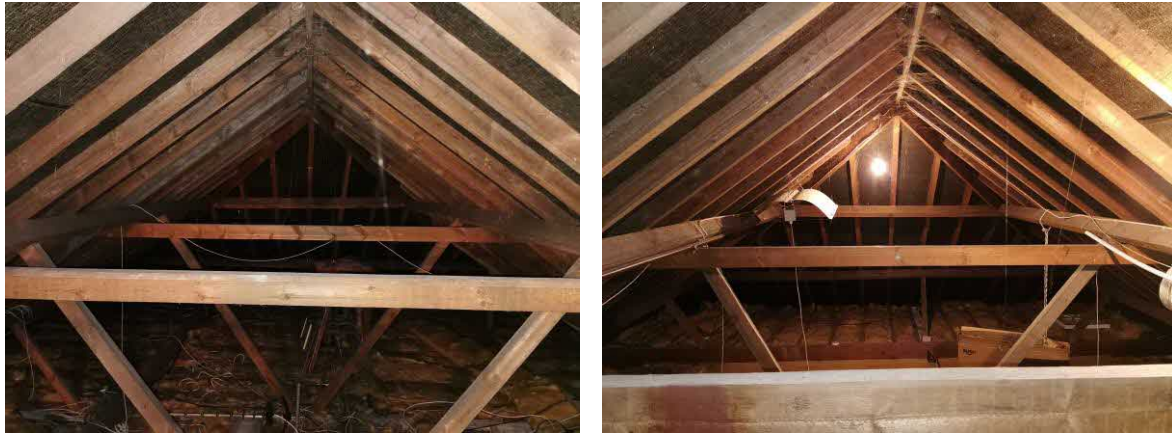
Internally there is a single large roof void which extends over the whole of the building, supported by timber trusses which are open from the floor of the roof void to the underside of the roof, which is lined with bitumen-based roofing felt, see photo 4 and 5. This roof void is also open to the roof void over the small projecting section which has a lower ridgeline.

Photos 4 and 5. Showing the roof void over the building
