GEO-ENVIRONMENTAL ASSESSMENT (GROUND INVESTIGATION) REPORT

UNITS 1-15 PREMIER ESTATES,
SUSSEX STREET,
BRISTOL,
BS2 0RA

Report Title: Geo-environmental Assessment Ground Investigation Report for Units 1-15 Premier Estates, Sussex Street, Bristol, BS2 0RA

Job No: P4639J2633/JLW

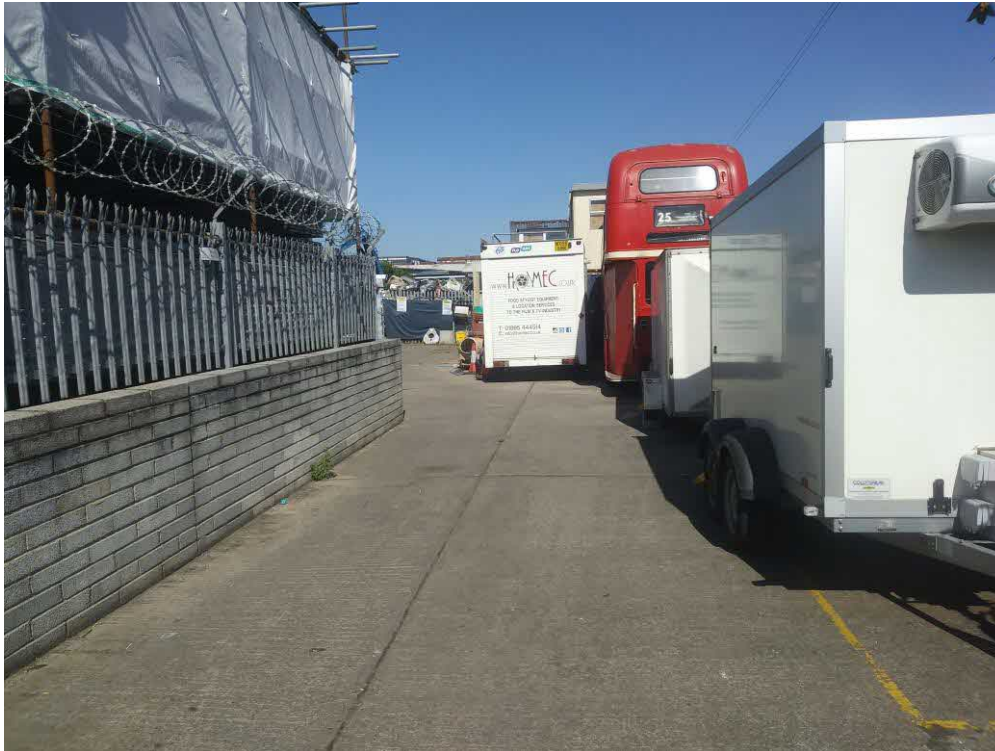
| Photo 1: Access to Units 2-5. Photo taken viewing north-west. | | Photo 2: External yard for Units 2-5, which contains storage containers utilised as offices. Photo taken viewing north. | |

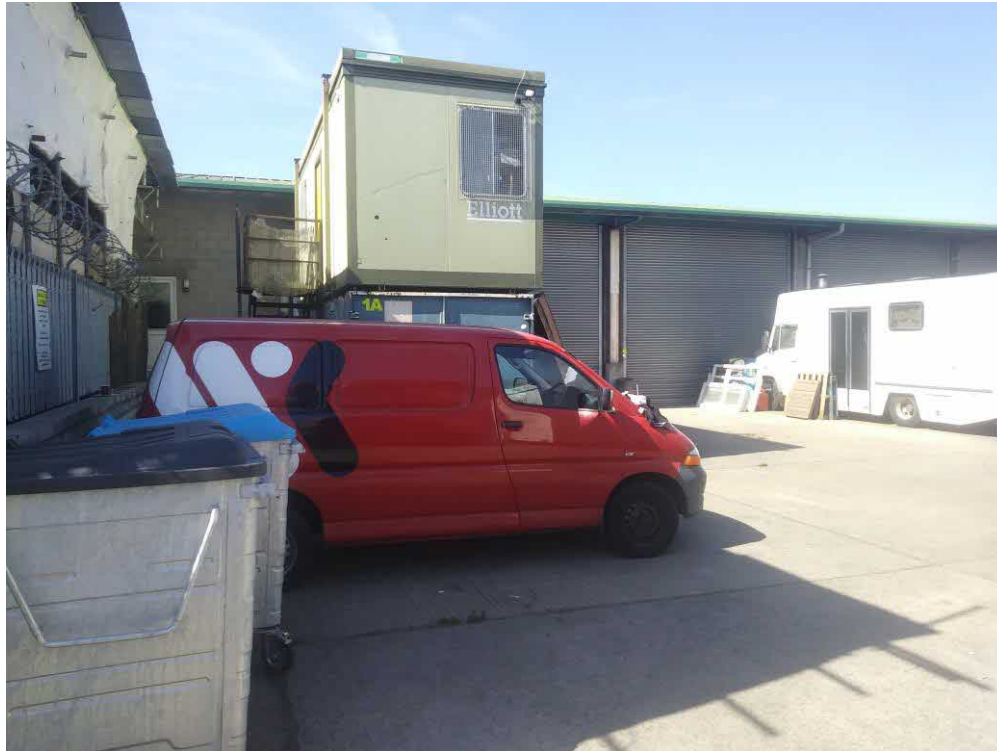
| Photo 3: External yard for Units 2-5, which contains storage containers utilised as offices. Photo taken viewing south-west. | | Photo 4: External yard for Units 2-5, with Units in the rear of the photo. Photo taken viewing west. | |

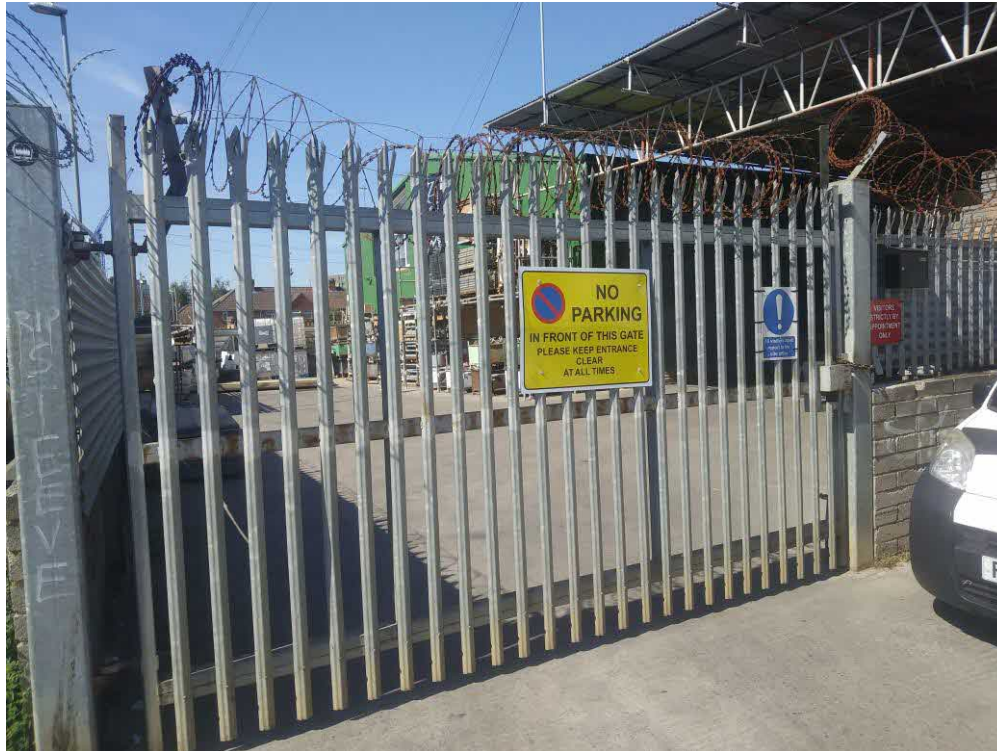
| Photo 5: Access gate to Unit 1 (Crown Scaffolding). Photo taken viewing west. | | Photo 6: External yard and buildings for Crown Scaffolding. Photo taken viewing west. | |

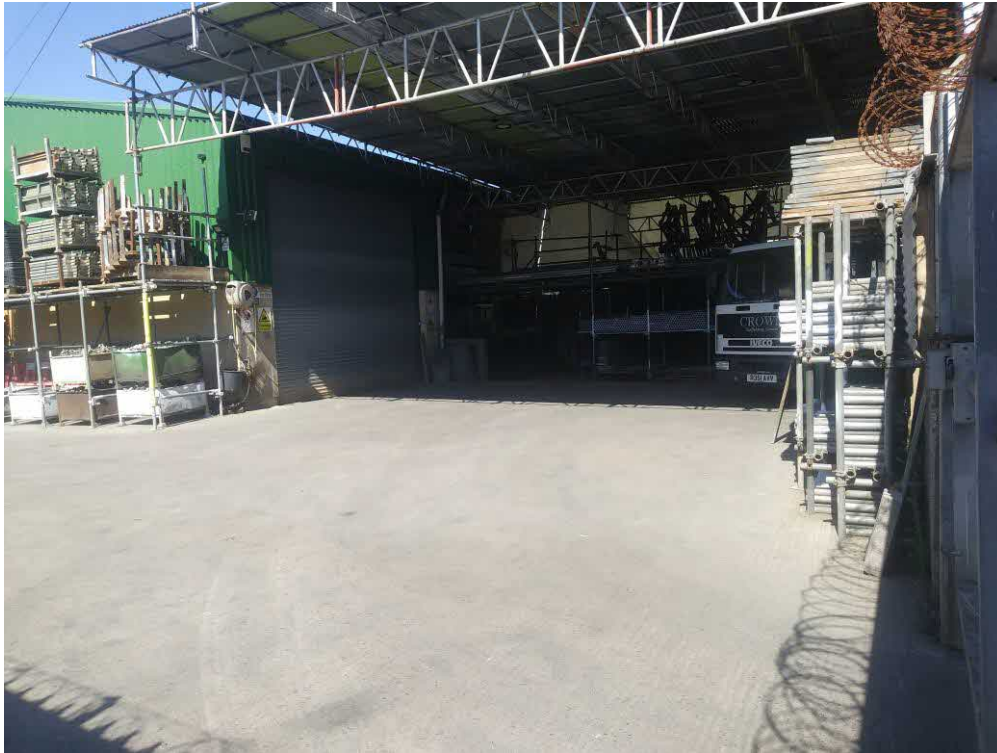
| Photo 7: External yard for Crown Scaffolding. Photo taken viewing north-west. | | Photo 8: Access to Units 12 & 13 (Calor Gas). Photo taken viewing west. | |

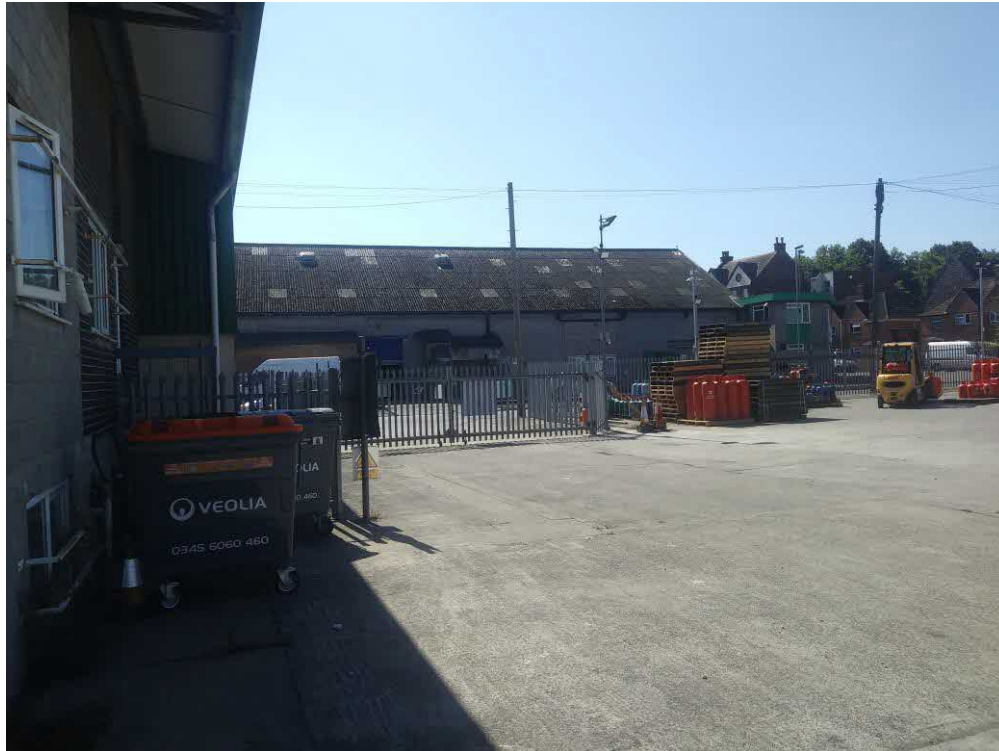
| Photo 9: External yard for Calor Gas. Photo taken viewing south. | | Photo 10: External yard and building for Calor Gas. Photo taken viewing south-west. | |

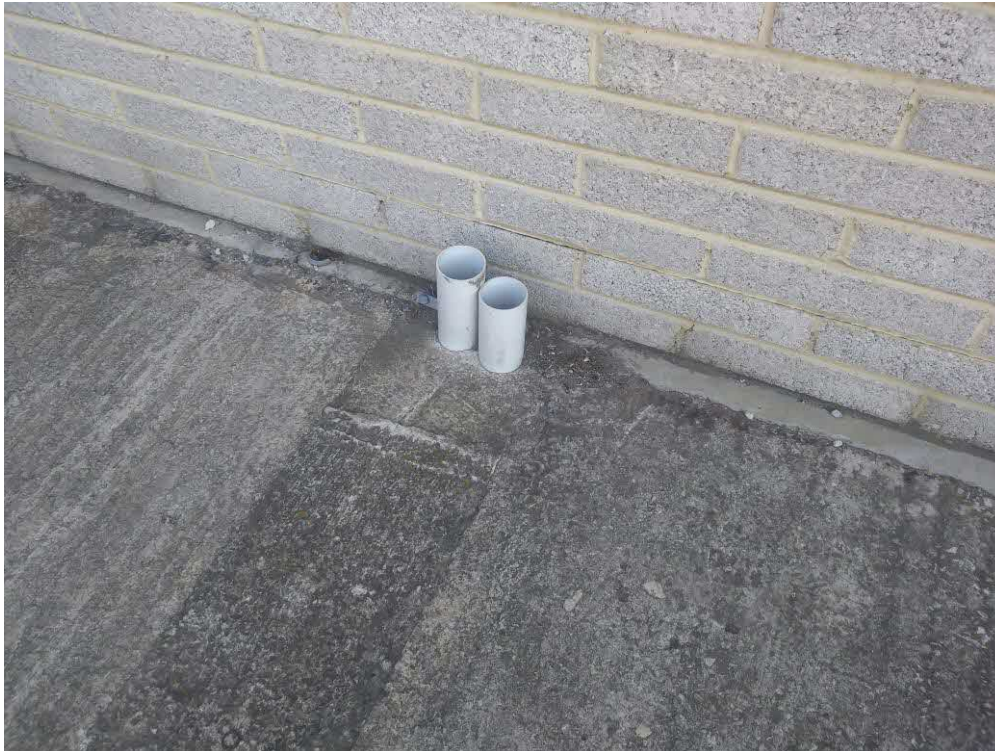
| Photo 13: 2No plastic pipes coming out of the concrete in the north of the Calor Gas yard, which could be vent pipes. | | Photo 14: Access to Units 14 & 15 (telecommunications company and The Invisible Circus. Photo taken viewing south-west. | |

8.2.13 Notwithstanding the above, it is understood that tanks are present on site which could be a potential source of VOCs. A request has been made to the petroleum licensing authority for more information. It is recommended that any tanks identified on site are removed along with surrounding impacted soils under the

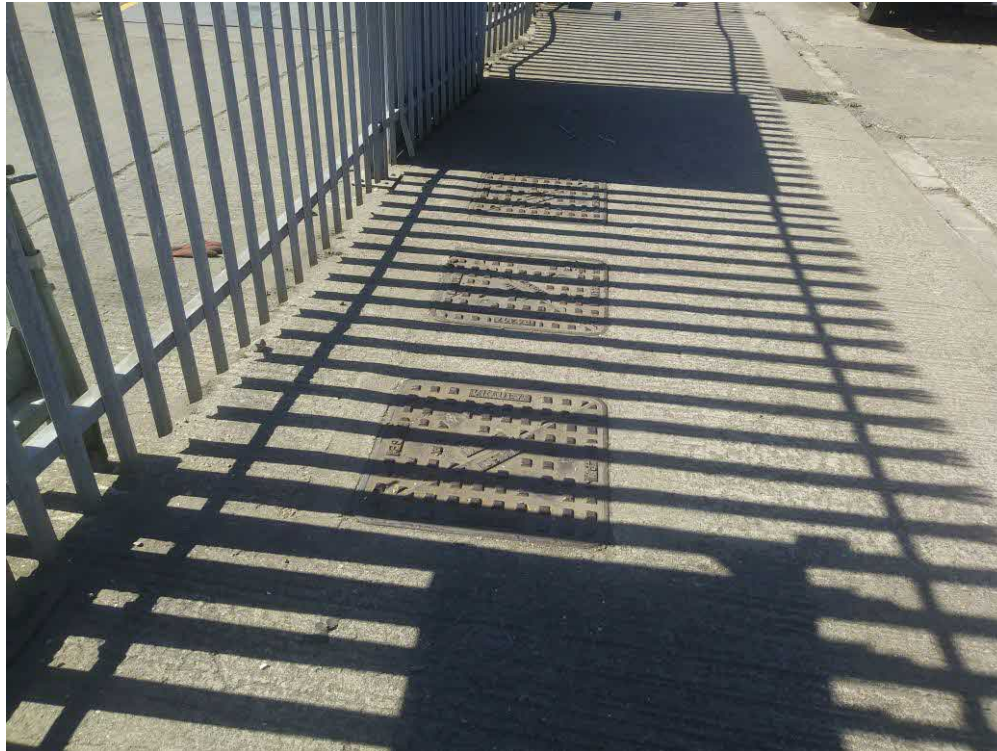
| Photo 15: 3No manhole covers identified in the north of the site. | | Photo 16: External yard for Units 14 & 15. Photo taken viewing north. | |

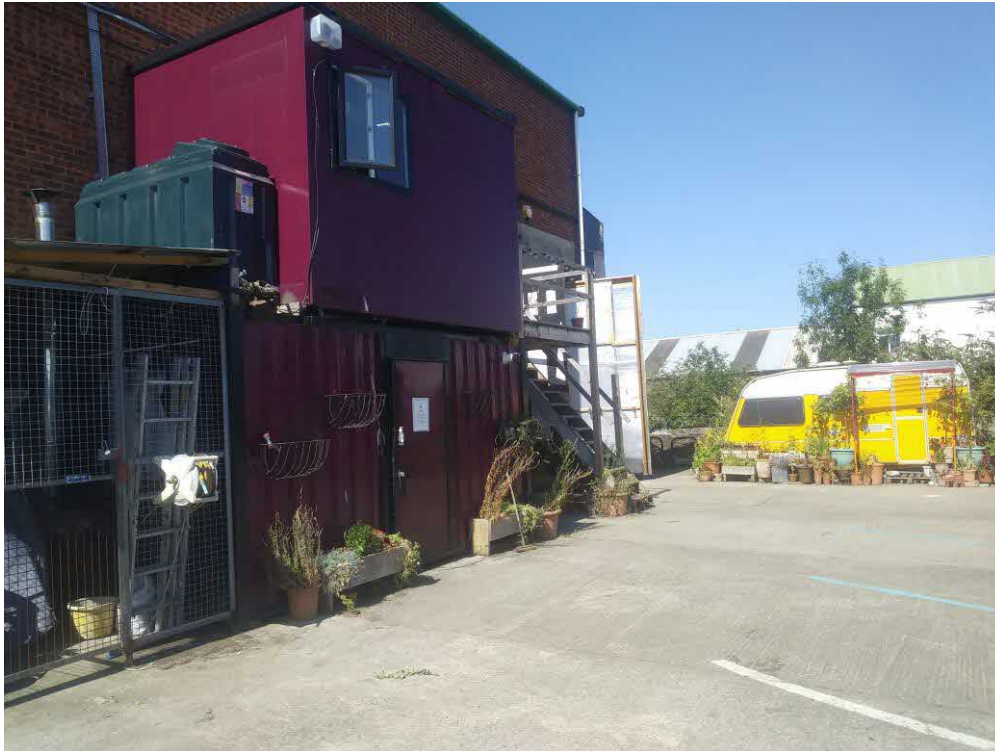
| Photo 17: External yard and building for Units 14 & 15. Photo taken viewing north-west. | | Photo 18: Roller door to Unit 14. Photo taken viewing south-west. | |

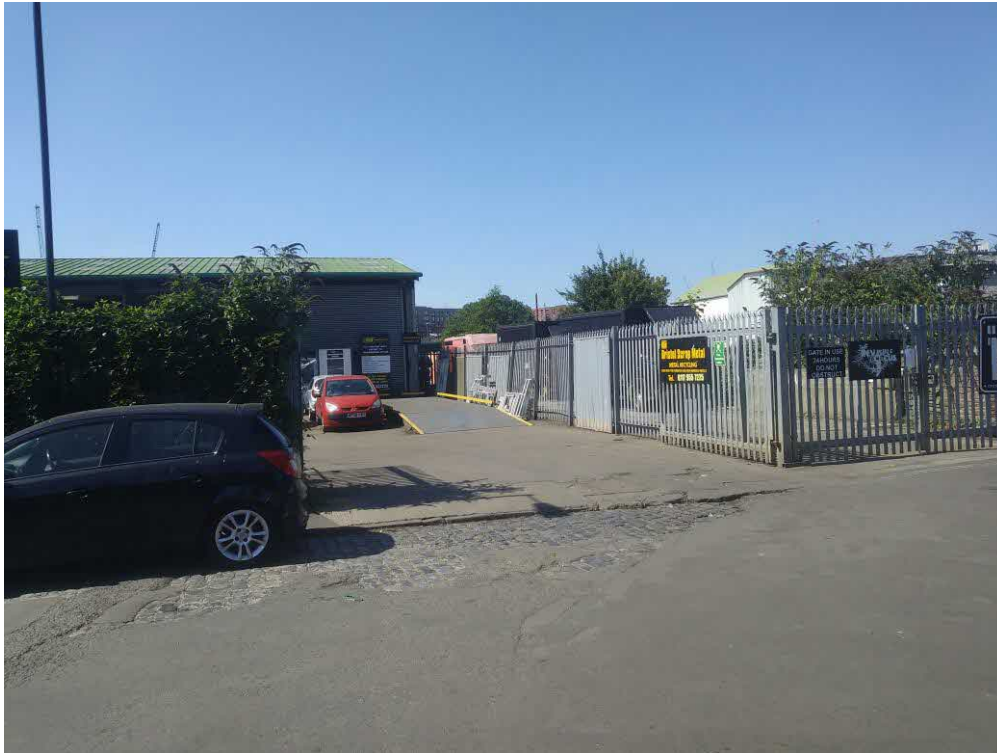
| Photo 19: Access to Units 6-11 (Bristol Scrap Metal). Photo taken viewing west. | | Photo 20: External yard and buildings for Bristol Scrap Metal. Photo taken viewing south. | |

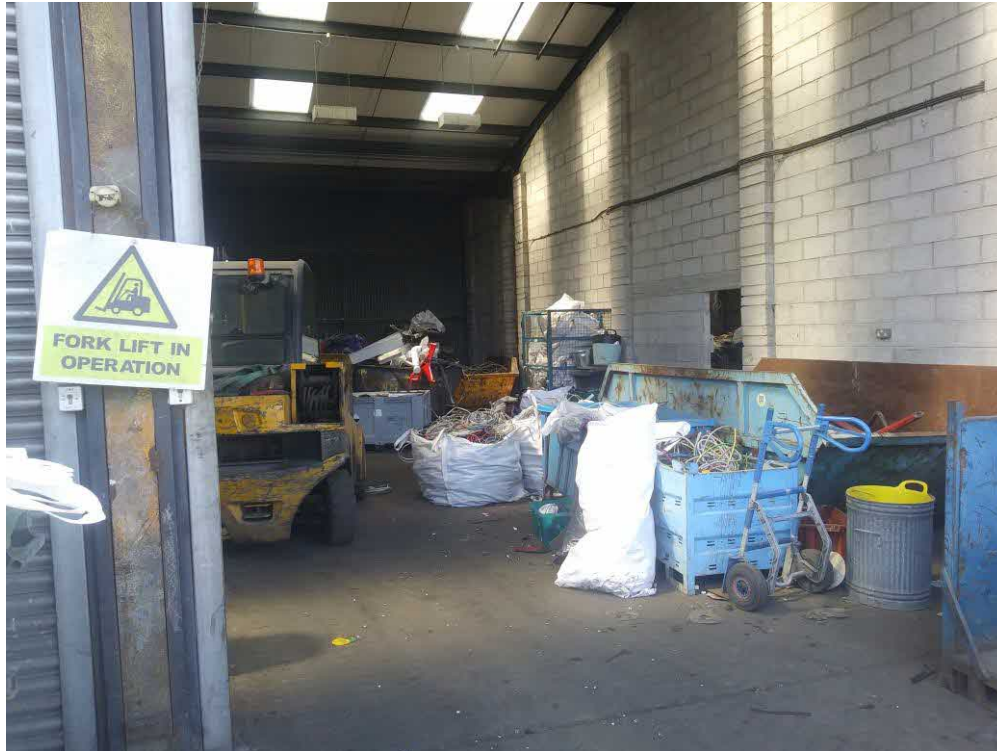
| Photo 21: Inside 1No unit occupied by Bristol Scrap Metal. Photo taken viewing west. | | Photo 22: External yard for Bristol Scrap Metal. Photo taken viewing north-east. | |

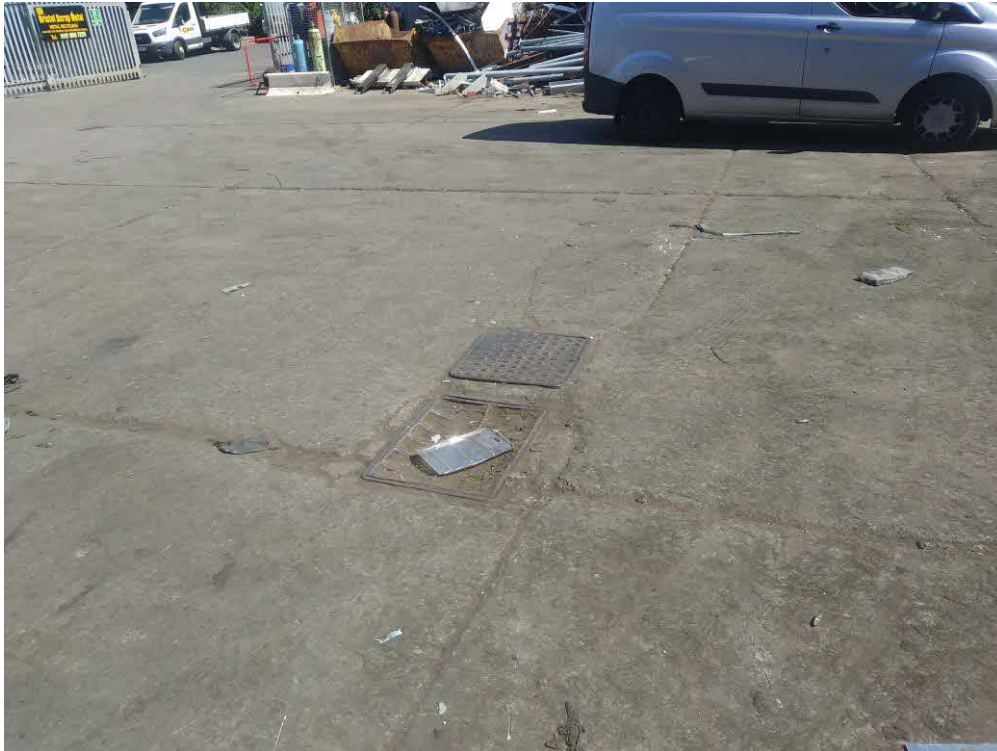
| Photo 23: 2No manhole covers located within the Bristol Scrap Metal yard. | | Photo 24: External yard for Bristol Scrap Metal. Photo taken viewing north. | |
