Flood Risk Assessment and Drainage Strategy

New Henry Street, Bristol

Issue P01 – 05 December 2023

FLOOD RISK ASSESSMENT AND DRAINAGE STRATEGY

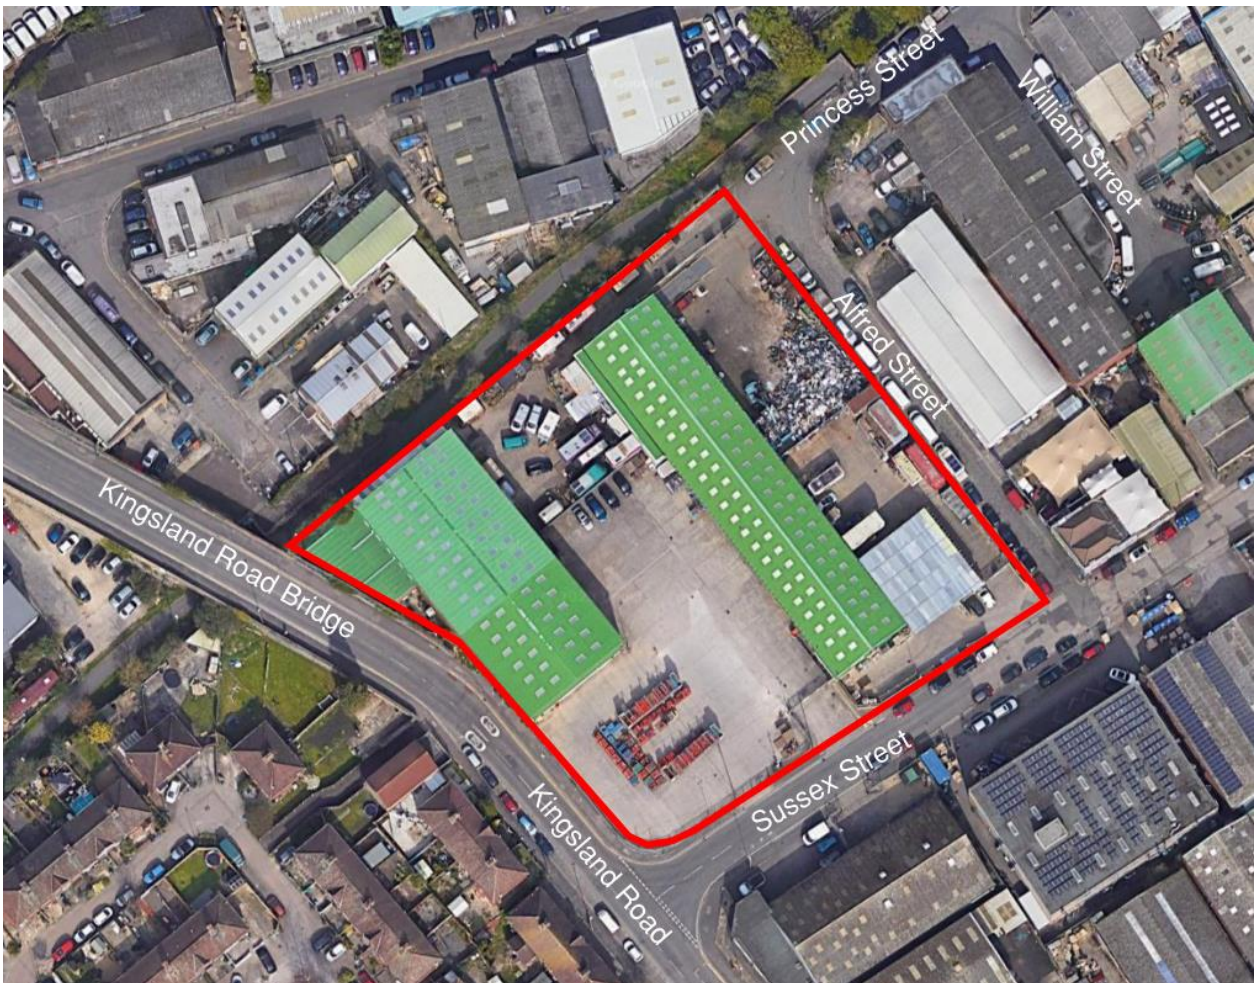
Figure 1: Indicative Site Location Plan

The private site area is 0.75 hectares (ha). The OS Grid Reference for the approximate centre of the Site is National Grid Reference ST 60139 72898. Refer to Figure 1 for an indicative Site location plan.

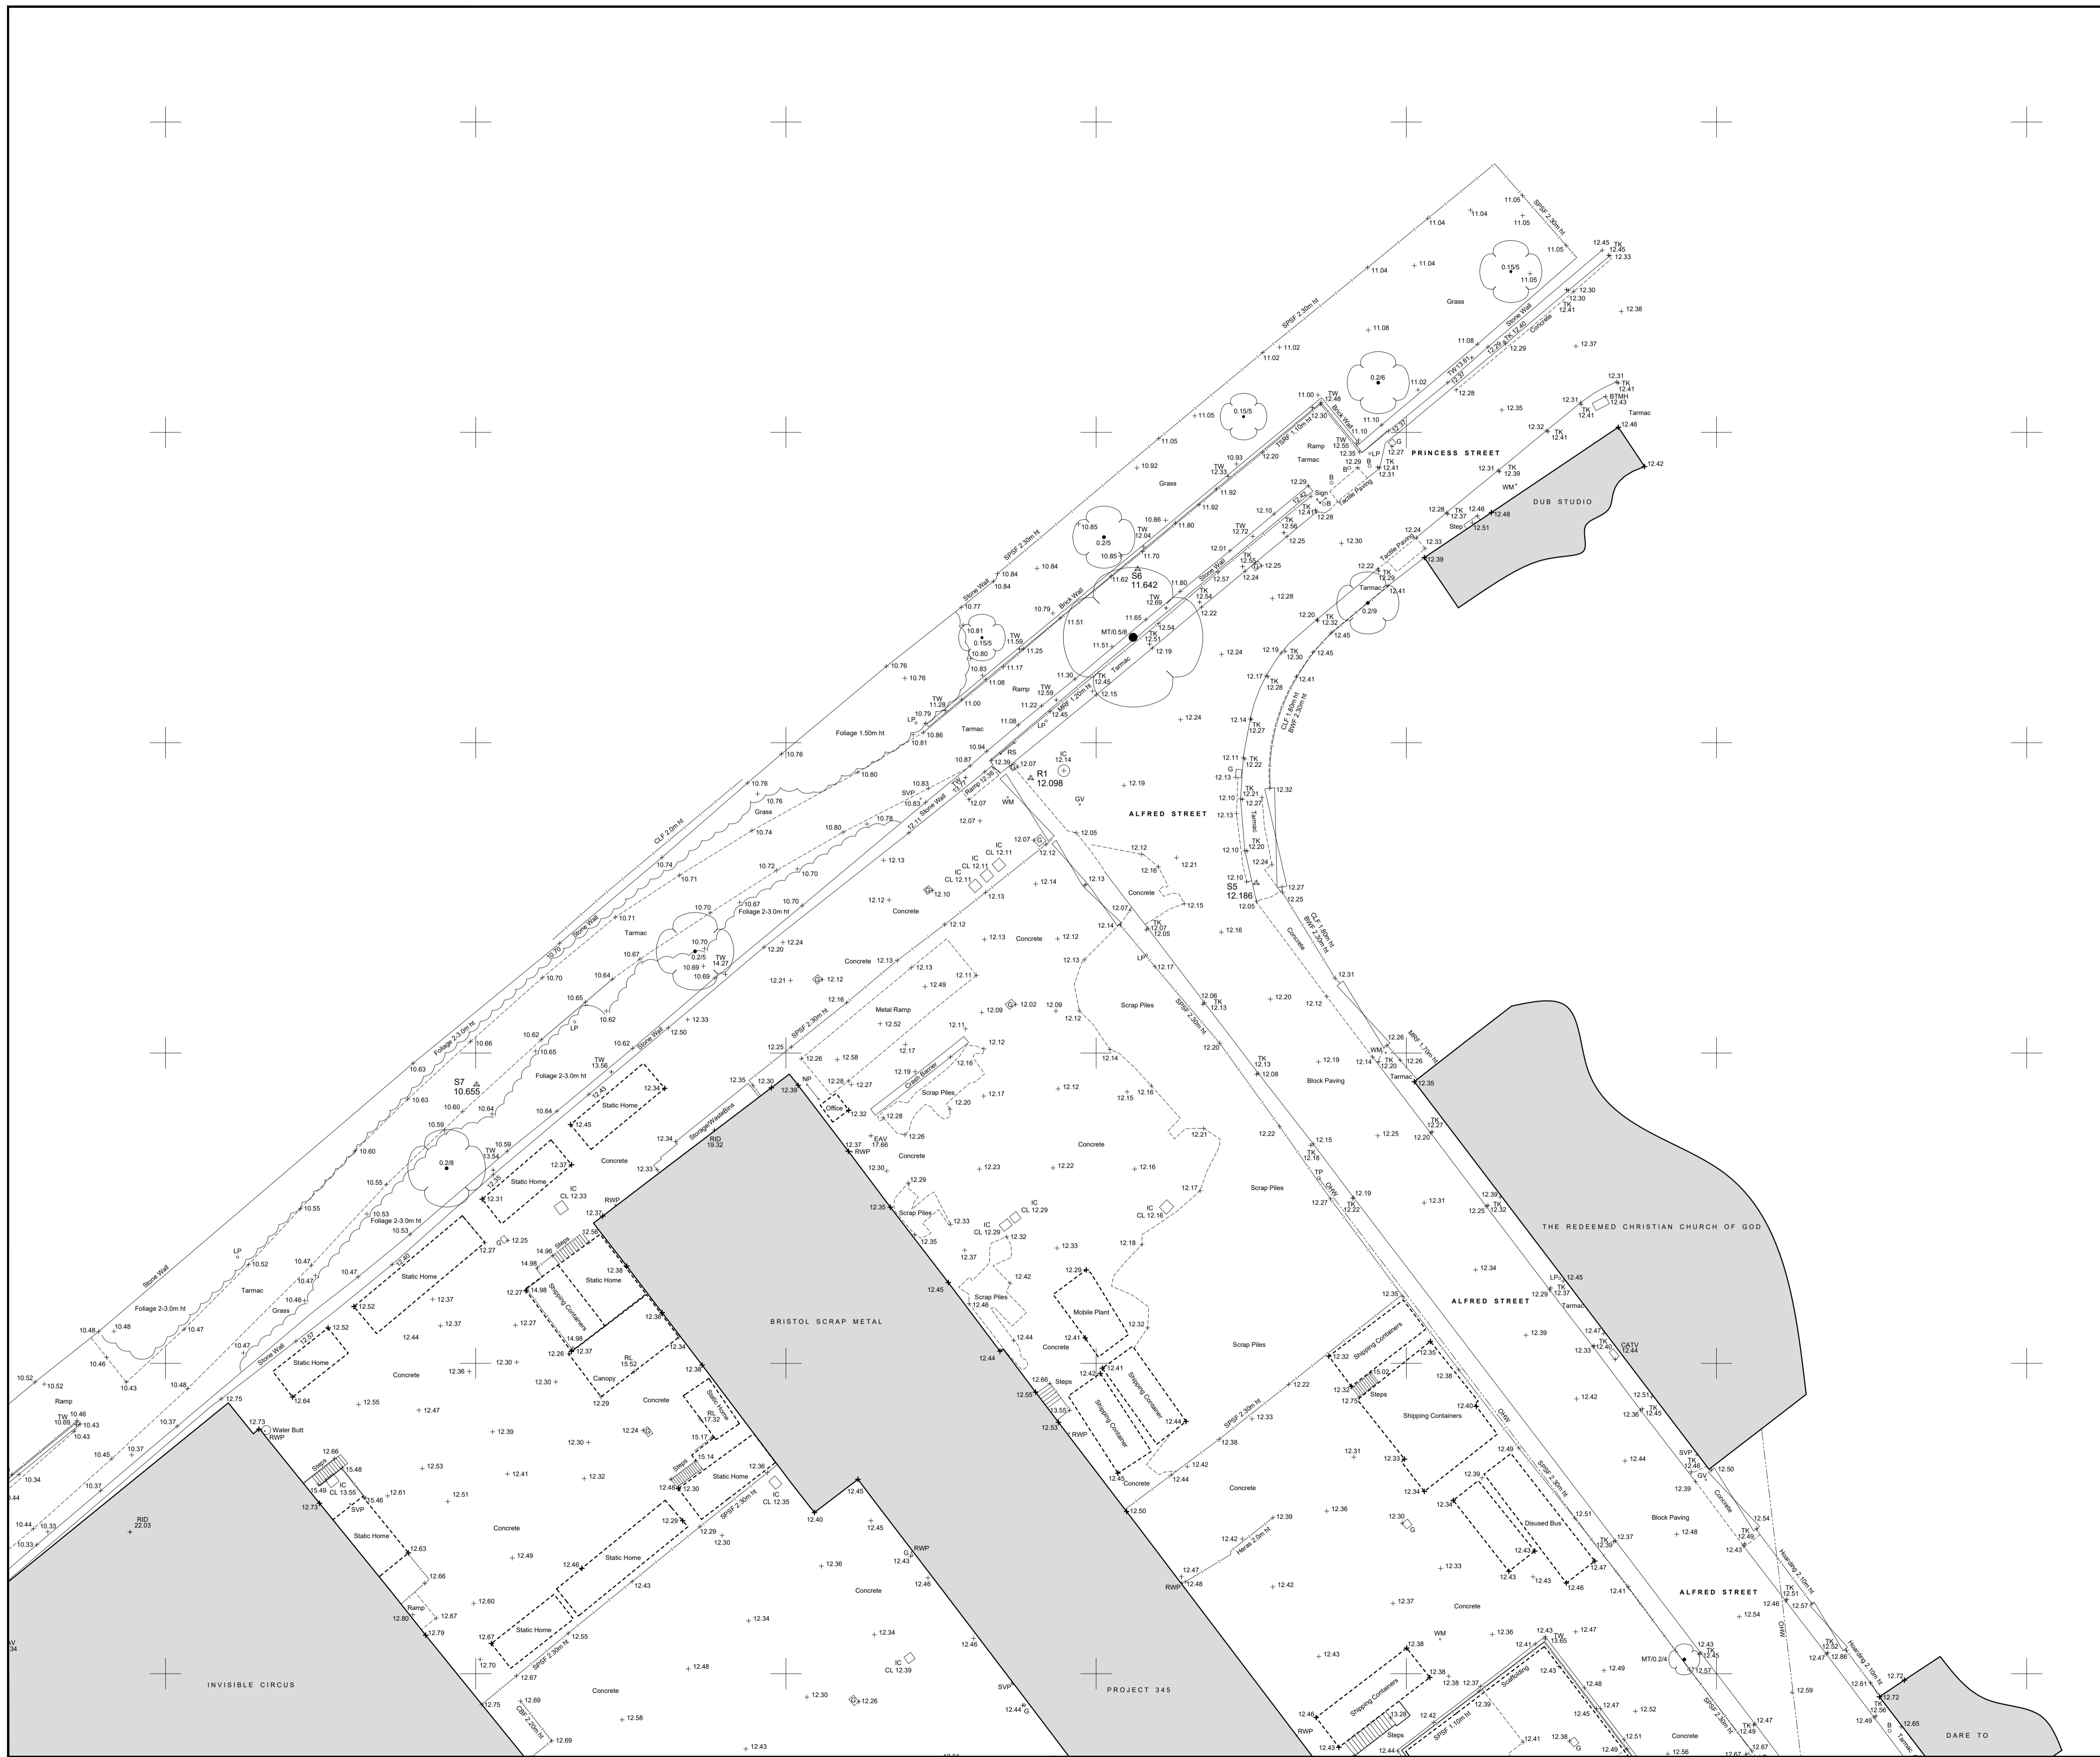
Job No	Rev	Drawing Number
22/281		22/281/100/Overview
Date	November 2022

TOPOGRAPHICAL SURVEY

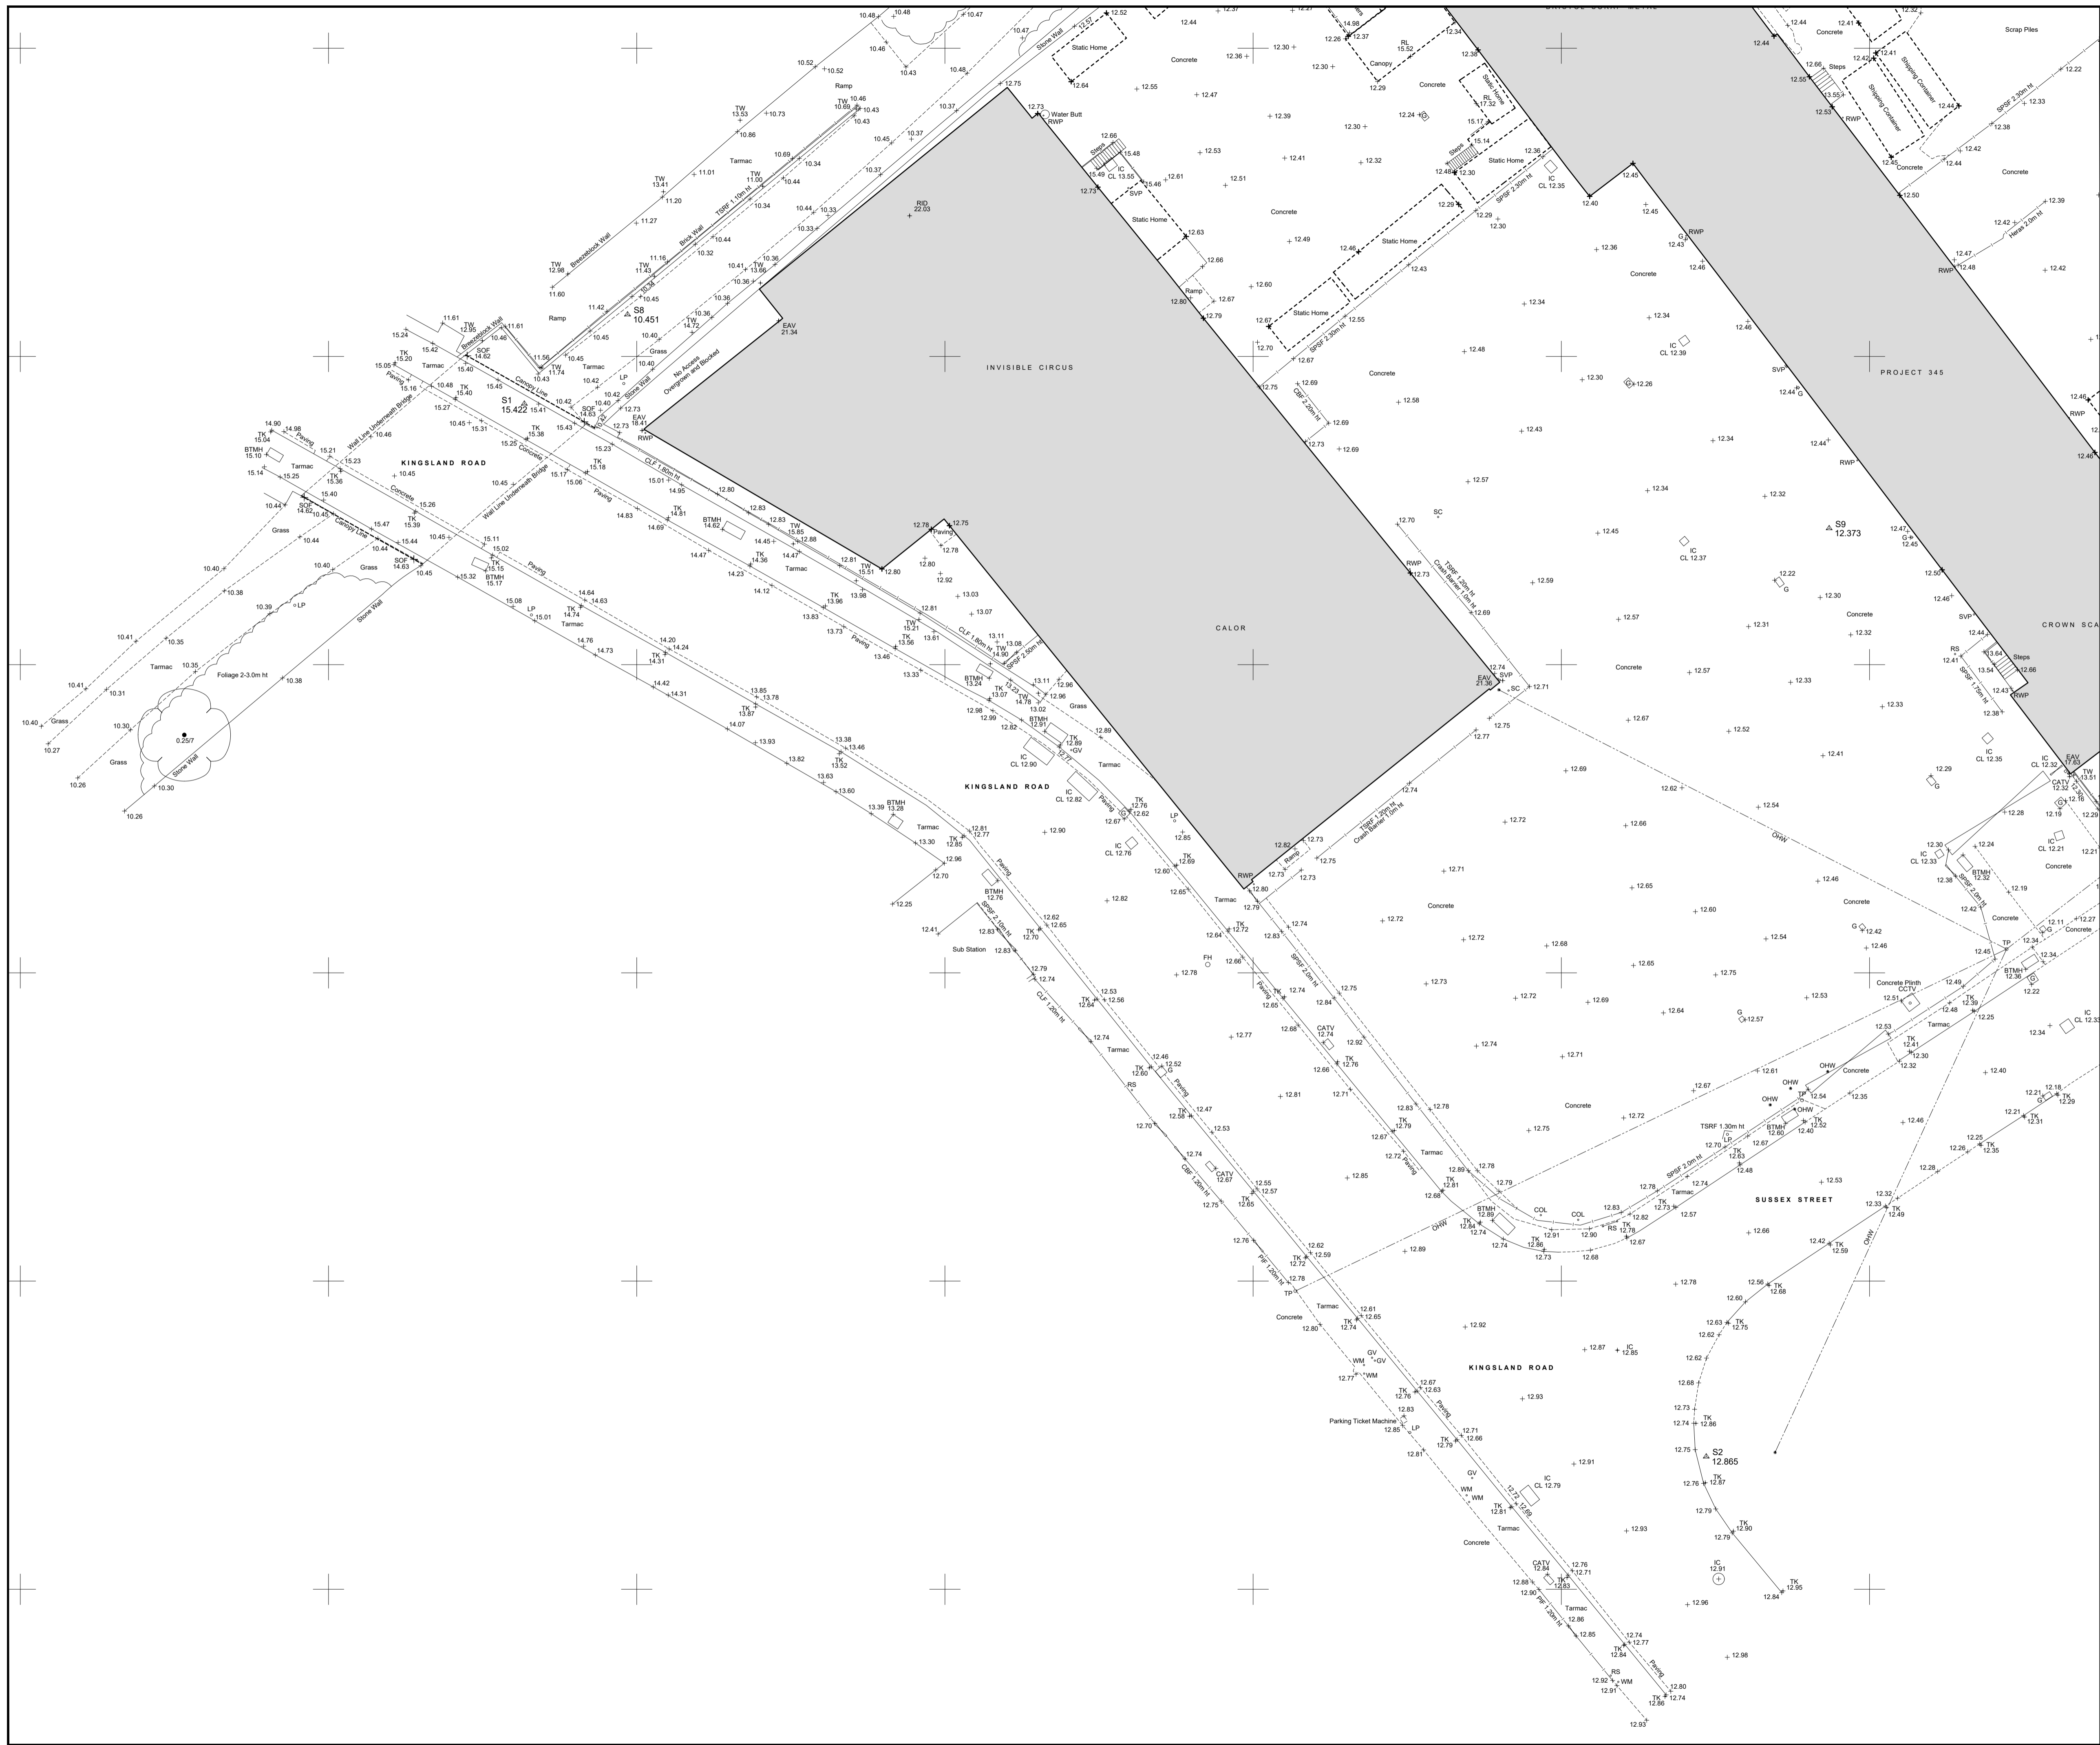
Job No	Rev	Drawing Number
22/281		22/281/100/A
Date	November 2022

TOPOGRAPHICAL SURVEY

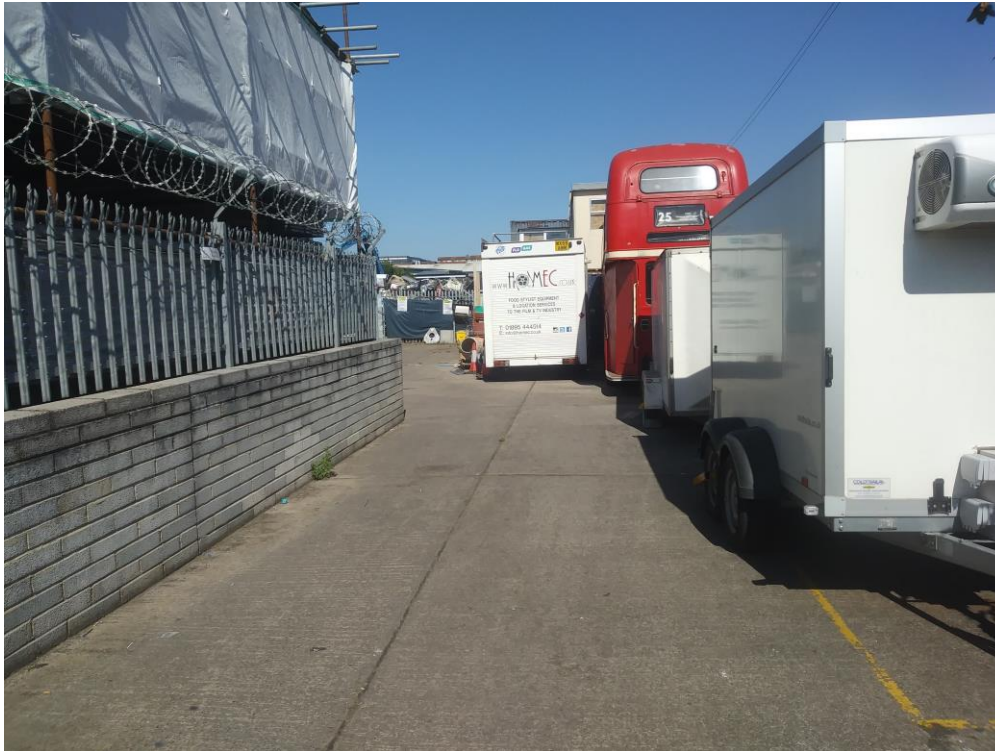
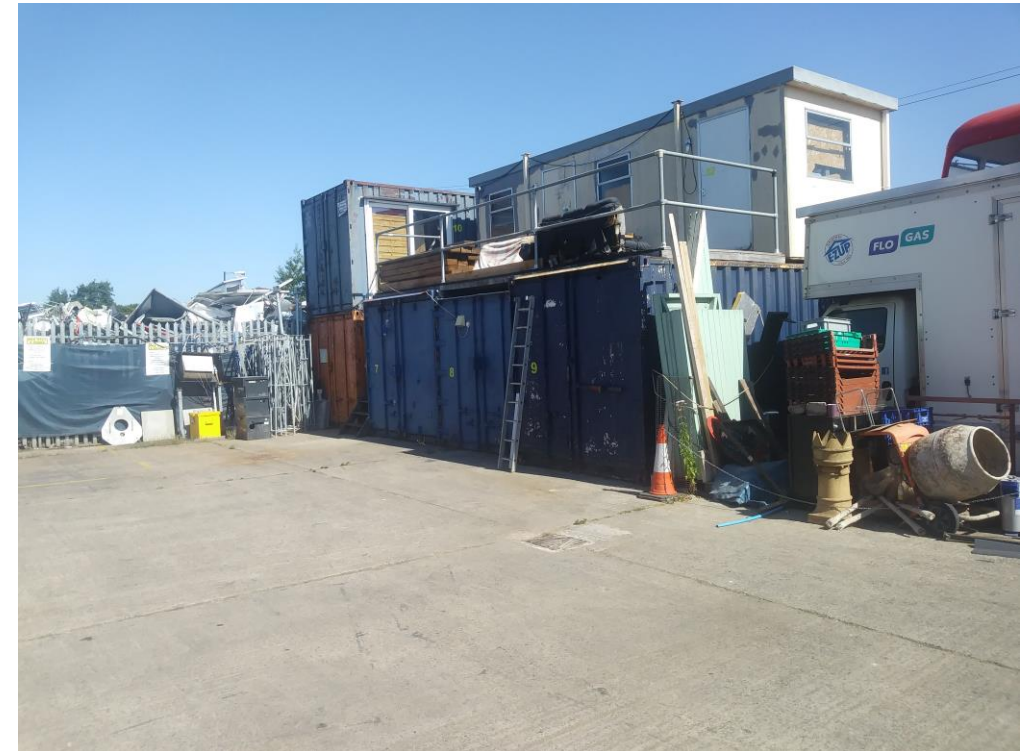
PROJECT NAME	Units 1-15 Premier Estates, Sussex Street, Bristol, BS2 0RA	CLIENT	Dominvs Project Company 23 Limited
TITLE	Site Photo Plan	FIGURE	3
Photo 1: Access to Units 2-5. Photo taken viewing north-west.		Photo 2: External yard for Units 2-5, which contains storage containers utilised as offices. Photo taken viewing north.

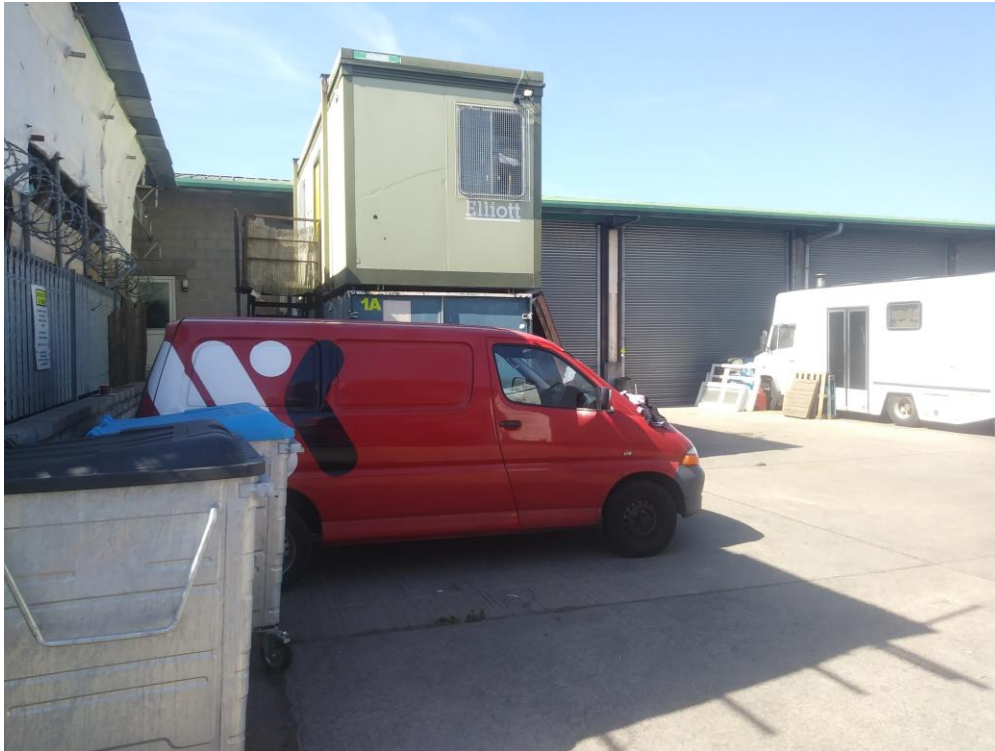
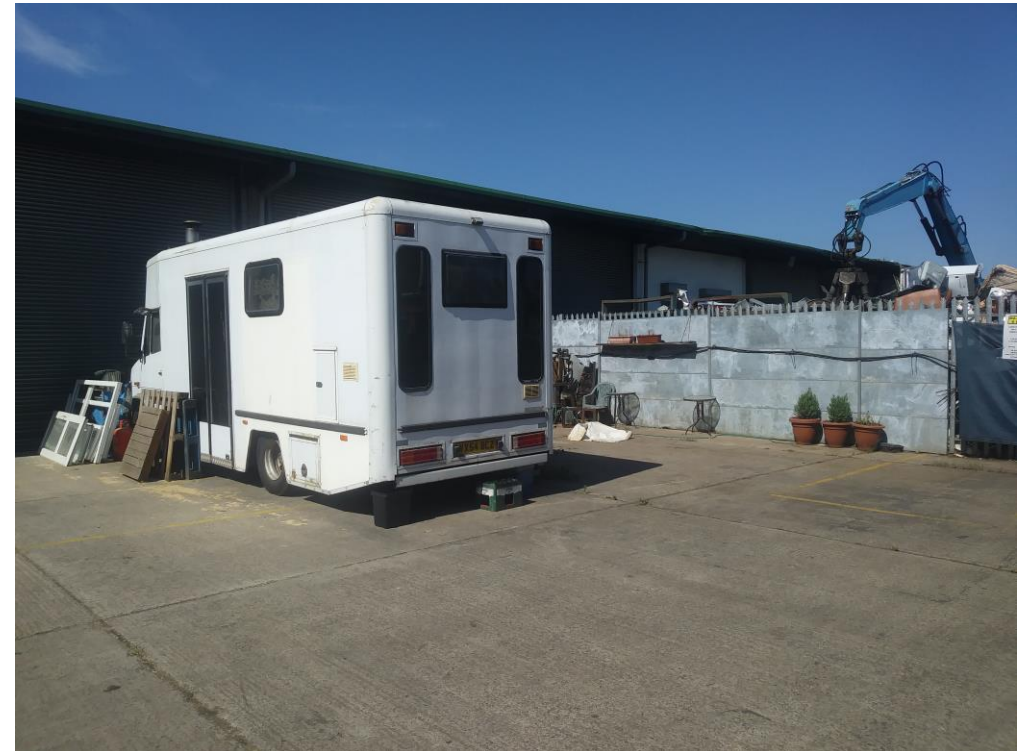
PROJECT NAME	Units 1-15 Premier Estates, Sussex Street, Bristol, BS2 0RA	CLIENT	Dominvs Project Company 23 Limited
TITLE	Site Photo Plan	FIGURE	3
Photo 3: External yard for Units 2-5, which contains storage containers utilised as offices. Photo taken viewing south-west.		Photo 4: External yard for Units 2-5, with Units in the rear of the photo. Photo taken viewing west.

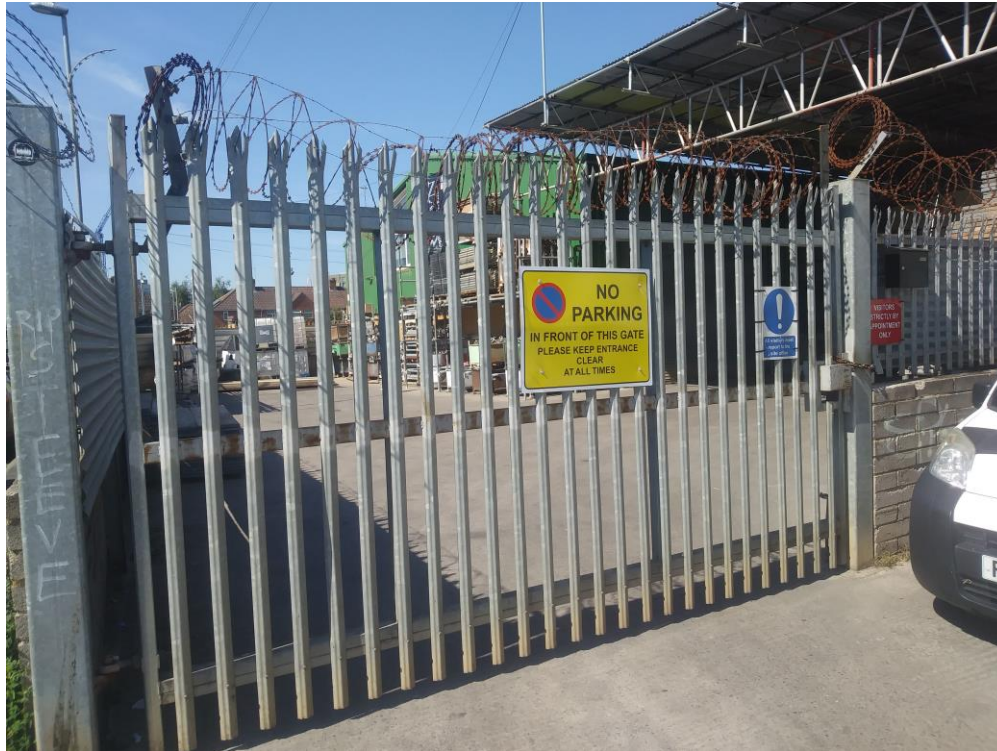
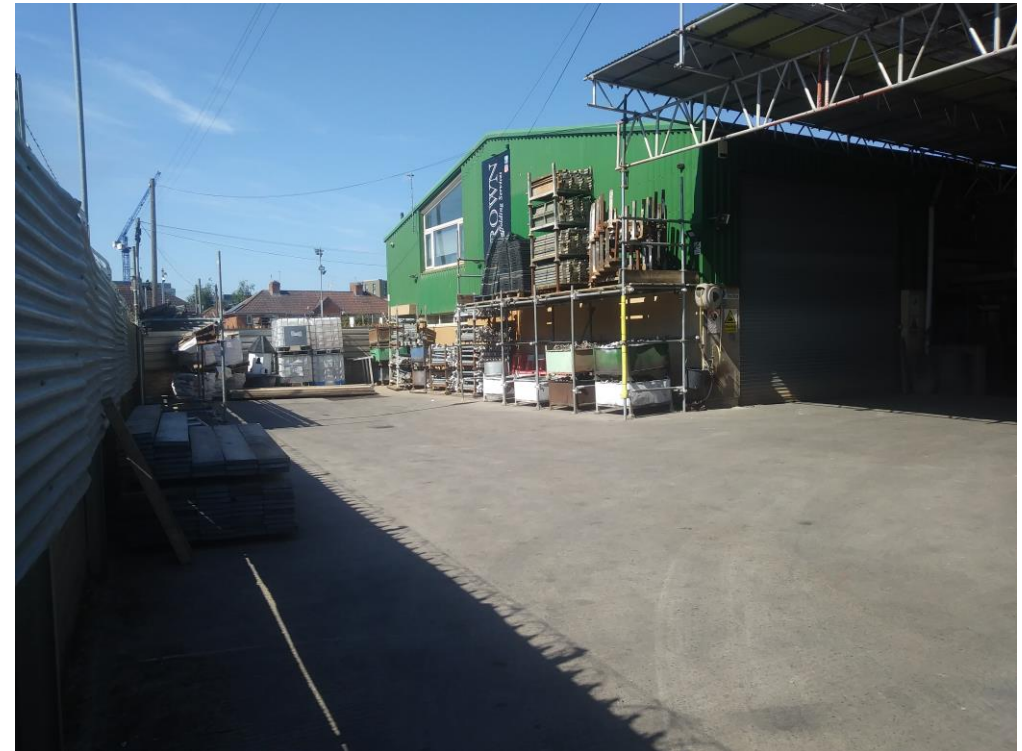
PROJECT NAME	Units 1-15 Premier Estates, Sussex Street, Bristol, BS2 0RA	CLIENT	Dominvs Project Company 23 Limited
TITLE	Site Photo Plan	FIGURE	3
Photo 5: Access gate to Unit 1 (Crown Scaffolding). Photo taken viewing west.		Photo 6: External yard and buildings for Crown Scaffolding. Photo taken viewing west.

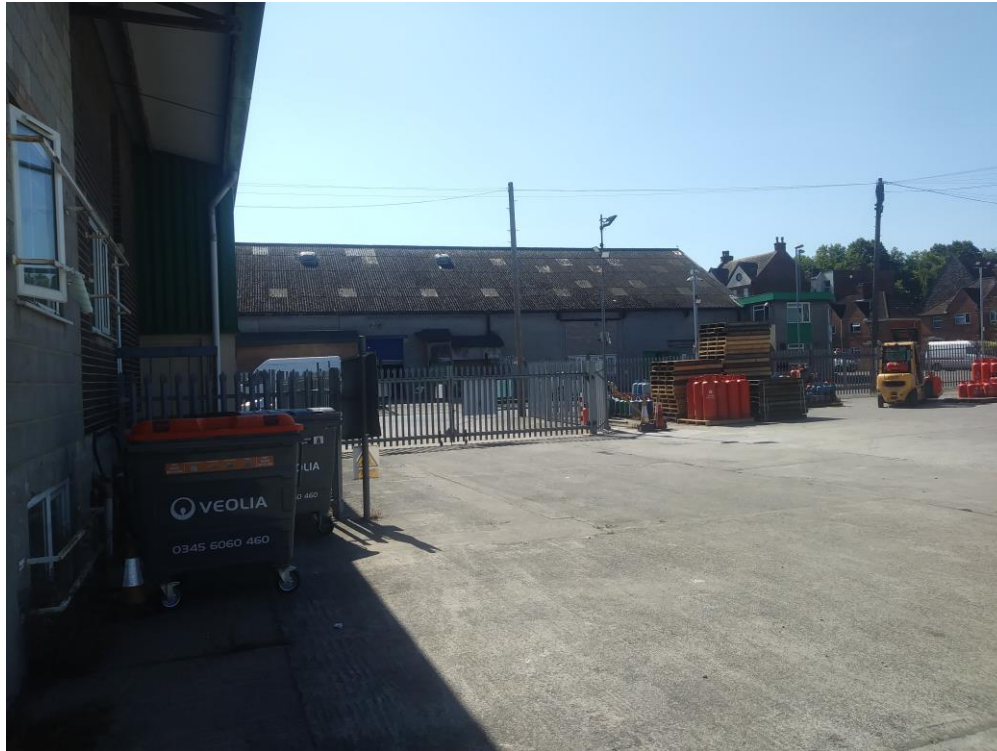
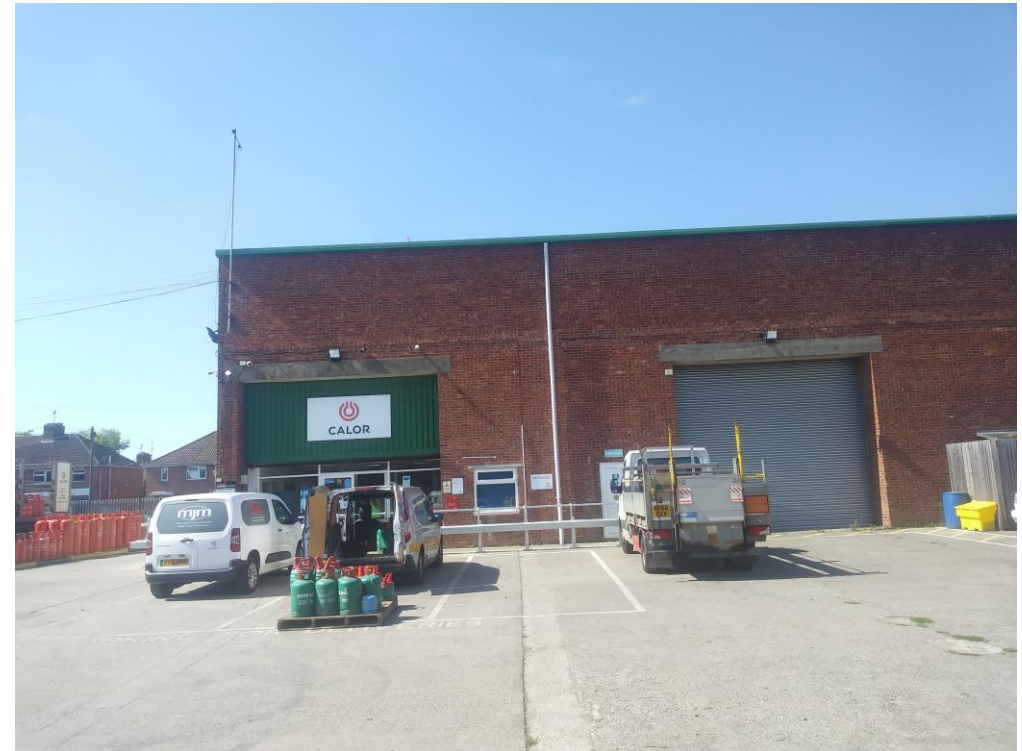
PROJECT NAME	Units 1-15 Premier Estates, Sussex Street, Bristol, BS2 0RA	CLIENT	Dominvs Project Company 23 Limited
TITLE	Site Photo Plan	FIGURE	3
Photo 9: External yard for Calor Gas. Photo taken viewing south.		Photo 10: External yard and building for Calor Gas. Photo taken viewing south-west.

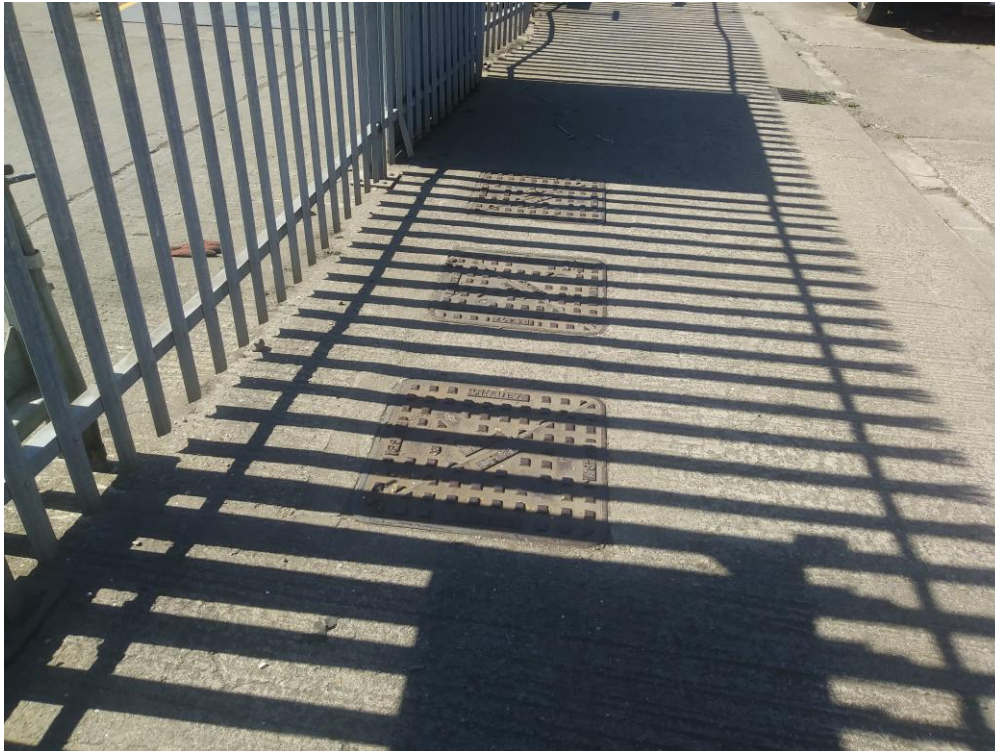
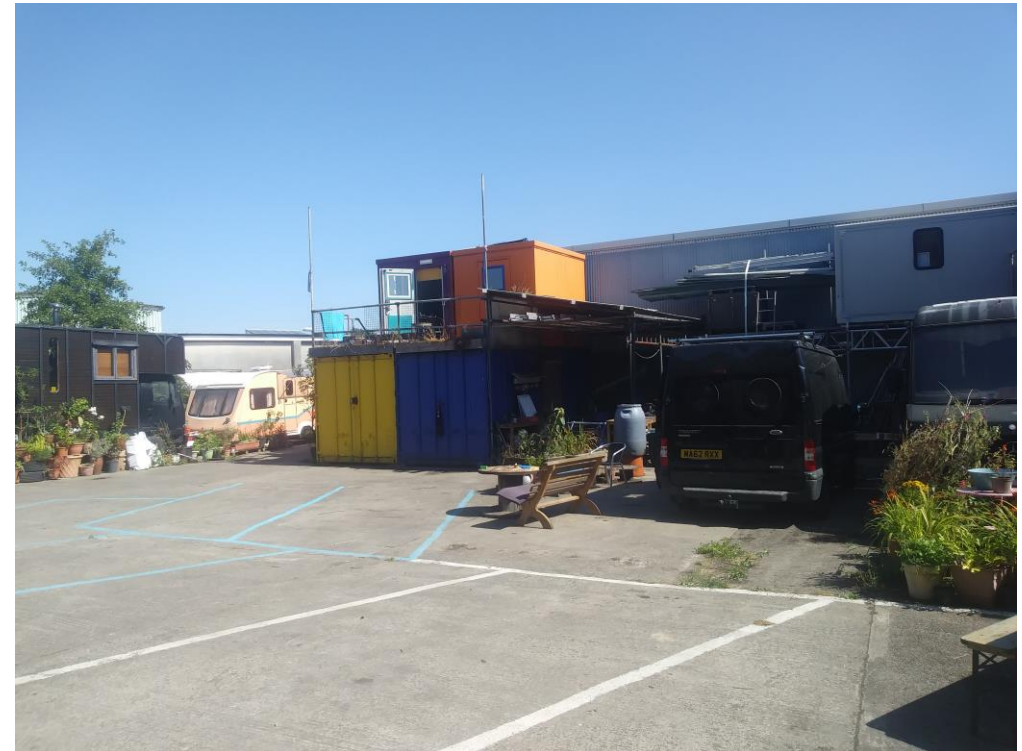
PROJECT NAME	Units 1-15 Premier Estates, Sussex Street, Bristol, BS2 0RA	CLIENT	Dominvs Project Company 23 Limited
TITLE	Site Photo Plan	FIGURE	3
Photo 15: 3No manhole covers identified in the north of the site.		Photo 16: External yard for Units 14 & 15. Photo taken viewing north.

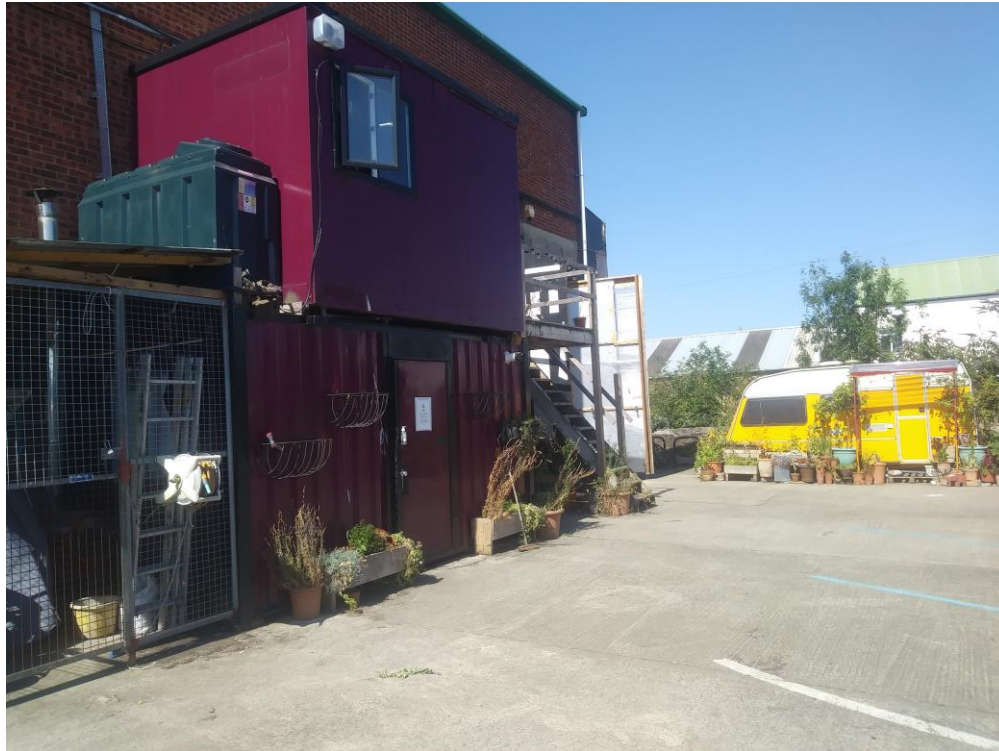
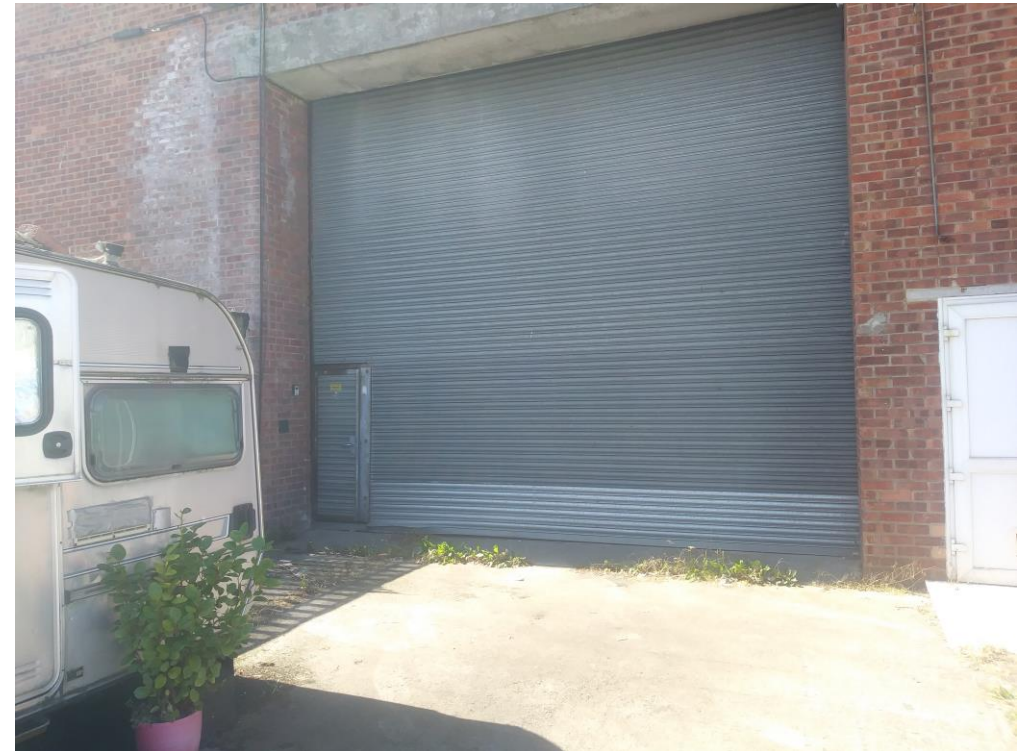
PROJECT NAME	Units 1-15 Premier Estates, Sussex Street, Bristol, BS2 0RA	CLIENT	Dominvs Project Company 23 Limited
TITLE	Site Photo Plan	FIGURE	3
Photo 17: External yard and building for Units 14 & 15. Photo taken viewing north-west.		Photo 18: Roller door to Unit 14. Photo taken viewing south-west.

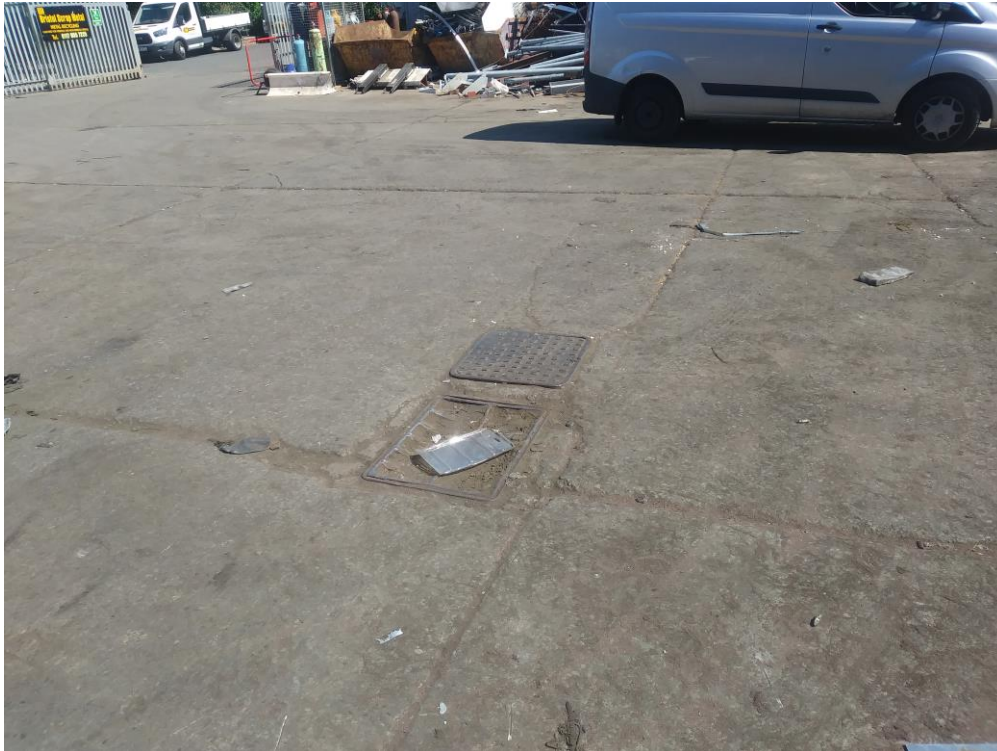
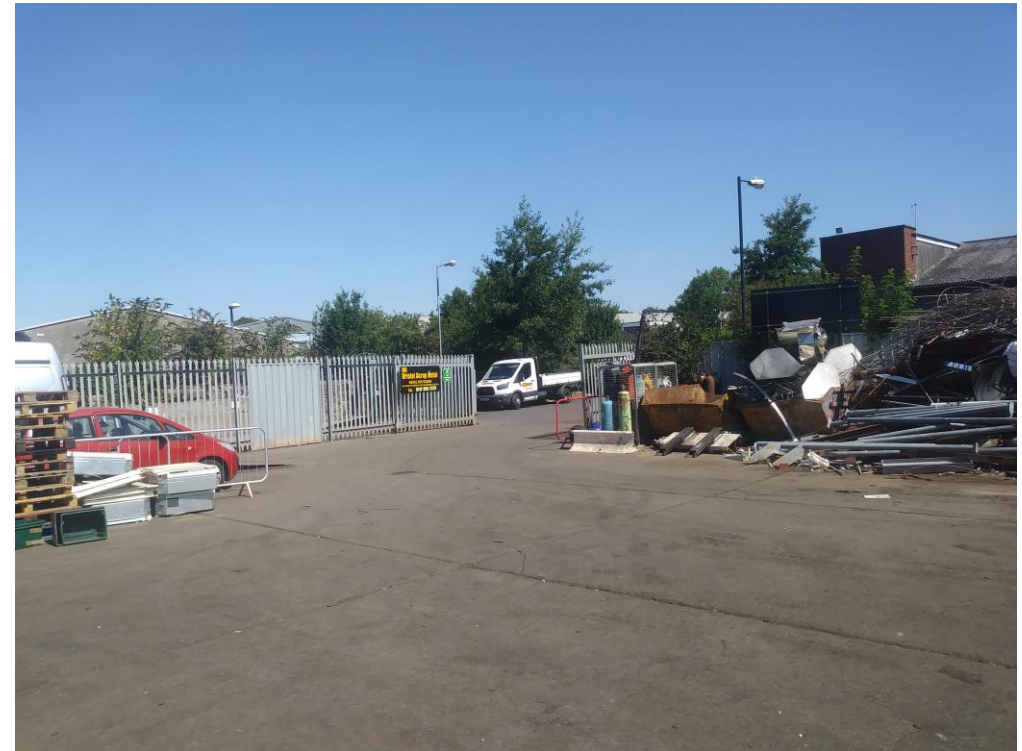
PROJECT NAME	Units 1-15 Premier Estates, Sussex Street, Bristol, BS2 0RA	CLIENT	Dominvs Project Company 23 Limited
TITLE	Site Photo Plan	FIGURE	3
Photo 23: 2No manhole covers located within the Bristol Scrap Metal yard.		Photo 24: External yard for Bristol Scrap Metal. Photo taken viewing north.
