Flood Risk Assessment and Drainage Strategy

New Henry Street, Bristol

Issue P01 – 05 December 2023

FLOOD RISK ASSESSMENT AND DRAINAGE STRATEGY

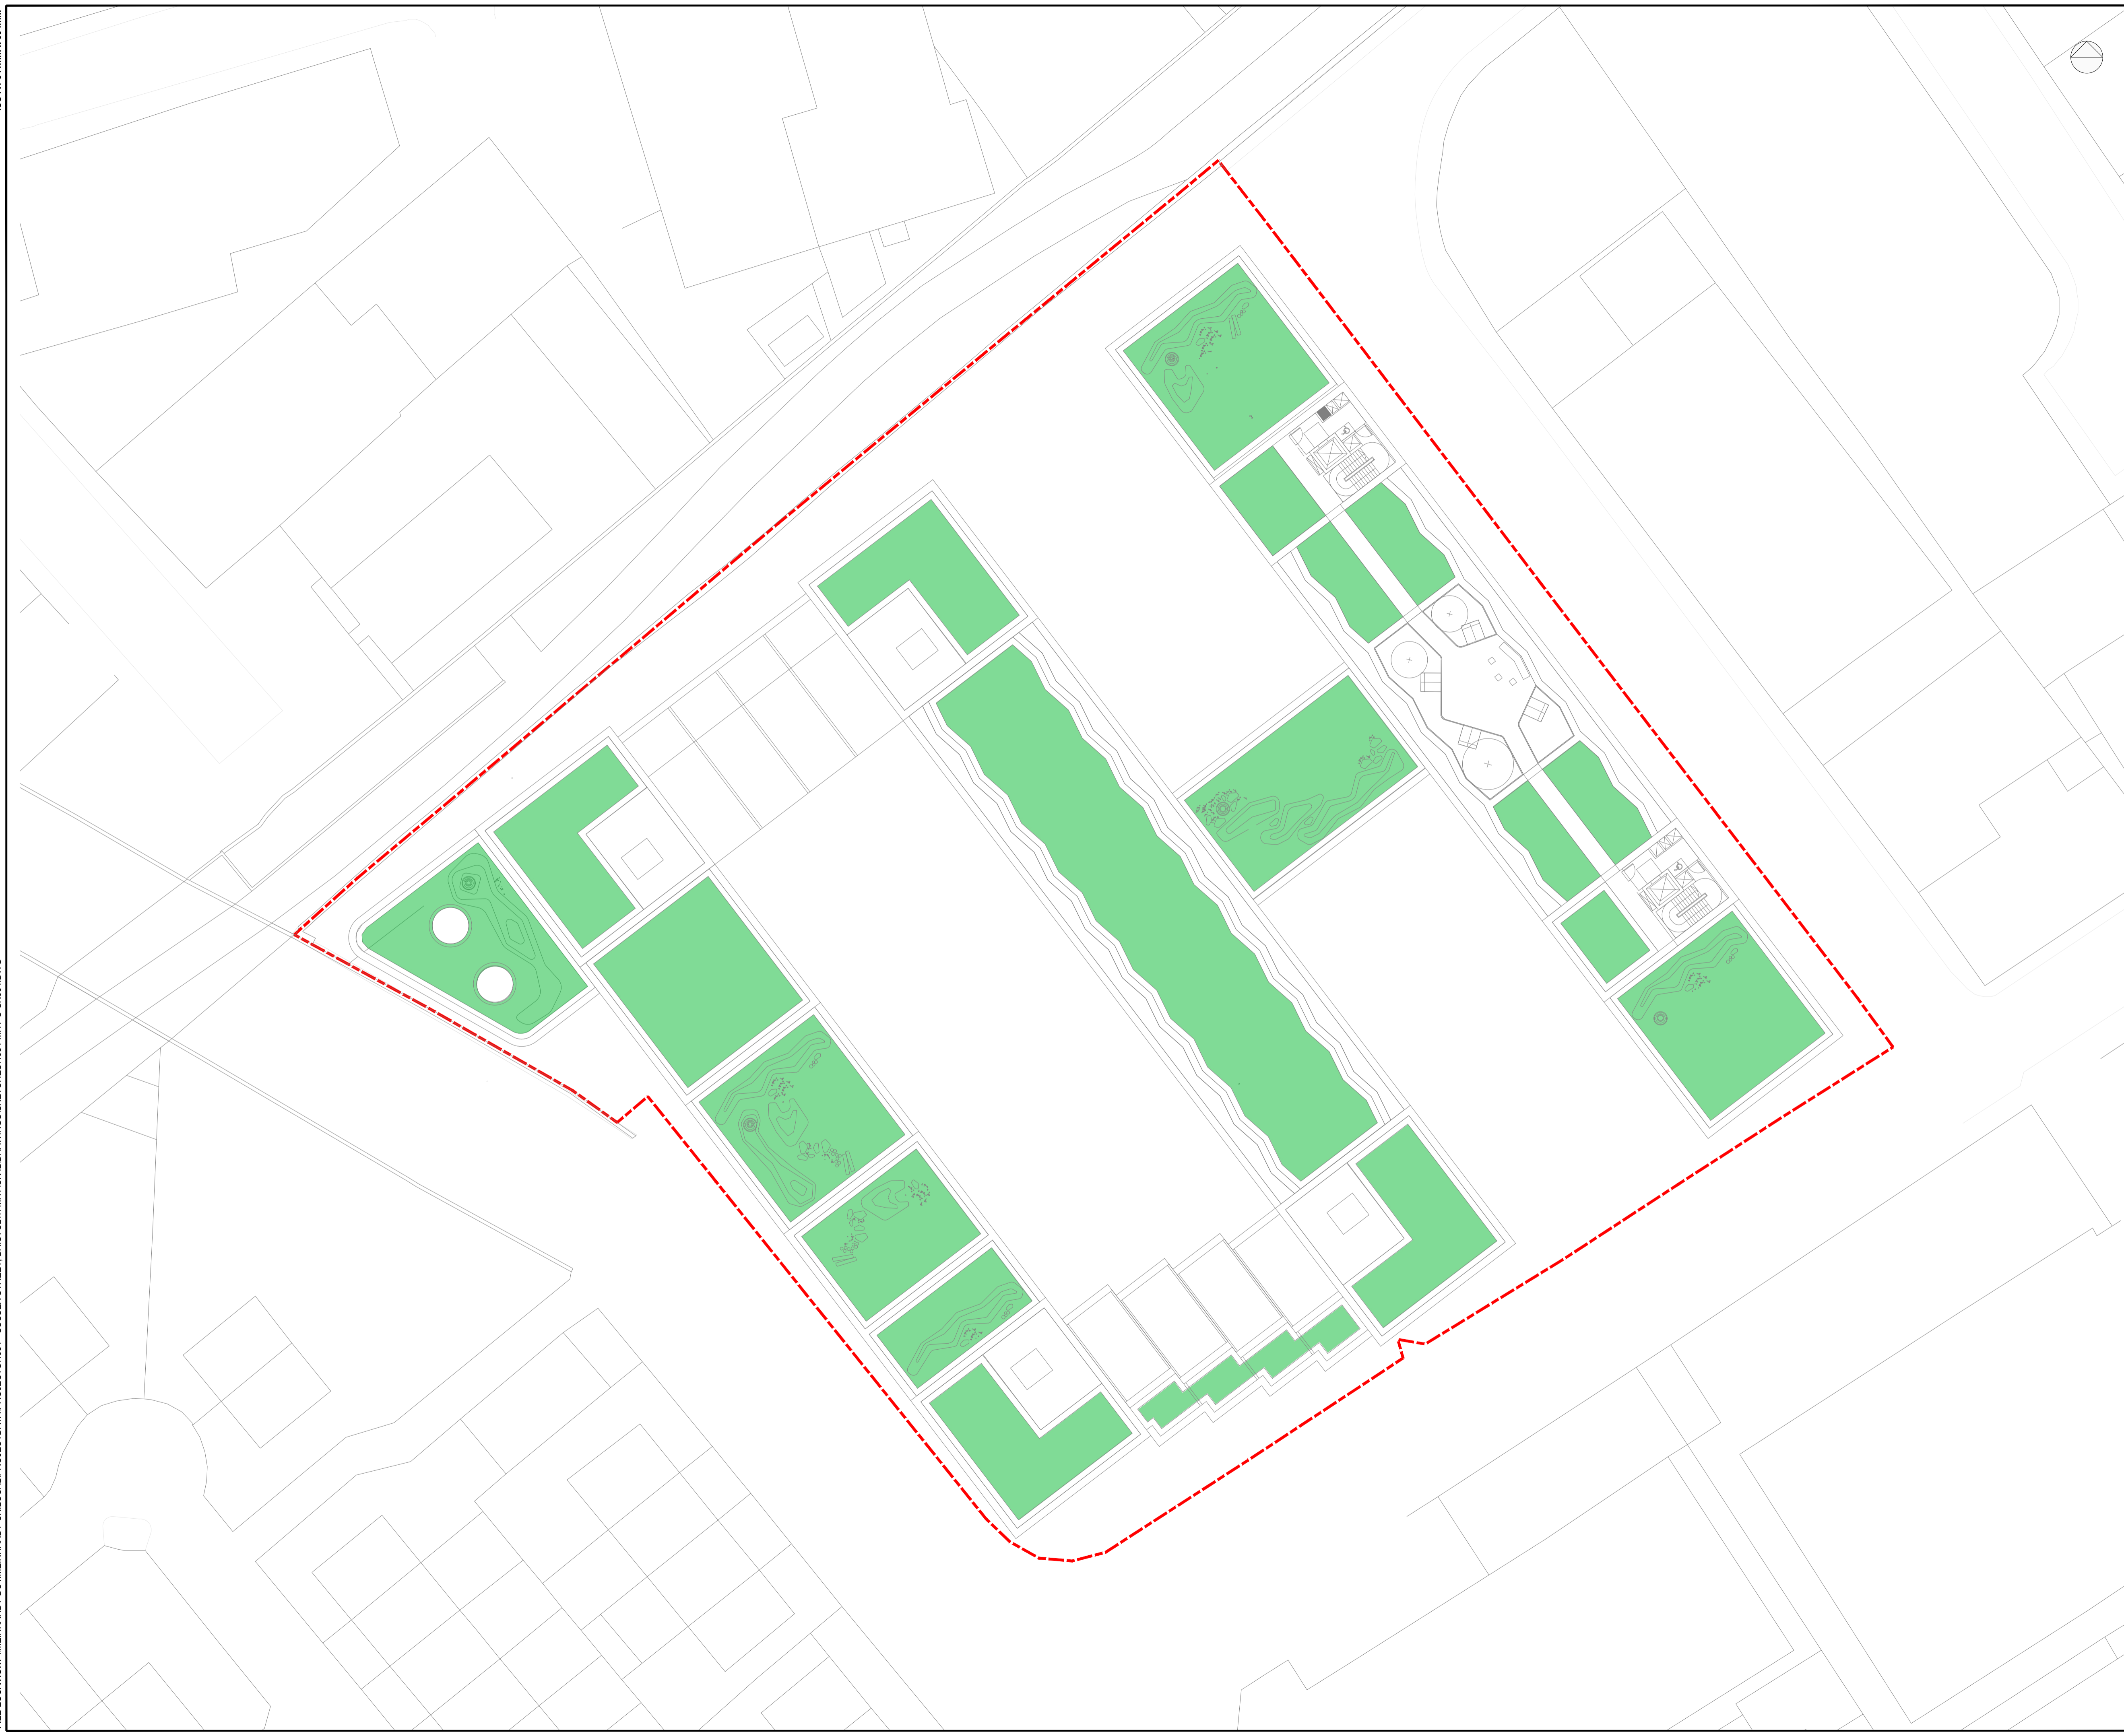
DISCIPLINE			SCALE
CIVIL			1:250
DRAWN	DESIGNED	CHECKED	APPROVED
JH	JH	GB	GB
DRAWING No			ISSUE
4054-MHT-C-SK004			103

- KEY:**
- SITE BOUNDARY
 - BIODIVERSE GREEN AND BROWN ROOFS. REFER TO LANDSCAPE ARCHITECTS DRAWINGS FOR FURTHER INFORMATION

TITLE
PROPOSED ROOF LEVEL LAYOUT
