PHASE II GEO-ENVIRONMENTAL SITE ASSESSMENT

**Moor House Farm,
Shincliffe
DH1 2TQ**

**Report Ref: 21-871-r2
Date Issued: August 2022**

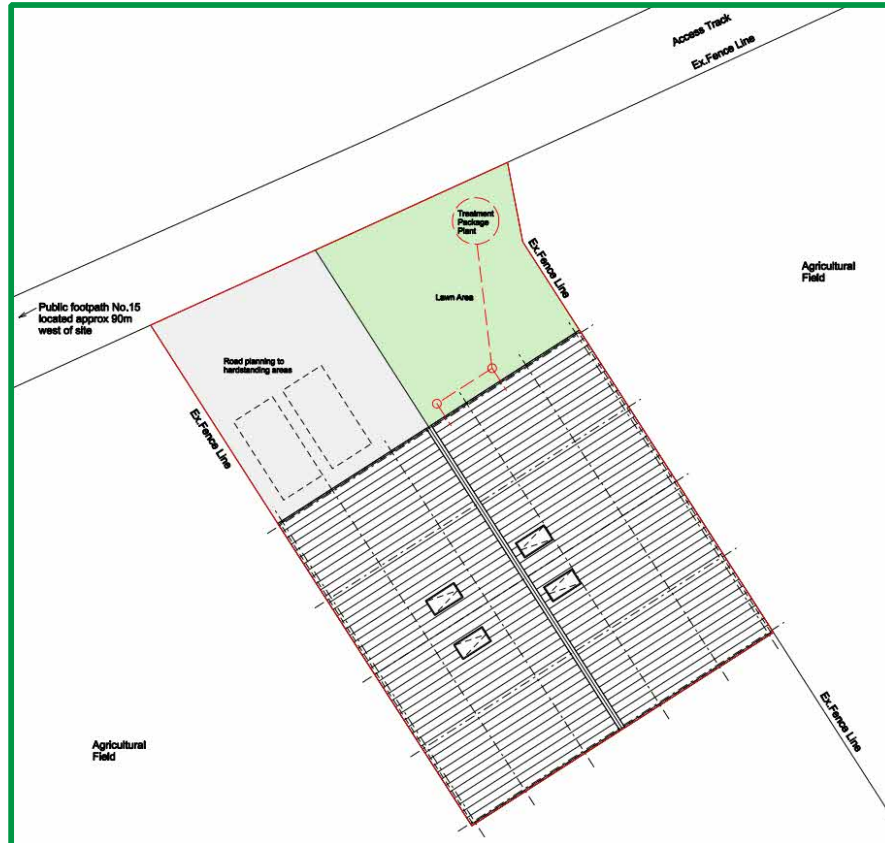
Figure 1.1 Snapshot of Proposed Development

The client intends to convert the existing barn for residential end use, with associated car parking, private garden area and sewage treatment plant. Drawing 21-871-002 (Appendix III) identifies the proposed development layout.

A snapshot of the proposed development layout is indicated in Figure 1.1:

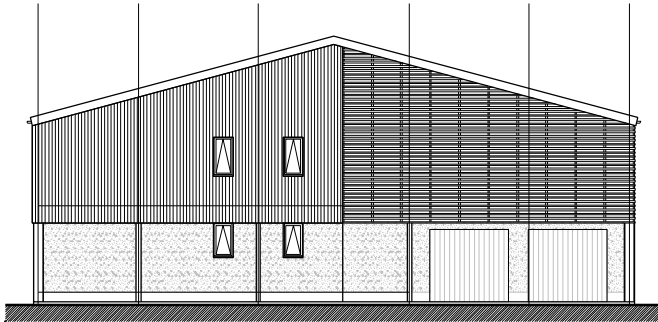
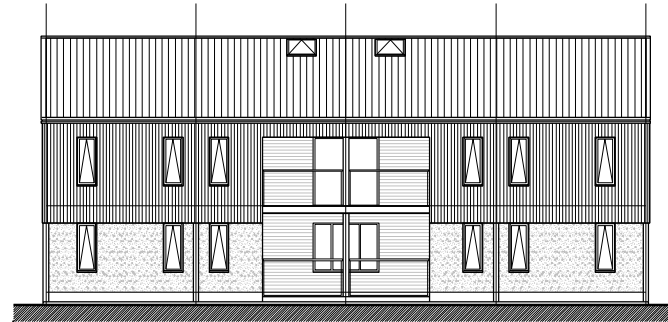
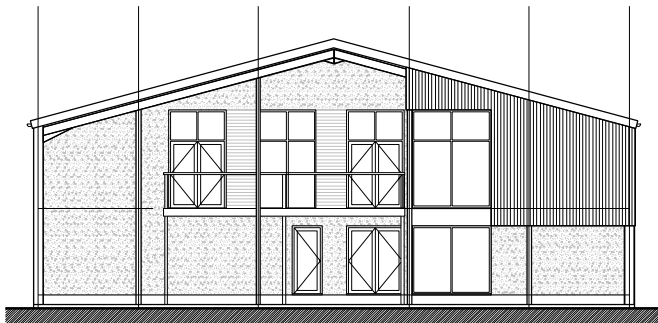
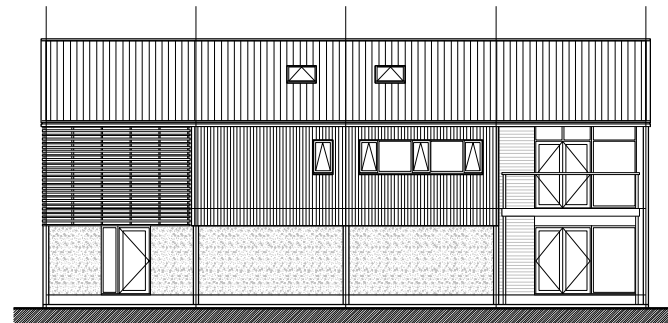
Front (NW) Elevation

Side (NE) Elevation

Rear (SE) Elevation

Side (SW) Elevation

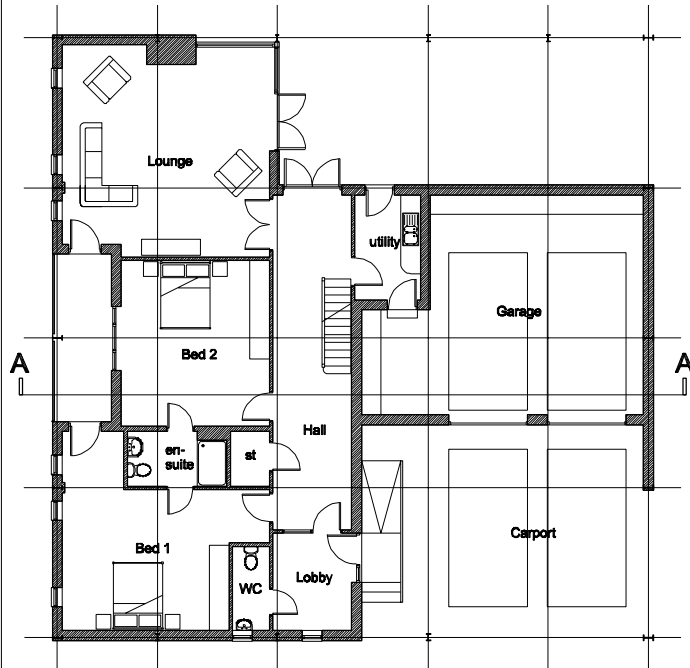
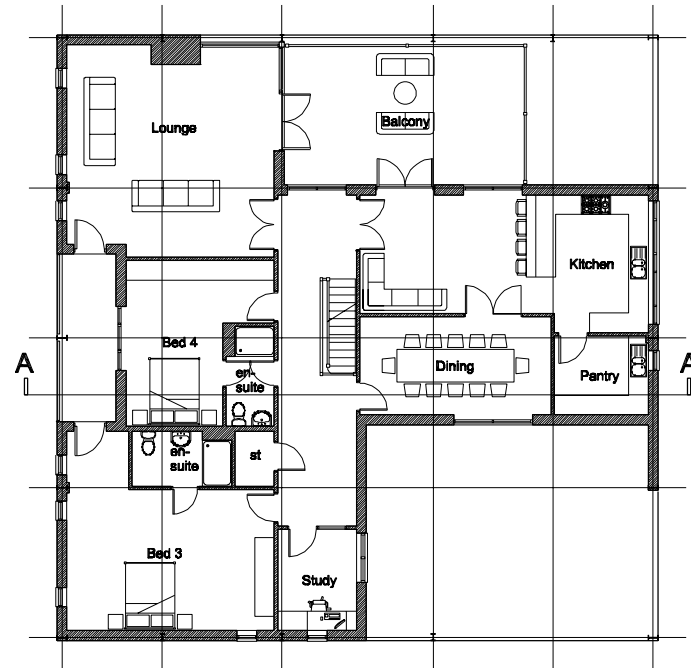
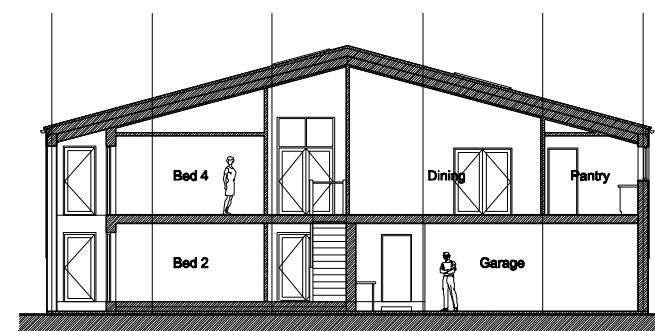
Ground Floor Plan

First Floor Plan

Section A-A

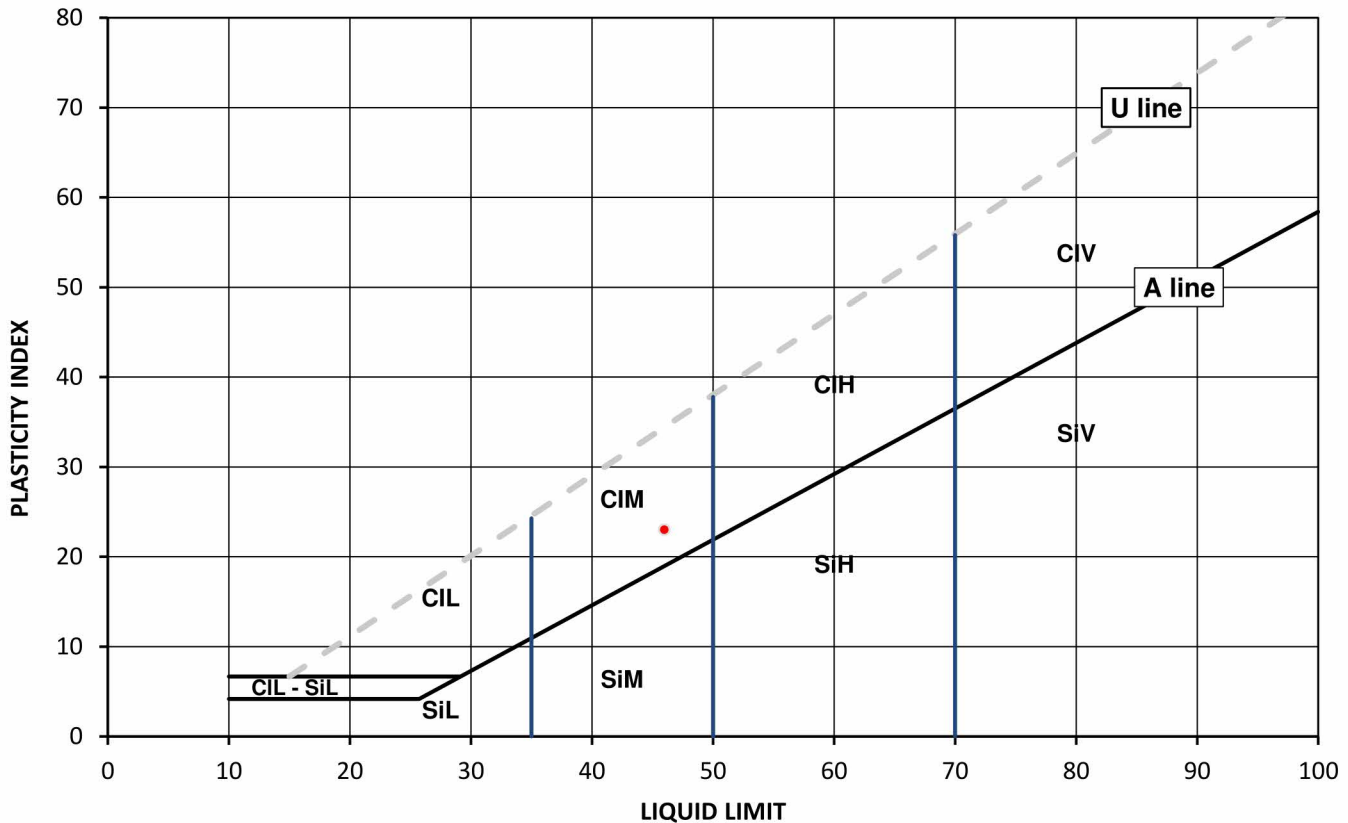
As Received Water Content [W] %	Liquid Limit [WL] %	Plastic Limit [Wp] %	Plasticity Index [Ip] %	% Passing 425µm BS Test Sieve
19	46	23	23	96

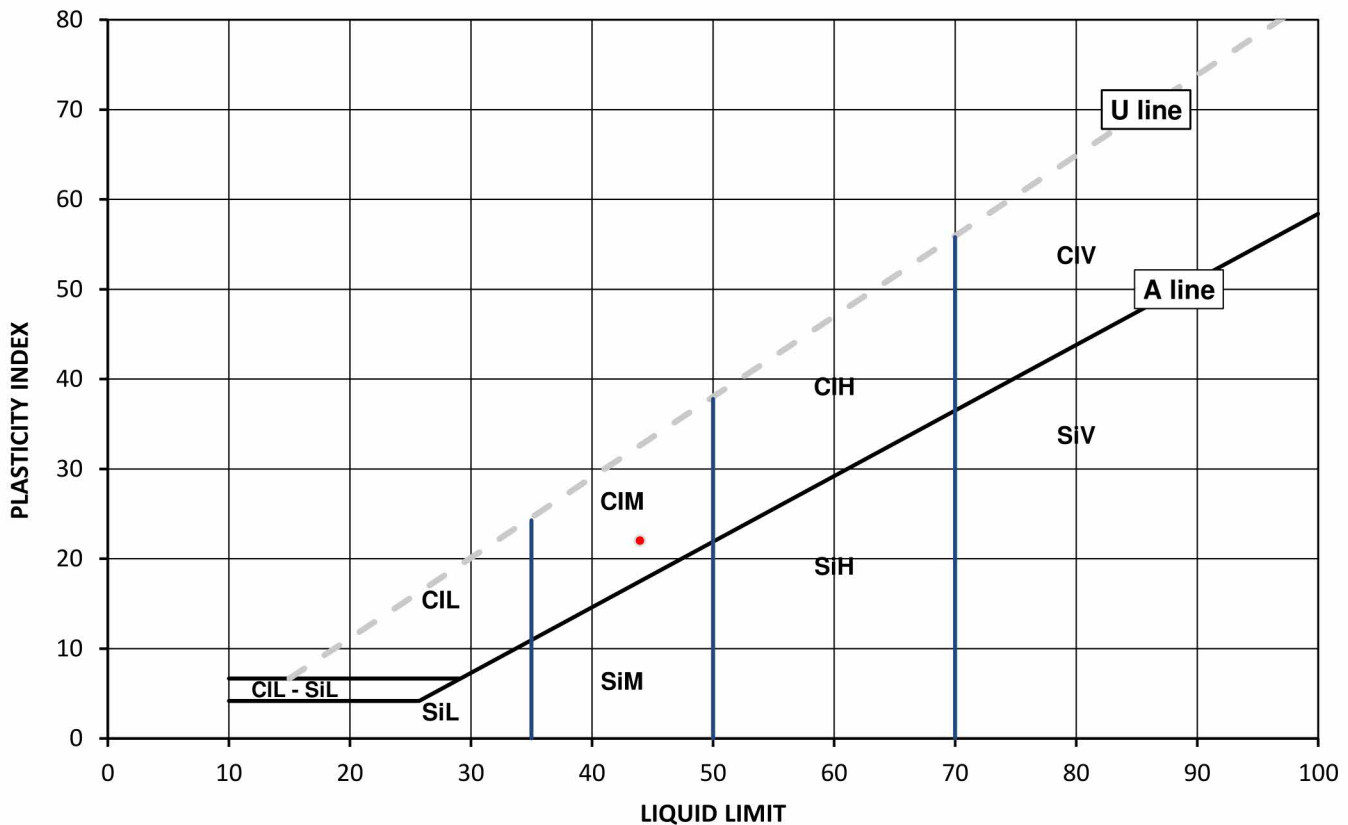
As Received Water Content [W] %	Liquid Limit [WL] %	Plastic Limit [Wp] %	Plasticity Index [Ip] %	% Passing 425µm BS Test Sieve
22	44	22	22	98

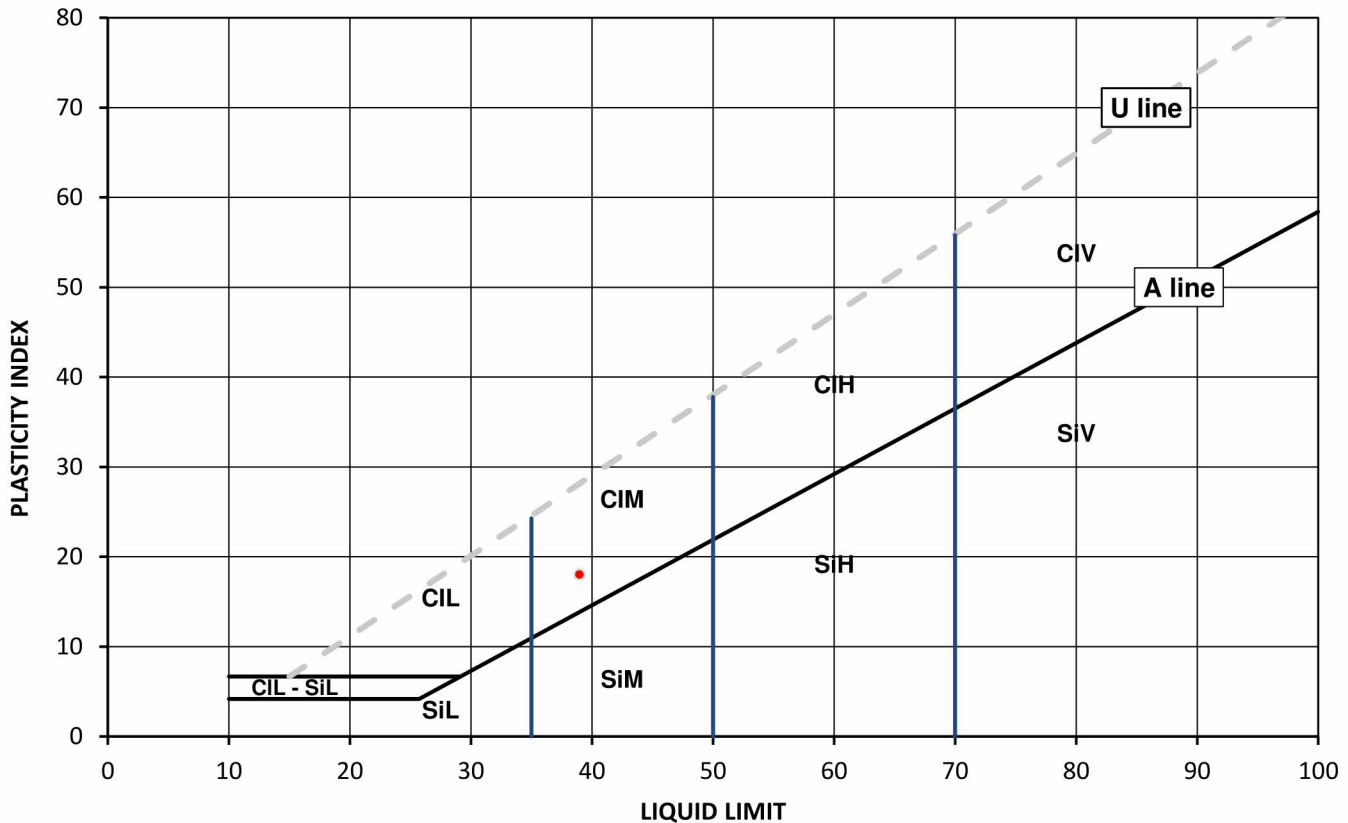
As Received Water Content [W] %	Liquid Limit [WL] %	Plastic Limit [Wp] %	Plasticity Index [Ip] %	% Passing 425µm BS Test Sieve
17	39	21	18	98

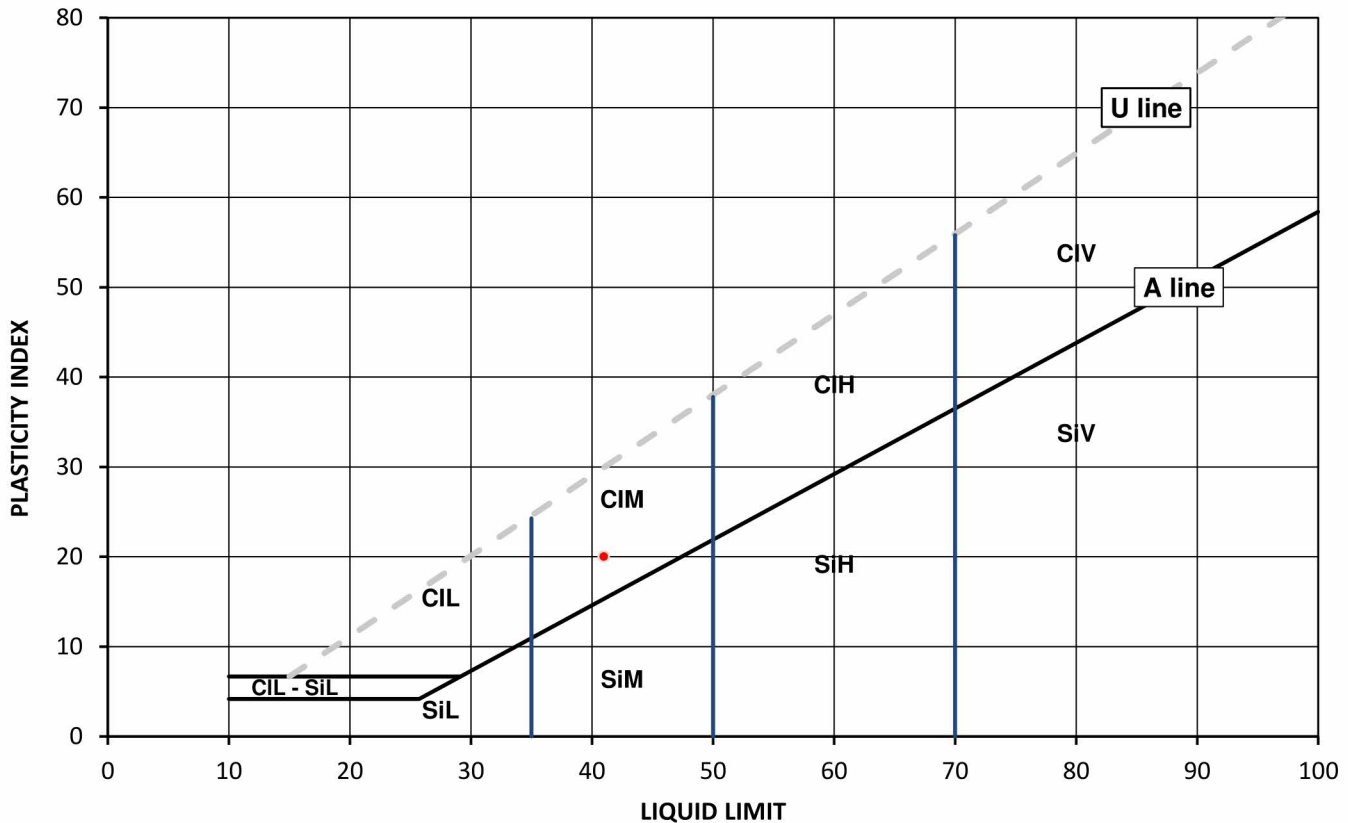
As Received Water Content [W] %	Liquid Limit [WL] %	Plastic Limit [Wp] %	Plasticity Index [Ip] %	% Passing 425µm BS Test Sieve
18	41	21	20	96
