## Arboricultural Report

BS 5837:2012 Tree Survey

**Shore Road, Gurnard**

Ref: AS/RM/0820 Rev. A

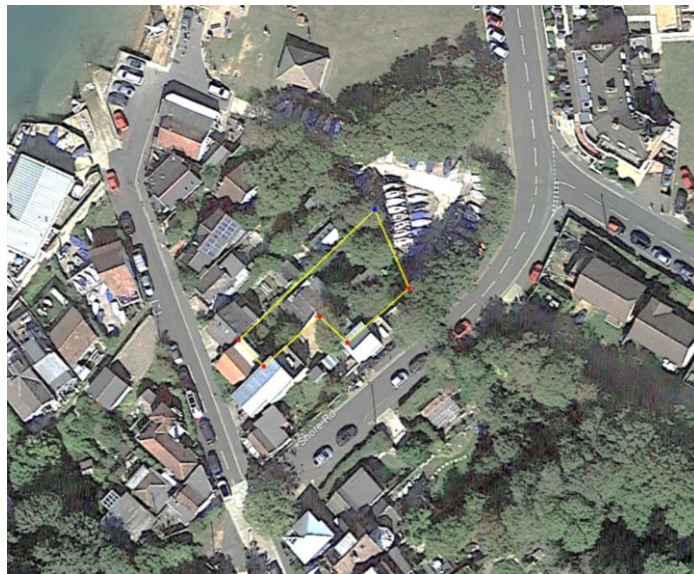
- 2.1 **Site visit:** I visited the site on 20<sup>th</sup> August 2020, with the weather at the time of survey being sunny but which in no way hindered my ability to view the trees satisfactorily. All observations were made from accessible points at ground level, with all measurements except stem diameter being estimated unless otherwise indicated in the Tree Survey Schedule and Notes.
- 2.2 **Site Description:** The site is part of several existing residential plots, consisting of multiple dilapidated buildings and disused amenity space. The only vegetation on site were scattered scrub around the boundaries, although several off-site trees within an adjacent residential plot and a boat yard were included for any possible constraints. The relevant area of the site measured approximately 0.04ha as shown in Figure 1.

Figure 1. Aerial view showing area covered within this survey (Google 2020)

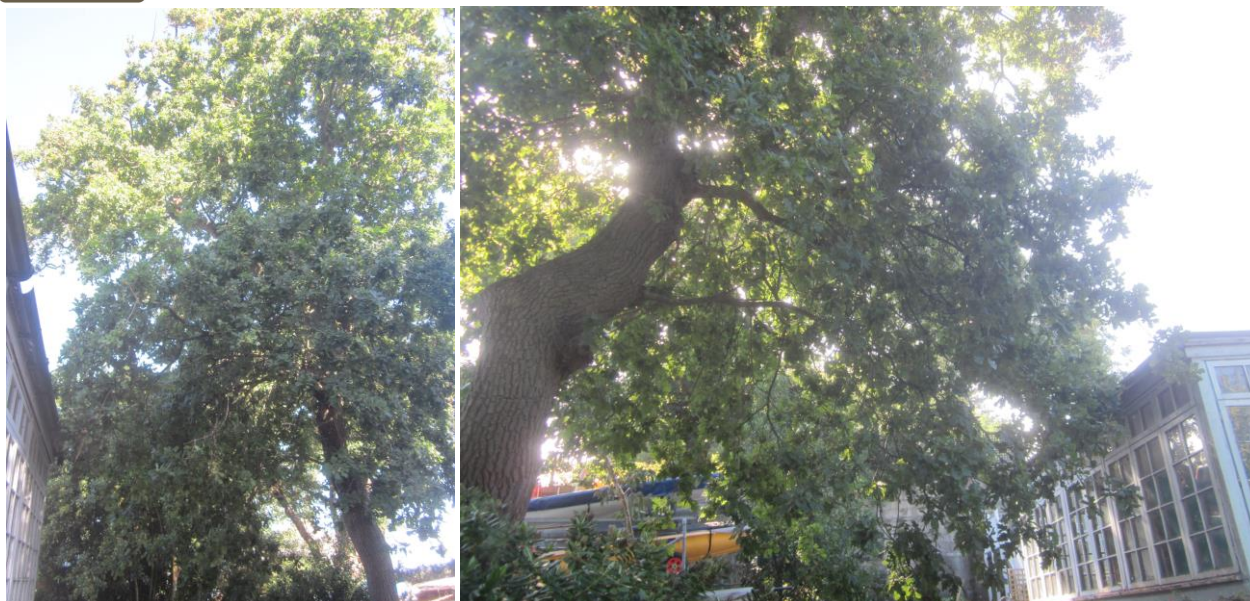
- 3.3.2 The canopy of T1 currently overhangs and touches the corner of the existing structure at no. 24, as shown in Figure 2, which had the dwelling been in use would already require pruning back to achieve reasonable clearance. This tree has a growth habit which is biased to the SE, particularly with lower canopy epicormic branching that has grown unmanaged over recent years. The replacement dwelling will result in a slight increase in overlap with the current crown spread, although this scheme does not encroach further towards the tree than a previously approved re-development of this site, which would have required the same level of facilitation pruning had the development been undertaken (P/01239/12). As the development will result in a small additional conflict with the existing crown spread of T1, details of proposed facilitation pruning are provided in section 3.5 below.

Figure 2. Existing conflict between T1 and no. 24 Shore Road

- 3.5 **Tree works:** As discussed between the LPA Tree Officer and architect on site, the crown of T1 is to be raised to 4m, to be above the height of the new balcony, with any overhanging foliage above this being trimmed back to clear the roof line. The crown lift should leave a clear trunk to 4m, to avoid potential future conflicts resulting from possible loss of light/nuisance issues where otherwise small diameter foliage growth would occur in close proximity to the balcony. This work will not result in any detrimental impact upon the health or amenity value of T1, as no large pruning wounds would result, but nonetheless all work must be carried out by insured arboricultural contractors in accordance with BS3998:2010.

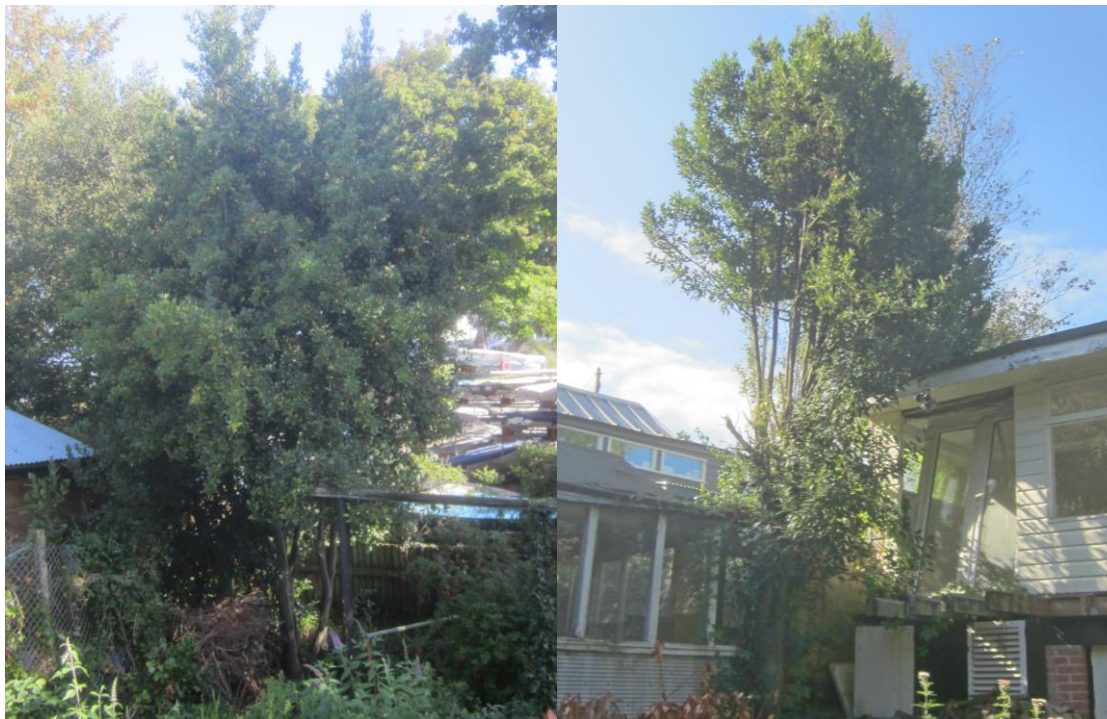
**Tree removal:** T3-4 as well as some smaller scrub/bushes would be removed to facilitate the redevelopment. These trees consist of self-set bay and minor shrub growth, and are all low quality vegetation with no significant wider public amenity value, as shown in Figure 4 below. In order to mitigate these losses, a suitable landscaping scheme could provide an opportunity to replace the scrub with better quality specimens; thereby contributing to a net enhancement of amenity value in the longer term.

Figure 4. Views of T3 (left) and T4 (right); both poor quality bay scrub to be removed as part of the redevelopment proposals
