SUDS DRAINAGE SYSTEM PROPOSALS

Construction of a New 2G
Synthetic Pitch

St. Gregory's Catholic
Academy

December 2023

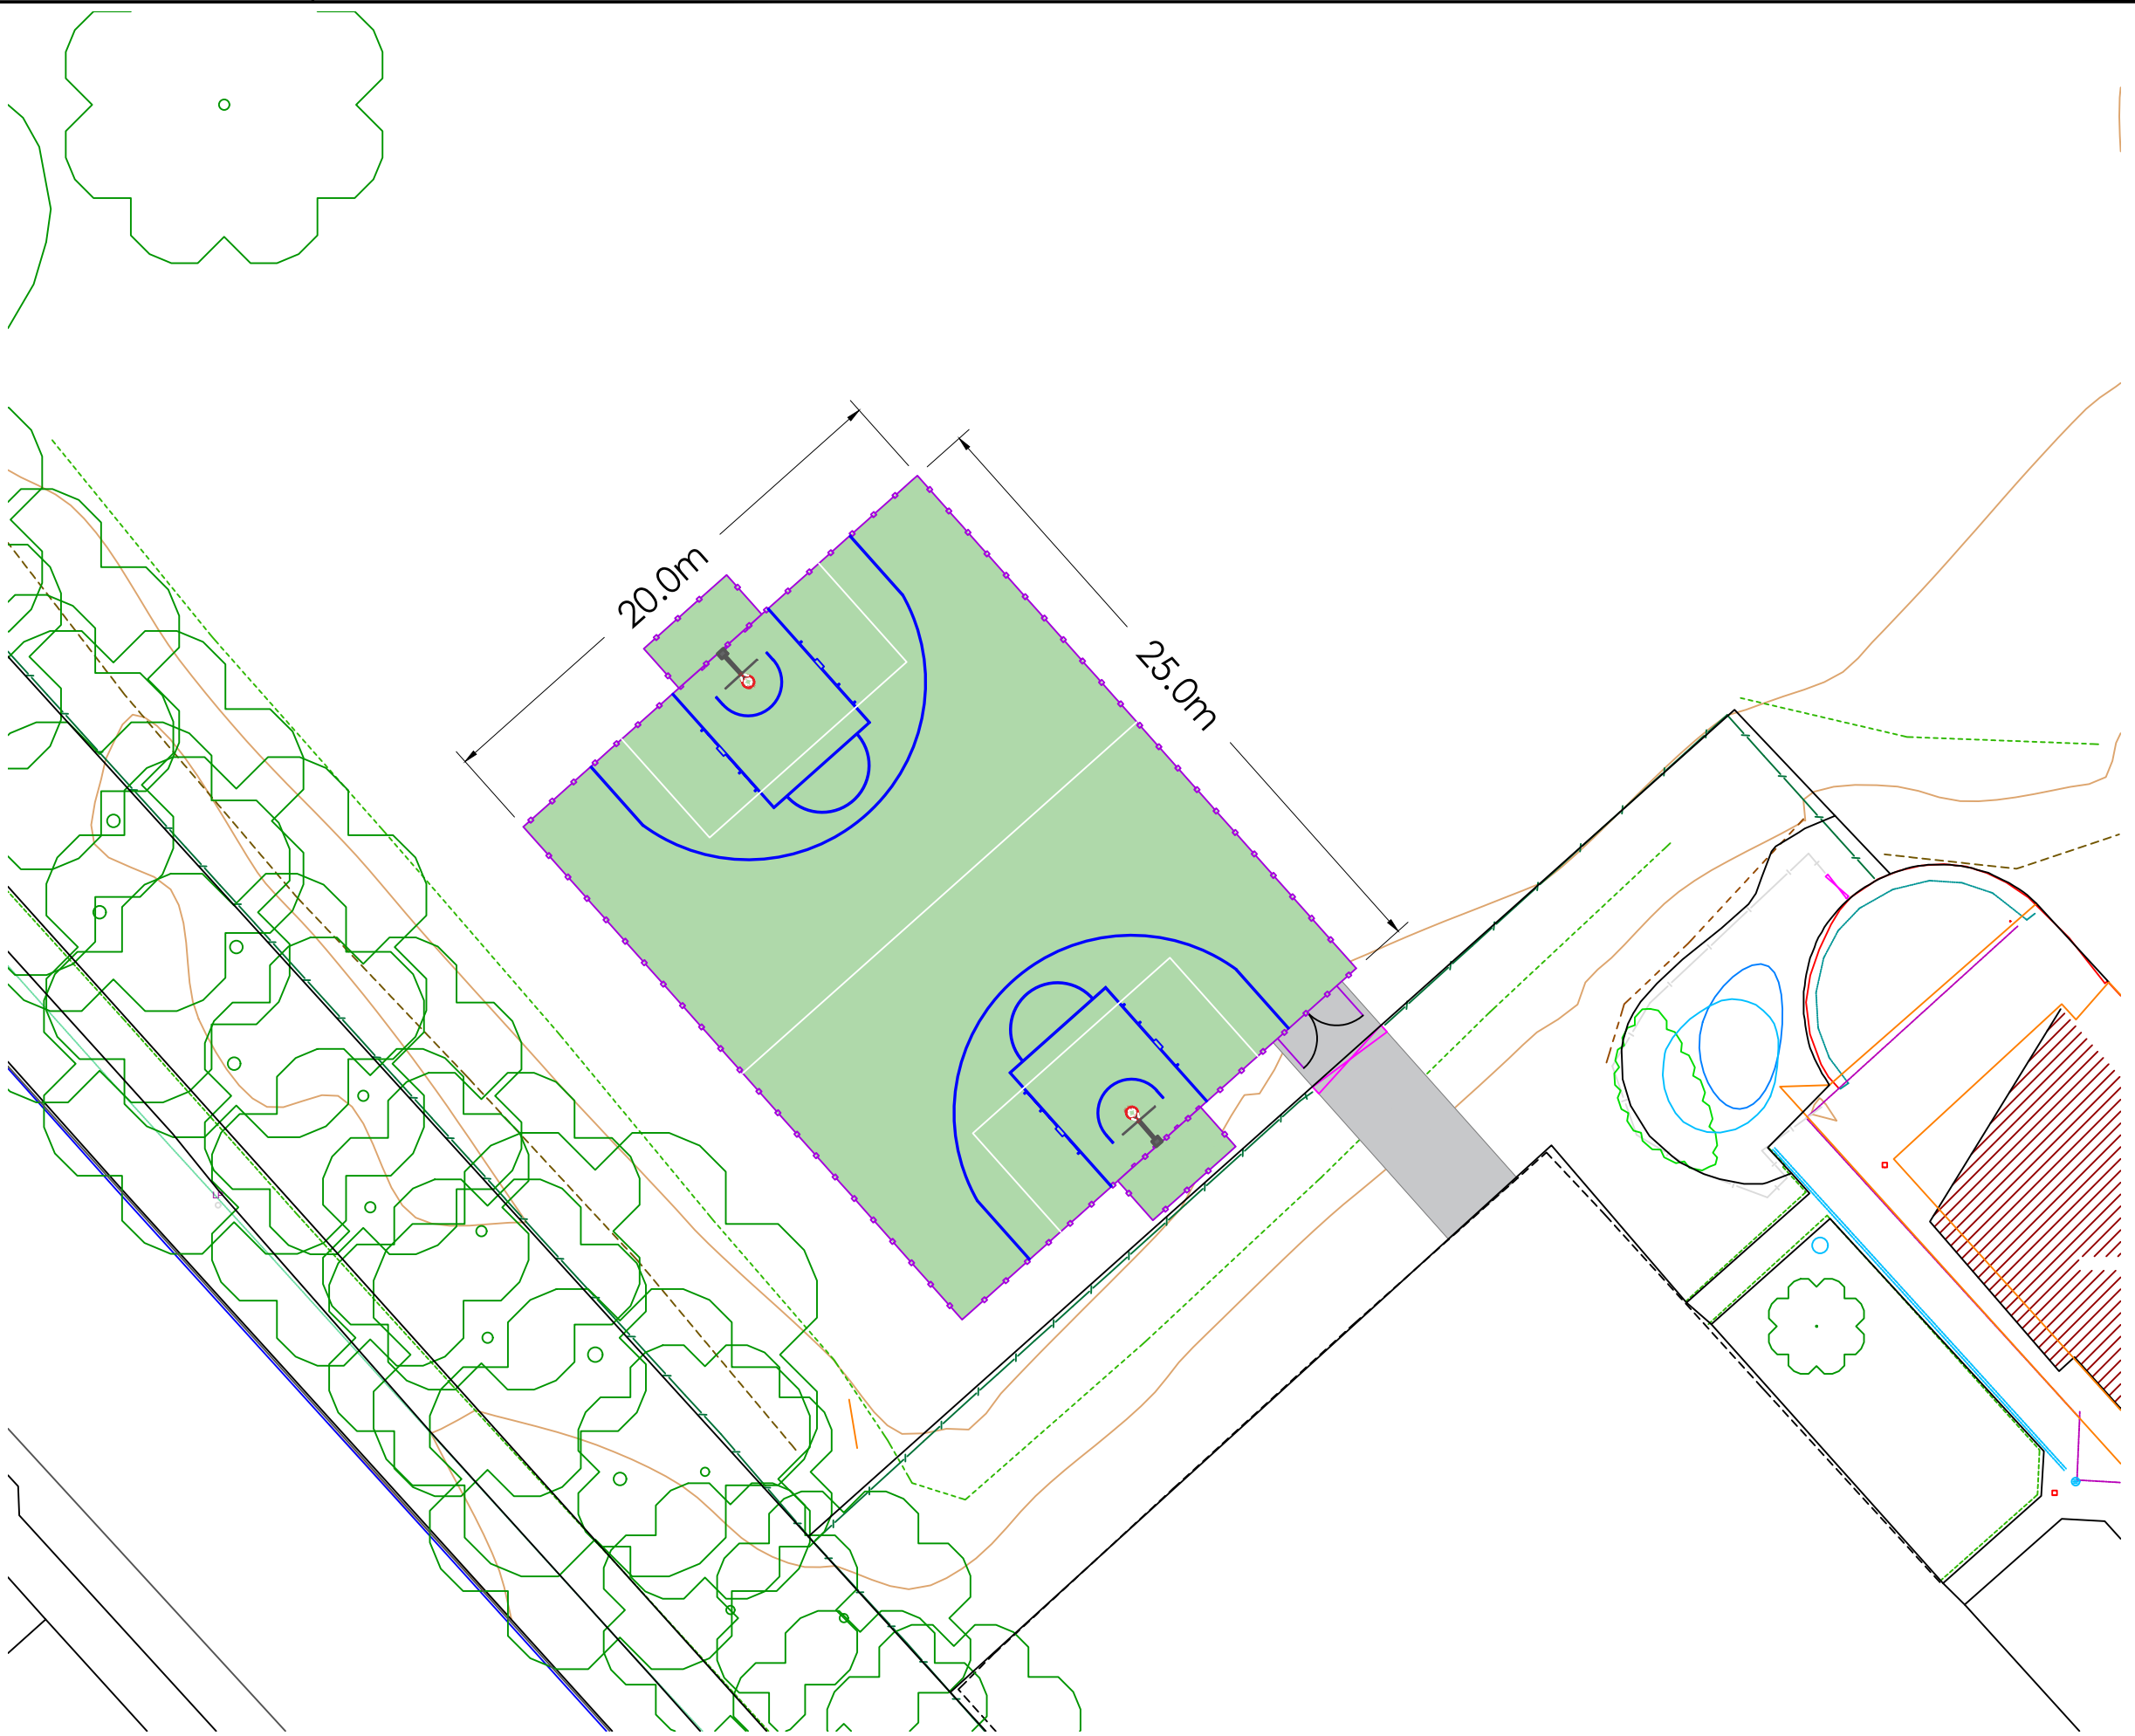
01 GENERAL ARRANGEMENT
SCALE: 1:250

- Key**
- 2G Synthetic Turf
 - New Access Path Hardstanding
 - 3.0m High Perimeter Fencing

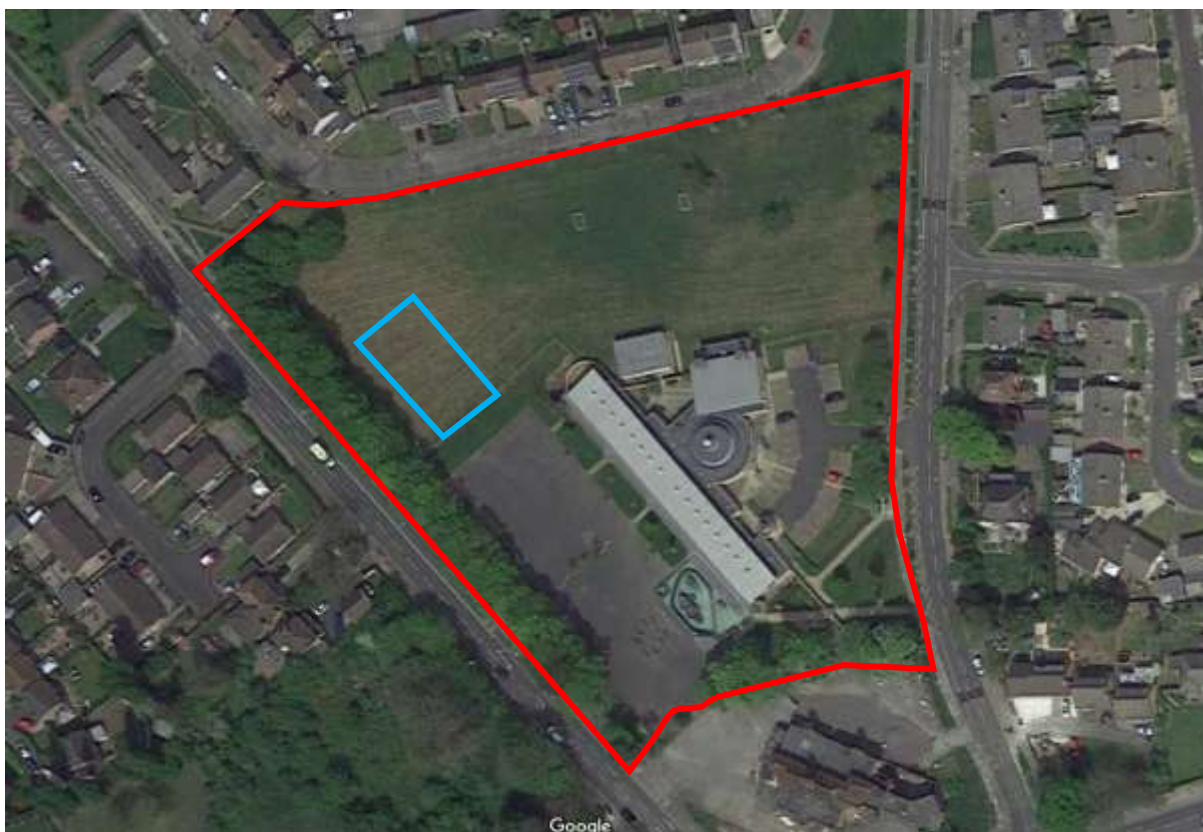
Figure 2-A: Aerial photograph of site boundary (red) and MUGA footprint (blue)

2.1.2 An aerial image showing the approximate site boundary and approximate development footprint is presented below, followed by a table summarising the key site features and a series of site photographs. A Site Plan is provided within Appendix A.

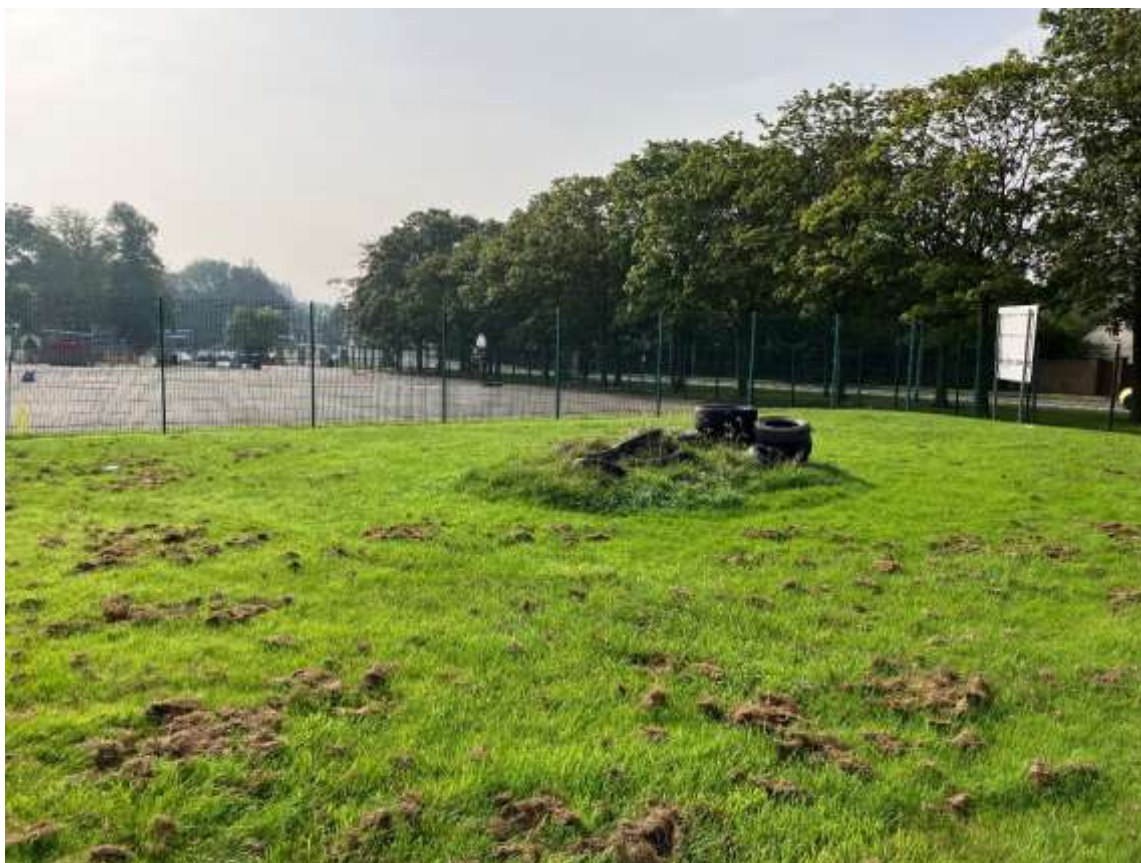
Figure 2-C: Small surface depression with tyres in the southeast of the proposed MUGA area

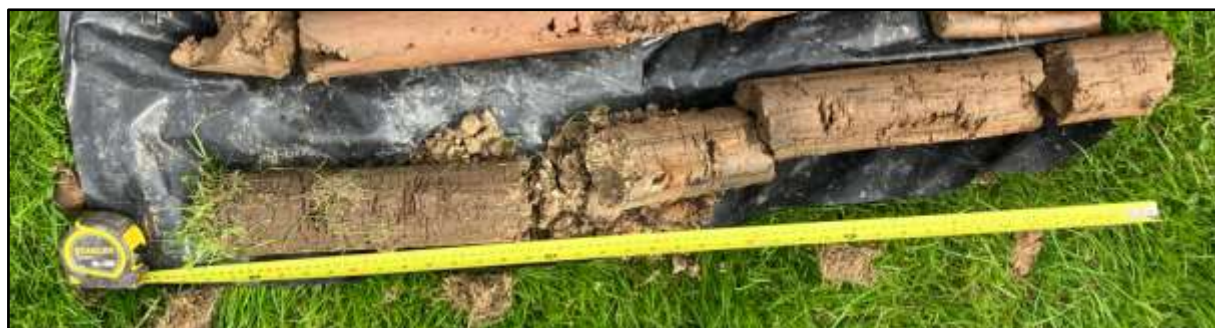
Figure 5-A: Arisings of topsoil and Made Ground 0.0-1.0m depth from WS05

5.3.2 A typical photograph of the Made Ground encountered is presented below.

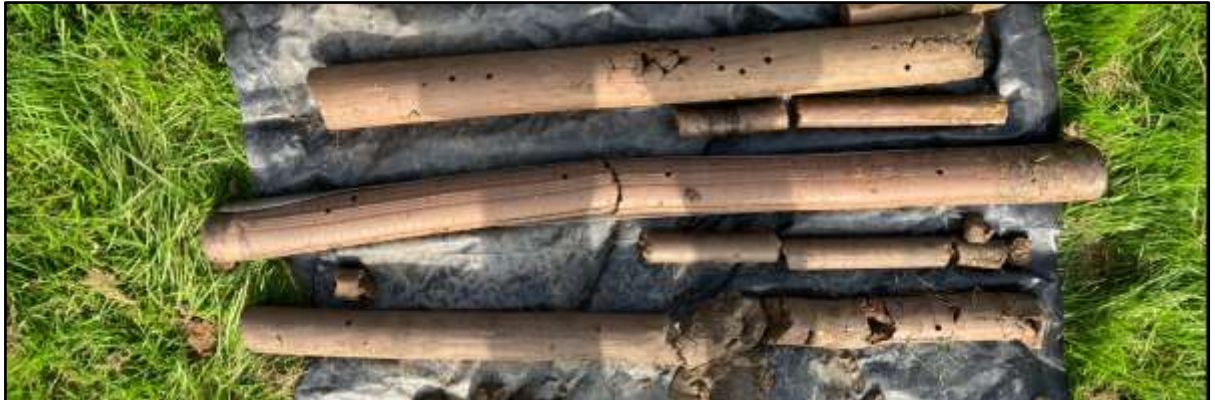
Figure 5-B: Arisings of Devensian Till 1.0-4.0m depth from WS01

- 5.4.2 Silty fine to medium sand was encountered at the base of WS01 and WS04 from a top depth of 4.0m and 3.7m respectively.
- 5.4.3 SPT refusal was met at the base of every borehole within Devensian Till deposits up to a maximum exploratory depth of 4.43m in WS03.
- 5.4.4 A typical photograph of the Devensian Till encountered is presented below.

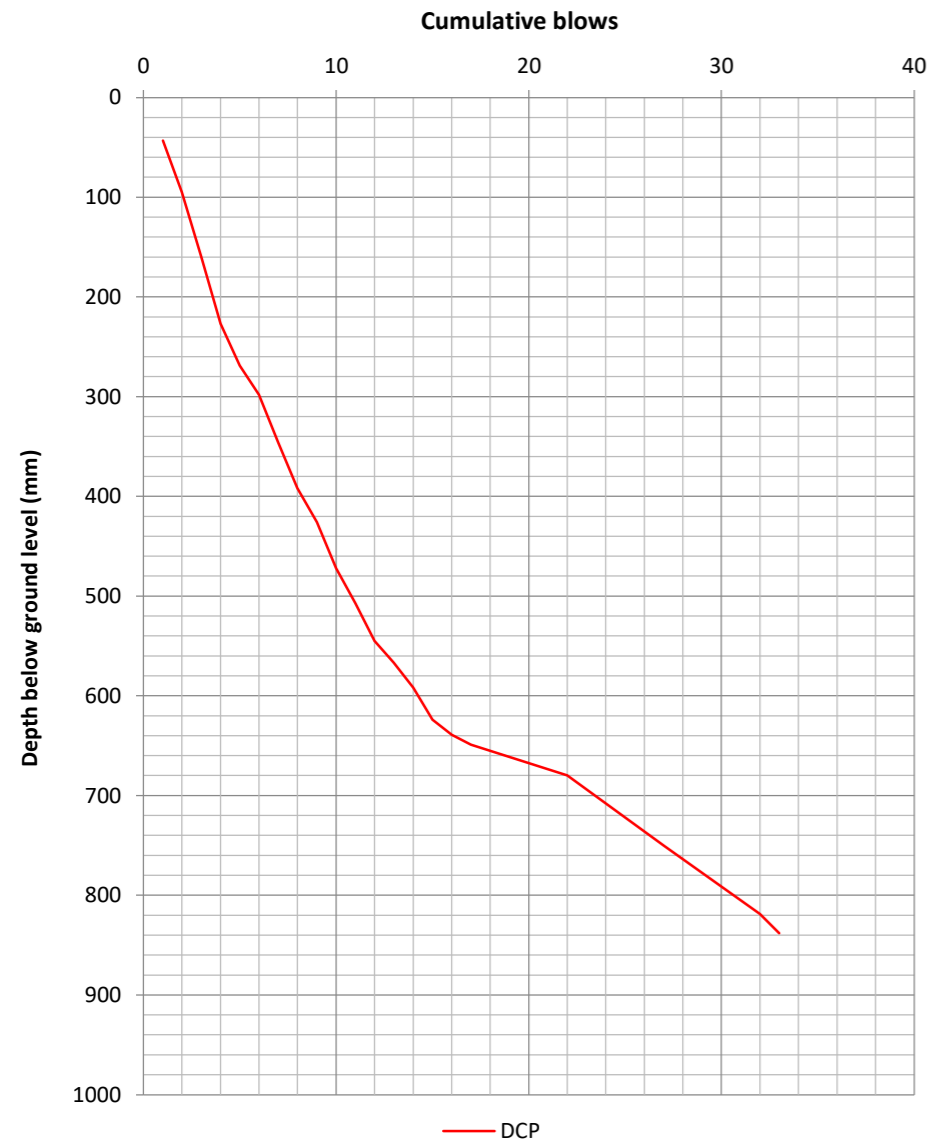
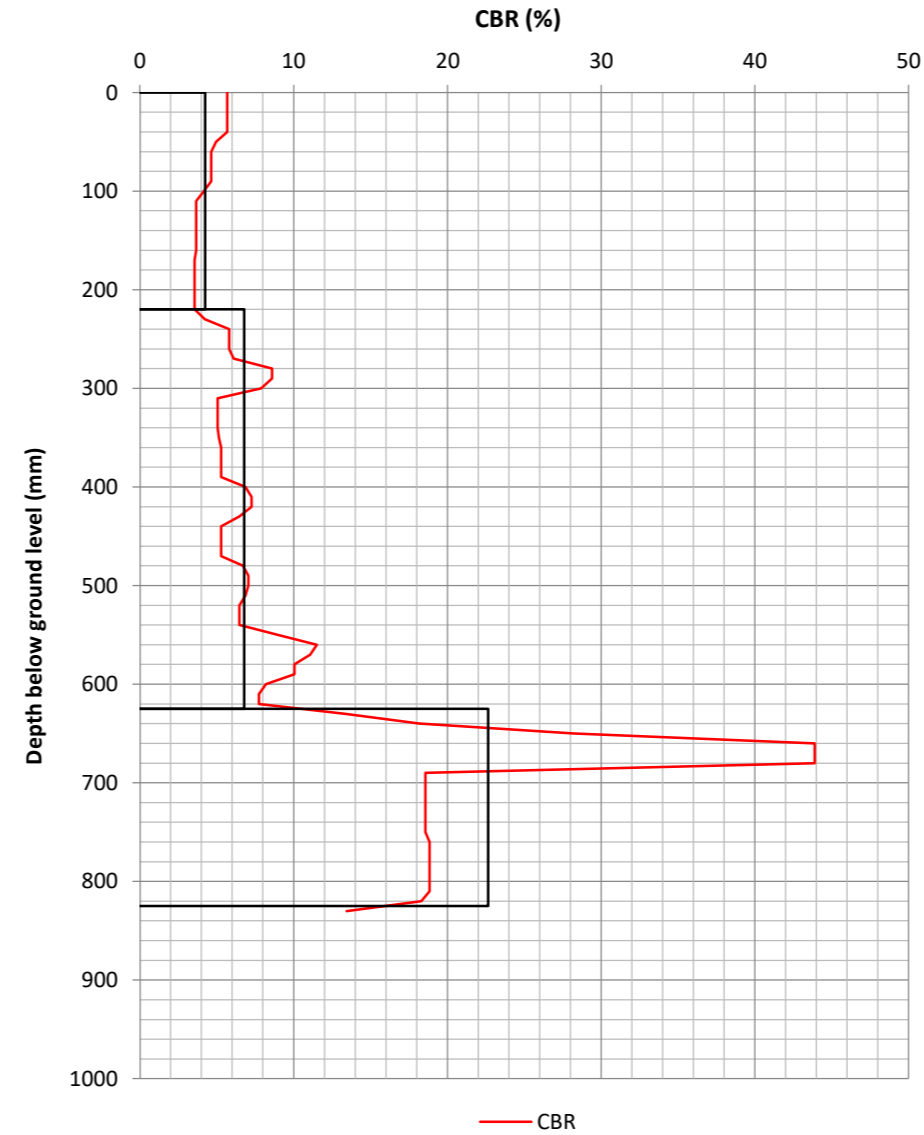
Plot showing number of blows against depth

Plot showing CBR (%) against depth

Layer No.	CBR (%)	Thickness (mm)	Start depth (mmBGL)	Base depth (mmBGL)
1	4.2	220	0	220
2	6.8	405	220	625
3	22.7	200	625	825

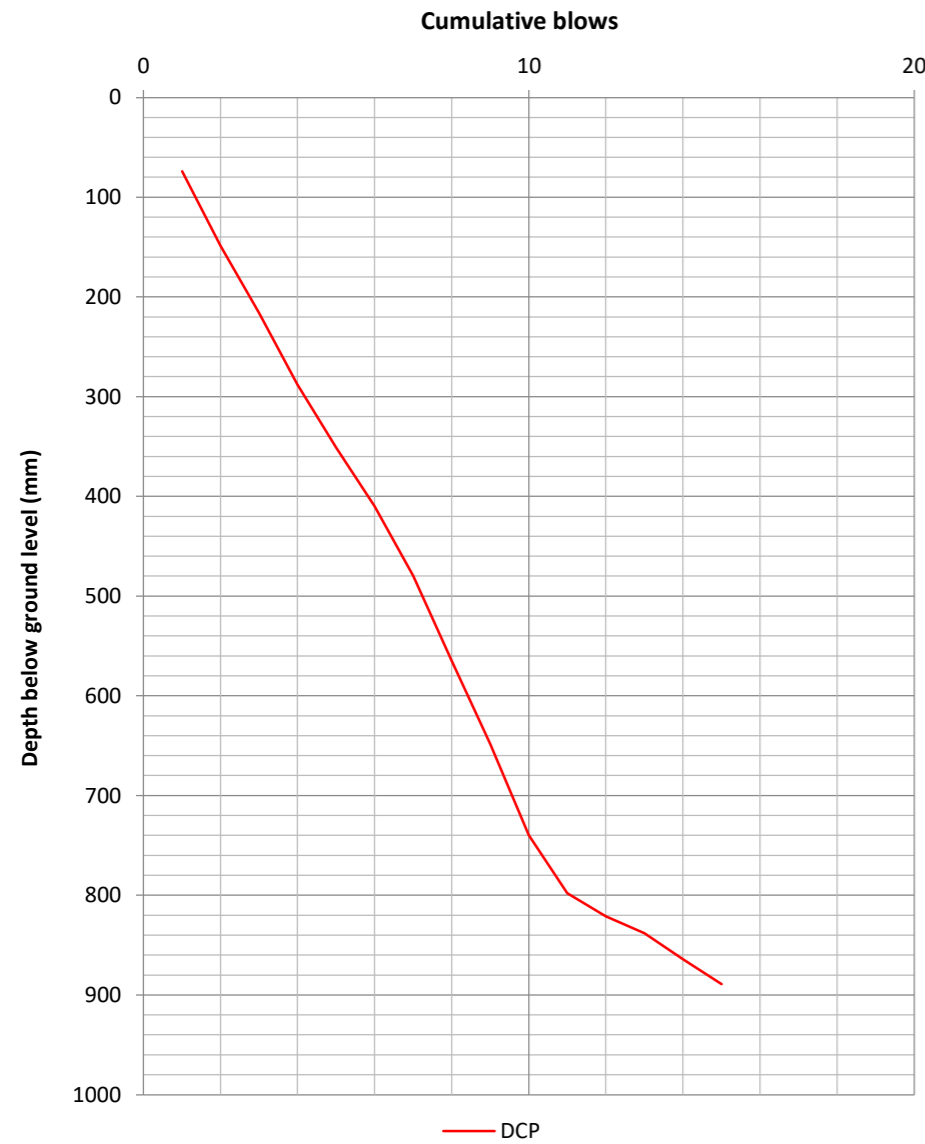
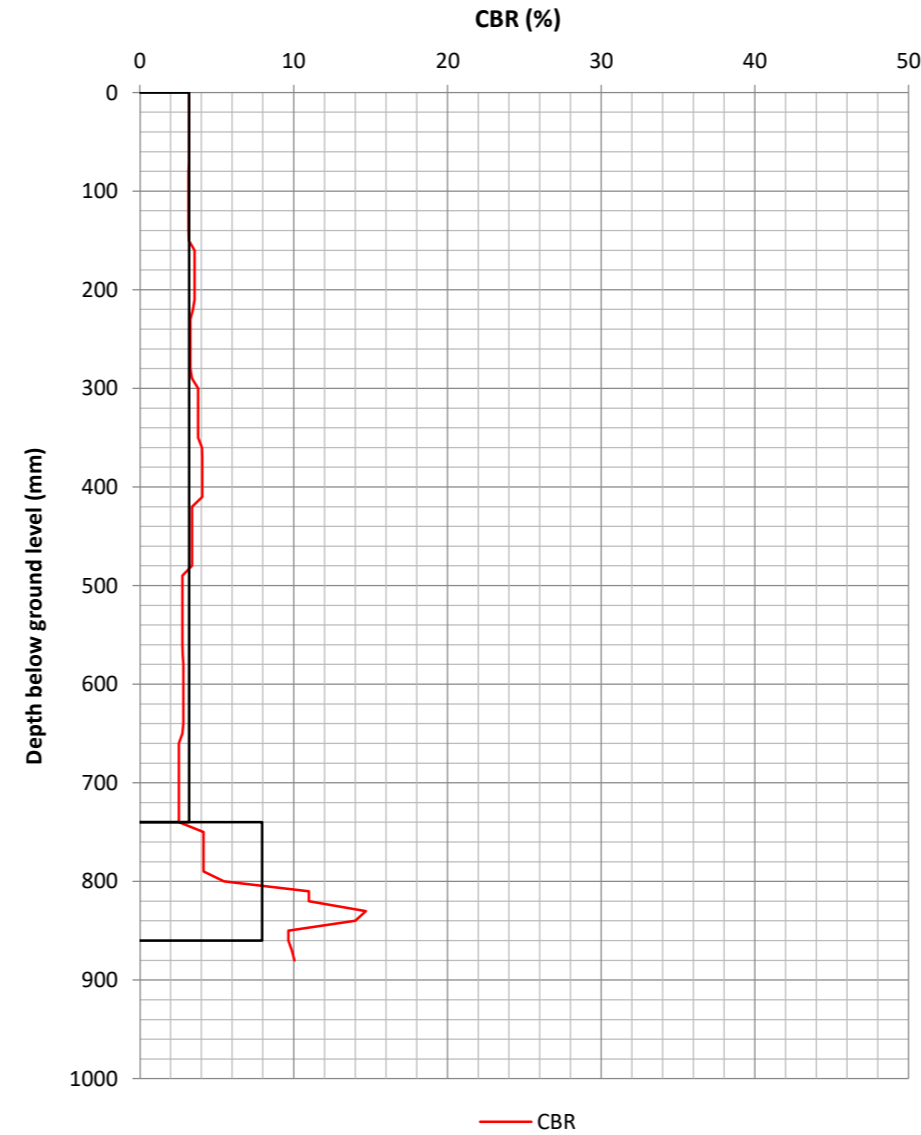
Plot showing number of blows against depth

Plot showing CBR (%) against depth

Layer No.	CBR (%)	Thickness (mm)	Start depth (mmBGL)	Base depth (mmBGL)
1	3.2	740	0	740
2	8.0	120	740	860

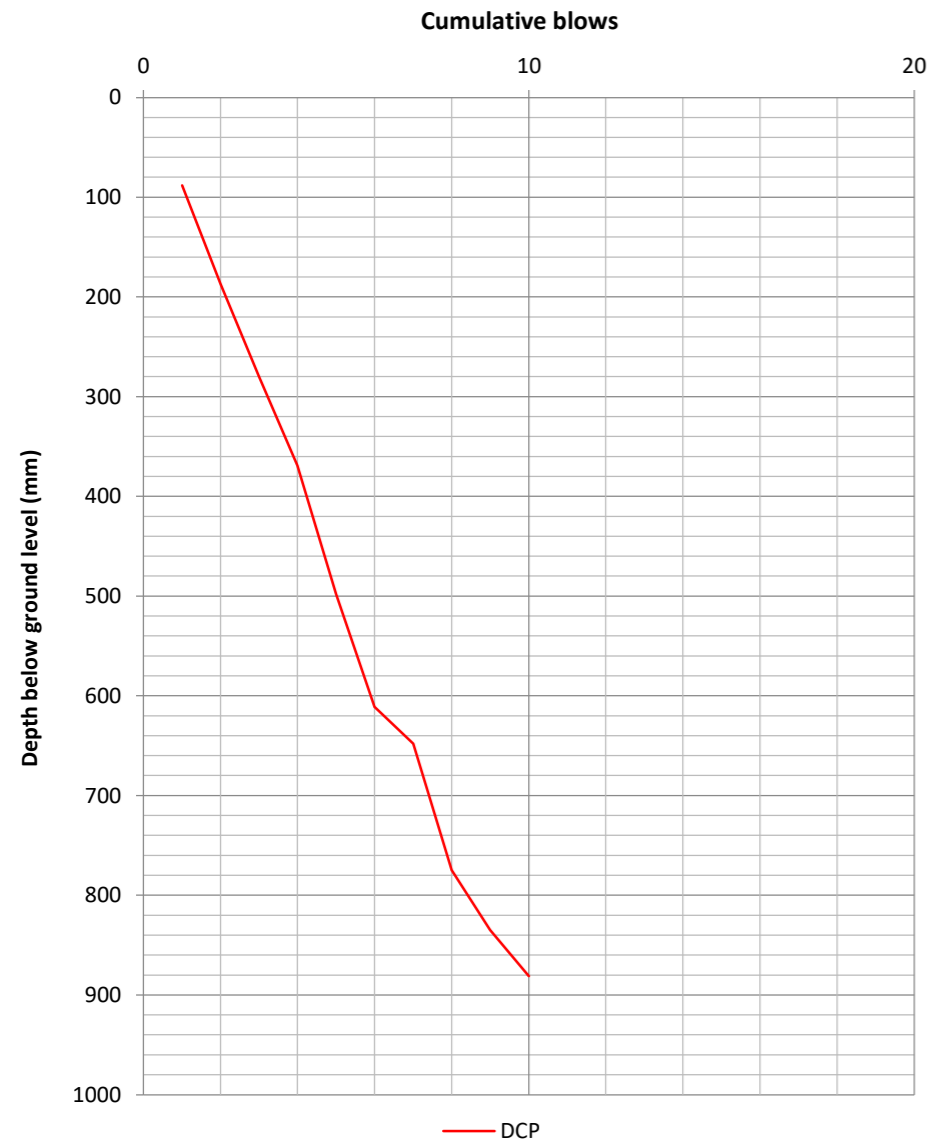
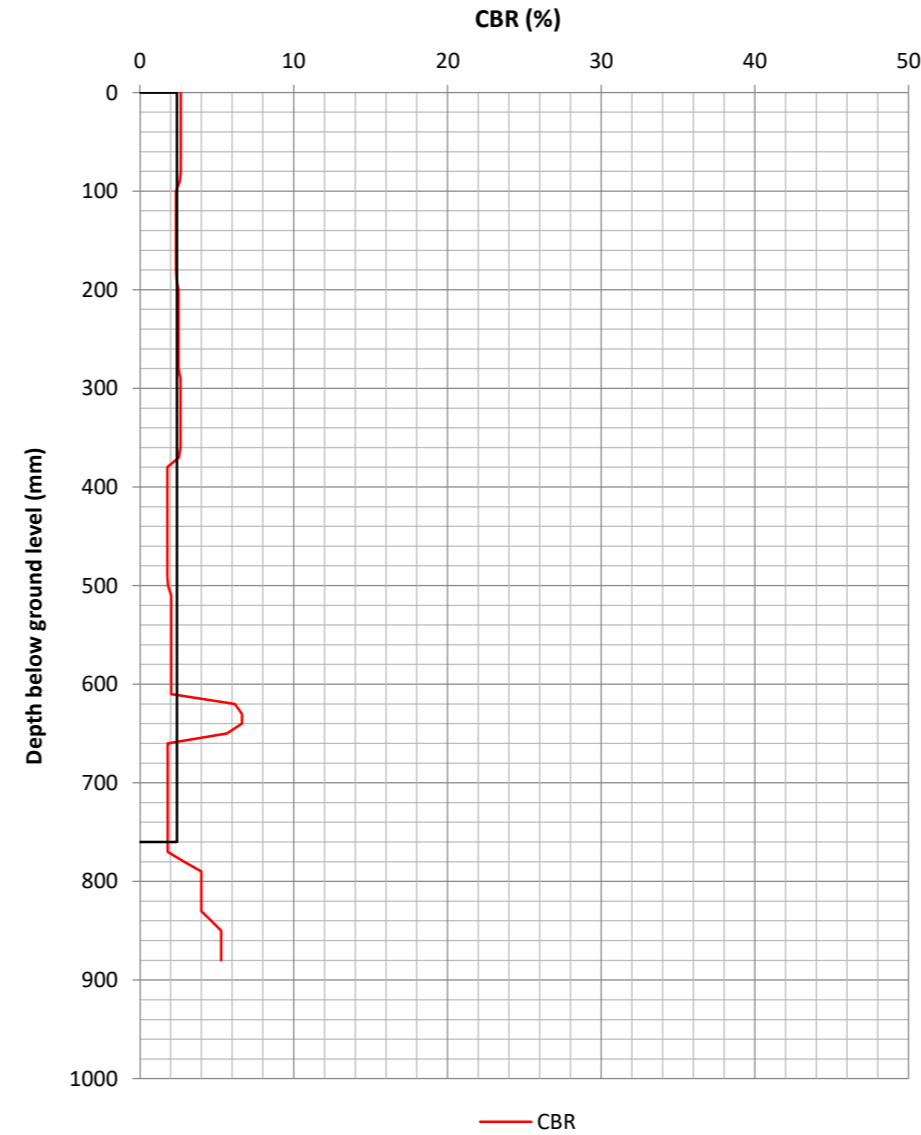
Plot showing number of blows against depth

Plot showing CBR (%) against depth

Layer No.	CBR (%)	Thickness (mm)	Start depth (mmBGL)	Base depth (mmBGL)
1	2.4	760	0	760

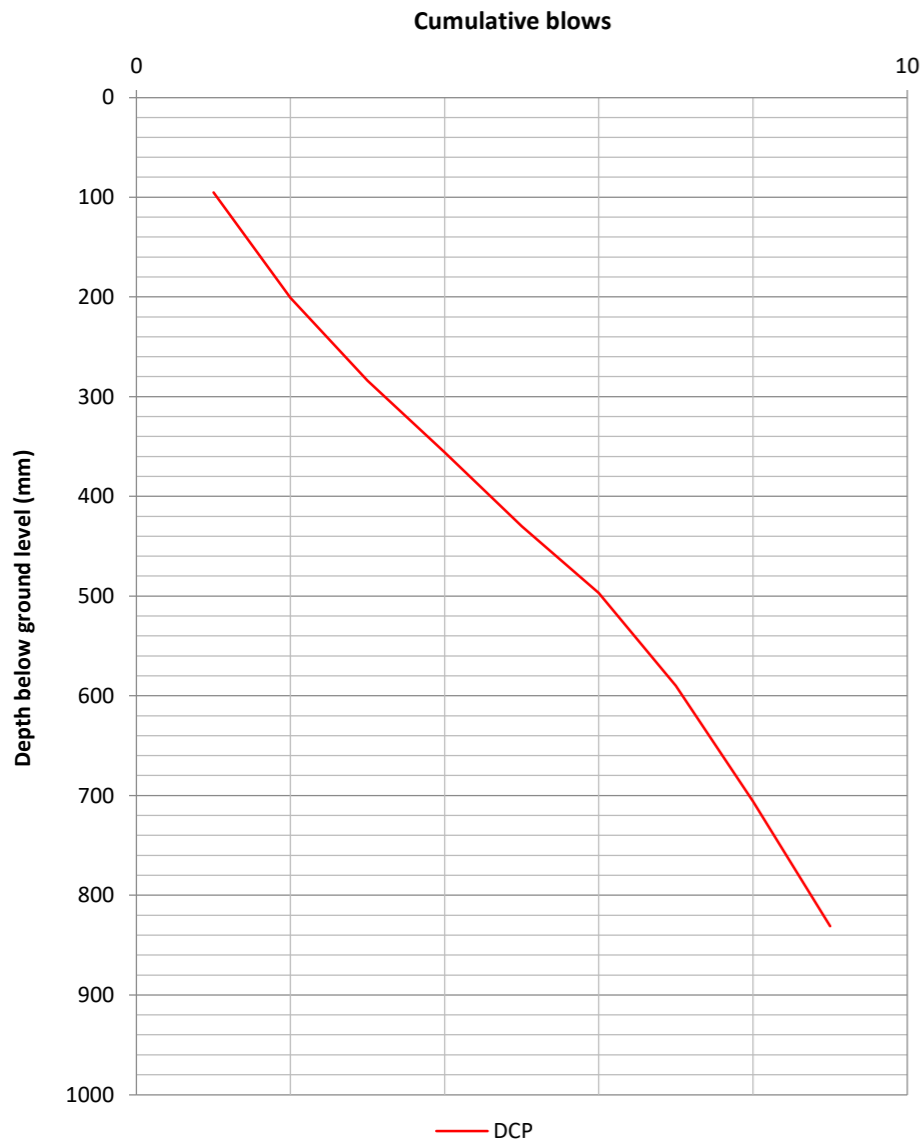
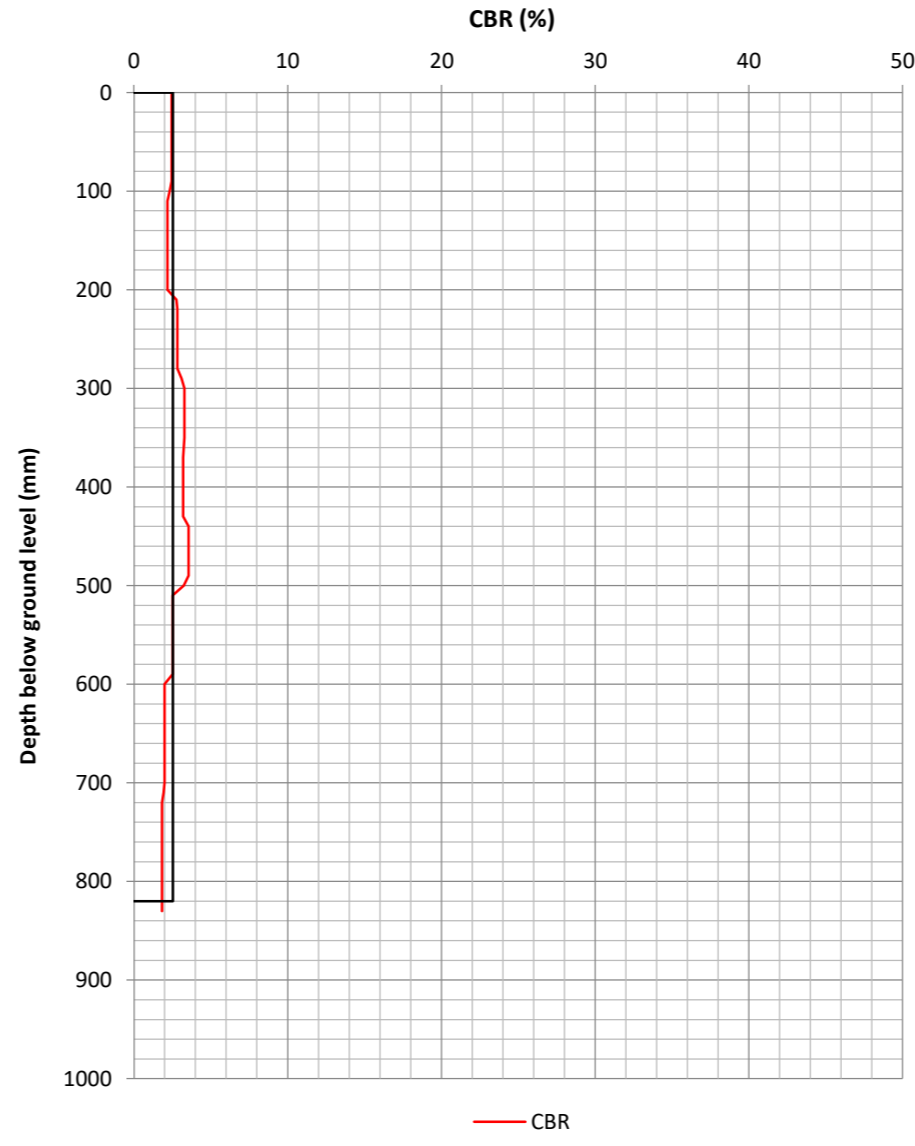
Plot showing number of blows against depth

Plot showing CBR (%) against depth

Layer No.	CBR (%)	Thickness (mm)	Start depth (mmBGL)	Base depth (mmBGL)
1	2.5	820	0	820

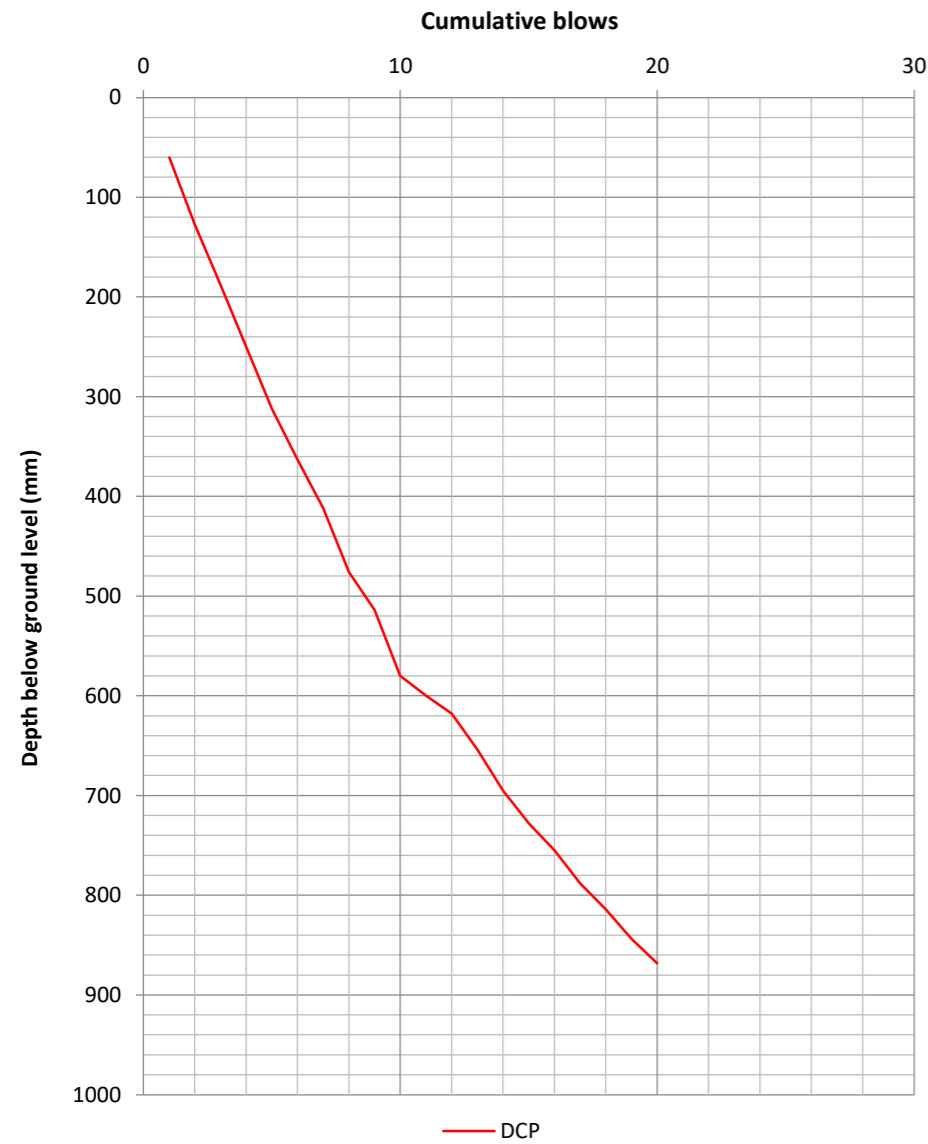
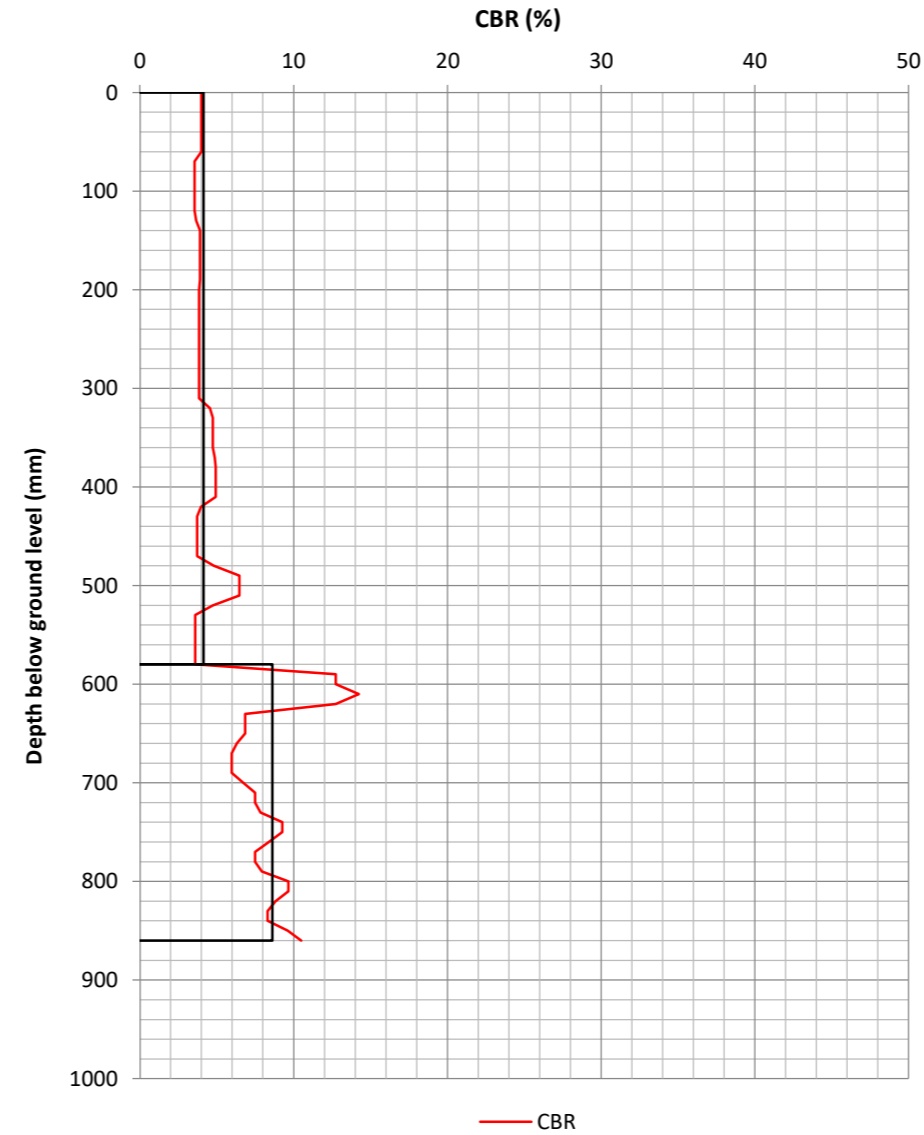
Plot showing number of blows against depth

Plot showing CBR (%) against depth

Layer No.	CBR (%)	Thickness (mm)	Start depth (mmBGL)	Base depth (mmBGL)
1	4.1	580	0	580
2	8.6	280	580	860

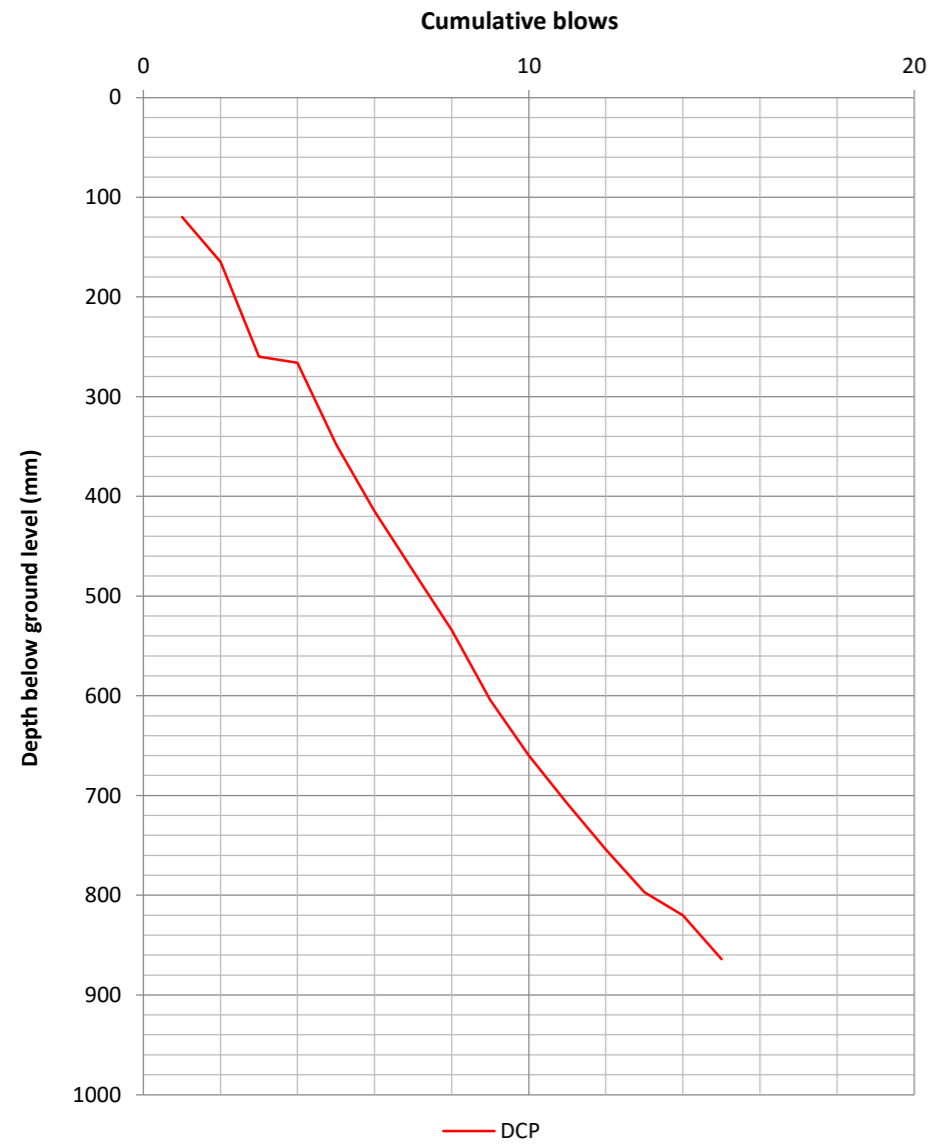
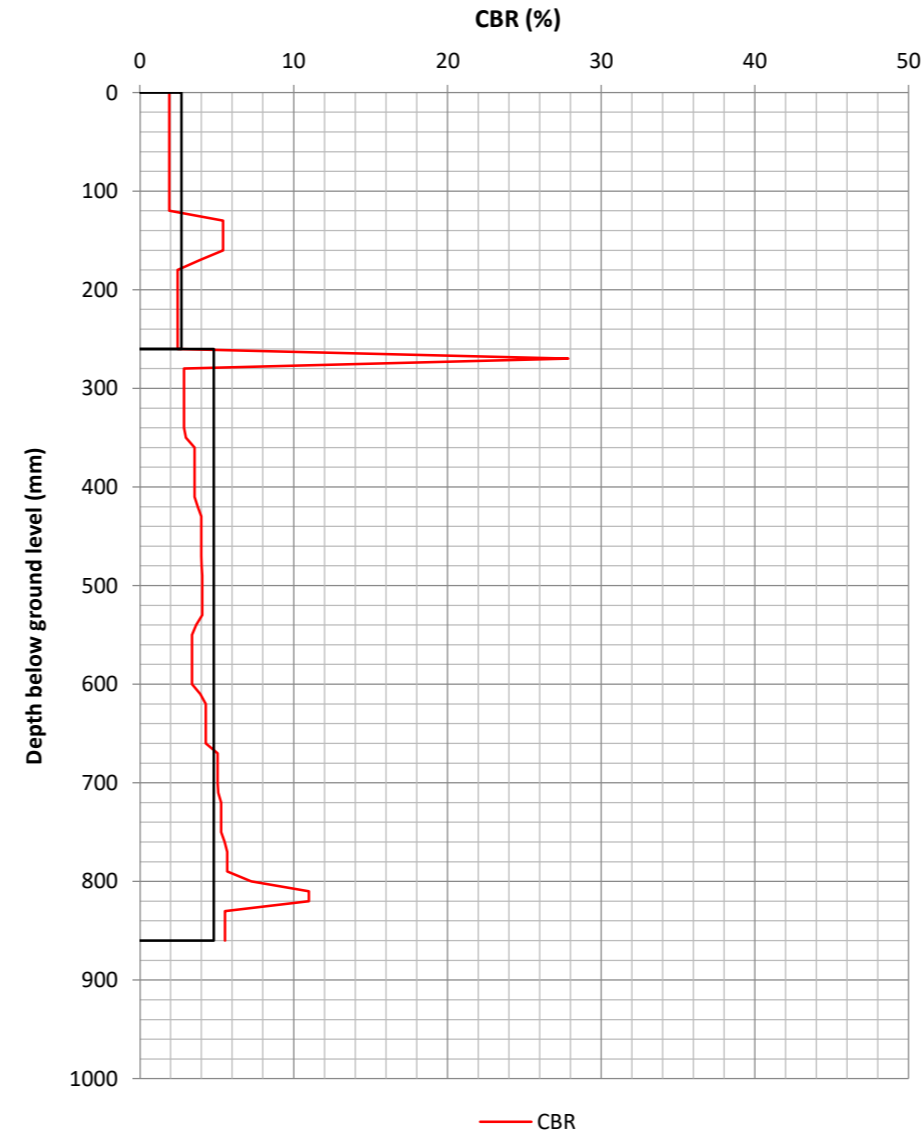
Plot showing number of blows against depth

Plot showing CBR (%) against depth

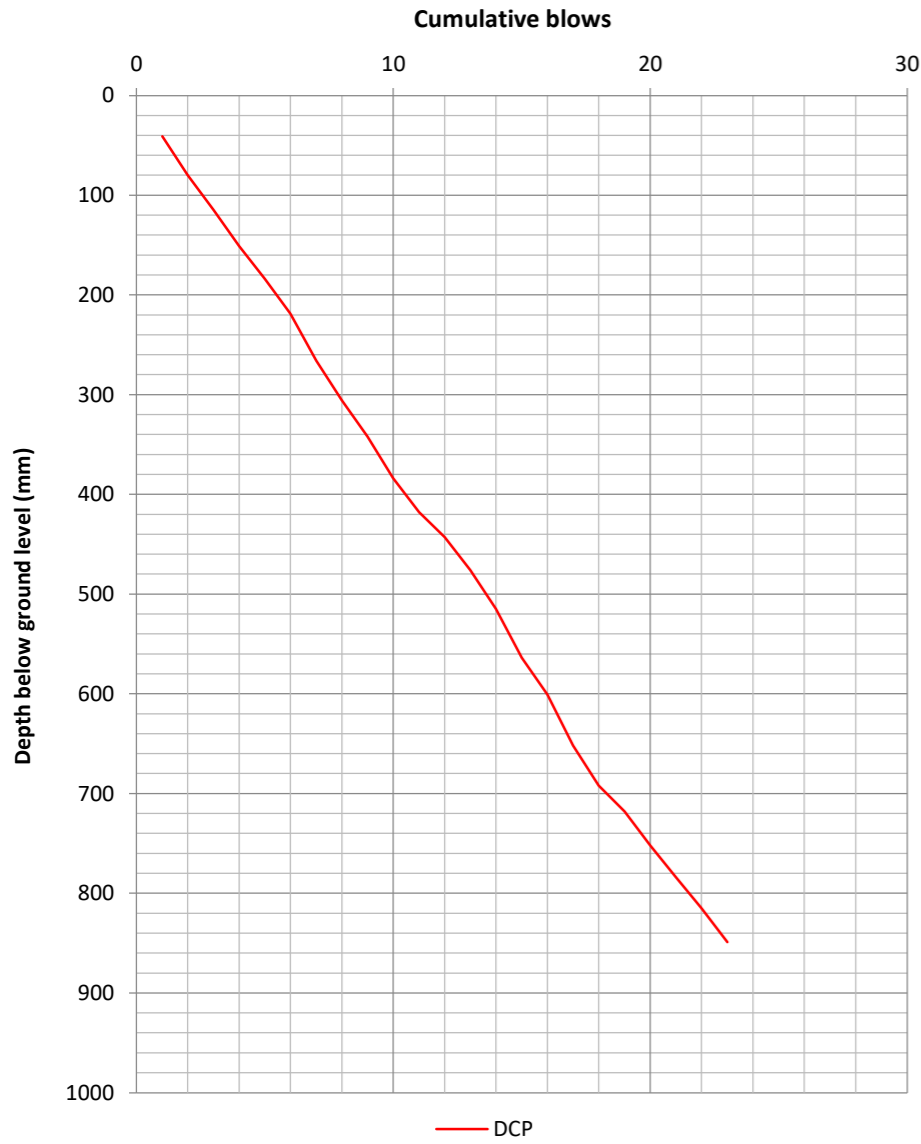
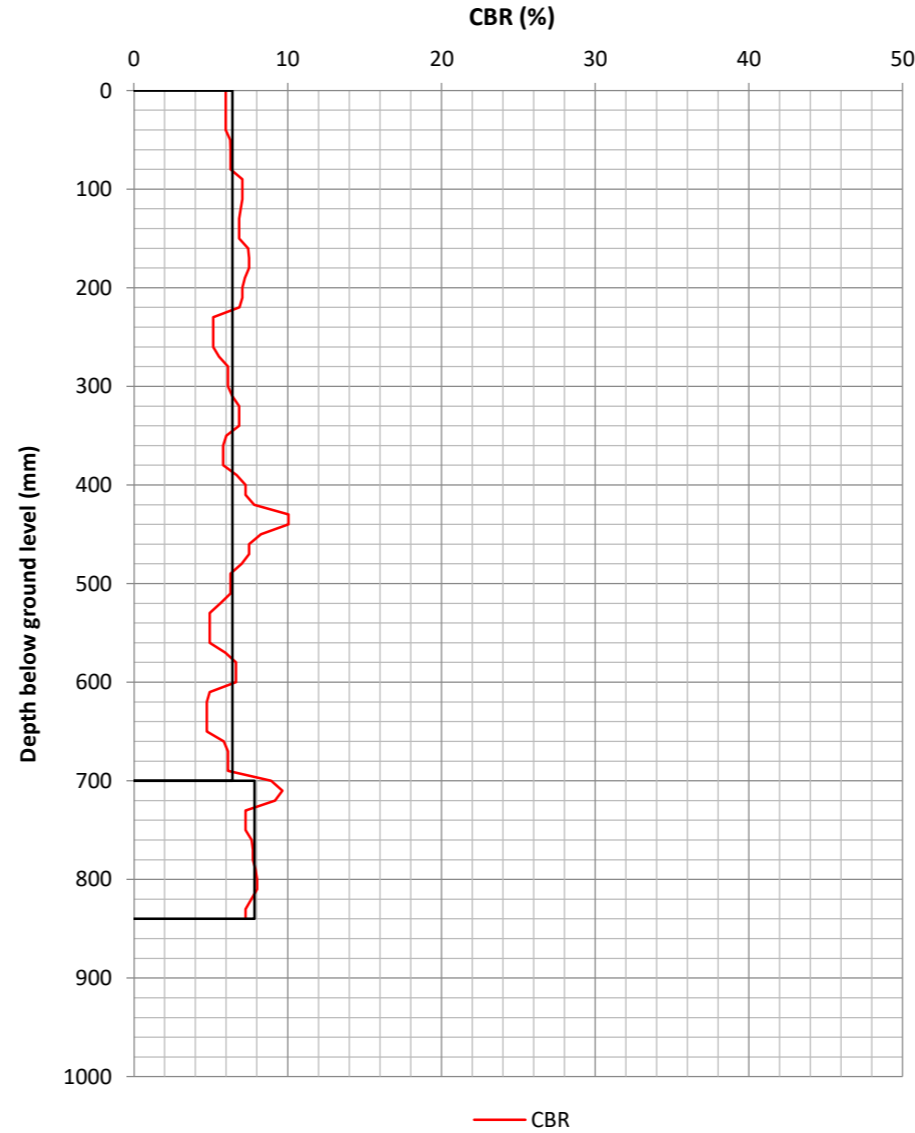
Plot showing number of blows against depth

Plot showing CBR (%) against depth
