SUDS DRAINAGE SYSTEM PROPOSALS

Construction of a New 2G
Synthetic Pitch

St. Gregory's Catholic
Academy

December 2023

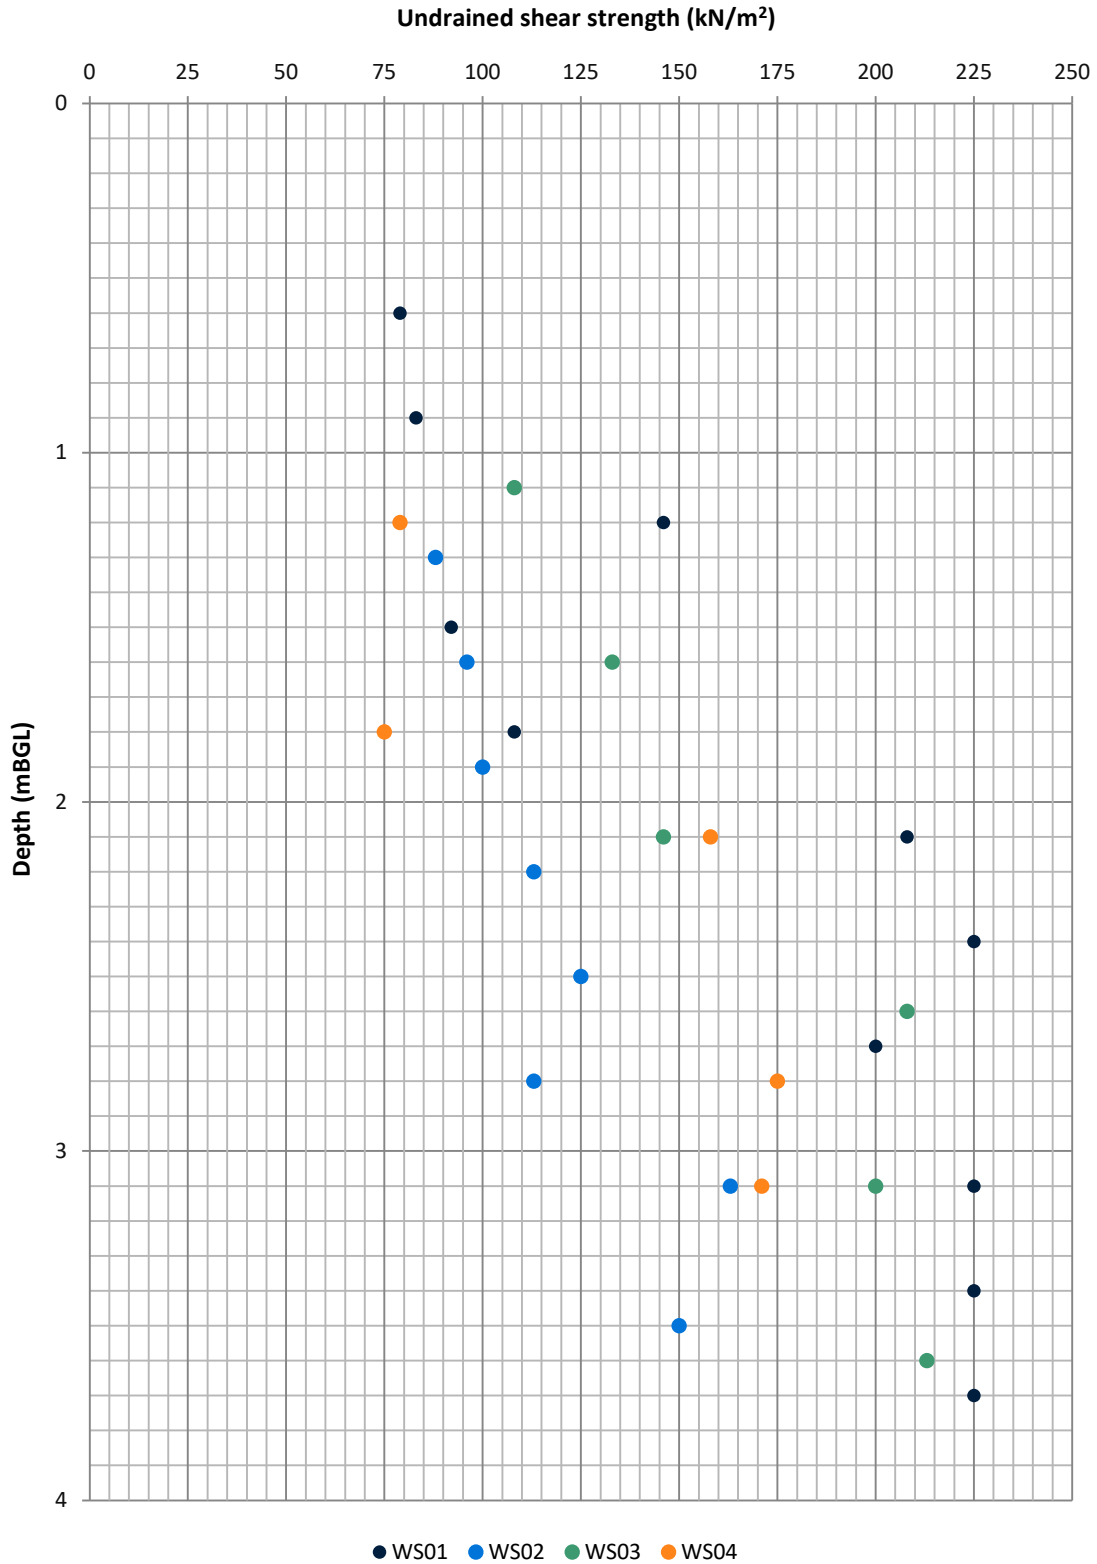
Plot summarising Pocket Penetrometer results versus depth filtered by location

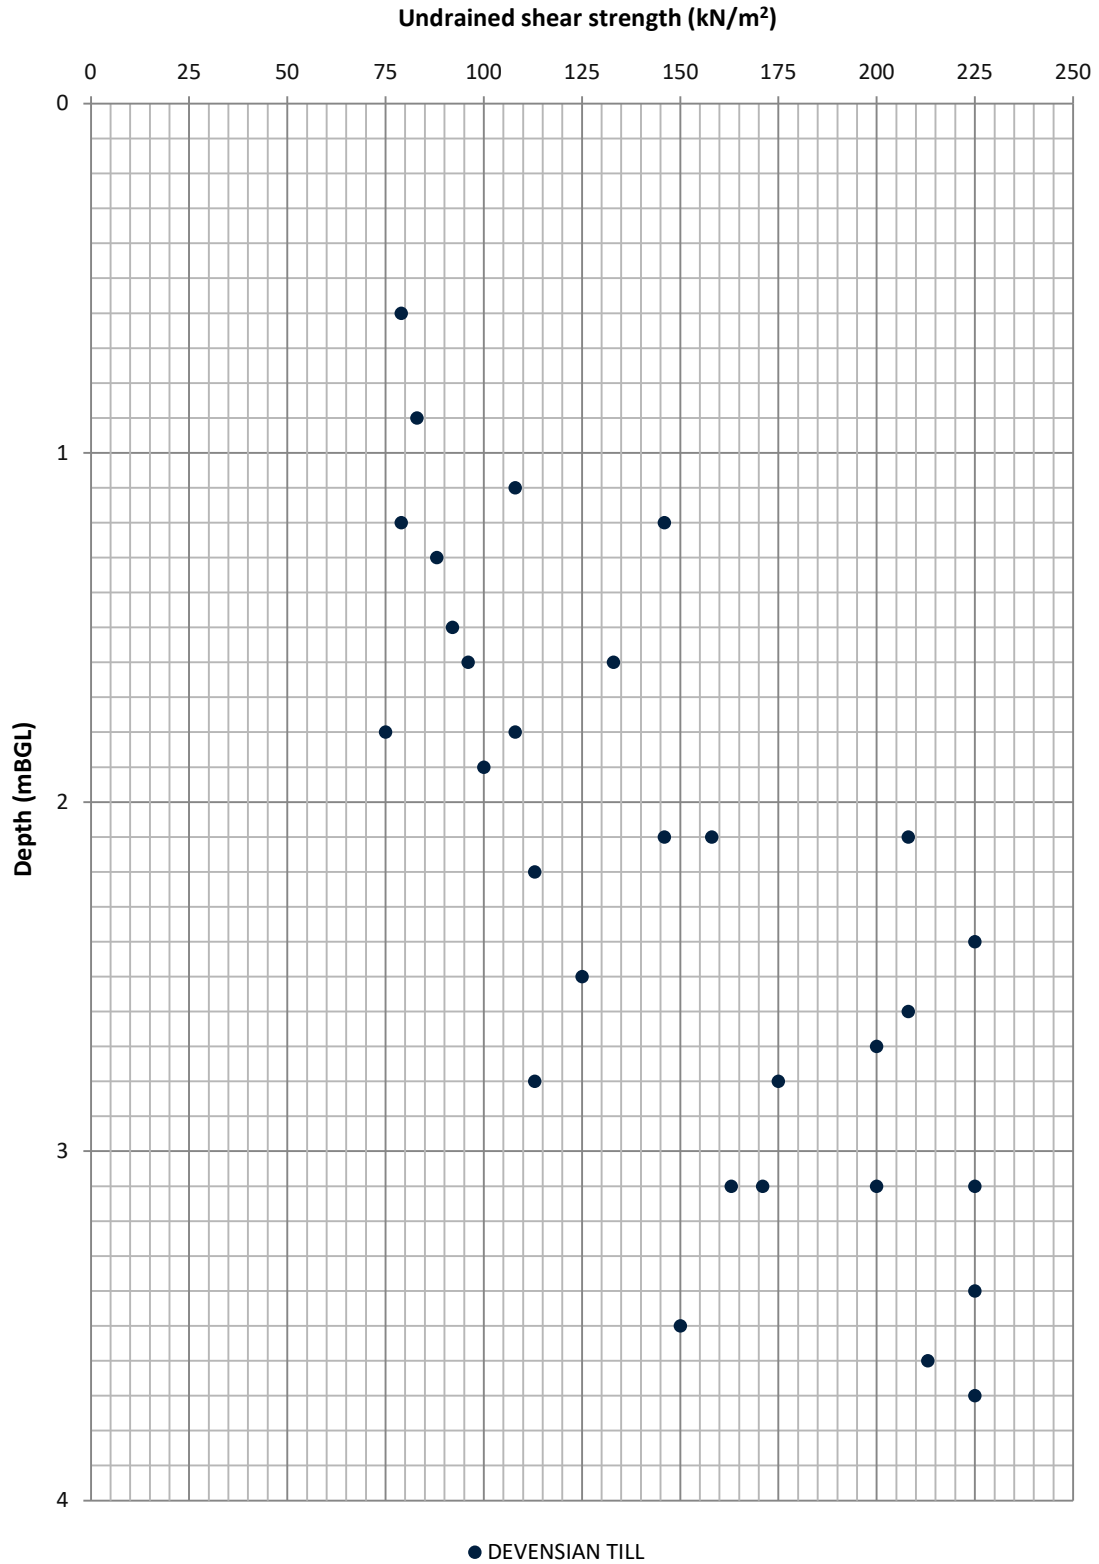
Plot summarising Pocket Penetrometer results versus depth filtered by geology

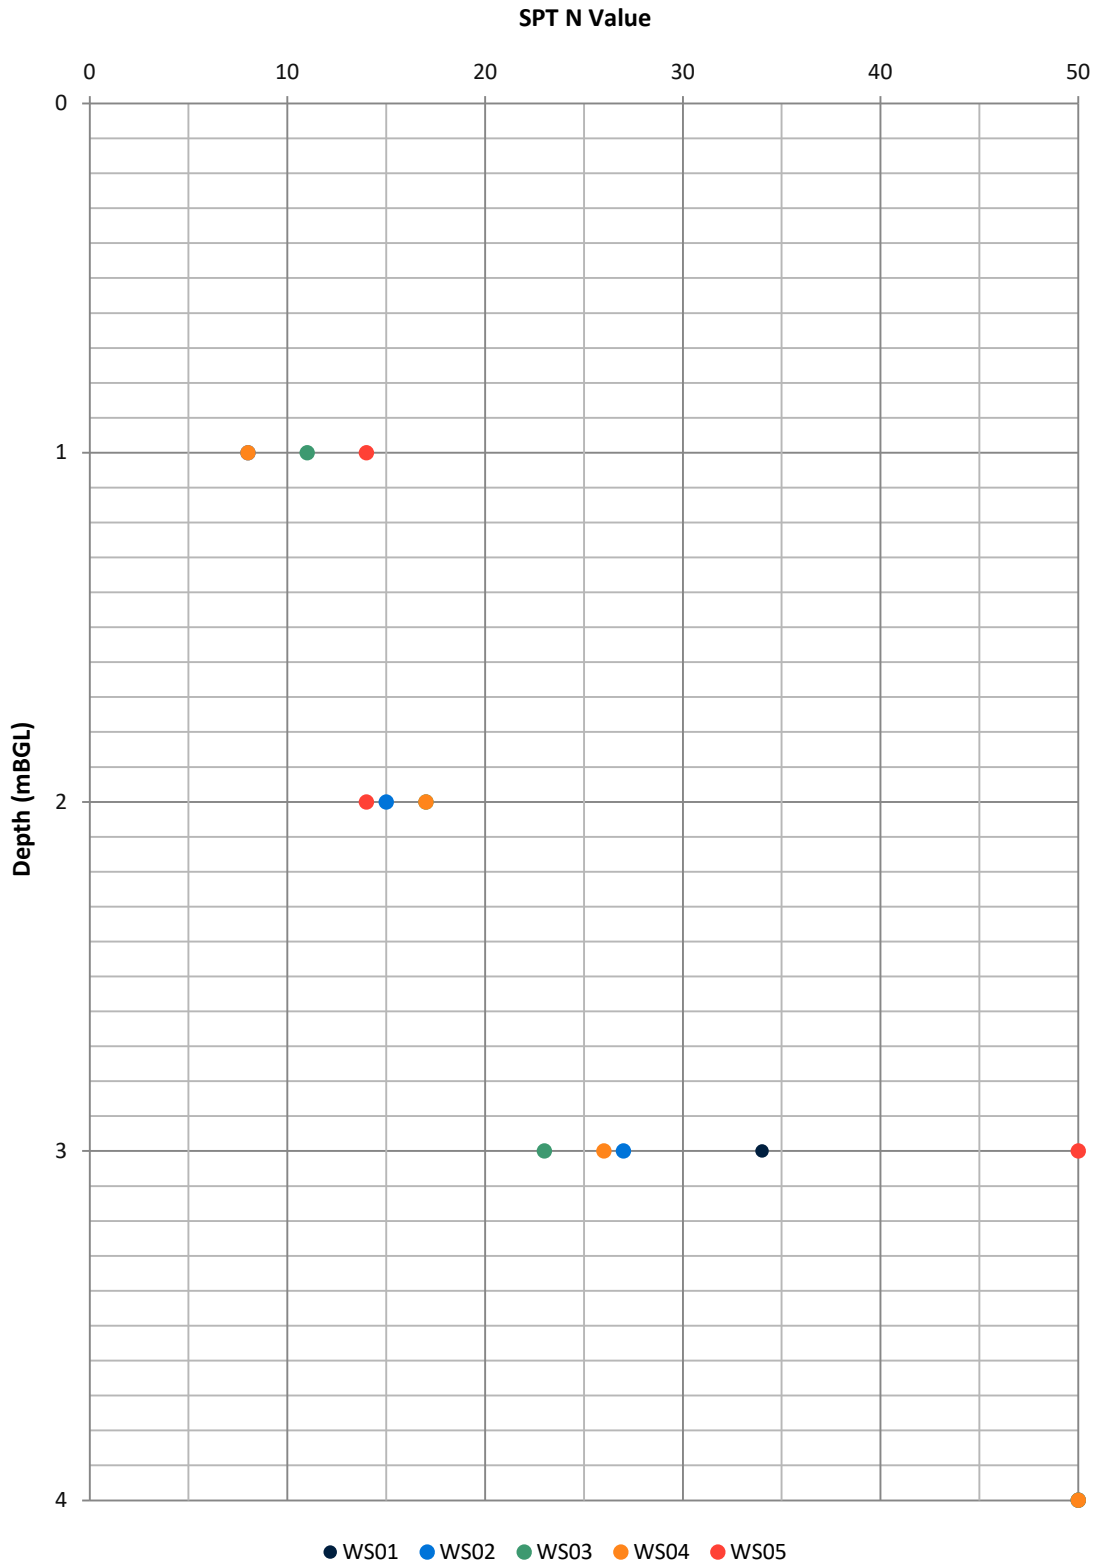
Plot summarising Standard Penetration Test (SPT) results versus depth filtered by location

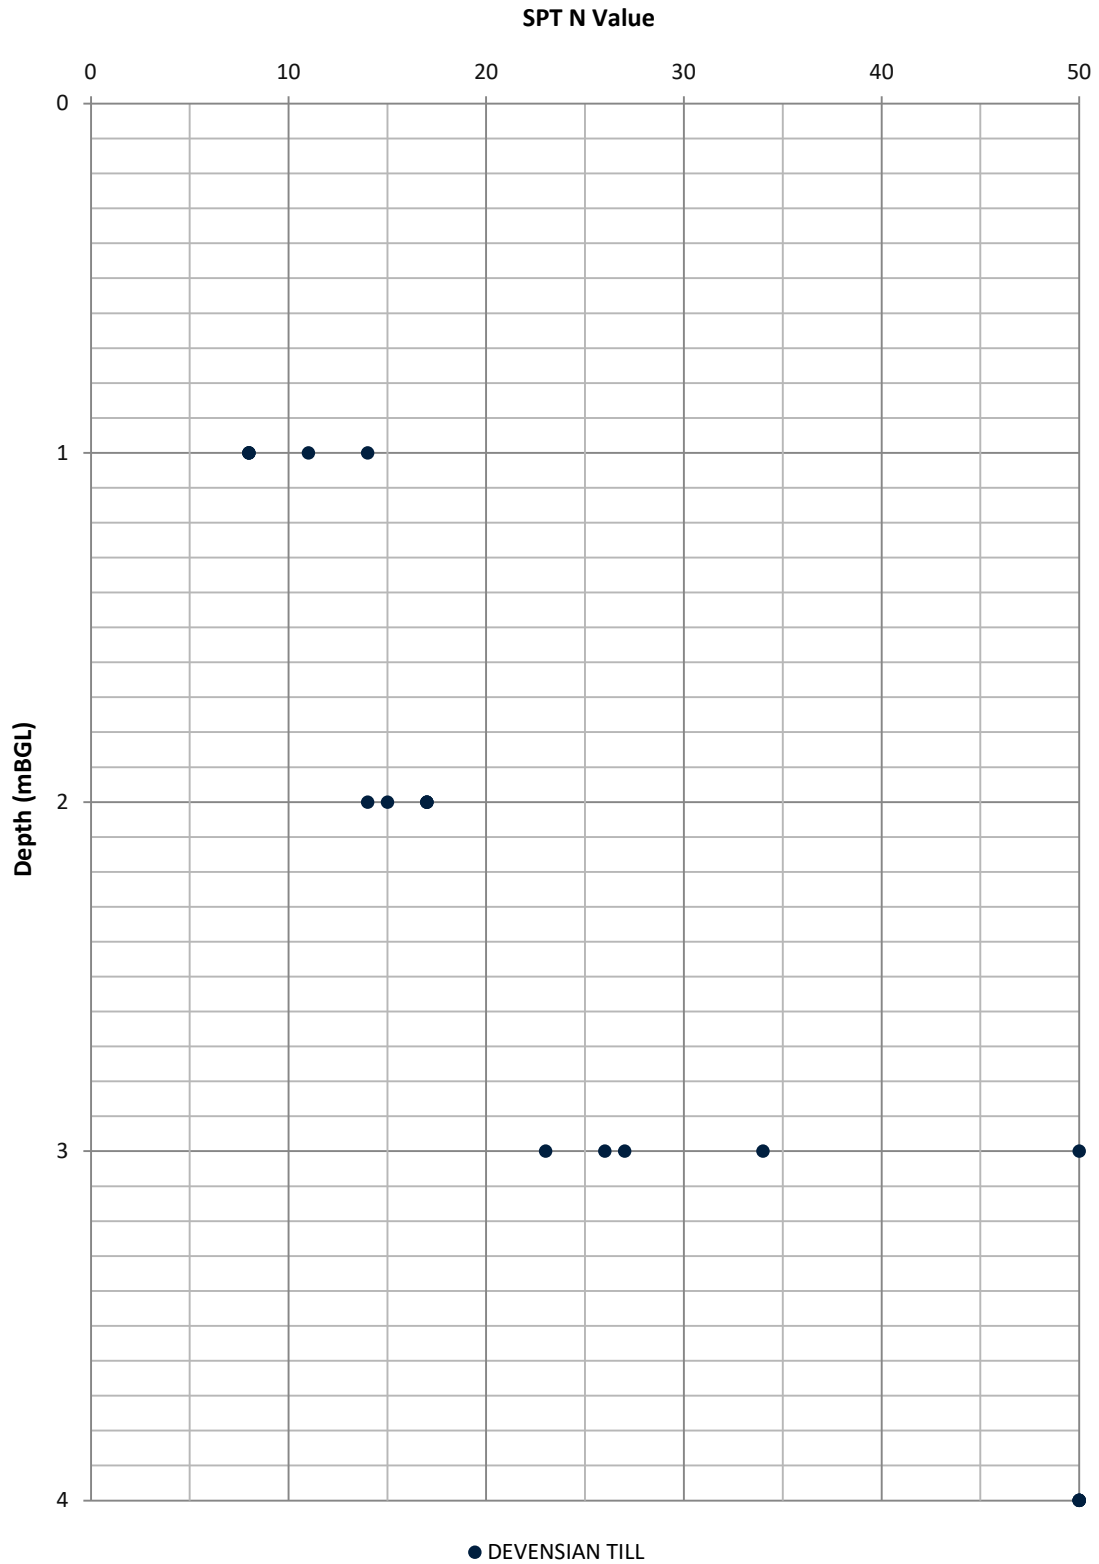
Plot summarising Standard Penetration Test (SPT) results versus depth filtered by geology

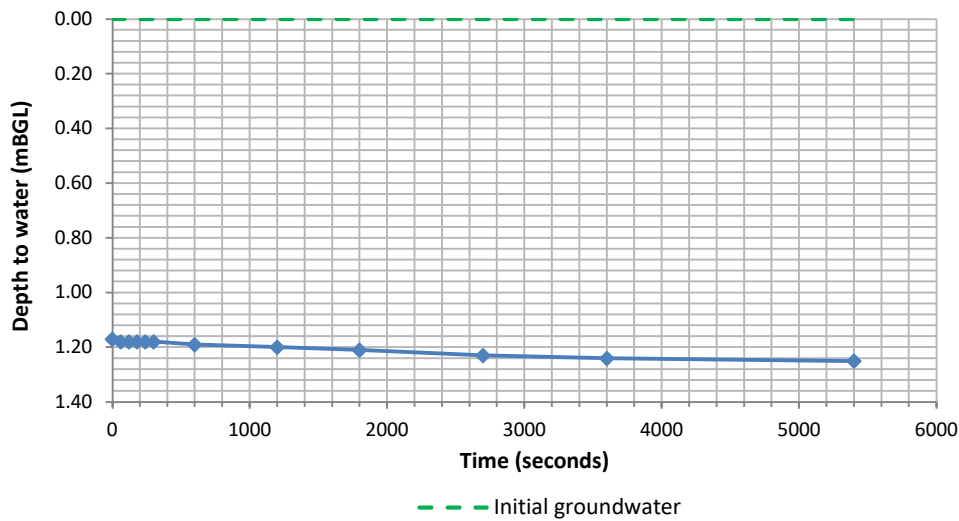
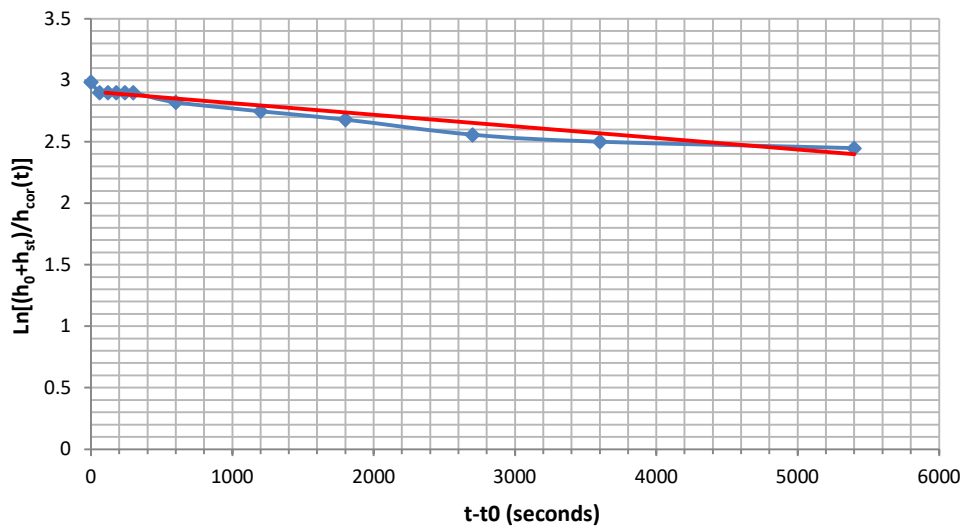
Groundwater (mBGL)	Water after injection (mBGL)	Change in head (m)
Dry	1.17	1.17

F	Shape factor according BS EN ISO 22282-1:2012	4.406 m
S	Cross sectional area of measurement tube	0.0079 m ²
h_{st}	Corrective term to initial static level	1.06E+00 m
α	Gradient of line alpha	-9.43E-05 s ⁻¹
k	Permeability (α S / F)	1.68E-07 m/s

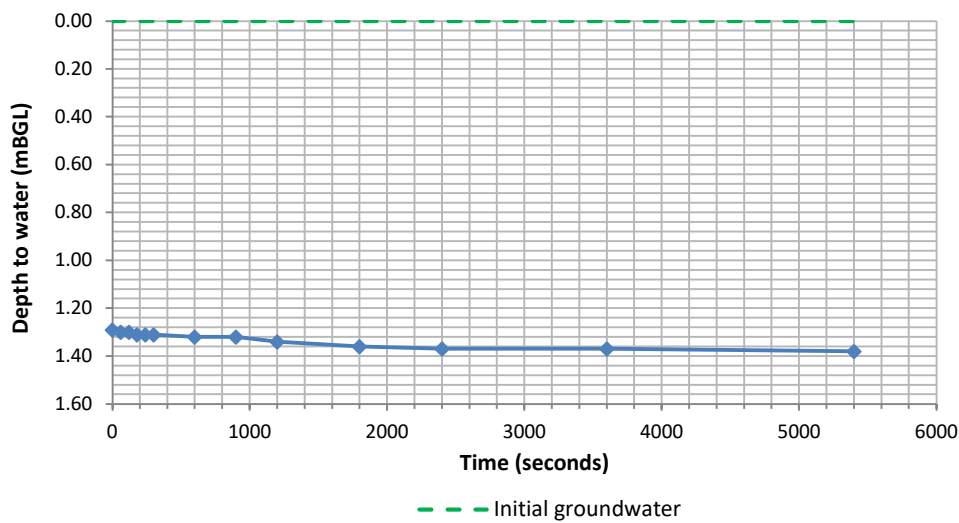
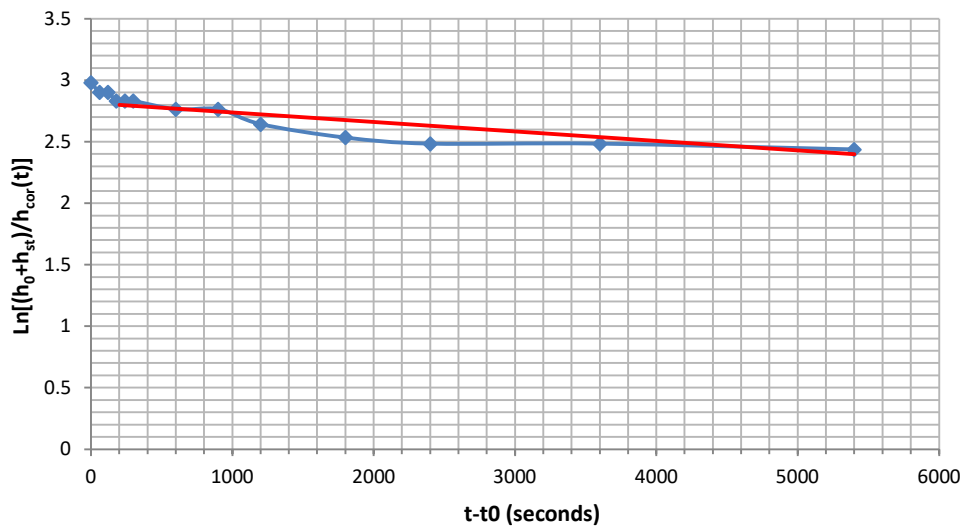
Groundwater (mBGL)	Water after injection (mBGL)	Change in head (m)
Dry	1.29	1.29

F	Shape factor according BS EN ISO 22282-1:2012	4.265 m
S	Cross sectional area of measurement tube	0.0079 m ²
h_{st}	Corrective term to initial static level	1.17E+00 m
α	Gradient of line alpha	-7.69E-05 s ⁻¹
k	Permeability (α S / F)	1.42E-07 m/s

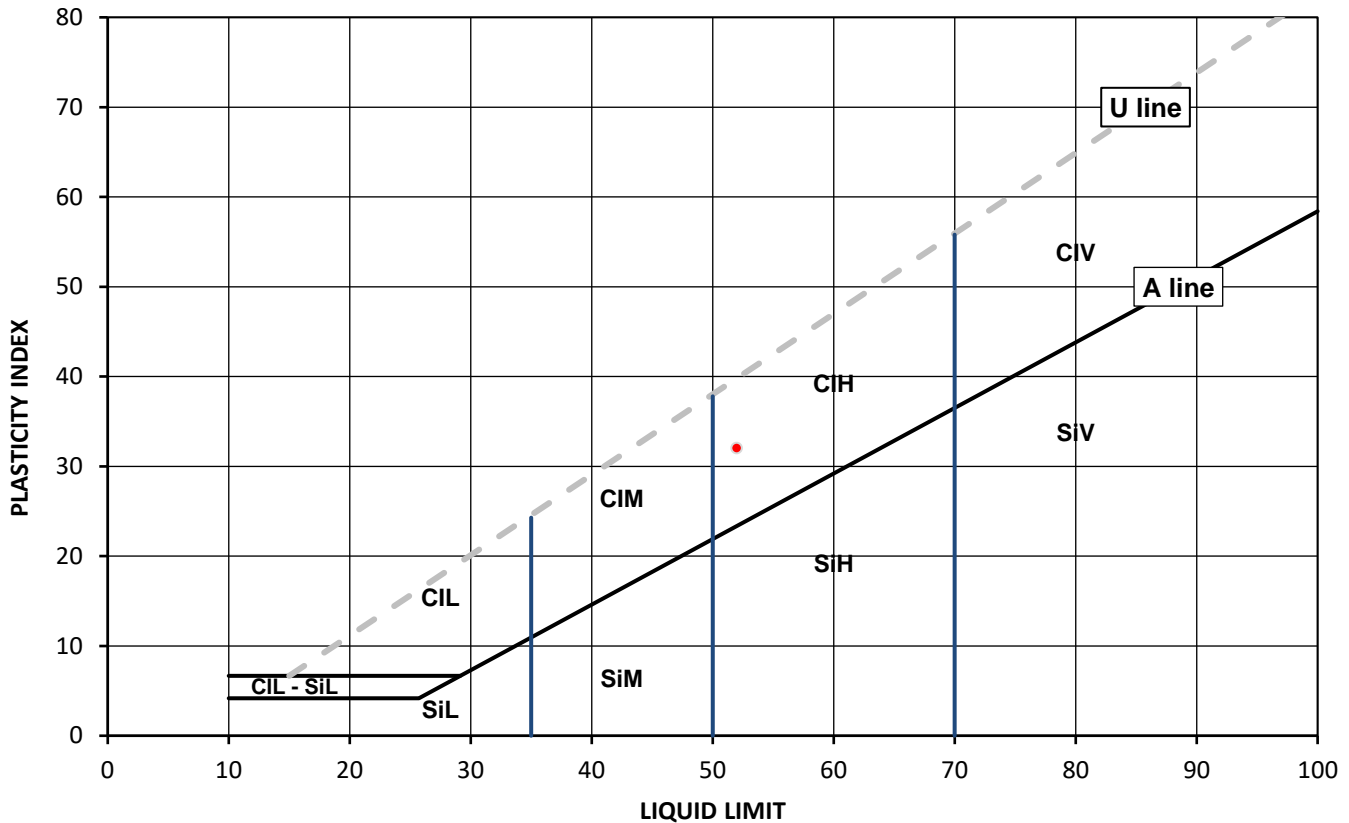
As Received Water Content [W] %	Liquid Limit [WL] %	Plastic Limit [Wp] %	Plasticity Index [Ip] %	% Passing 425µm BS Test Sieve
24	52	20	32	98

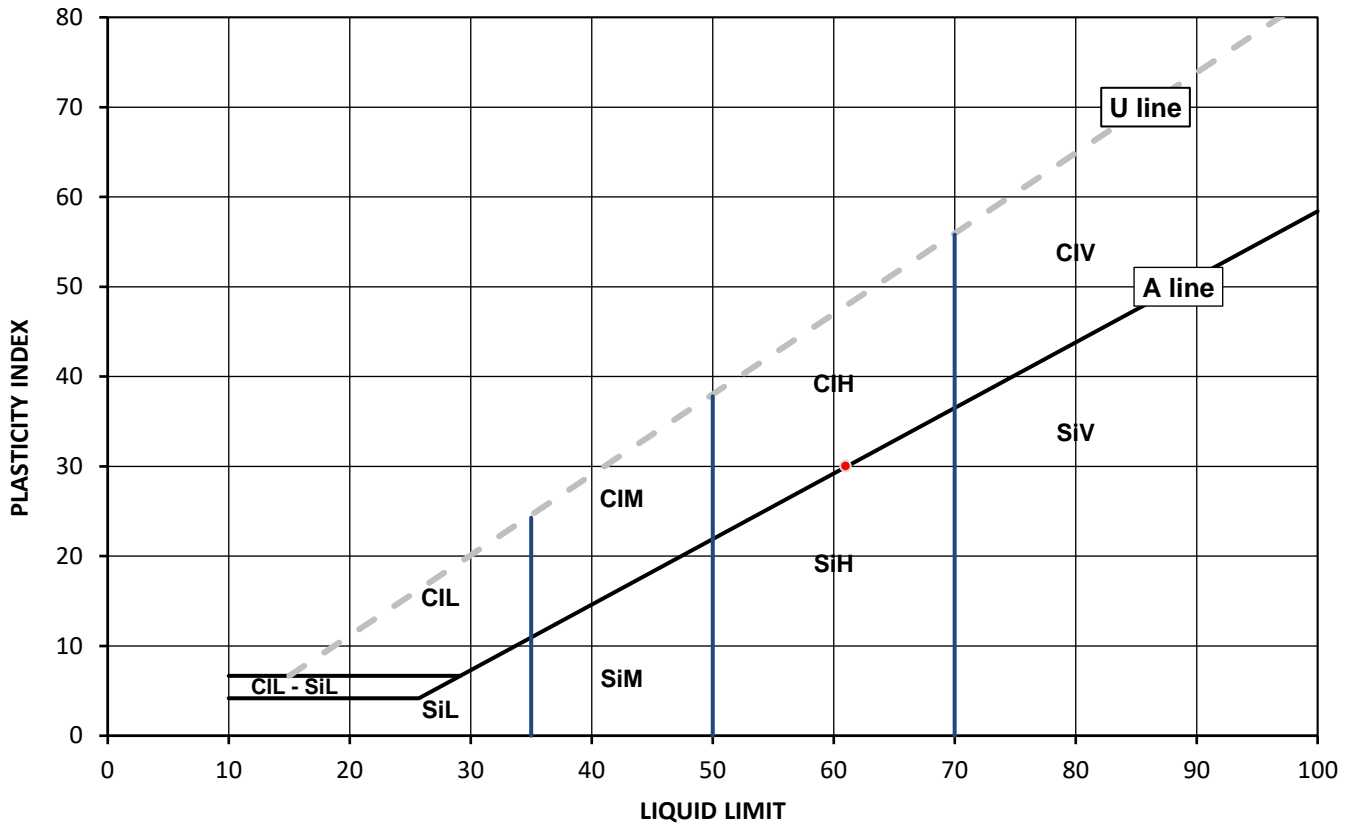
As Received Water Content [W] %	Liquid Limit [WL] %	Plastic Limit [Wp] %	Plasticity Index [Ip] %	% Passing 425µm BS Test Sieve
30	61	31	30	100

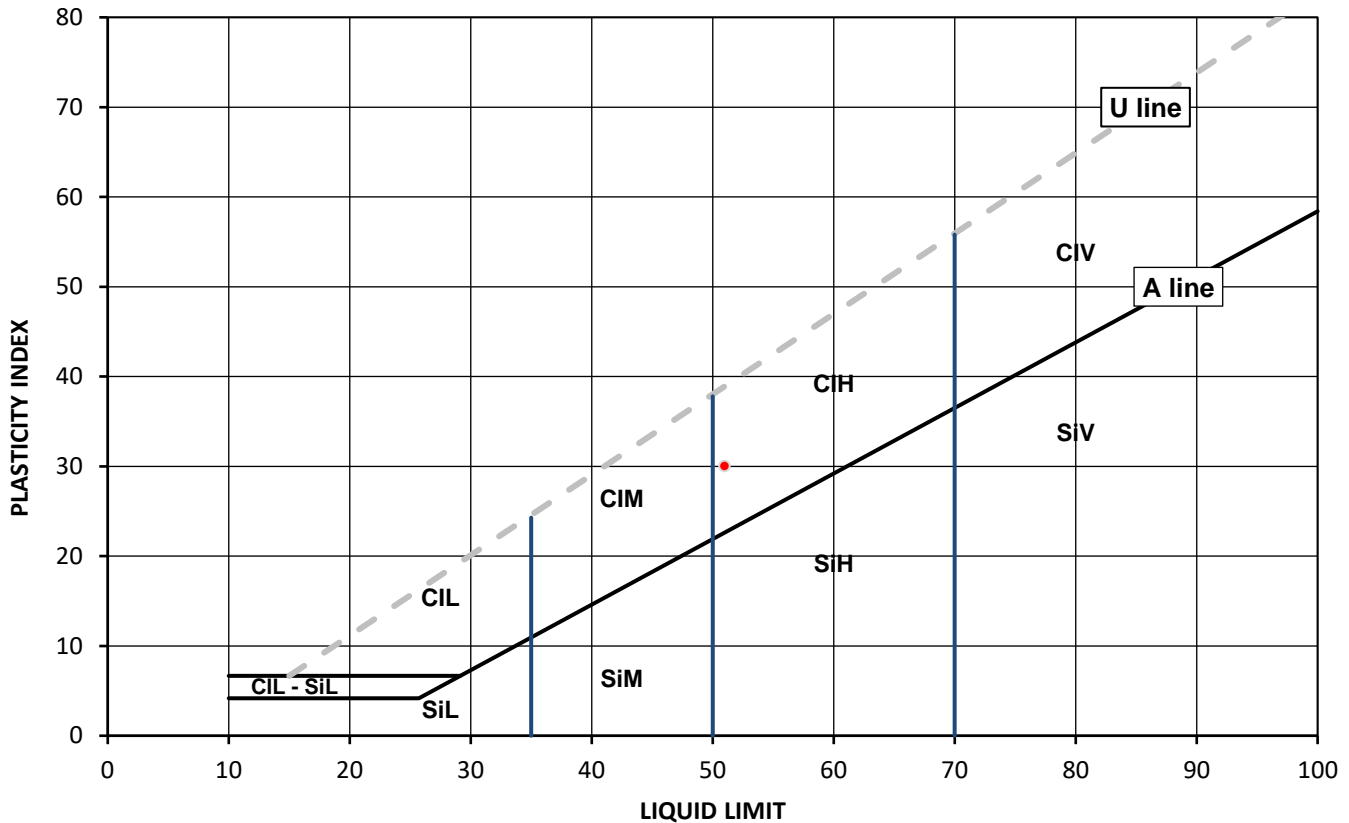
As Received Water Content [W] %	Liquid Limit [WL] %	Plastic Limit [Wp] %	Plasticity Index [Ip] %	% Passing 425µm BS Test Sieve
25	51	21	30	99
