**Stone Walls located at  
5 Dean Wood Close,  
Upholland, Skelmersdale, Lancashire  
WN8 0BS**

**Survey & Assessment in Respect  
of Bat Species and Nesting Birds.**

**22<sup>nd</sup> May 2020**

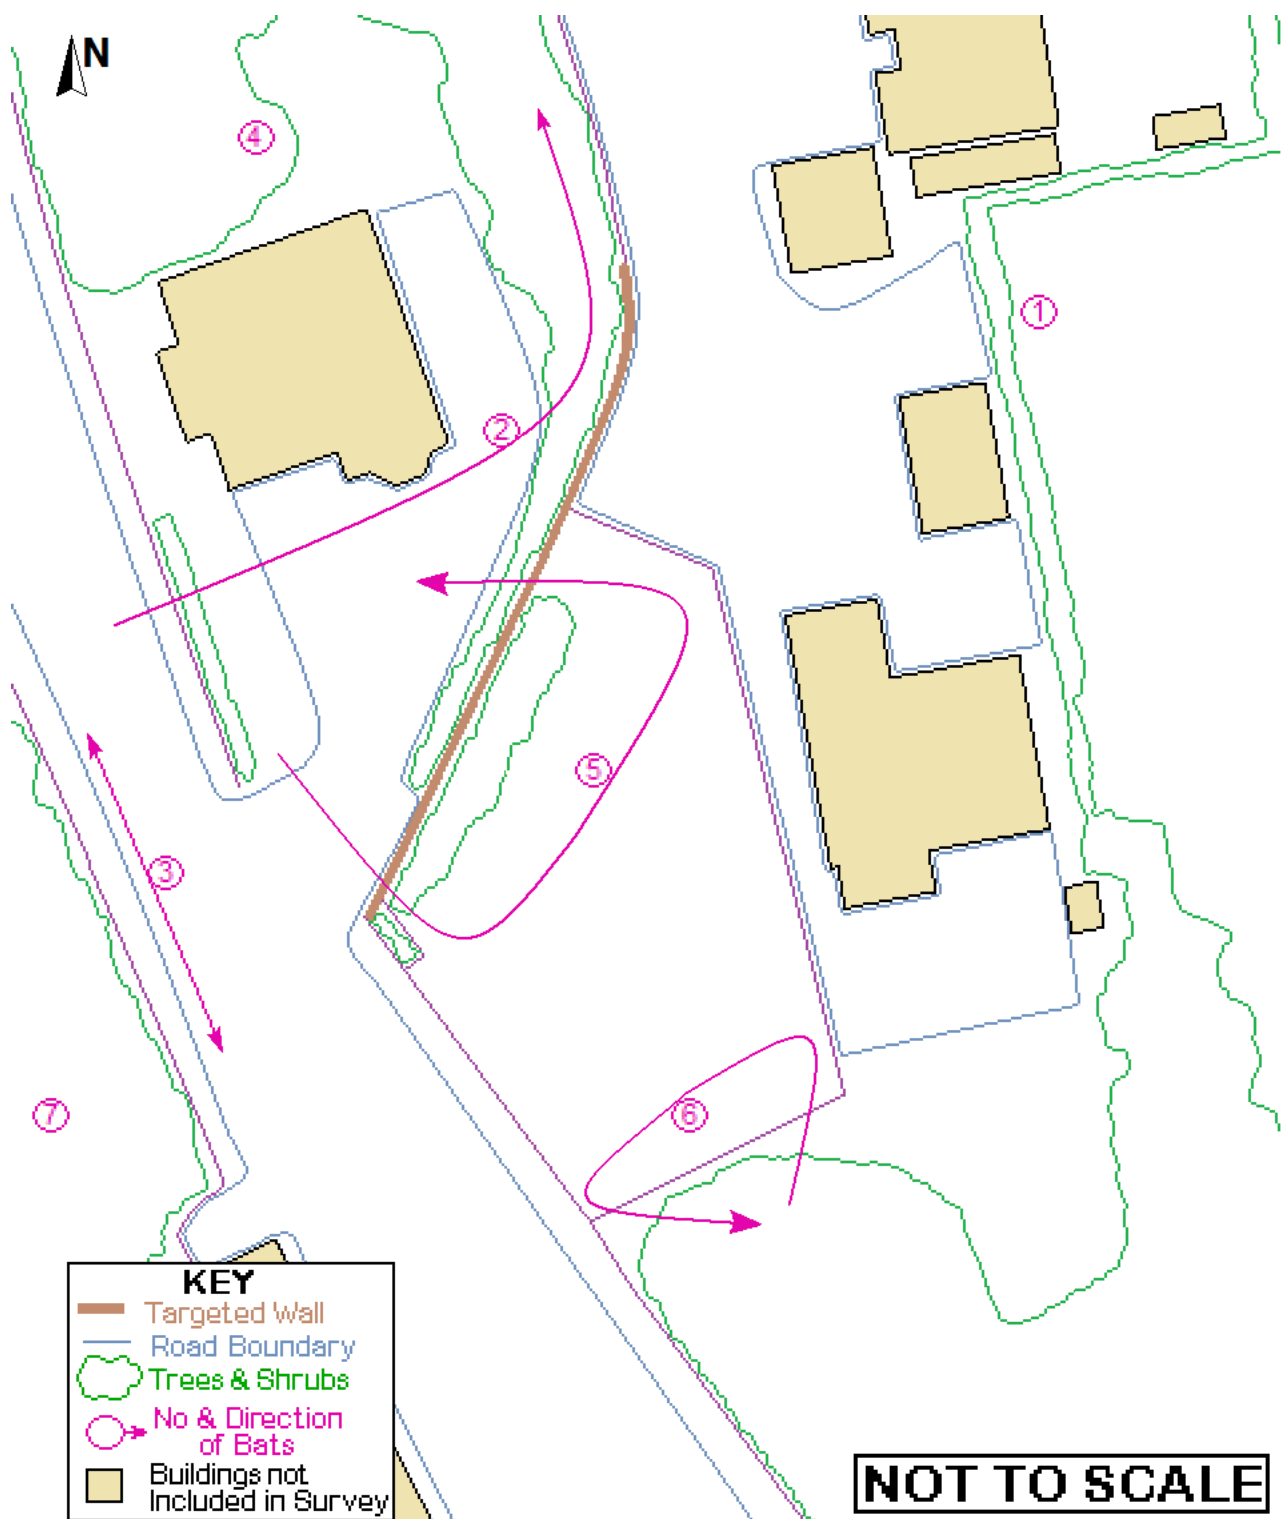
Fig 4 – Plan of Evening Bat Emergence Results

The first bat recorded was a common pipistrelle (*Pipistrellus pipistrellus*), heard but not seen over the boundary hedgerow between the golf course, and Dean Wood Close to the north-east of the site at 20.59 hrs, (refer to **fig 5** and **pink arrow 1**).

A pipistrelle was observed at 21.01 hrs commuting from across Parliament Street to the west of the site, passing to the north of the northern wall, before exiting in a northerly direction, (refer to **fig 5** and **pink arrow 2**).

Beginning at 21.06 hrs a common pipistrelle foraged along the tree line which was the western boundary of Parliament Street. This behaviour continued until the survey ended during which time, numerous feeding buzzes were heard, (refer to **fig 5** and **pink arrow 3**).

From 21.07 hrs a pipistrelle was heard foraging but not seen, amongst the trees to the north of the gated entrance to Dean Wood Close. It was thought that this could be the same bat observed commuting some minutes before, and again this behaviour continued until the survey ended, (refer to **fig 5** and **pink arrow 4**).

Two pipistrelles began to forage in loops over the site, the first beginning at 21.11 hrs over the site, the northern wall, and the garden and drive of the property to the north. The second was from 21.15

hrs over the site itself, the southern wall, and the adjacent woodland to the south of the wall, This foraging behaviour continued until the survey ended, during which time feeding buzzes were frequently heard, (refer to **fig 5** and **pink arrows 5** and **6**).

At 21.16 hrs a single pipistrelle was heard but not seen amongst the trees to the west across Parliament Street. As this echo calling was only heard a few times, it was assumed that this was at the eastern end of a foraging loop amongst the trees, (refer to **fig 5** and **pink arrow 7**).

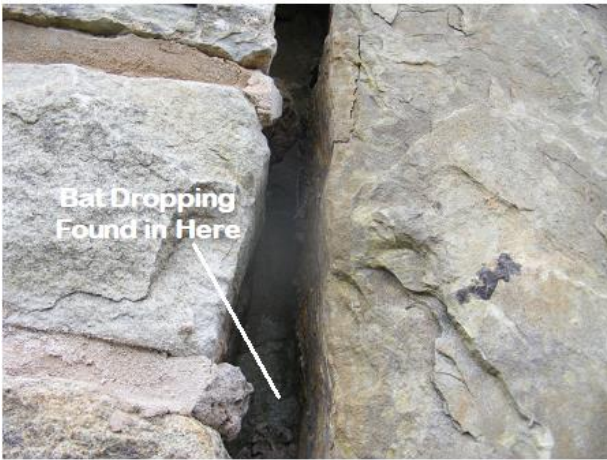
**PHOTO 9**  
**Central Expansion Joint**

- There were three expansion joints, at various intervals between them, and these were carefully searched, initially using a bright torch beam, and then with an endoscope to investigate the deeper holes. The majority of the joints were empty of any evidence of bats, however, a single pipistrelle dropping was found within the central expansion joint, but, the dropping could not be extracted to investigate it further, (refer to **figs 3 and 4**, and **photos 1, 4, 5**, and **8 to 12**).

Inspection of the northern wall had found a single bat dropping within an expansion joint, testifying to the joint's use at some point by a roosting bat, and therefore, however transient, the wall is a confirmed bat roost, but no other evidence of roosting bats was observed.

**4.4** As no other evidence of the presence of roosting bats within the walls was found, it was concluded that this was just an occasional night roost, and if the expansion joints in the wall are left uncovered during any future construction on the site, then there will not be requirement for an EPS mitigation licence (as issued by Natural England) but as a measure of best-practice, precautionary measures should be applied as described in section 5 below.

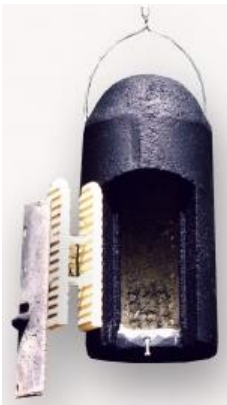
#### Schwegler 1FD Bat Box

This Schwegler 1FD bat box has been developed specifically for smaller bats. The interior and the type and size of the entrance hole match the requirements of smaller species. It features a special layout inside the domed roof, an increased interior height, and two grooved internal wooden front panels with precise spacing between them.

These boxes are to be erected as recommended by the Bat Conservation Trust guidelines which state that

- Ideally, erect the boxes facing so they face in different directions, to provide a range of temperature conditions. For example, boxes facing from south-east to south-west allow the sun to fall on each box for part of the day. During very hot days a south-facing box may overheat, but the other boxes should have some shade during the day.
- Bat boxes should be located close to a linear vegetation feature such as a tree line or hedgerow or to lines of buildings. Some bat species use these features for navigation between their roosting site and feeding ground and to avoid flying in open and exposed areas.
- Ensure that tree branches or other items will not impede the bats’ approach to the box – clear away underneath the box so the bats can land easily before crawling into the box.
- Boxes should be erected at a height of approximately 4m above ground level
