Elmswell Tavern

Preliminary Ecological Appraisal and Ecological Assessment Report

Document Title: Elmswell Tavern Preliminary Ecological Appraisal and Ecological Assessment Report
Revision: 1.1
Document Status: <Final Draft for Issue>
Date: November 2023
Client Name: Peter Dow
Project: The Railway Tavern Public House
Project Manager: David Magnani
Author: Lee Rudd

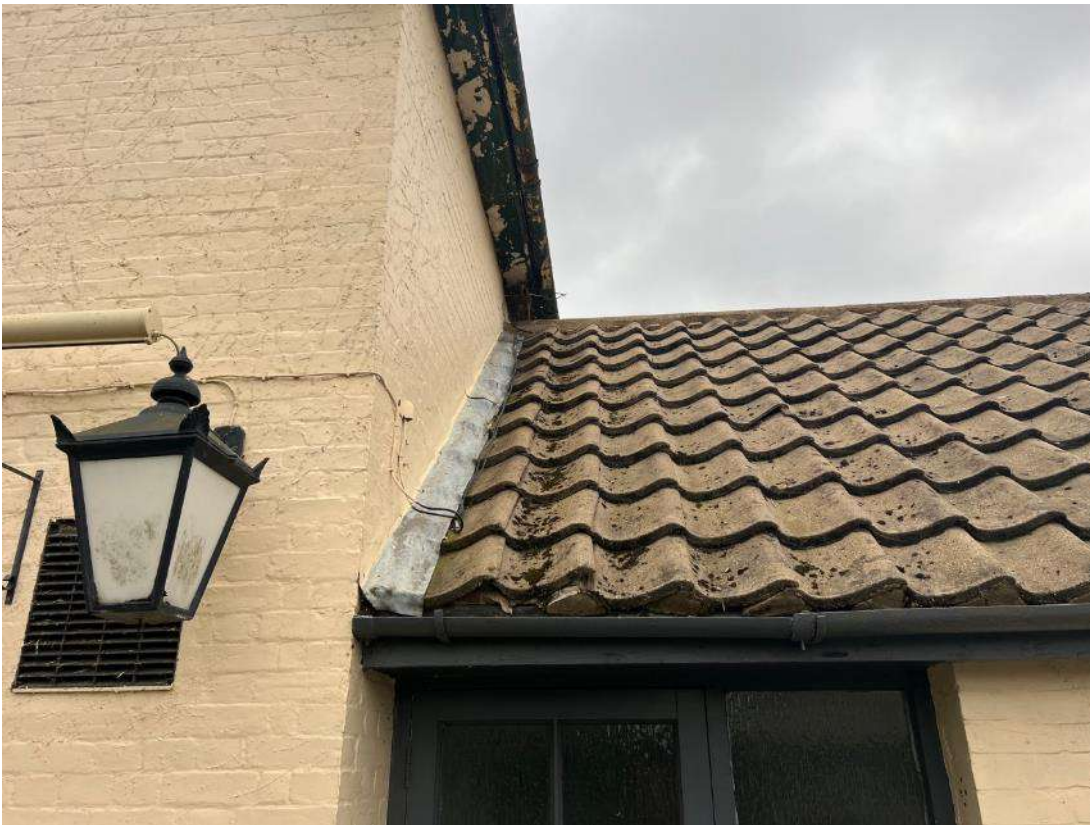
Photo 3. Interface between building 1 and building 2. Gap under lead flashing. Shows most of gaps under pantiles as being infilled with mortar. All gaps here, were cobwebbed.

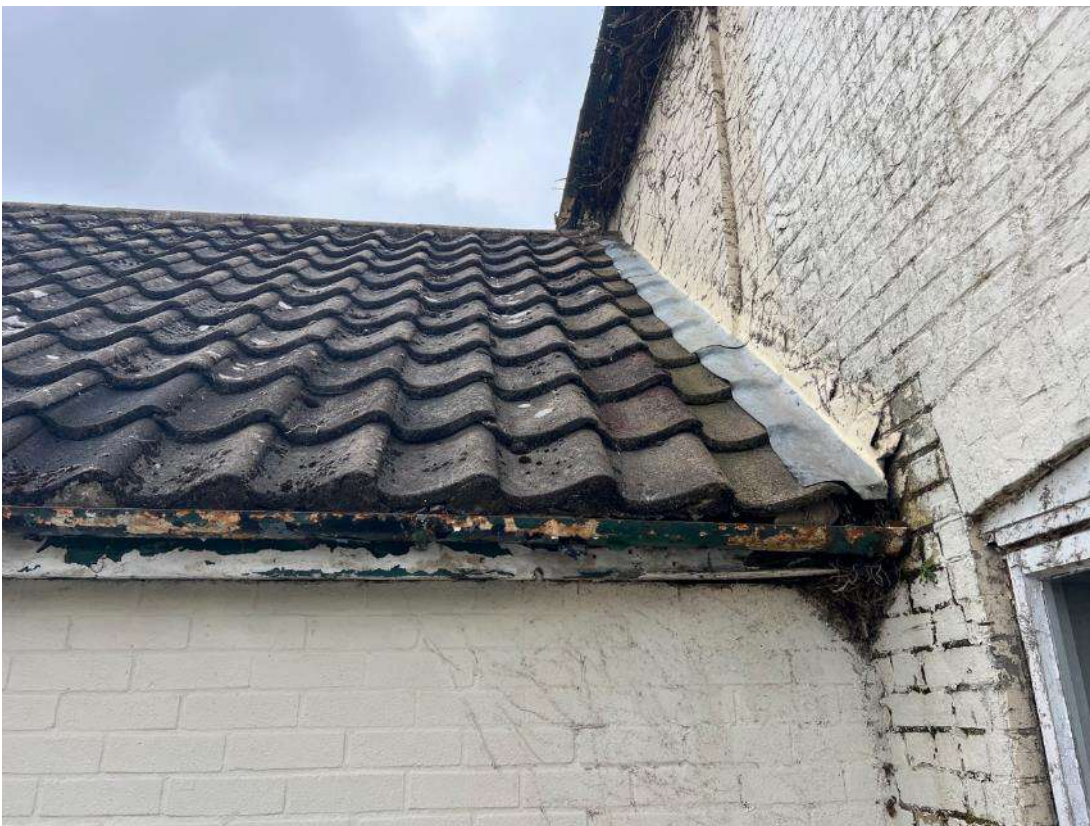
Photo 4. Interface between building 1 and building 2. Gap under lead flashing and damaged barge board. Evidence that this section of the building was recently overed in a climbing plant.

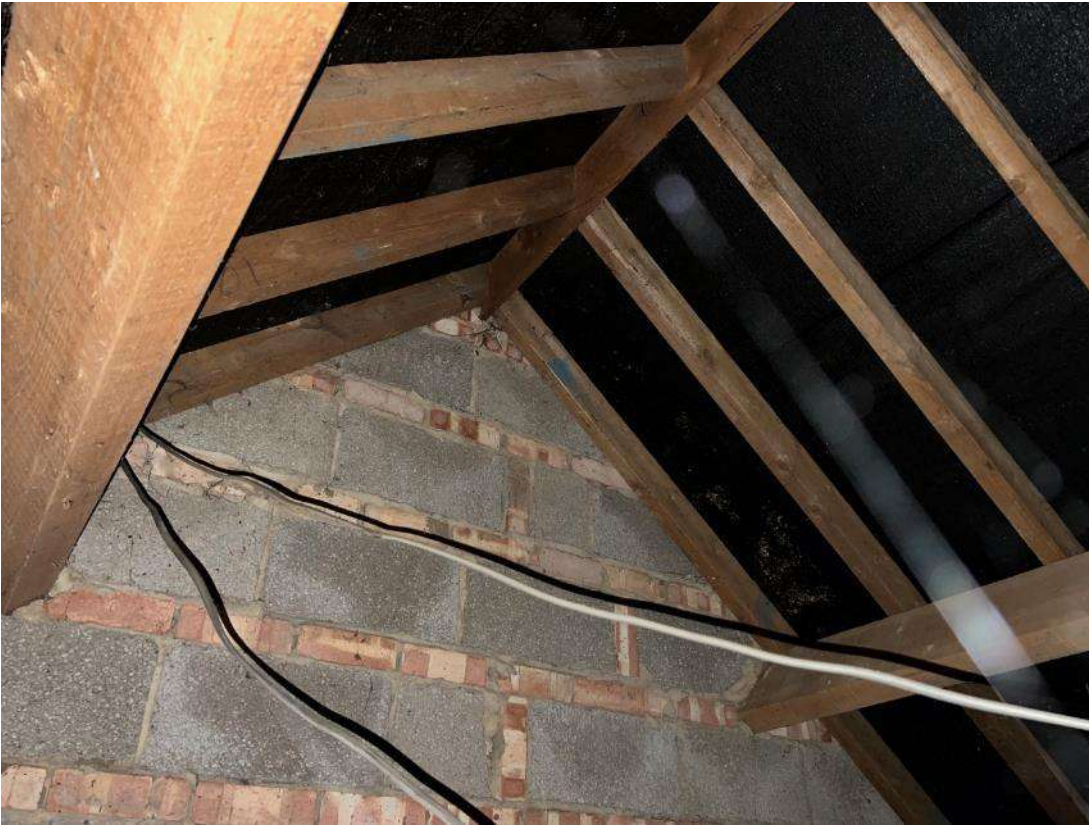
Photo 6. Building 1. Shows modern timber work, block work and roof lined with felt. North end of roof space.

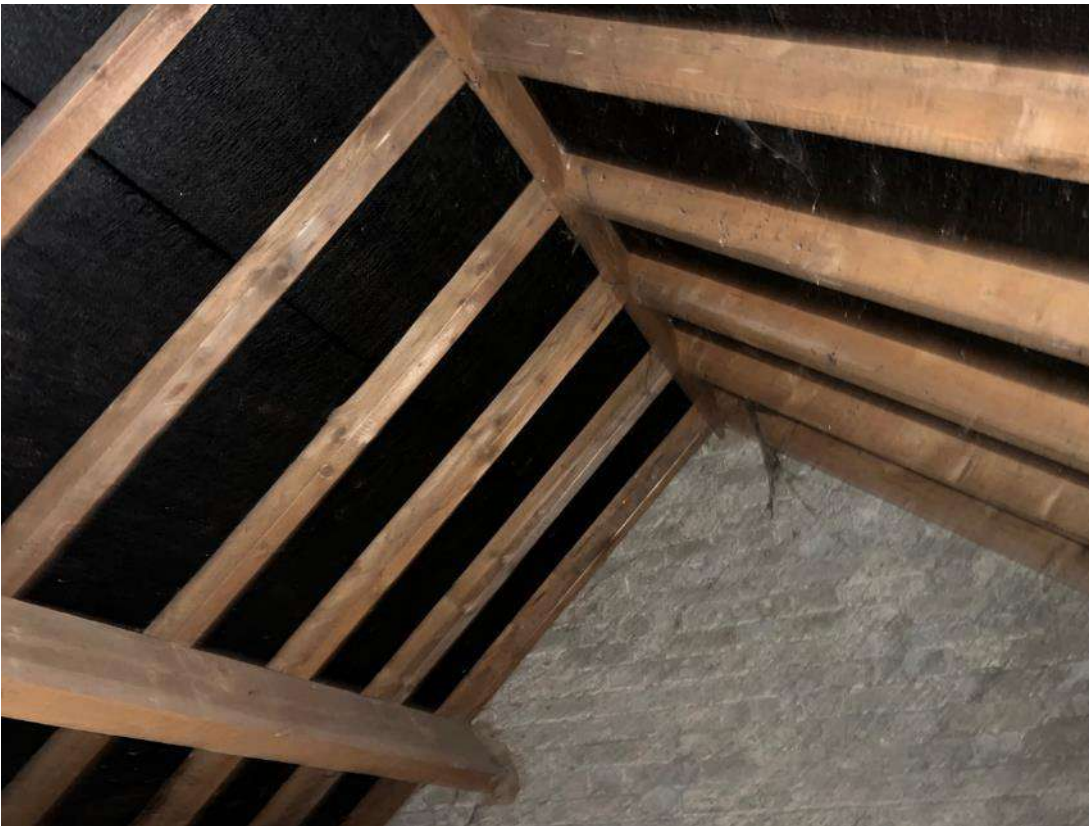
Photo 7. Building 1. South end of roof space. No access points between building 1 and 2.

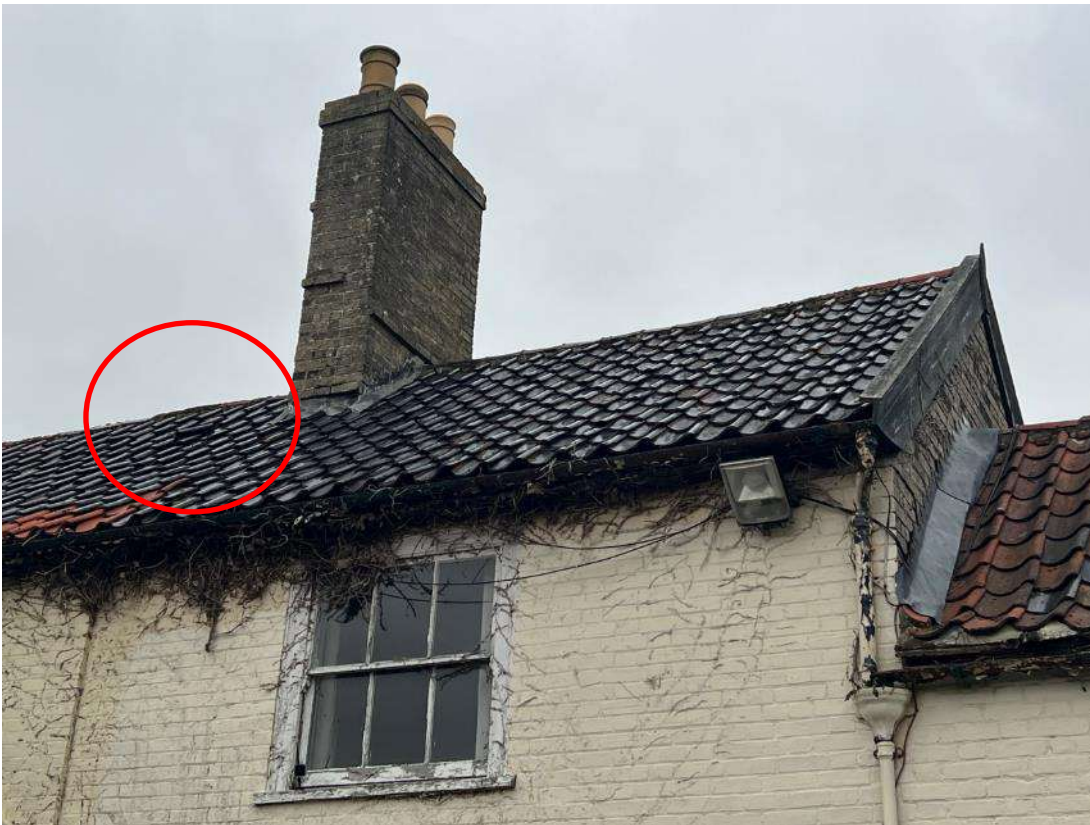
Photo 8. Building 2 (ref B2A). Shows some slipped pan tiles as outlined in red. Evidence that this part of the building was covered with a climbing plant. This has caused damage to the fascia, soffit and under felt.

The proposed Scheme will involve replacing the pantile roof on buildings 1 and 2 on a like for like basis. The underfelt will also be replaced. Building 4 will be demolished to make way for an extension of building 3.

Across all the buildings the soffits, fascia and barge boards will also be replaced as required. The roof spaces will also benefit from being insulated.

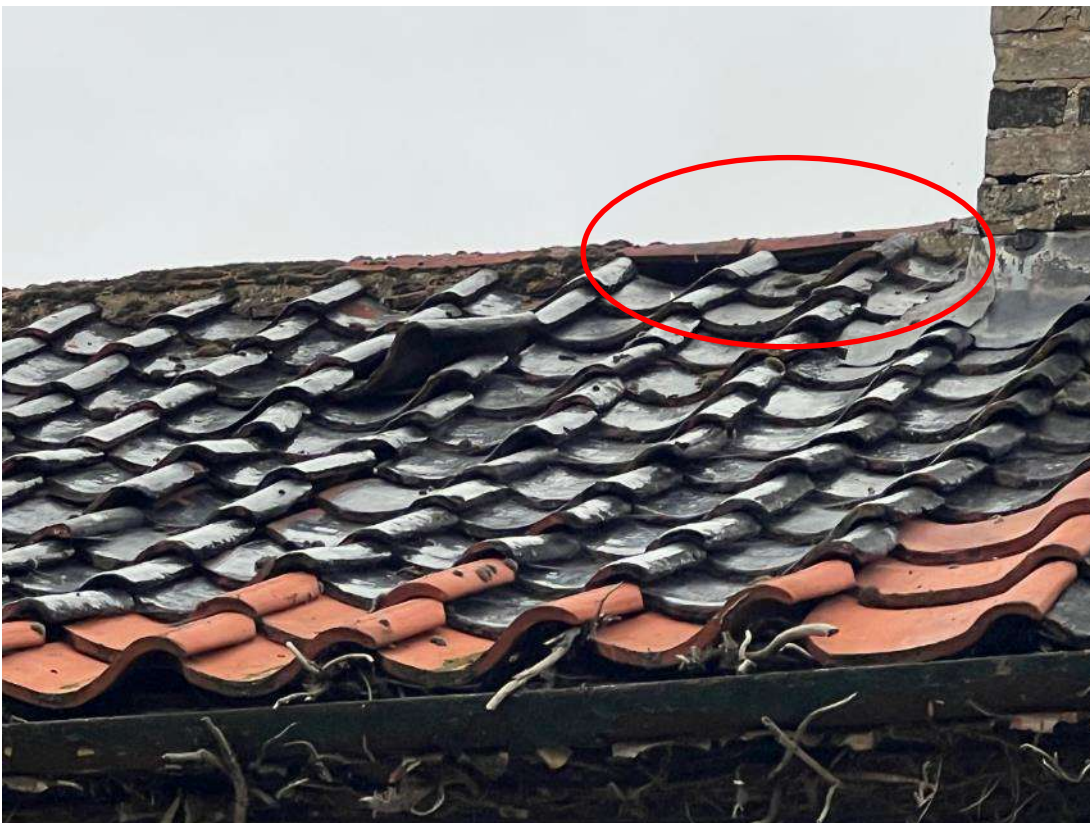
Photo 9. Building 2 (ref B2A). Close up of roof as shown in photo 8. Shows missing mortar under ridge tiles as shown in red.

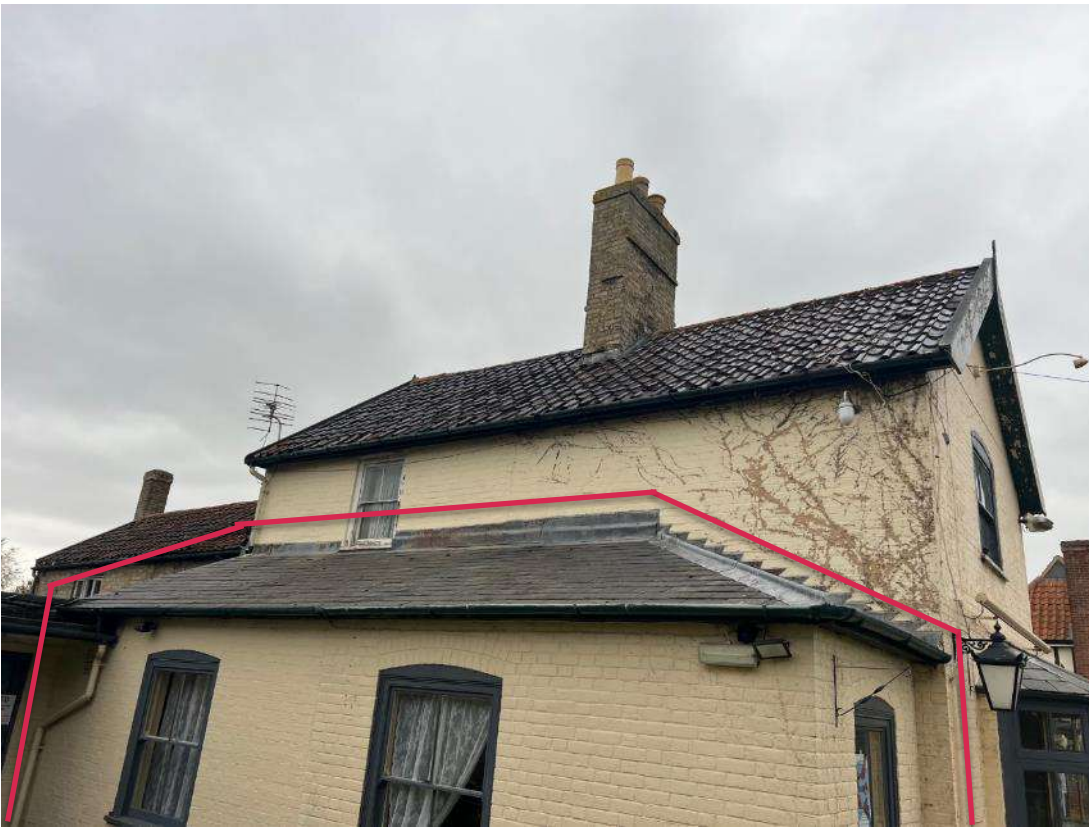
Photo 10. Building 2 (ref B2A and B2B). Shows evidence of climbing plant on side of building B2A. Building B2B is identified by the red outline.

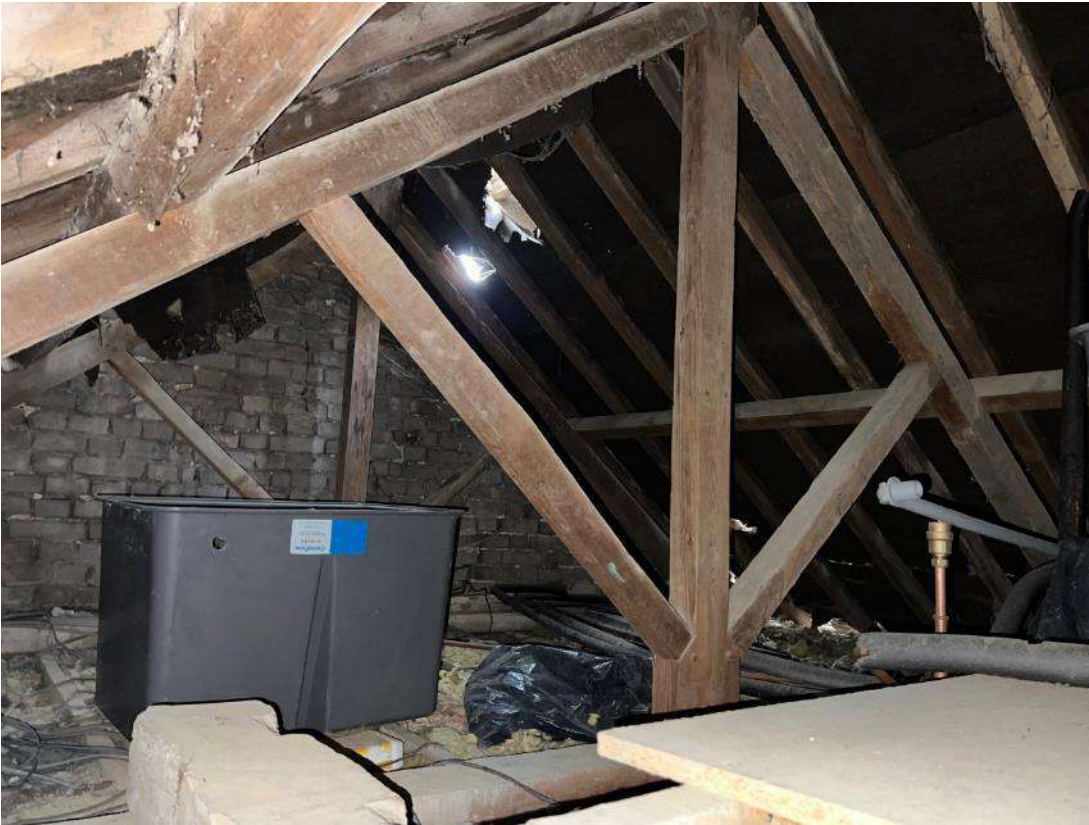
Photo 12. Building 2 (ref B2A). Interval view of roof space. Shows damaged under felt and fire wall between building B2A and B3A. Taken from loft hatch.

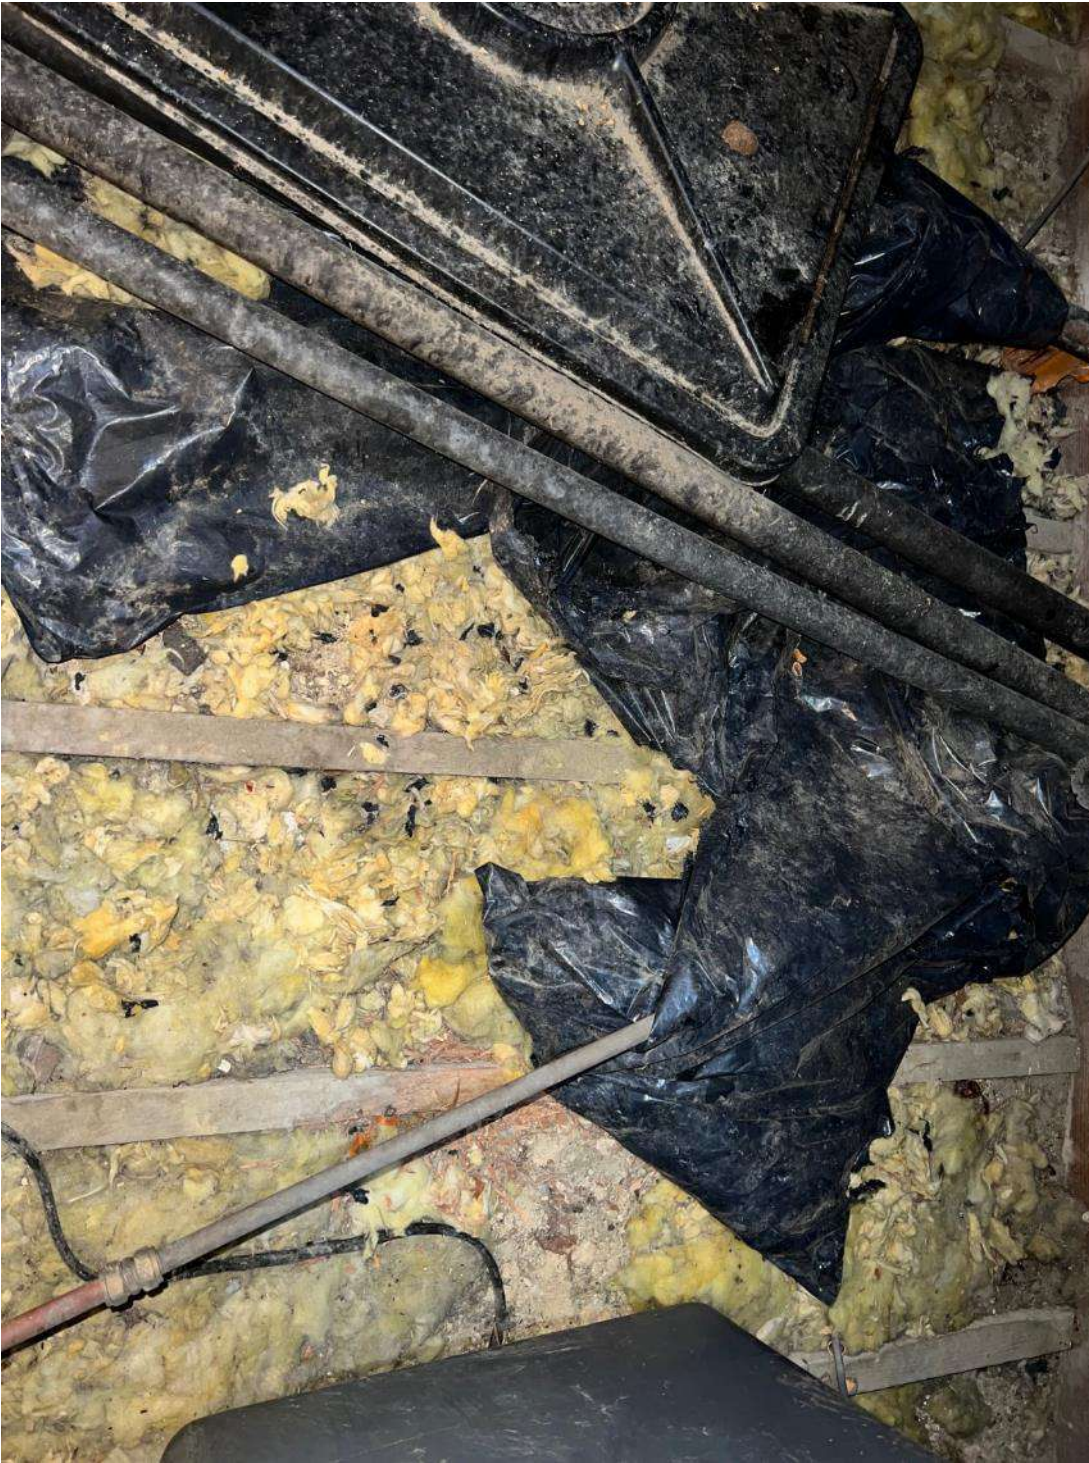
Photo 14. Building 2 (ref B2A). Likely evidence of squirrel damage. A squirrel has been seen to enter the roof space of building 3 on multiple occasions during the survey visits.

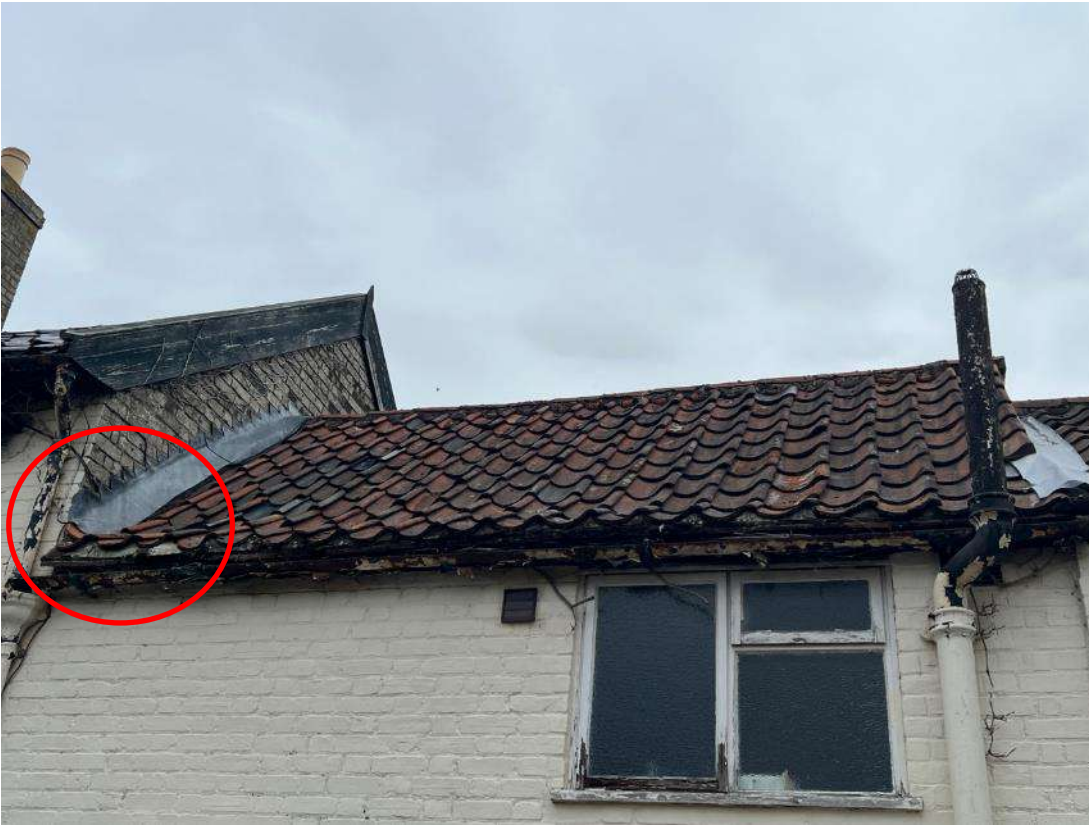
Photo 16. Building 3 (ref B3A). Shows gap under lead flashing where building B3A adjoins building B2A as identified by red circle. Most of the gaps beneath the pan tiles are all mortar filled. West aspect.

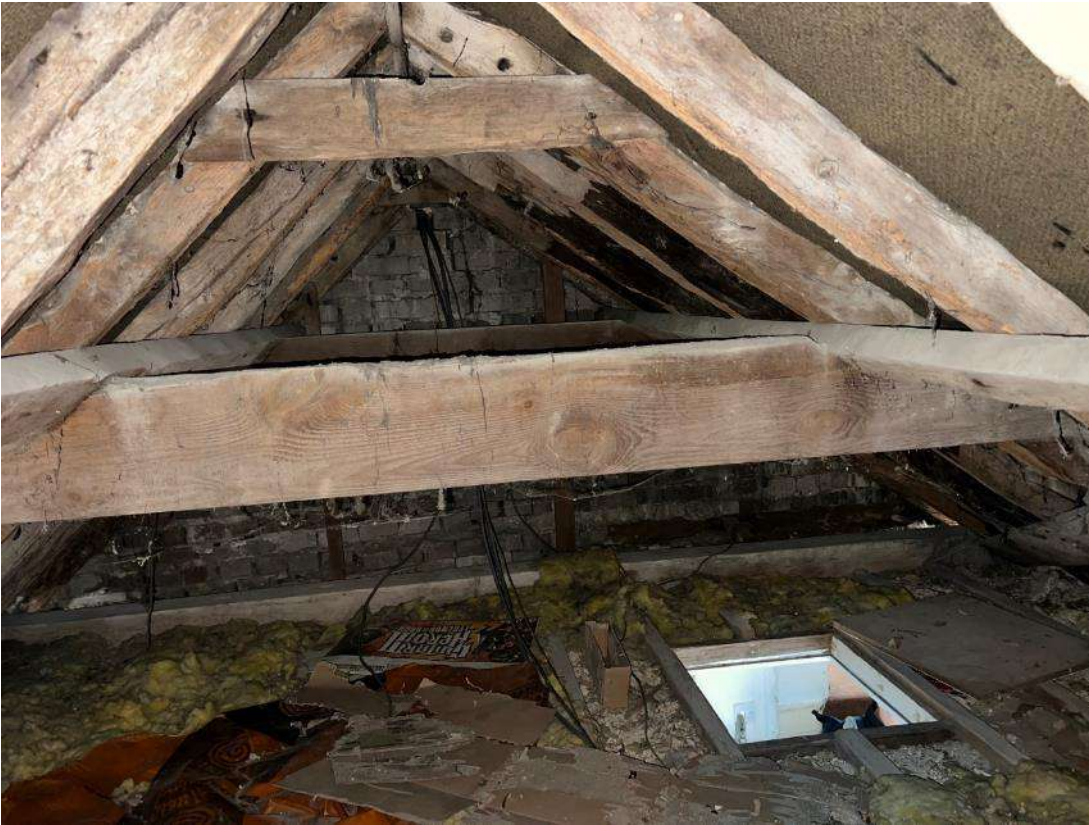
Photo 18. Building 3 (ref B3A). Roof space. Shows old timber work and sarking underlay.

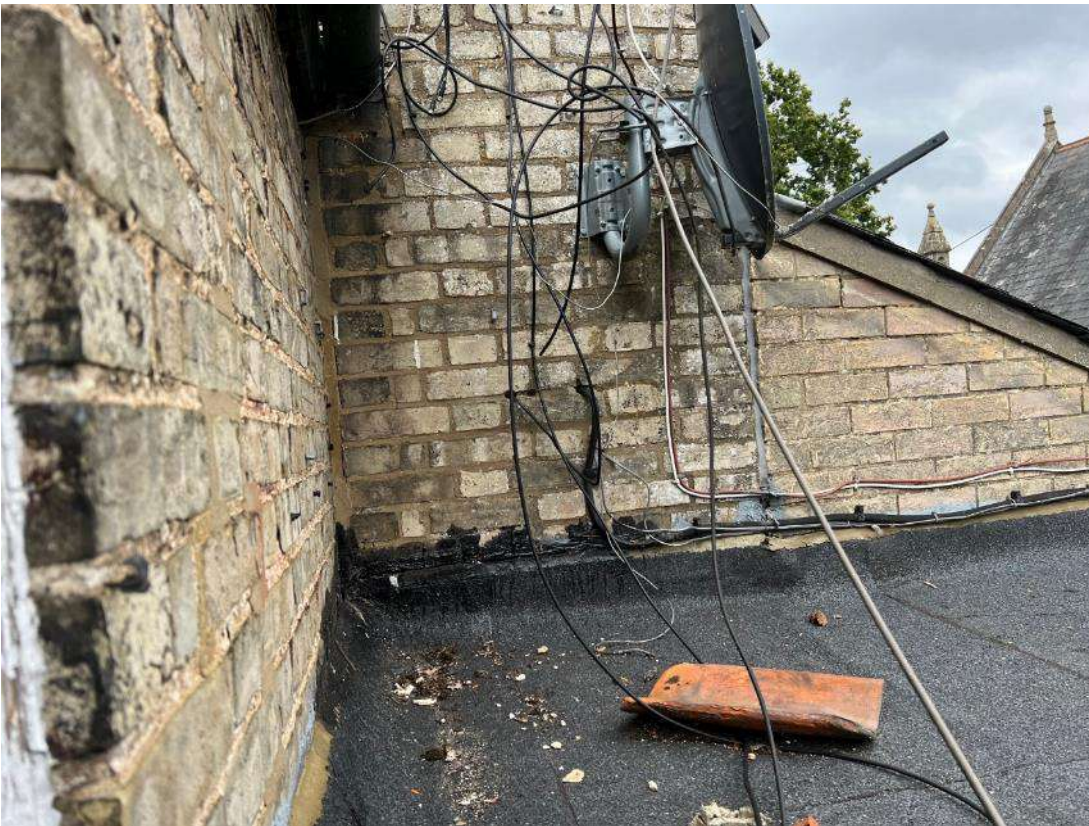
Photo 19. Building 3 (ref B3B). Shows flat roof of building B3B adjoining eastern aspect of building B3A.

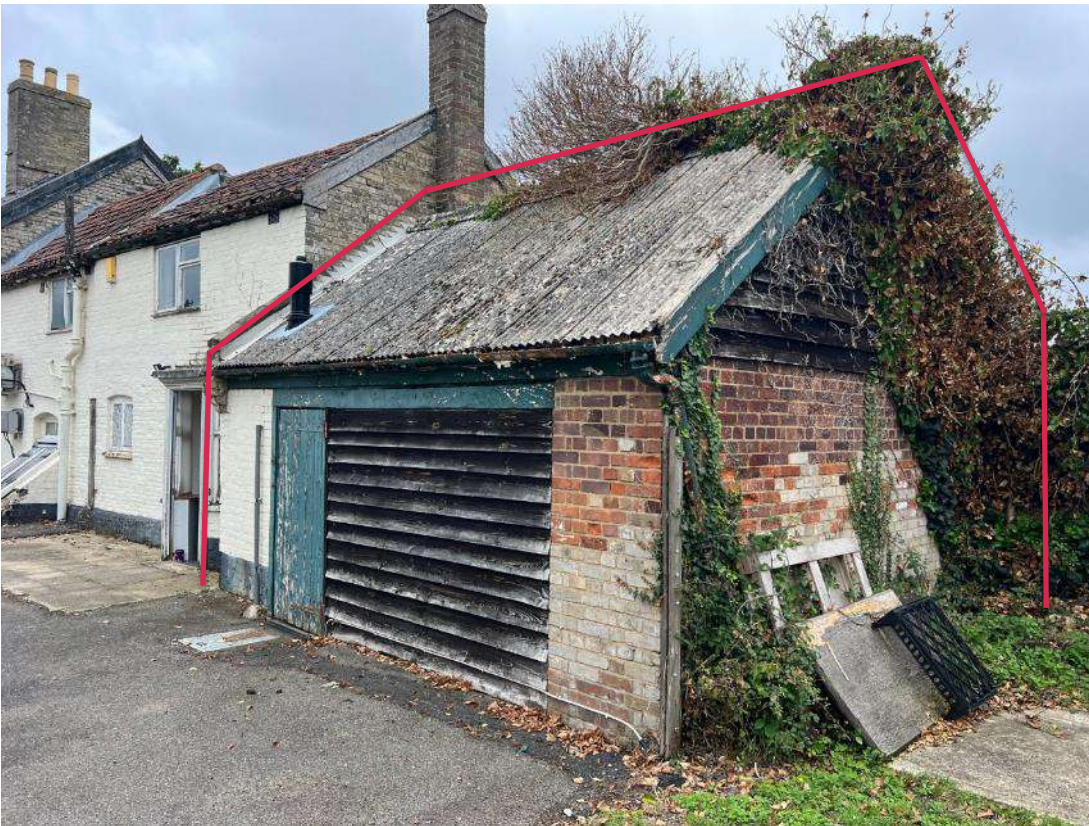
Photo 21. Building 4 (ref B4). Outline of building shown in red. Shows western access point and timber cladding. There is a corrugated cement roof.

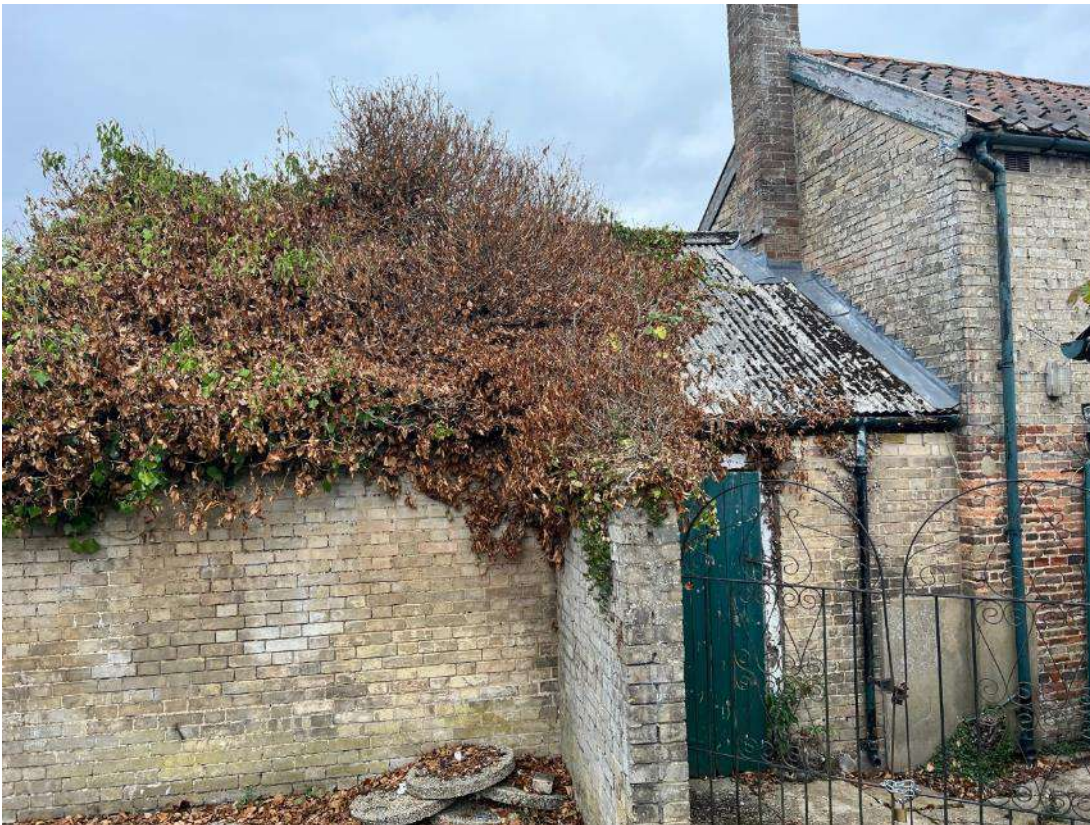
Photo 22. Building 4 (ref B4). Shows building 4 built up to building B3A. Most of the roof is covered in dense ivy growth.

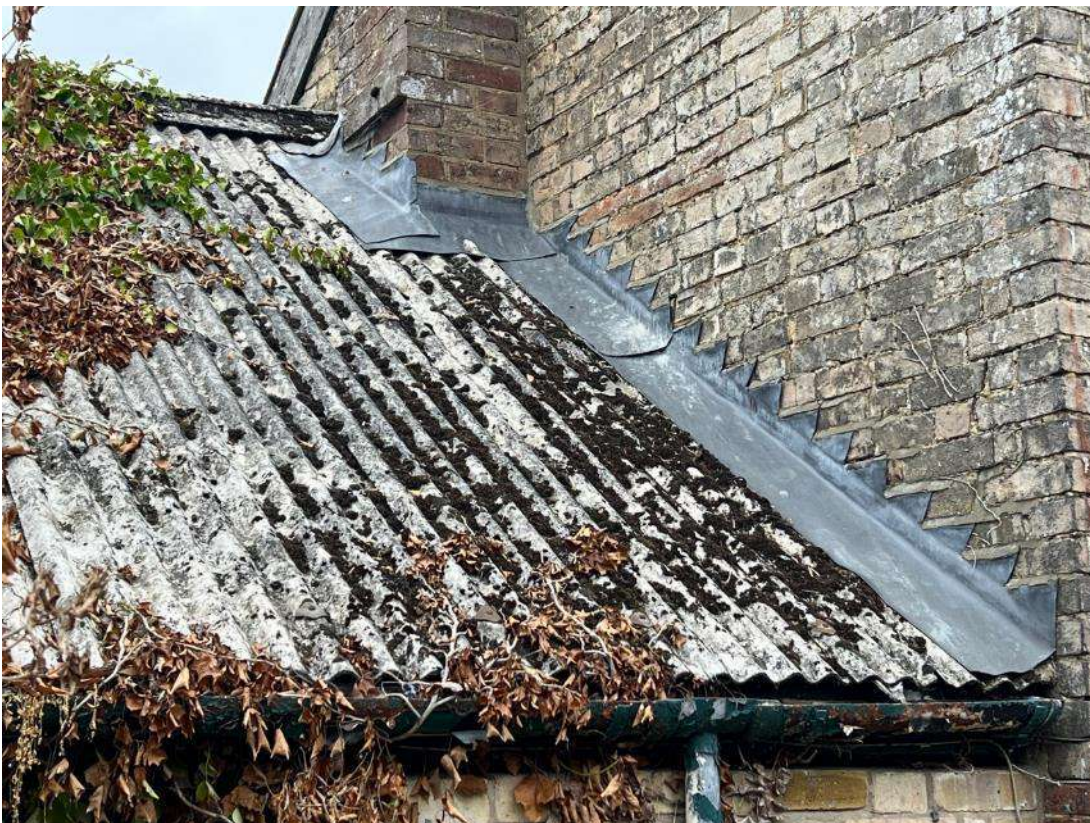
Photo 23. Building 4 (ref B4). Shows gaps between roofing material and brick work. There are also gaps under corrugated ridge.

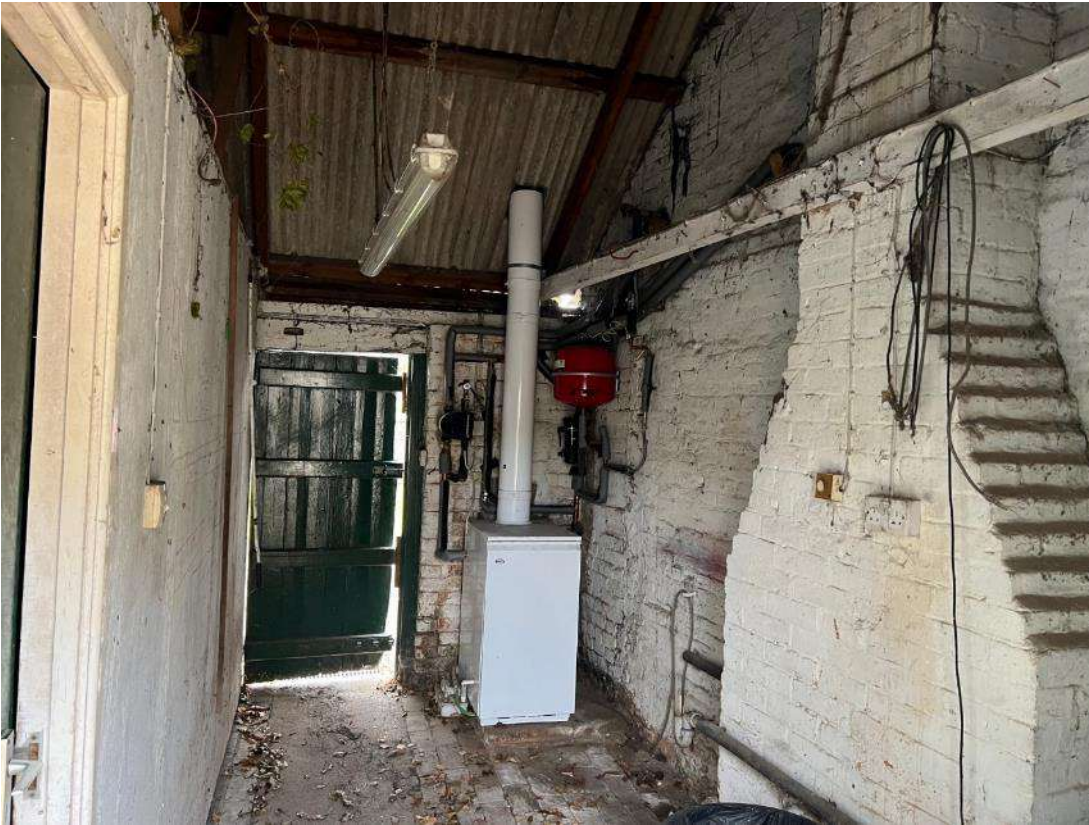
Photo 24. Building 4 (ref B4). Internal view, looking towards western access point. Shows no underlay material.

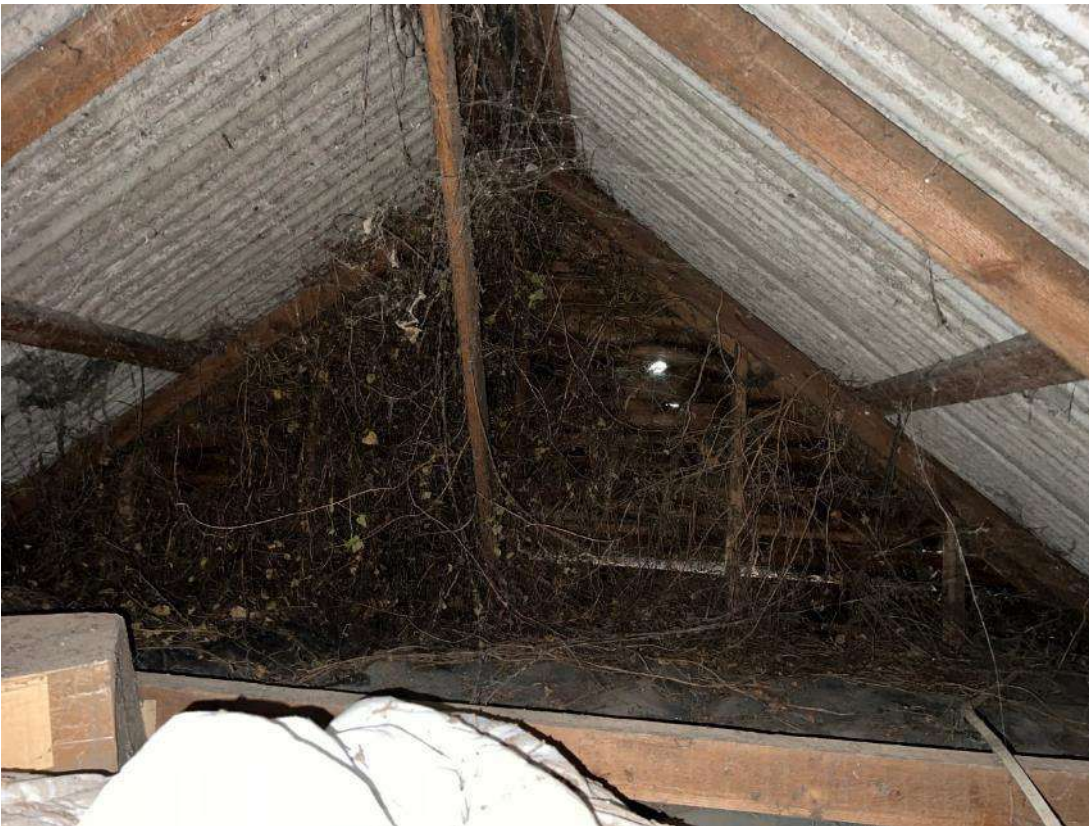
Photo 25. Building 4 (ref B4). Internal view, looking towards southern gable. Shows dense ivy growth within roof space and exposed corrugated sheeted roof.

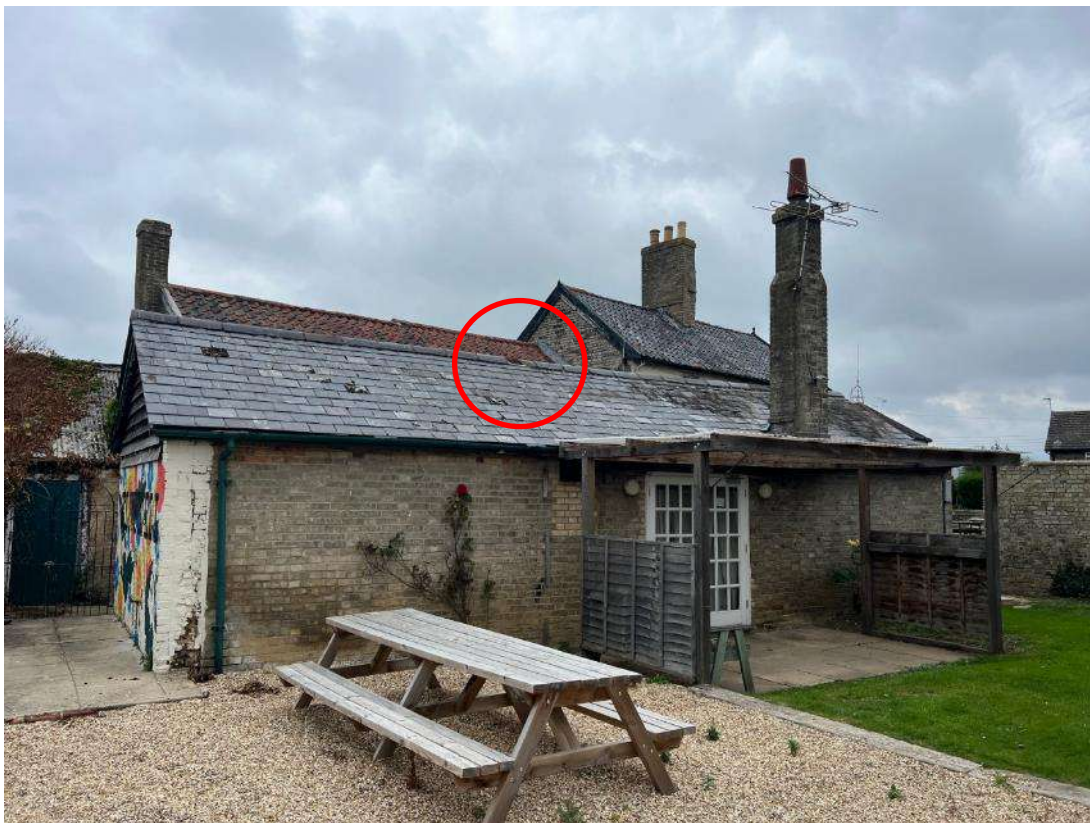
Photo 26. Building 5. Shows eastern aspect of building along with pergola and patio area. Red circle outlines damaged ridge tile.

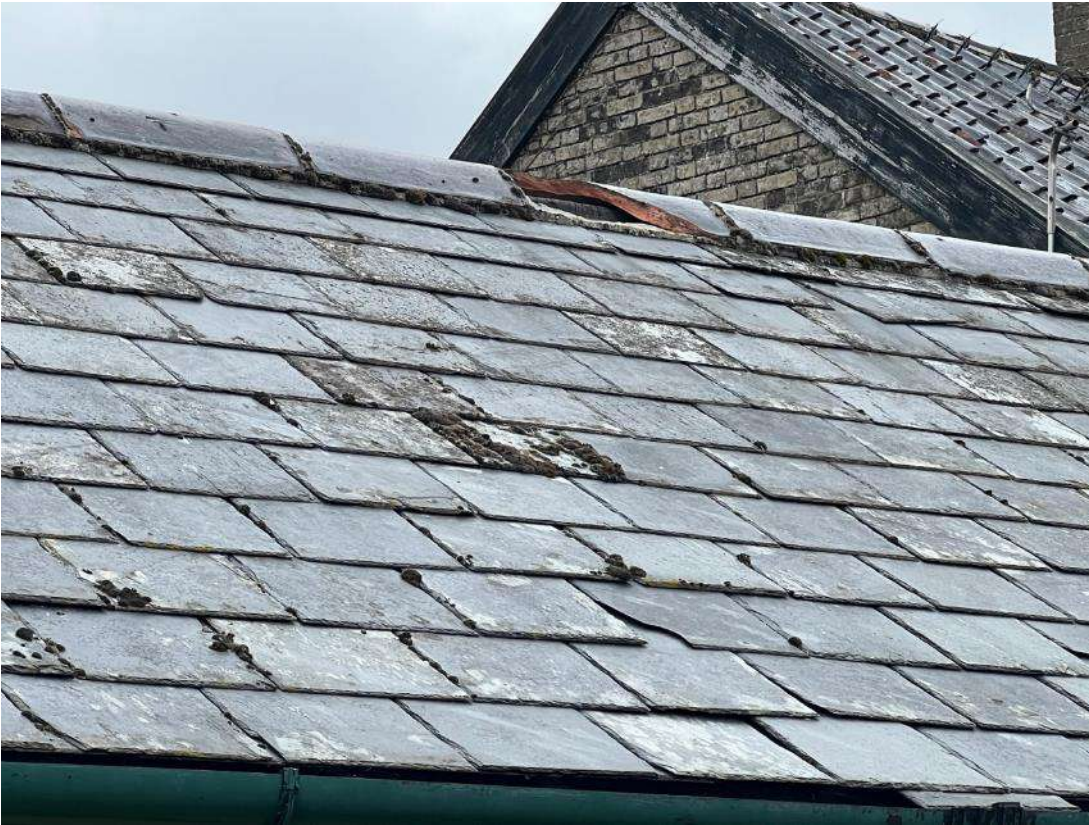
Photo 27. Building 5. Shows close up of damaged ridge tile identified in photo 26.

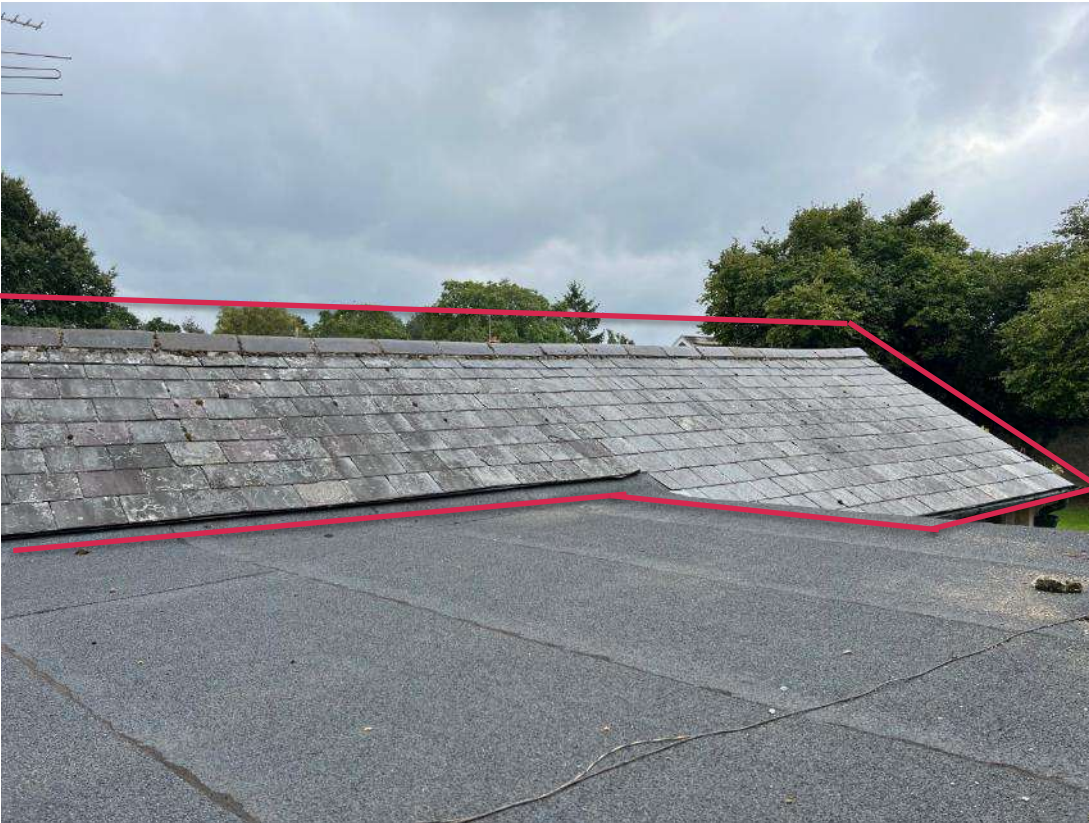
Photo 29. Building 3 and building 5. Shows building 5 slated roof as outlined in red.

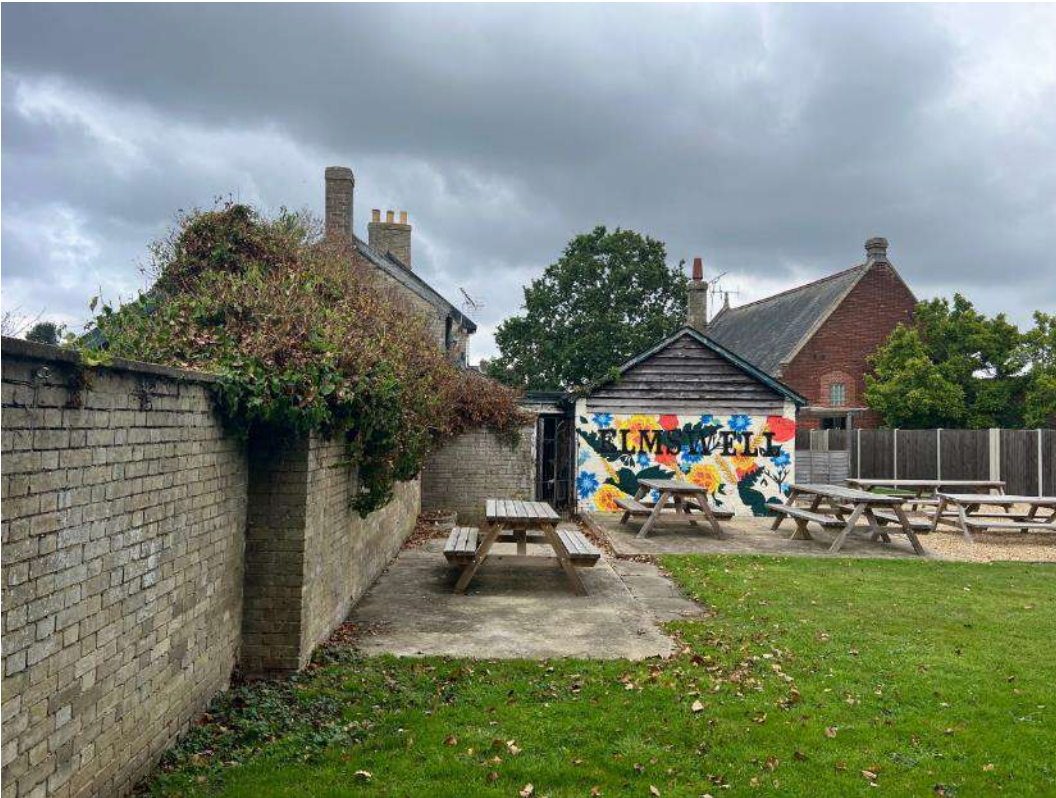
Photo 43. Taken alongside internal brick wall boundary to south of garden. Shows dense ivy growth at rear of building 4 (ref TN2).
