Bat Survey Report

The Cottage, Church Road, Old Newton, Suffolk

November 2022

20206 R1 v2

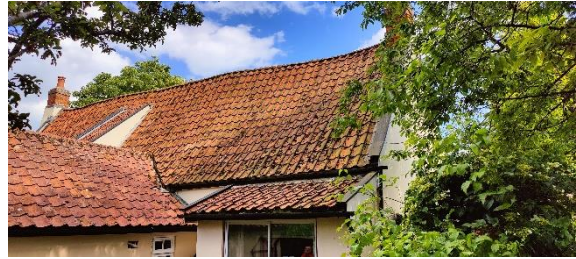
Photo 2 North west elevation (rear) showing single storey extension

- 3.2.4 On the north side of the Cottage, a single storey lean-to extension was present along approx. 755 of the elevation, with a perpendicular single-storey extension extending northwards into the garden. This single storey extension was of relatively recent construction (20th Century) and the roof was in excellent condition with intact mortaring along the ridge tiles and few potential roost features (PRFs).

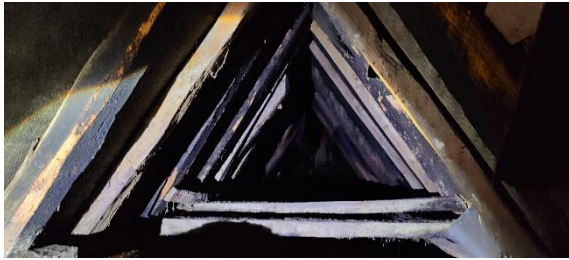
Photo 7 Interior of loft – west end showing fire damaged roof timbers

- 3.2.8 Access to the loft of the Cottage was via a small hatch adjacent to the Chimney stack at the west end of the house. Due to the unstable condition of the timbers and boards, it was not considered safe to enter the roof and thus access was restricted to viewing the roof from the west end of the loft. The loft space was reduced in height to approx. 1m from board to apex, due to the floor boards. The roof timbers were in poor condition with many blackened beams, indicative of the historic fire damage noted in the listed building description above.

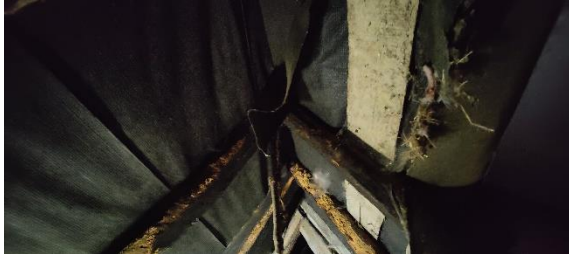
Photo 8 Interior of loft – west end showing felt lining and damaged roof timbers

- 3.2.10 The roof was lined with old bitumen felt that appeared to have been patched in places.
- 3.2.11 It was concluded that bats could potentially access the loft space via loose roof and ridge tiles and at the chimneys at each end, and that although there was a moderate level of cobwebbing there was potential for bats to fly within the loft.

5.3.4 It is recommended that the re-roofing works be undertaken using traditional type 1F bitumen felting to minimise the risk of bat mortality arising from bat becoming entangled within the fibres of Non-Bitumen Coated Roofing Membrane (NBCRM).

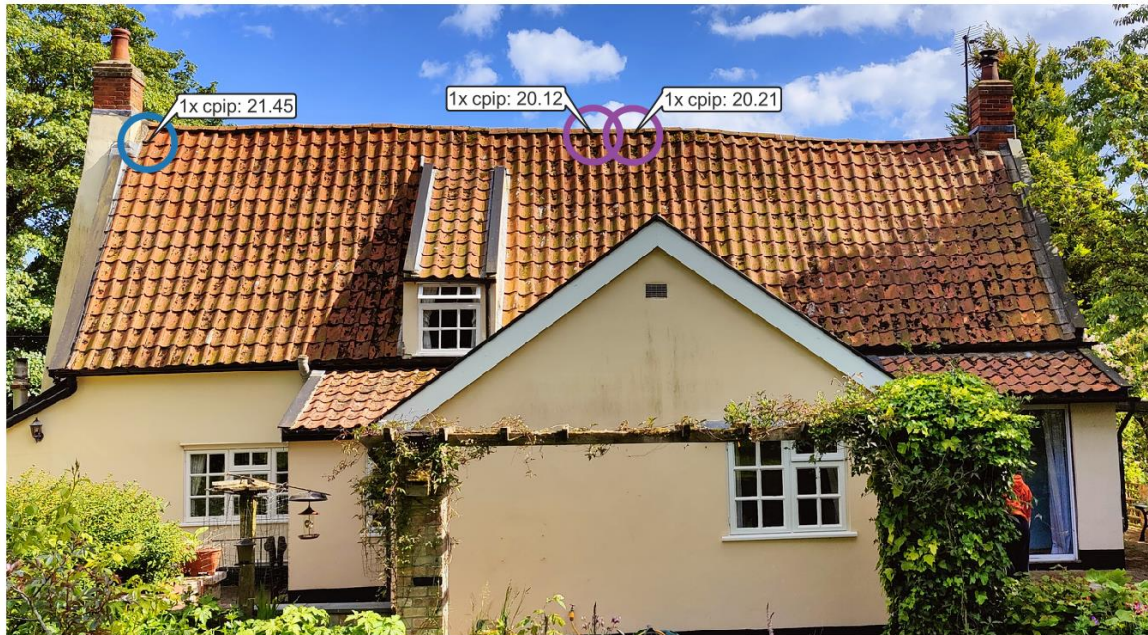
Figure 5 Emergence locations from combined surveys – north elevation. Blue – June 2022 survey; Purple – August 2022 survey. (cpip – Common pipistrelle)

4.2.4 Following a review of the bat calls recorded during the survey and the infrared video coverage from each vantage point, it was confirmed that one Common pipistrelle *Pipistrellus pipistrellus* was observed to emerge at 21.45 from a roof tile adjacent to the east chimney, approx. 2 tiles down from the ridge.

4.2.19 In summary, two Common pipistrelle bats were observed emerging from ridge tiles in the same approximate area of the roof, approx. mid-way along the roof. It is possible that the bats emerged from the same tile or from an area with several loose tiles in close proximity. The two bats were recorded emerging at 20.12 and 20.21, and the first bat was observed immediately foraging close to the building.

4.3.1 In summary, bats were observed emerging from loose roof tiles on two of the three surveys, with all bats emerging from the north elevation. A single Common pipistrelle emerged from a tile adjacent to the east chimney during the June emergence survey, approx. 1 tile down from the ridge. Two Common pipistrelle bats were observed emerging from ridge tiles in the same approximate location mid-way along the roof on the August survey.

- If possible, retention of a loft space within the Cottage, with access provided through appropriate access points and tiles;
- Provision of 3x 'raised ridge' bat access tiles along the ridge, creating potential roosting locations for bats to replace lost cavities;
- Provision of 3x raised pan tiles, creating access points to provide replacement roost spaces under tiles – cavities can be created when installing new tiles by using wedges or battens to raise individual tiles, or via the use of specific tiles designed to create bat access points (see below)
- Provision of 2x no. bat box suitable for use by pipistrelle bats to be erected in trees adjacent to the Cottage;
- No increase in upward pointing artificial lighting around The Cottage, subject to no overriding constraints requiring lighting.
