2.7.4 Southwards from the development site, from Crockford Lane to the Crockford Roundabout on the A33 (for pedestrian facilities), and onwards to cover cycle facilities from the Crockford roundabout, alongside the A33 and on Norn Hill, Basing View and Alencon Link

#### 2.8. Walking, cycling and horse-riding survey data (Large schemes only)

## 3. User Opportunities

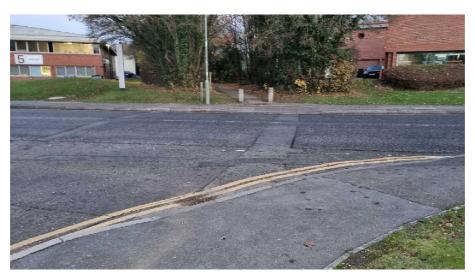
Photo 14: Looking east towards crossing point on Lime Tree Way

Provide tactile paving at the dropped kerb pedestrian crossing points on both Crockford Lane and Lime Tree Way, that are located at the western and eastern ends of the off-carriageway path located to the south of Redwood 3. In addition, the off-carriageway path could be improved with lighting and a bound surface. If feasible, the path could be widened to create a shared footway / cycleway.

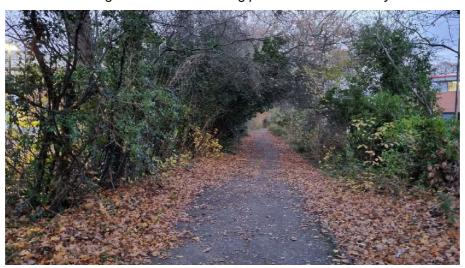
Photo 15: Looking west on paved off-carriageway path towards Lime Tree Way

Improve the lighting on the off-carriageway path on the eastern side of Lime Tree Way. If feasible, the path could be widened to create a shared footway / cycleway, continued through the bridge to provide a cycle link with Hanmore Road.

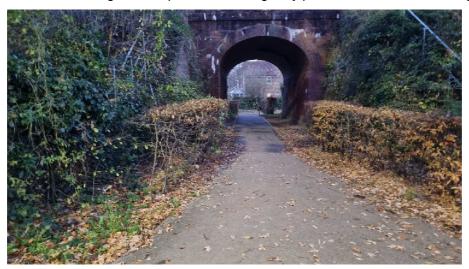
Photo 16: Looking east towards bridge passing beneath railway

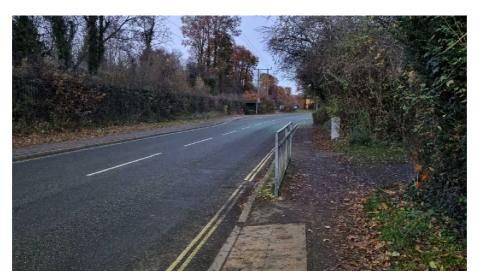
Photo 17: Looking south on Hanmore Rd towards eastern bridge egress and crossing point

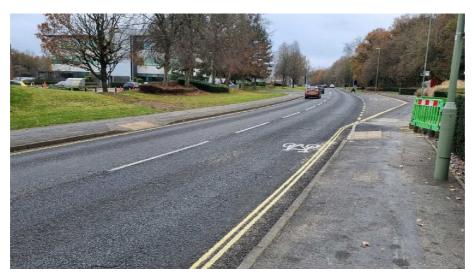
As described in section 2.7.2, Crockford Lane is a lit two-way single carriageway road subject to a 30mph speed limit and has an approximate width of 7 metres. South of the site it has 2-metre-wide footways on both sides and no cycle facilities. The Lindenwood roundabout and Lime Tree Way roundabout both have pedestrian dropped kerb crossing points with tactile paving throughout, and south of the Lime Tree Way roundabout, Crockford Lane has advisory cycle symbol markings and signage (see photo 18) extending to Chineham Gate at the southern end of Chineham Business Park.

Photo 18: Crockford Lane looking south, advisory cycle symbol markings

If feasible, it would be preferable to provide off carriageway cycle facilities along the full length of Crockford Lane. Where this is not feasible, traffic calming measures should be introduced to reduce traffic speeds, with advisory cycle marking / signage in the carriageway.

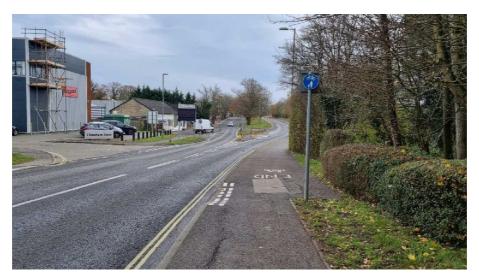
Approximately 200 metres south of Chineham Gate, Crockford Road becomes a dual carriageway over a distance of 300 metres as it approaches the signalised Crockford roundabout on the A33. On the western side of this dual carriageway there is a 3-metre-wide shared footway / cycleway (see photo 19); on the eastern side the 2-metre-wide footway continues southwards and becomes a 2-metre-wide shared footway / cycleway with a dropped kerb located north of the Audi garage to allow cyclists to join from the southbound side of the dual carriageway (see photo 20).

Photo 19: Crockford Lane looking south towards dual carriageway section and shared cycleway / footway

Improved signage and a crossing point for cyclists should be provided at the northern end of the 3 metre wide shared footway / cycleway on Crockford Lane, to provide an alternative route for southbound cyclists (avoiding the 2 metre wide footway / cycleway further south on the eastern side of the road).

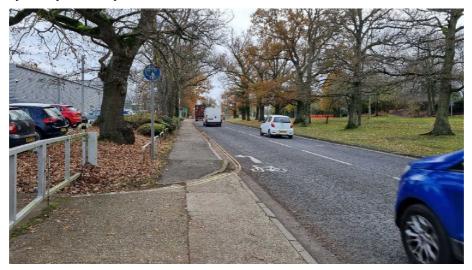
Photo 20: Crockford Lane looking south, Shared footway / cycleway on eastern side

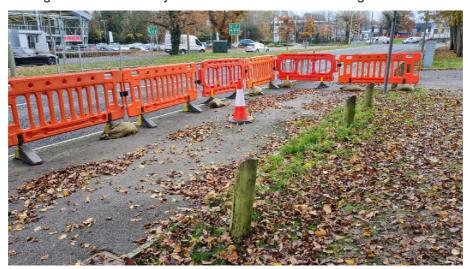
It was noted during the site visit that (i) a short section of the western shared footway / cycleway was closed with no diversion provided. It is not clear whether this is a short-term temporary arrangement; however, the closure appeared to be related to an uneven surface which may have been in this condition for some time (see photo 21); and (ii) the vehicle access serving the Audi garage on the eastern side of Crockford Lane has tactile paving on one side only, and that tactile paving is angled towards the southbound carriageway, forming a hazard for mobility impaired pedestrians (see photo 22).

Photo 21: Temporary closure of Crockford Lane western footway / cycleway

Repair the damaged section of the western shared footway / cycleway (which is currently closed) on the eastern side of Crockford Lane.

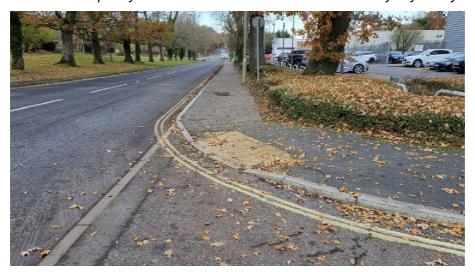
Photo 22: Crockford Lane looking north, mis-aligned tactile paving

Rectify the misaligned / sub-standard tactile paving provision at the vehicle access serving the Audi garage on the eastern side of Crockford Lane.

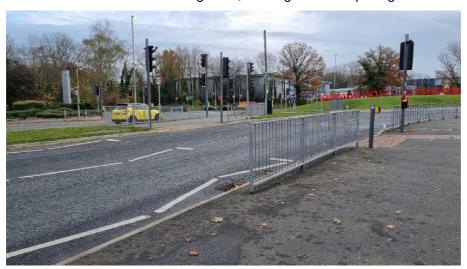
The Crockford Lane arm of the Crockford roundabout is signal controlled and includes 4-metre-wide pedestrian / cycle crossing facilities (see photo 23). From this point there are

Photo 23: Signalised crossing facilities at southern end of Crockford Lane Page 23 of 38

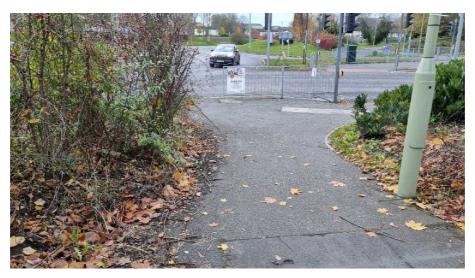
Pedestrians and cyclists can access Carpenters Down from the southern end of Crockford Lane via a 3-metre-wide shared footway / cycleway. This link reduces to 2 metres for a length of 20 metres, then widens to 3 metres as a shared facility on the northern side of Carpenters Down, with a crossing point providing access to a 3-metre-wide shared footway / cycleway on the southern side of the road.

Photo 24: East of Crockford Lane, looking west towards pinch point

Widen the pinch point link between Crockford Lane and Carpenters Down.

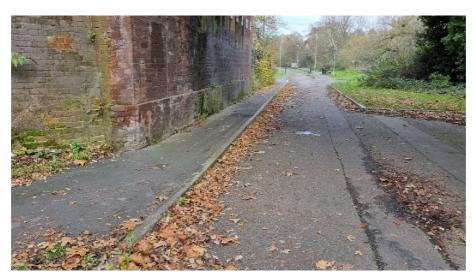
Pedestrians and cyclists can access Hanmore Road / Reading Road from the southern end of Crockford Lane via a shared footway / cycleway which is formed from a disused section of road passing beneath the railway line. This section is accessed from Crockford Lane via a 2metre-wide pinch point (see photo 24), which then widens out to onto the disused road (see photo 25). On the eastern side of the bridge the route splits into two paths, both 2 metres in width; one veers towards the north for a distance of approximately 30 metres where there is a dropped kerb crossing point on Hanmore Road with tactile paving, providing access to the pedestrian footway on the opposite side. The other path continues eastwards, following the alignment of the disused carriageway for a distance of approximately 40 metres, leading onto Reading Road. There is a barrier across the disused road at this point (see photo 26) forcing pedestrians and cyclists to use the two-metre-wide footway / cycleway, which itself ends after a short distance on Reading Road, requiring pedestrians to cross Reading Road. There is a dropped kerb at the end of this path with a vehicle crossover located on the opposite side of Reading Road; this crossing point does not have tactile paving. There are no cycle facilities on Hanmore Road or Reading Road, therefore cyclists are required to continue their journey on carriageway.

Photo 25: Route on disused road beneath railway line

Widen the link between Crockford Lane and the disused section of road passing beneath the railway line.

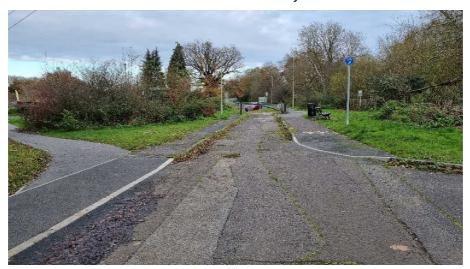
Photo 26: Eastern end of route on disused road, looking east

Widen the two paths on the eastern side of the bridge (leading to Hanmore Road and Reading Road respectively). Improve the pedestrian crossing arrangement on Reading Road.

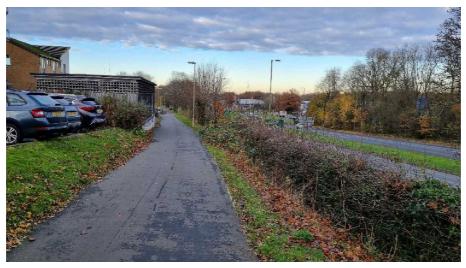
route is well separated from the carriageway and this section of the route has its own off carriageway lighting (see photo 28).

Photo 28: Looking north adjacent to A33 dual carriageway

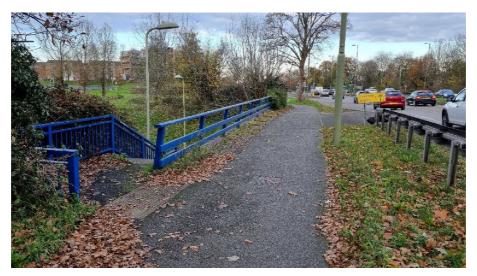
The shared route continues to the south of the Popley Road junction, along the western side of the lit A33 dual carriageway. On this section the footway / cycleway has a width of 2.2 metres and is separated from the A33 northbound carriageway by a grass verge buffer approximately 2 metres wide. The route passes over a pedestrian / cycle underpass, where there is a 1-metre-high parapet (see photo 29).

Photo 29: Looking north toward parapet adjacent to A33

Provide an improved parapet (replacing the 1-metre-high parapet) where the route passes over a pedestrian / cycle underpass on the A33.

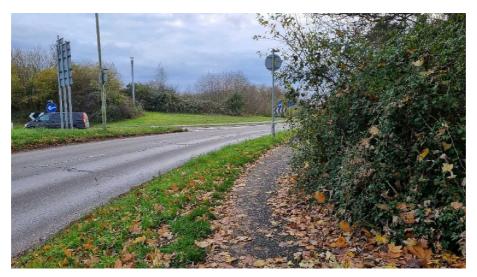
As the route approaches the A33 / A339 signalised roundabout junction, there is vegetation growth reducing the effective width of the route down to around 1 metre wide (see photo 30).

Photo 30: Looking north towards A33 / A339 roundabout

Trim back the vegetation growth on the path near to the A33 / A339 roundabout junction.
