Change of use of Detached outbuilding at Hallgarth Manor House

Our Ref: 373-23

Date: 14th December 2023

Re: Outbuilding conversion at Hallgarth Manor House

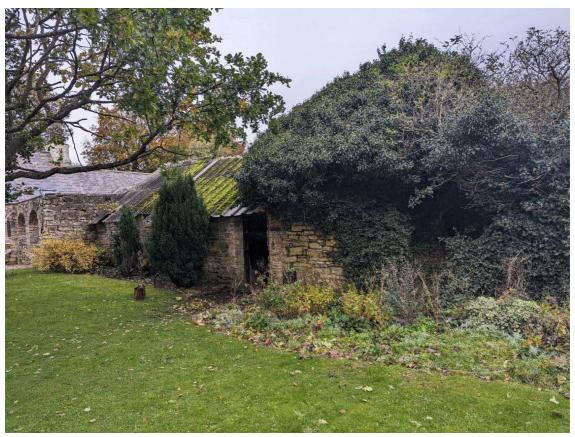
Figure 1 –Front Elevation

The property is a single storey with a pitched roof and is currently being used as a garden store. The roof is constructed in timber consisting of A-frame trusses supporting purlins and rafters over. The roof is covered in corrugated sheeting. The walls were constructed in solid stonework construction with areas of brickwork noted towards the peak of the gables. The ground floor slab was constructed in concrete and was ground bearing.

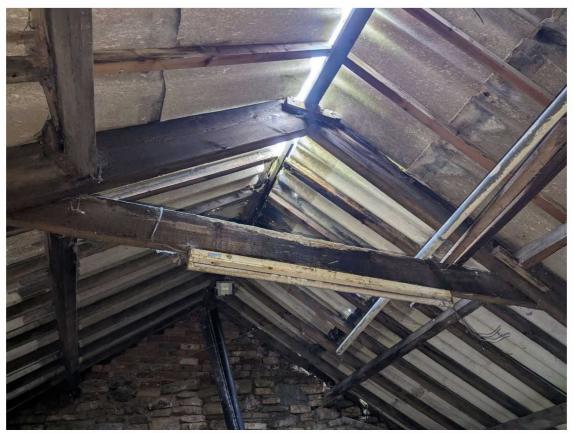
Figure 3 – Existing roof structure

The roofing sheets were in poor condition with voids in a number of locations. The roofing sheet construction material will require testing to confirm that no hazardous materials such as asbestos are present prior to completion of any works. There were areas of deteriorated timber to the roof trusses noted.

The roof structure will require replacement to accommodate existing defects and insulation requirements to suit change of use.

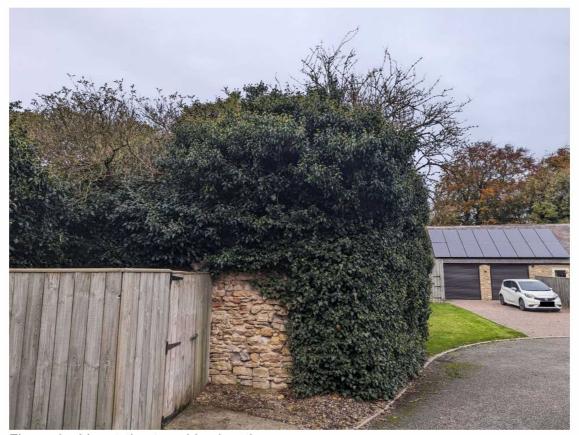
Figure 4 – Vegetation to gable elevation

The masonry was in good condition with no significant cracking noted. There were large areas of vegetation present to the side elevation which prevented inspection of masonry behind. The vegetation will require removal and masonry inspected to these locations, there were no cracks found internally suggesting defects caused by the vegetation.
