## HERITAGE STATEMENT

Retrospective repair works to the inn sign and details of its proposed refixing to the post.

**Inn Sign in front of White Horse Inn,  
Tattingstone IP9 2NU**

December 2023

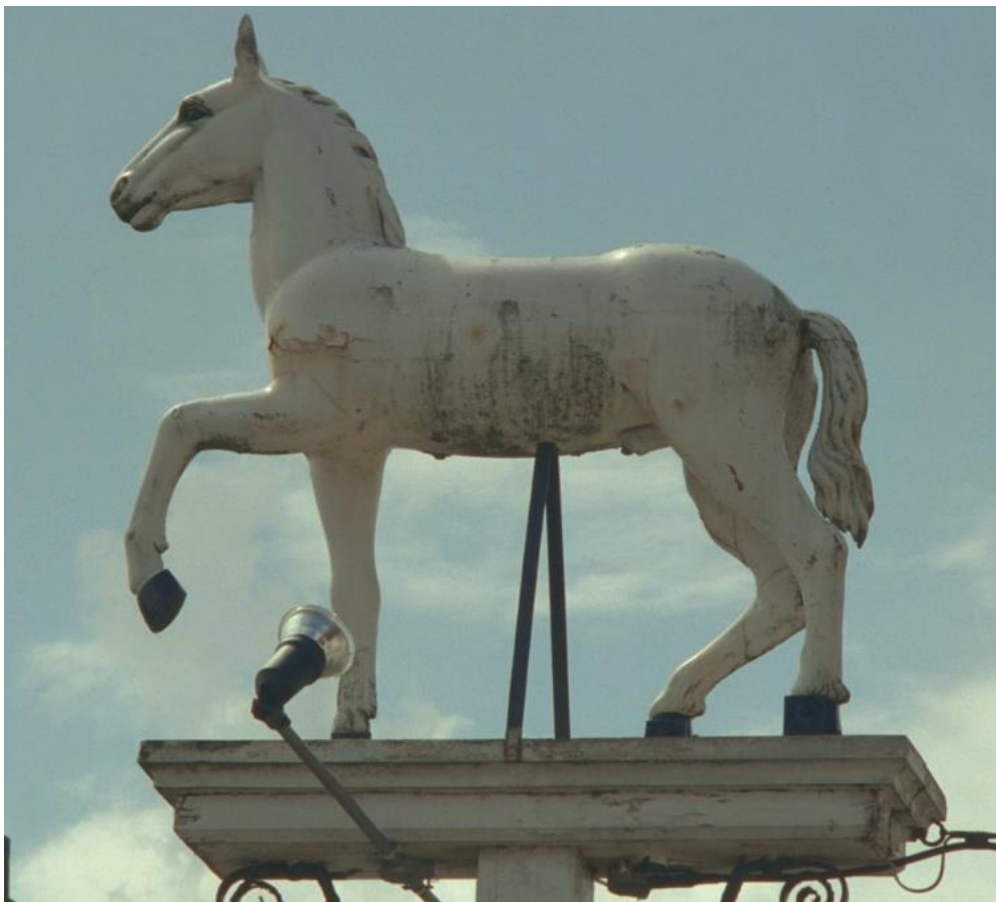
*Images of England photo (1999) Historic England Archive showing the horse at the top of the post (IOE01/00221/19)*

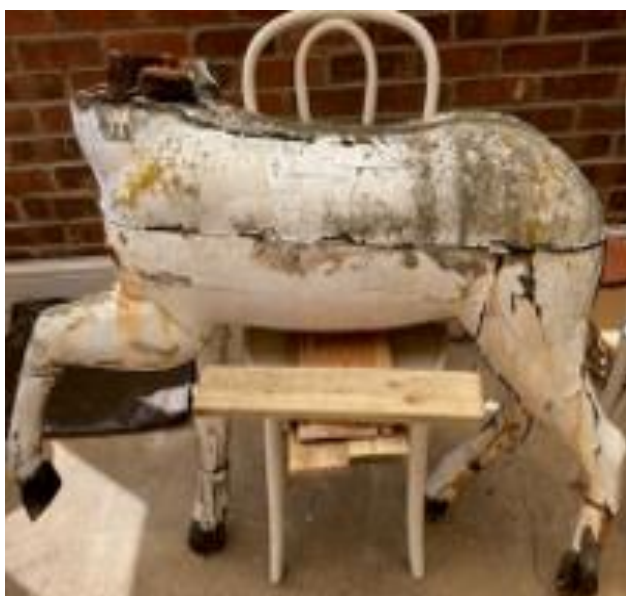
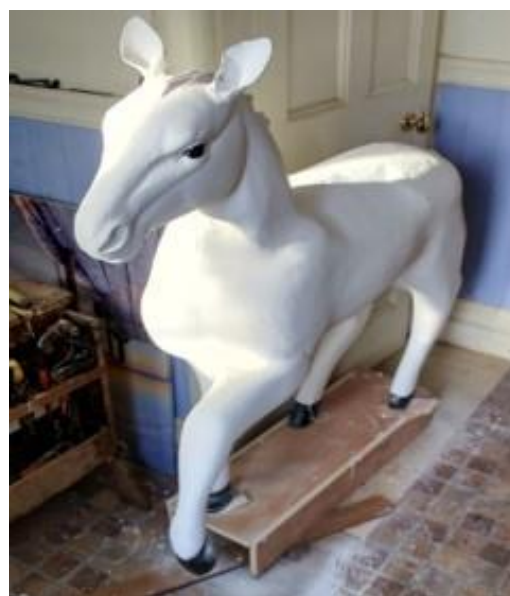
6.3 The restoration of the horse has been undertaken by a carpenter who has confirmed the horse is made of pinewood. In the process of removing the horse, the head became detached, the photo below illustrates the condition of the horse once removed.

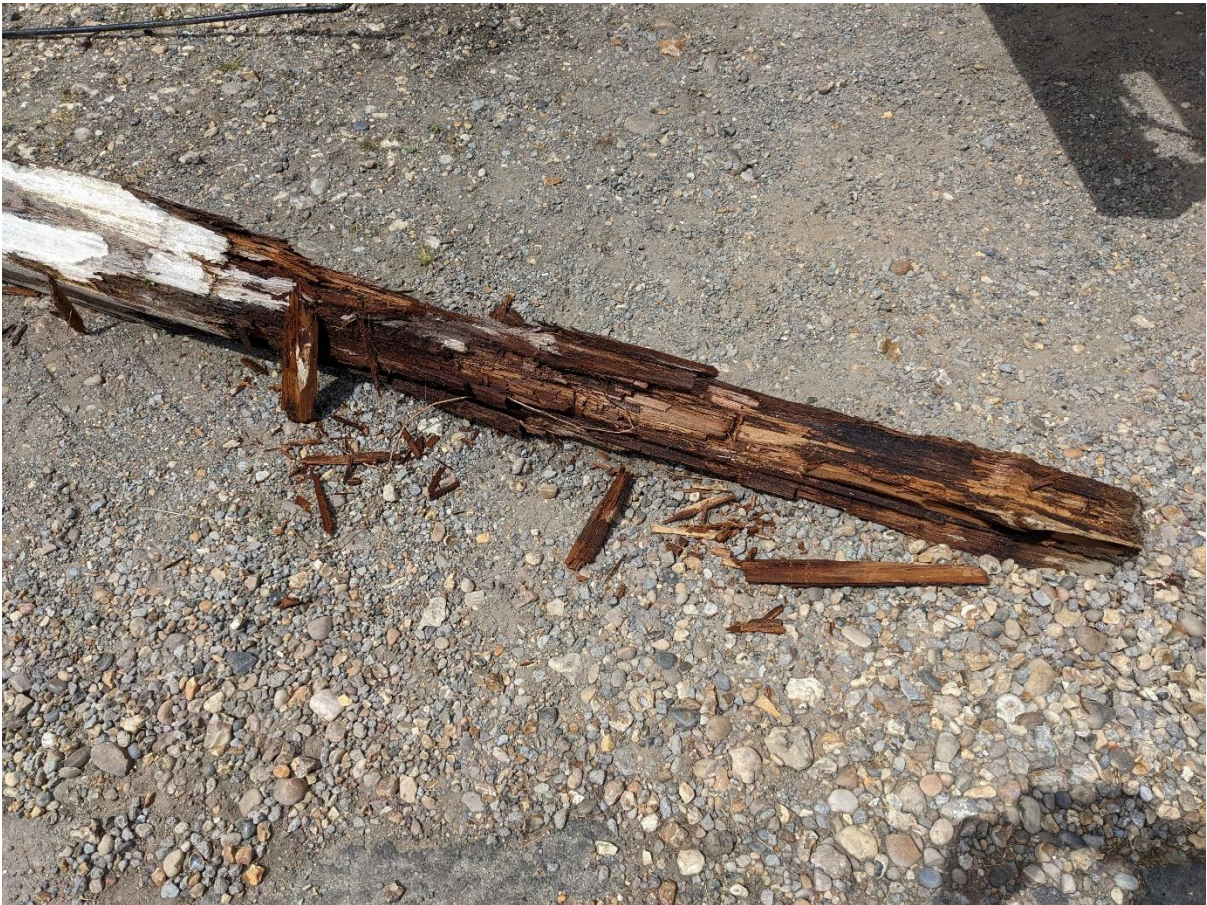
*Photo 1* Base of the post showing rot – the post is to be replaced

7.2 The works are justified based on the timber of the post and head of the horse showing signs of advanced decay. The horse has been taken down for health and safety reasons and to facilitate its repair. The horse has needed to be taken to a workshop where the materials have been matched and a skilled repair undertaken to reuse as much of the original fabric as possible and seamlessly reunite the head to the body. This could not be actioned in situ.

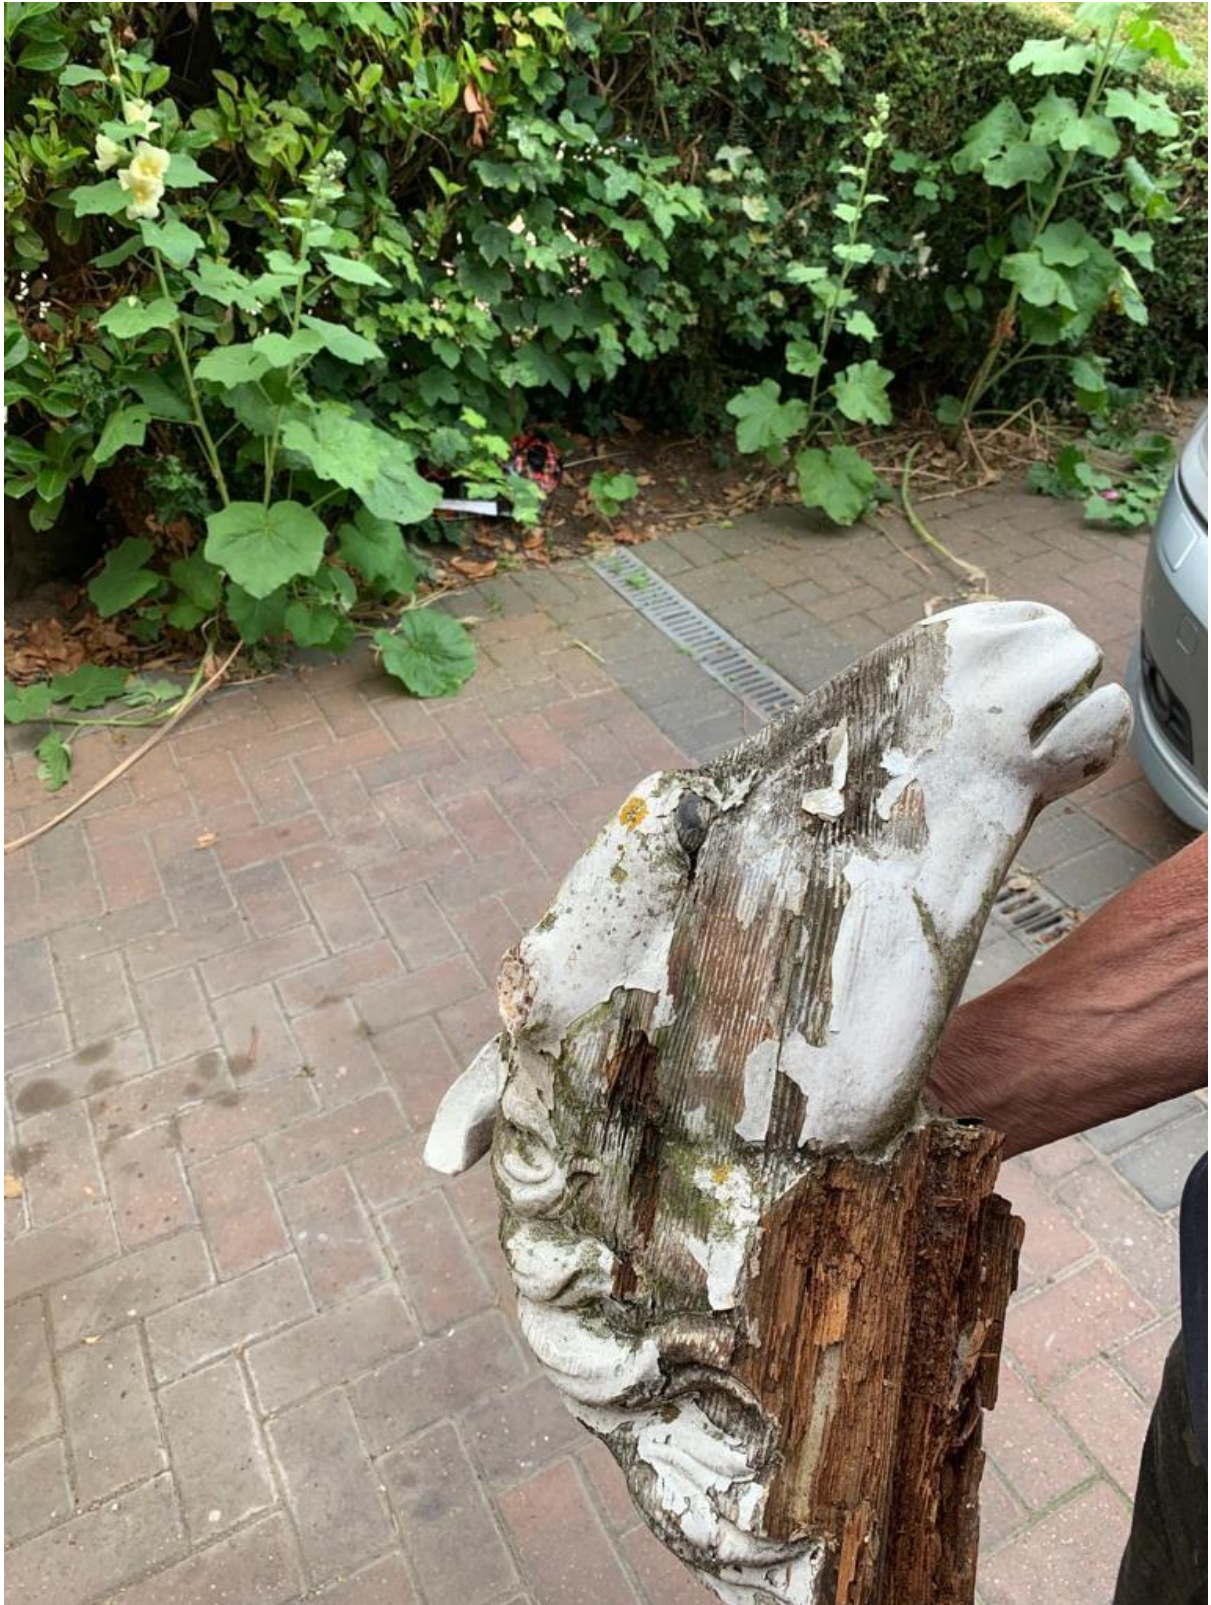
*Photo 2* Condition of the head after removal of the horse

6.4 The horse has been repaired using old, salvaged 200-year-old pine to seek to match the wood of the original horse. As much of the original horse has been reused as possible as part of the repairs including the head. It is stressed this is not a replacement horse but the original horse which has been repaired. The entire horse has been repainted white with black hooves so the repairs are not visible.

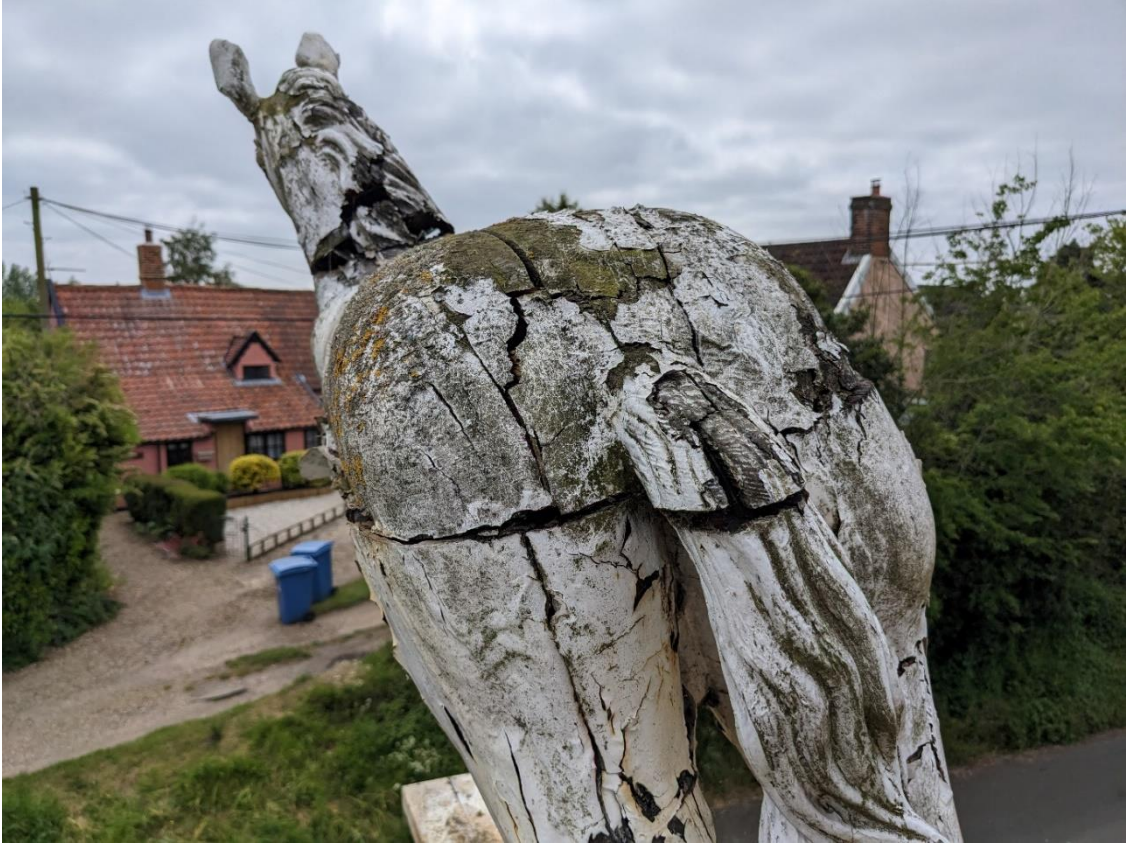
*Photo 3* Horse at time of removal – it is at an angle following a storm

7.5 The works became urgent after damage to the sign by a storm earlier this year and the post carrying the horse began to list and the safety of the sign became an issue.

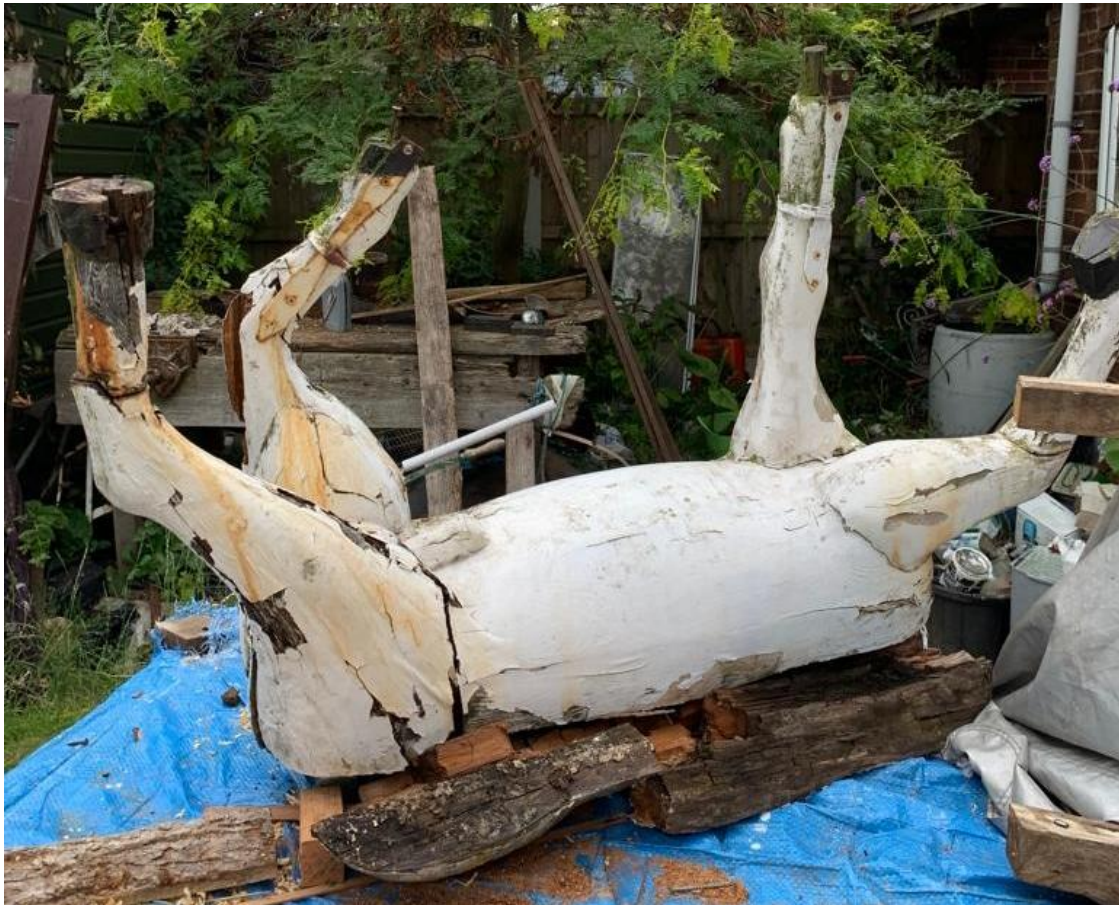
*Photo 4* The torso was retained and repaired

7.4 The works have sought to retain as much of the horse as possible, including the head. Where the timber was too rotten the repairs have been undertaken using timber that has been matched so that it is both pine and of a similar age to the original horse. The paint finish ensures that the repair work is not visible and the whole horse is refurbished.

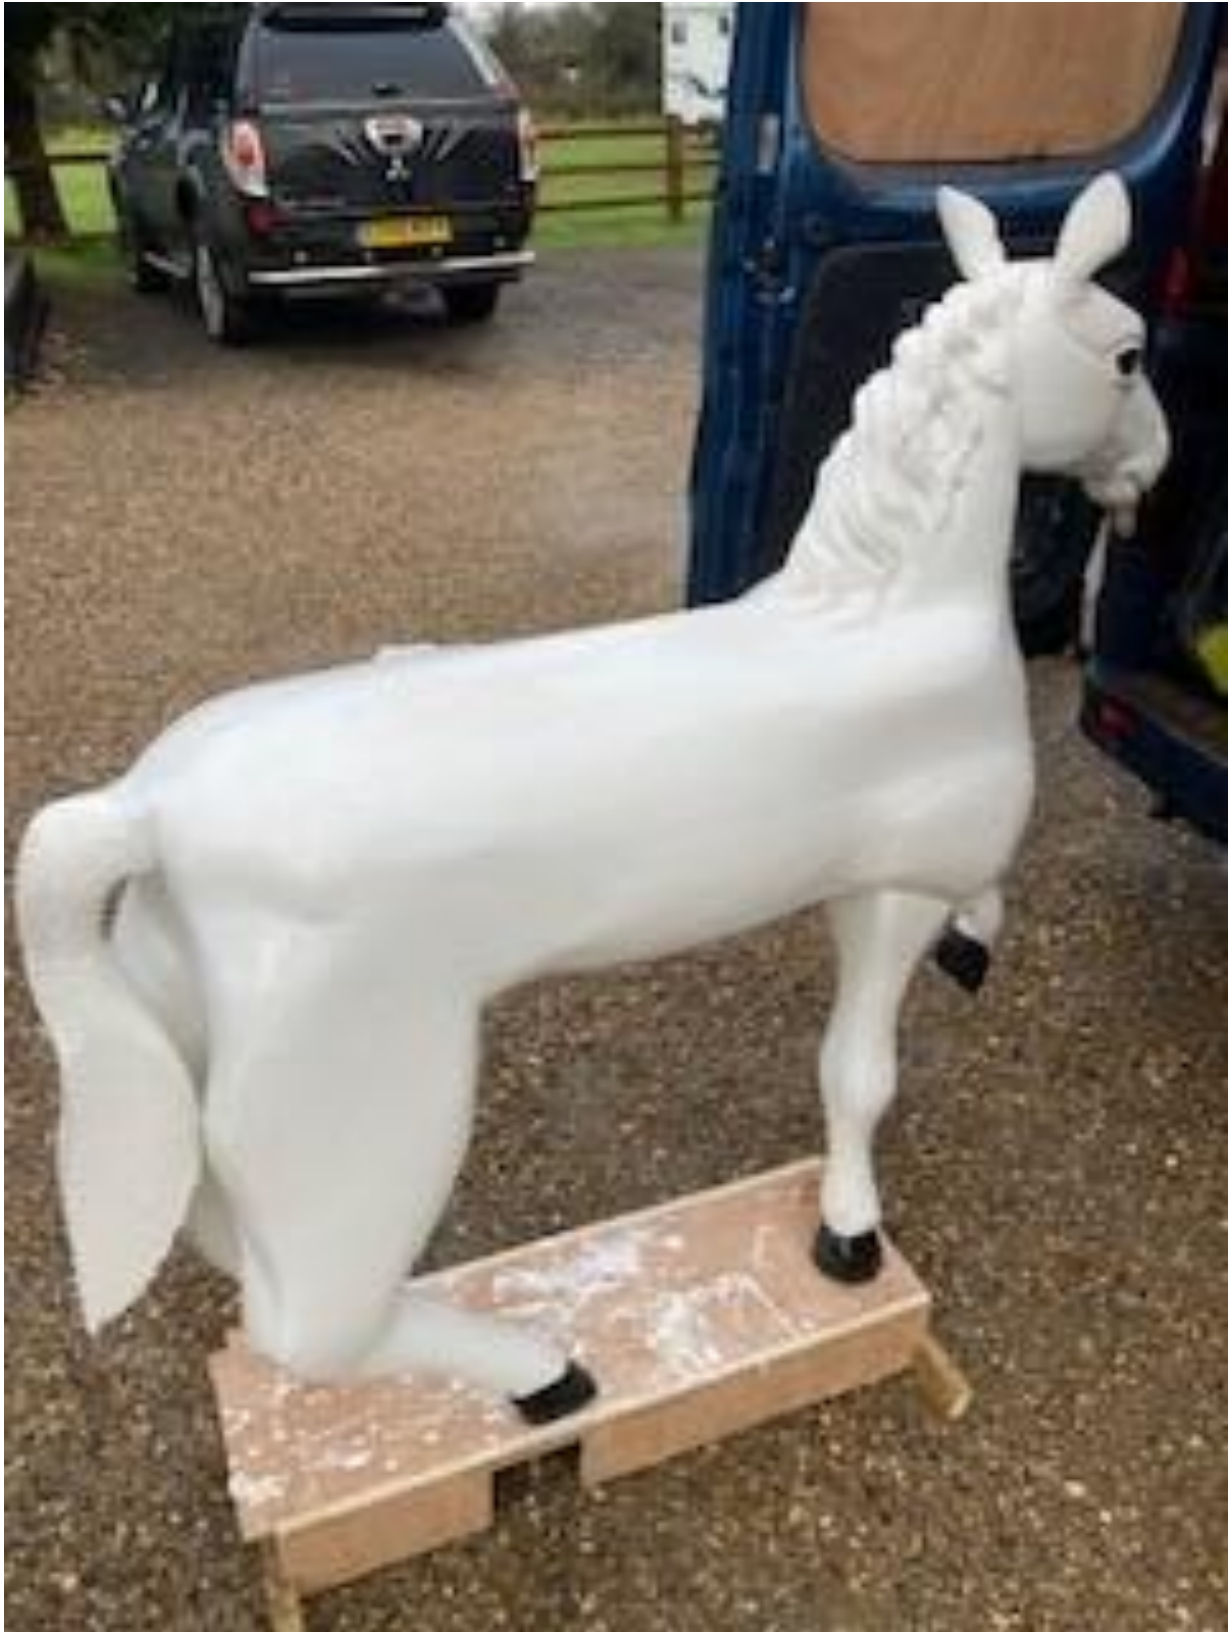
Photo 5 Restored horse

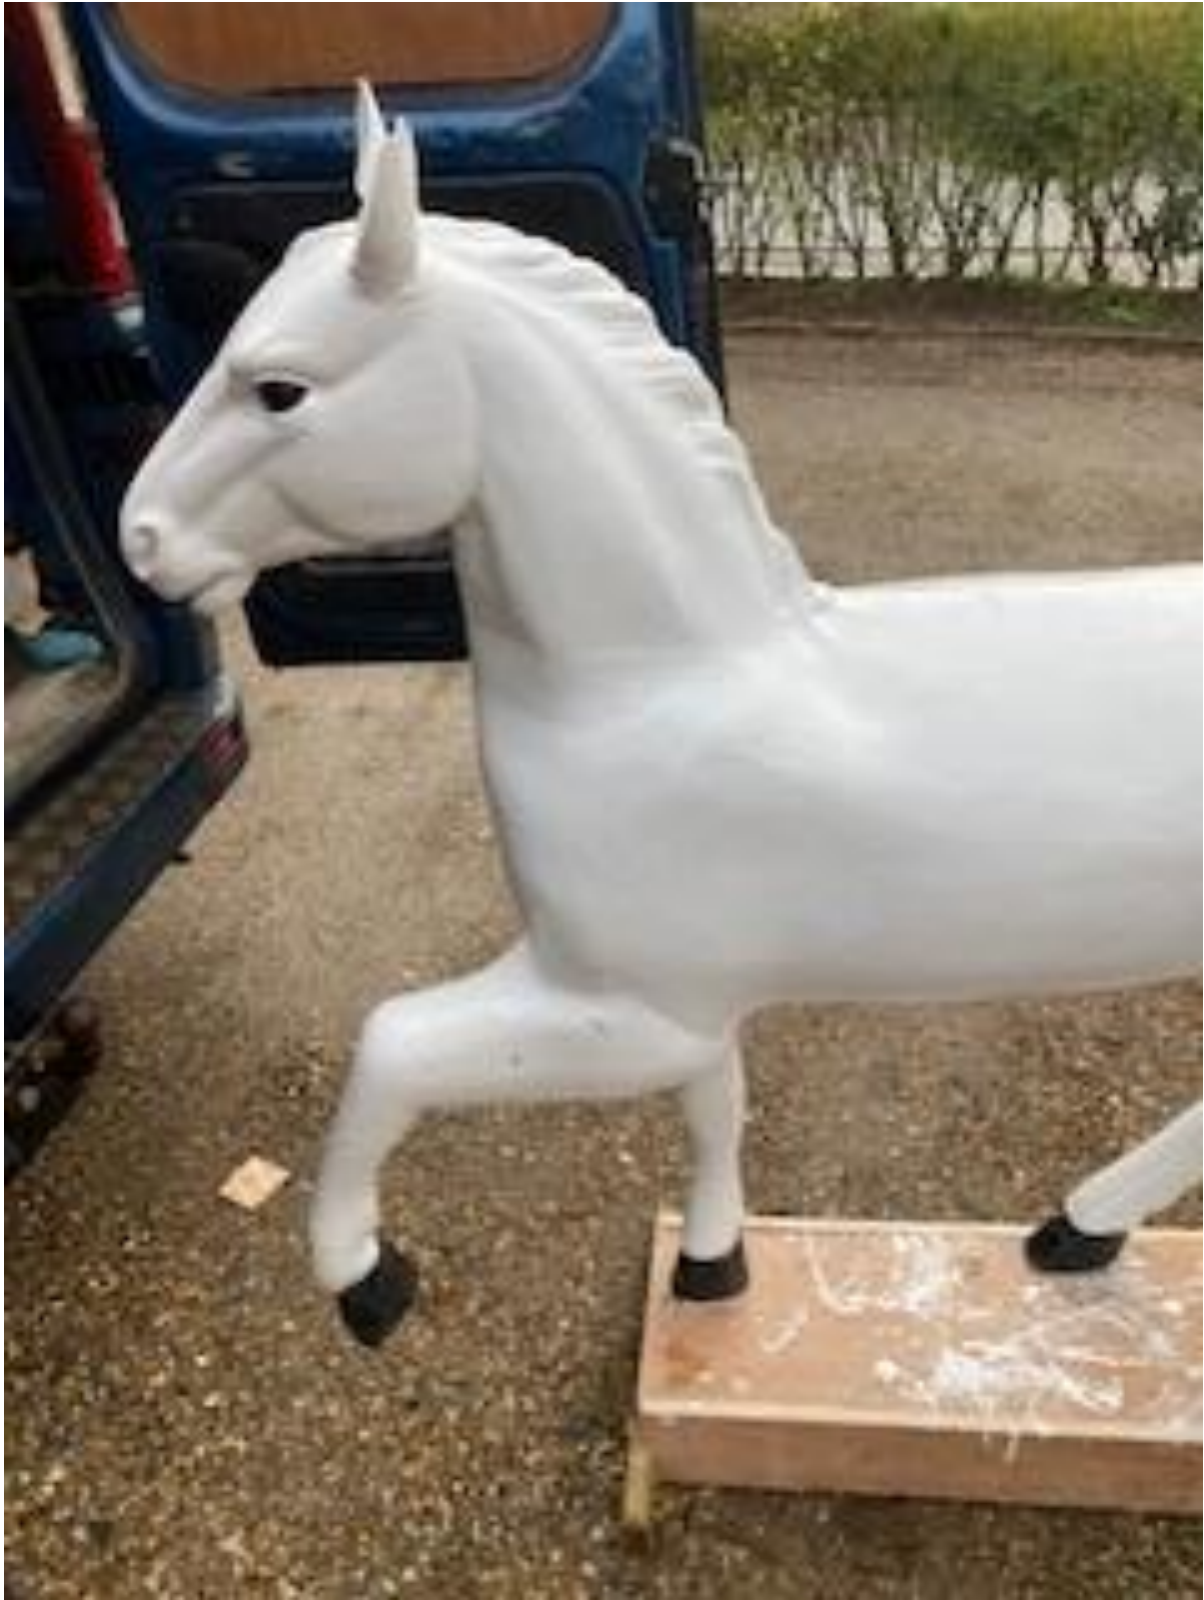
*Photo 6* Head of restored horse

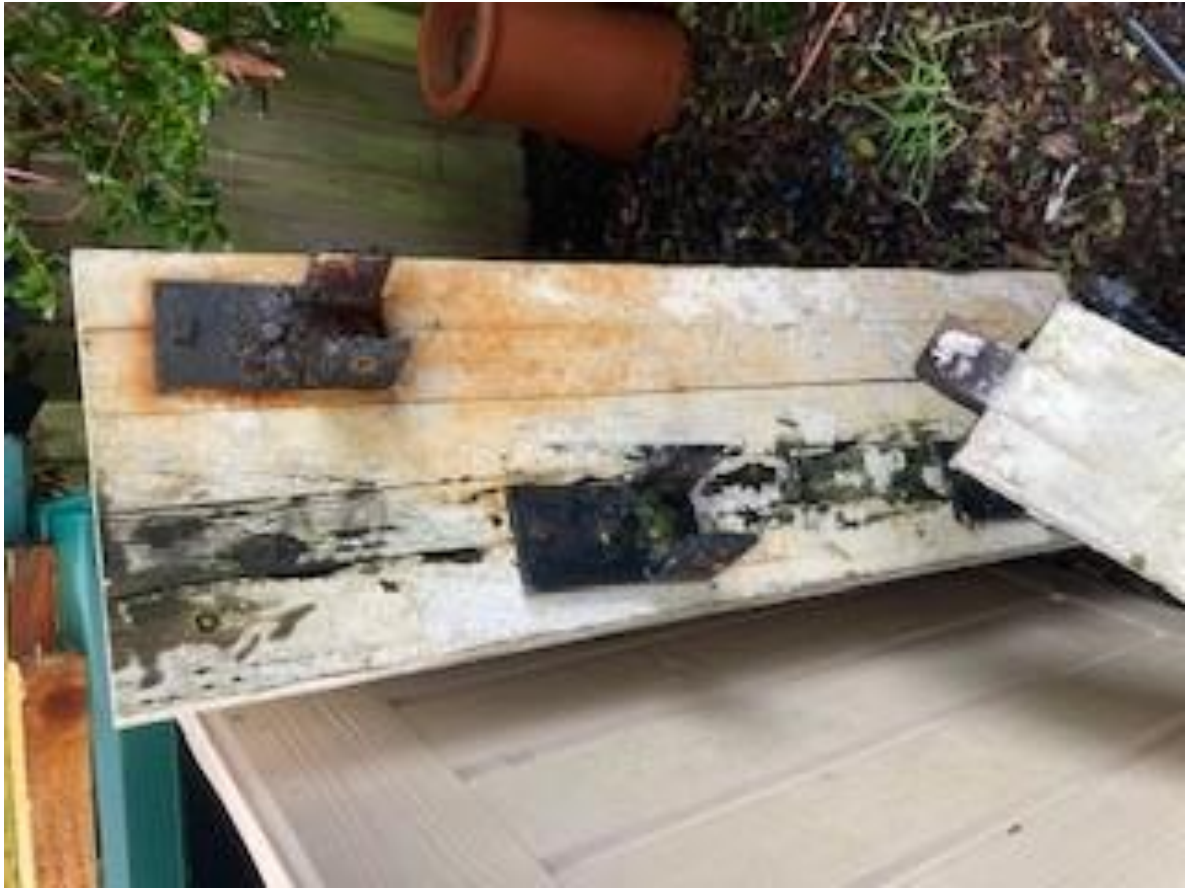
*Photo 7 Plinth which has been retained and is yet to be repaired with stainless fittings proposed*

6.5 Stainless steel bolts are to be used to restore the horse onto the repaired original tiered base and square profile post, like the original.

7.6 The horse will be reinstated on a square post on a stand which follow the form of the original sign. One key difference is the use of stainless-steel fixings rather than iron to avoid any damage from rust and provide a robust means of fixing with a long life (See photo 7 Appendix 2).
