**17 Pownall Avenue, Bramhall**

**Bat Assessment**

August 2022

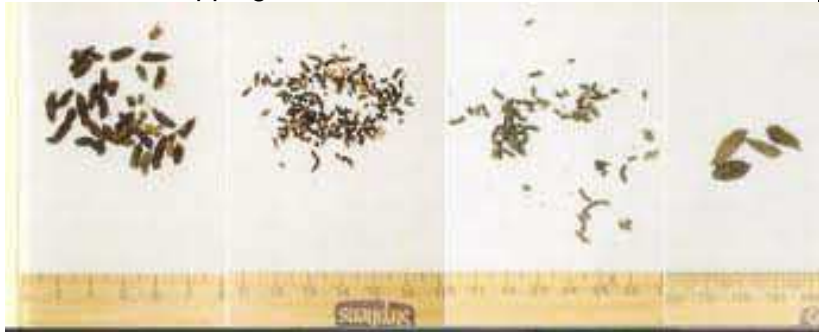
<b>5. Evidence of bats</b>	<p>The evidence of bats which is most likely to be discovered during the course of any building works is that of droppings. The droppings are small, approximately 5 – 10mm long (refer to Plate 1 below) and crumble into a fine powder when crushed unlike mouse droppings which cannot be crumbled.</p> <p>Plate 1 Bat droppings</p>

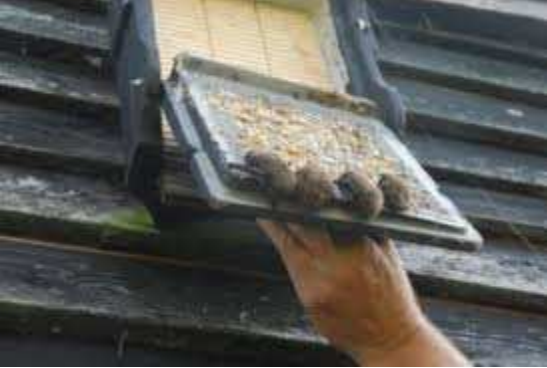
Action	Method
	<p>Plate 2 Pipistrelle bats</p>

<p>If bats are discovered during the course of the works, it is likely that they will appear to be huddled behind or within a crevice rather than hanging from the rafters as many people believe. The most likely species to be identified at this property is the Pipistrelle spp. bat as pictured in Plate 2 below. They are tiny bats which are no bigger than an adult's thumb and may appear cold and lifeless if they are in torpor and may take up to half an hour to wake if disturbed.</p>

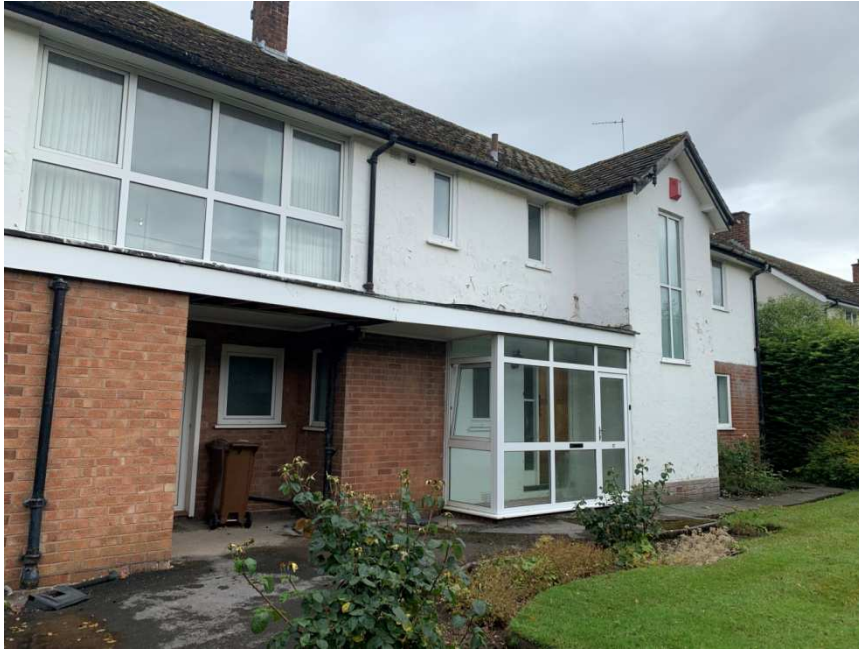
Plate 1

- 4.3 The house is a modern, double height detached property with a pitched roof which faces north-south (refer to Appendix B, Plate 1). The roof is in good condition with no raised or slipped tiles (Plate 2). Similarly, the ridge tiles, and the mortar between and beneath the ridge, are in good condition. The lead flashing surrounding the chimney lies flush to the chimney and the roof tiles beneath (Plate 3). The end tiles and the mortar beneath at each of the gables of the house are intact and no gaps have developed (Plate 4). The timber box soffits are intact with no potential access or egress points (Plate 5).

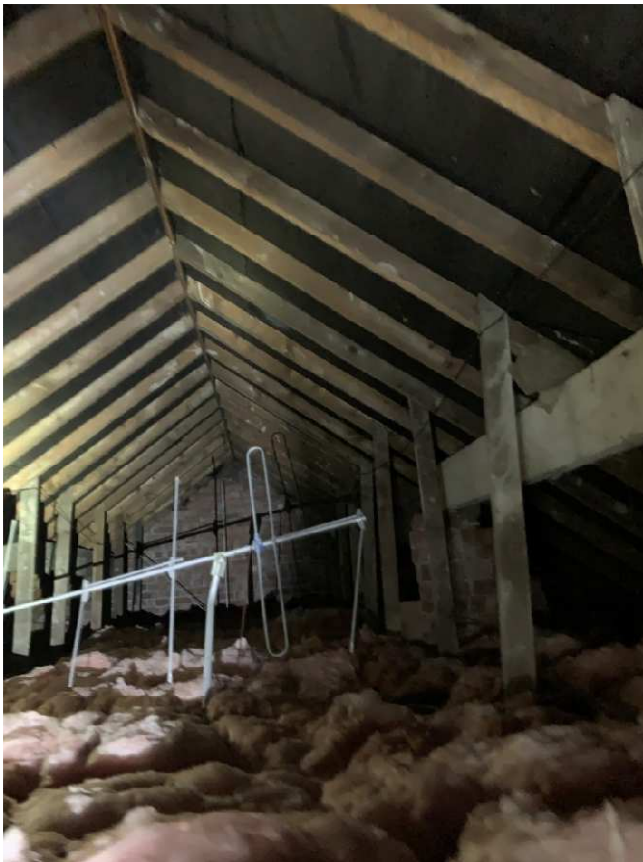
Plate 6

- 4.6 The internal inspection revealed that the roof void is currently not used for storage as the property is uninhabited (Plate 6). The underside of the roof is lined with 1F felt. The felt is intact and does not provide any access for bats from the exterior of the roof (Plate 7).

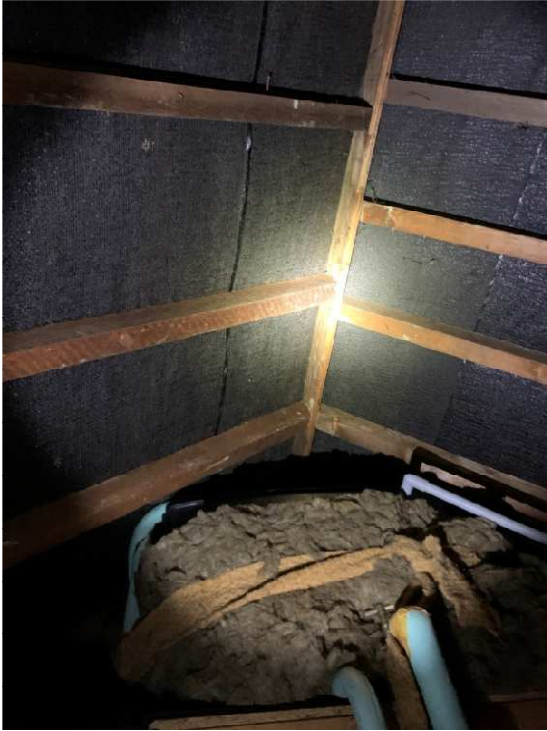
Plate 7

- 4.7 No potential access points into the interior of the roof void were noted at the eaves or the ridge as both areas are sealed internally. No evidence of bat activity in the form of droppings or staining was noted within the interior of the roof void.
