**1 Shorefield Way, Milford on Sea,
SO41 0RX**

Ecological Appraisal

Report Number: 1

Date of Issue: 13th July 2023

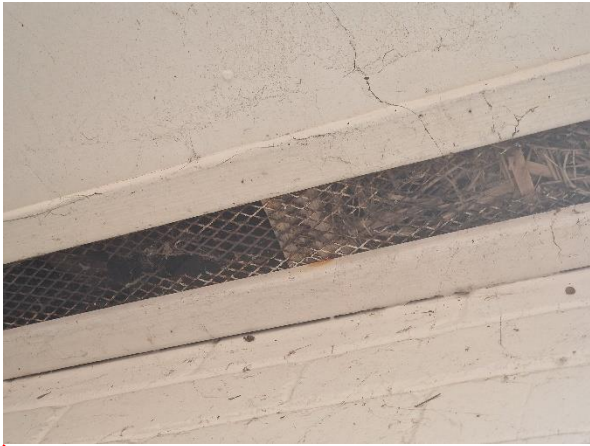
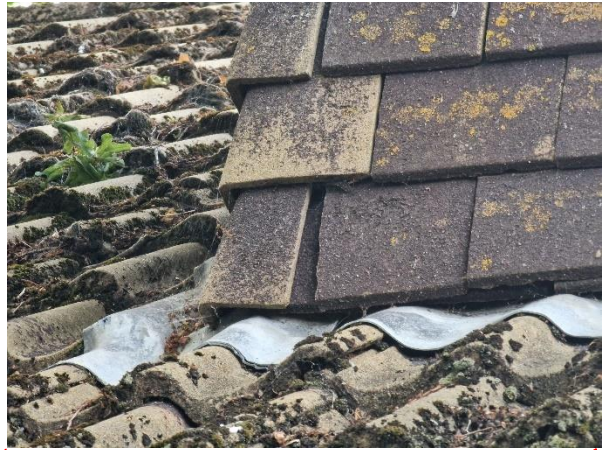
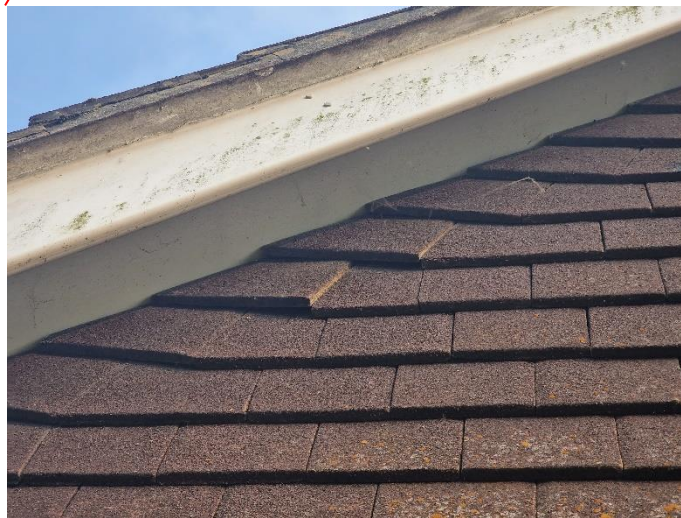
north elevation

- 4.7 The North and South sides of the building showed potential gaps that could be utilised by bats and birds but no other evidence of bats such as; live or dead specimens, droppings, staining and/or squeaking noises were recorded. Sometimes bats leave no visible sign of their presence on the outside of a building (and even when they do, wet weather can wash evidence away).

- 4.8 A previous year's birds nest was found in the covered car parking area, see the top left of **Photo 1**
- 4.9 Internally, the second floor extends and takes up the majority of potential attic space leaving eave storage along the South and North. There is a larger portion of attic space above the single-story extension but this is used as storage regularly by the homeowners, there is also a window into this space creating a large amount of light. At the very apex of the roof is a small attic space that runs the length of the building and was not accessible at the time, it's potential for supporting bats in need of attic space is limited but not negligible. No evidence of bats was found.

(Photo 1: Shows some of the potential roosting and access opportunities on the North elevation including elevated tiles and other appropriate gaps)

- 5.1 There are numerous gaps and lifted tiles that could be utilised by bats and birds. The habitat surrounding the housing estate is of high importance to commuting and foraging bats. The building will require at least two bat emergence/re-entry surveys carried out between May and September in order to determine the roosting status of the site. At least one of these must be undertaken before the end of August.

- 5.2 Works on the existing roof will need to be undertaken under ecological supervision and these works will need to avoid commencing during the bat hibernation season (which runs from the end of November to February, inclusive). Any bats found can be moved to a bat box provided on site. The completed proposals will have new crevices built in for crevice roosting bats.

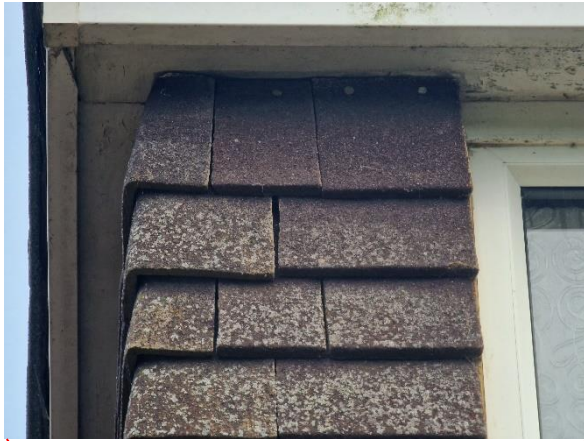
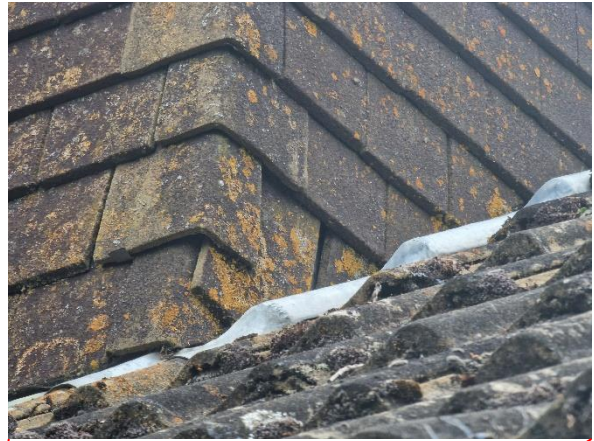
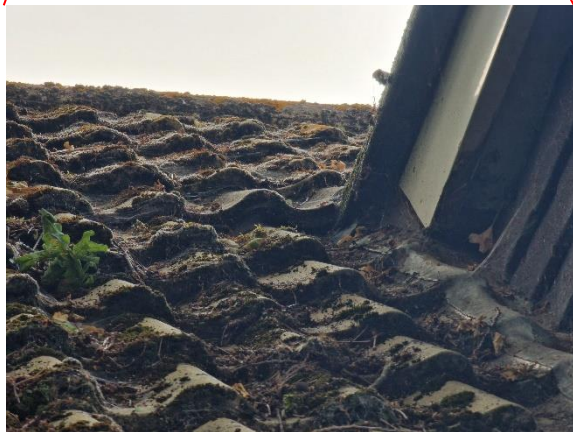
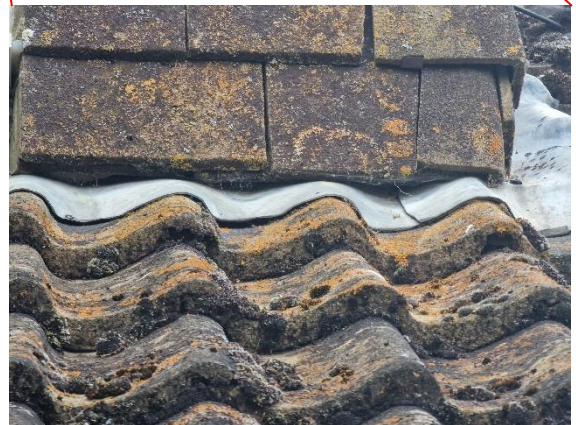
south elevation

(Photo 2: Shows some of the potential roosting and access opportunities on the South elevation including elevated tiles and other appropriate gaps)
