DRAWING No.

As Proposed, Roof

PLAN

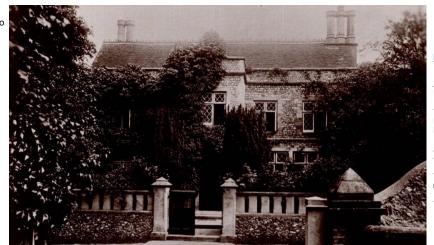
Chimney pots: Terracotta chimney pots to match photo dating circa 1917

Chimney pots: Terracotta chimney pots to match photo dating circa 1917 - Chimney pots:
Terracotta chimney pots to
match photo dating circa
1917 • New conservation grade rooflights Repair works to chimneys, faces to be tile hung (refer to elevations) Roof to be insulated (between and below rafters) Roof to be re-tiled. Existing peg hanging tiles will be reused. The existing pegs have rusted and swollen, if not replaced (with galvanised pegs) they will continue to swell and damage the tiles. Broken tiles will be replaced with Sussex hand-made 6 1/2 x 10 1/2inch peg hanging tiles to match existing.
