**Preliminary Roost Assessment and
PEA 2023**

**Land at Tara, Underhill Lane
BN6 8XE**

1.1 The Ecology Partnership was commissioned by Baker Brown Studios to undertake an internal and external bat inspection and PEA, of land at Tara, Underhill Lane, BN6 8XE.

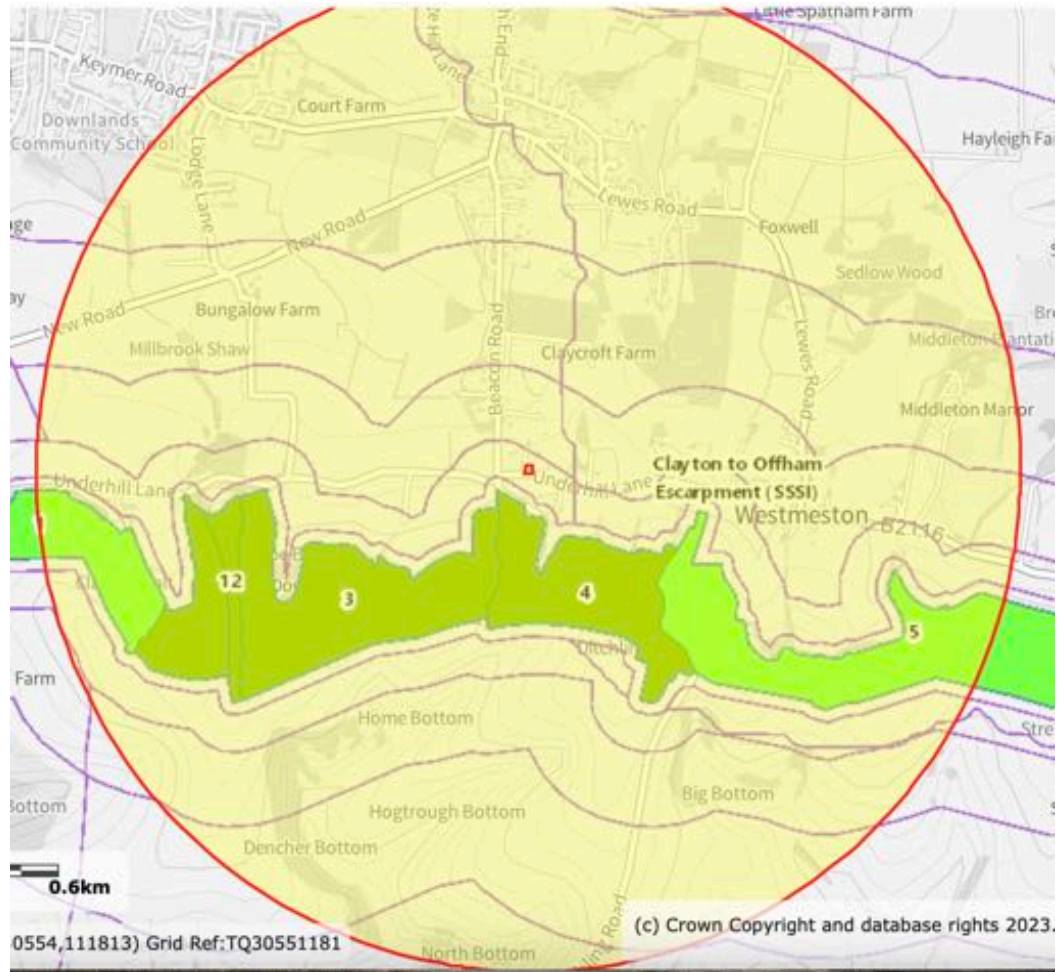
- 3.1 The site does not fall within or adjacent to any nationally or internationally designated sites. However, the site lies just over 130m north of Clayton to Offham Escarpment SSSI, see figure 3 below.

Figure 3: Location of site in relation to the SSSI

4.2 The site does not fall within any statutory or non-statutory designated sites. However, the nearest designated site is just over 130m to the south of the red line boundary. At this distance the site lies within one of the SSSI impact risk zones.

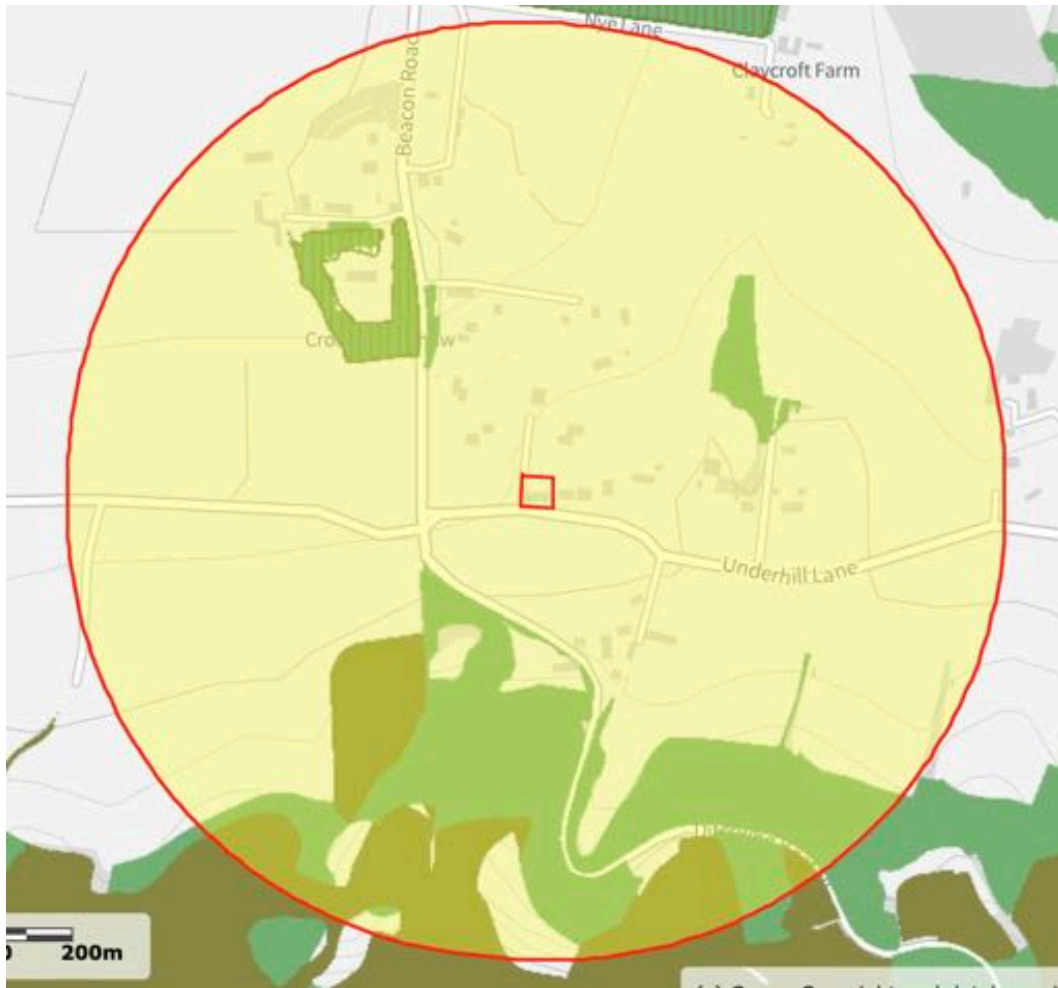
- Ancient woodland located 180m to the north west of the site;
- Lowland deciduous woodland located 163m to the north west of the site and 120m to the south of the site;
- Lowland calcareous grassland located 185m to the south west of the site.

Figure 4: Priority habitat within 500m of the redline boundary

4.5 There are no priority habitats on site. Priority woodland habitat is located within the immediate landscape, albeit not adjacent. Ancient woodland is located in the local area, but well outside 15m recommended buffer zone. The redevelopment of the site will not result in any priority habitat loss, and as such no impacts on priority habitats are predicted.

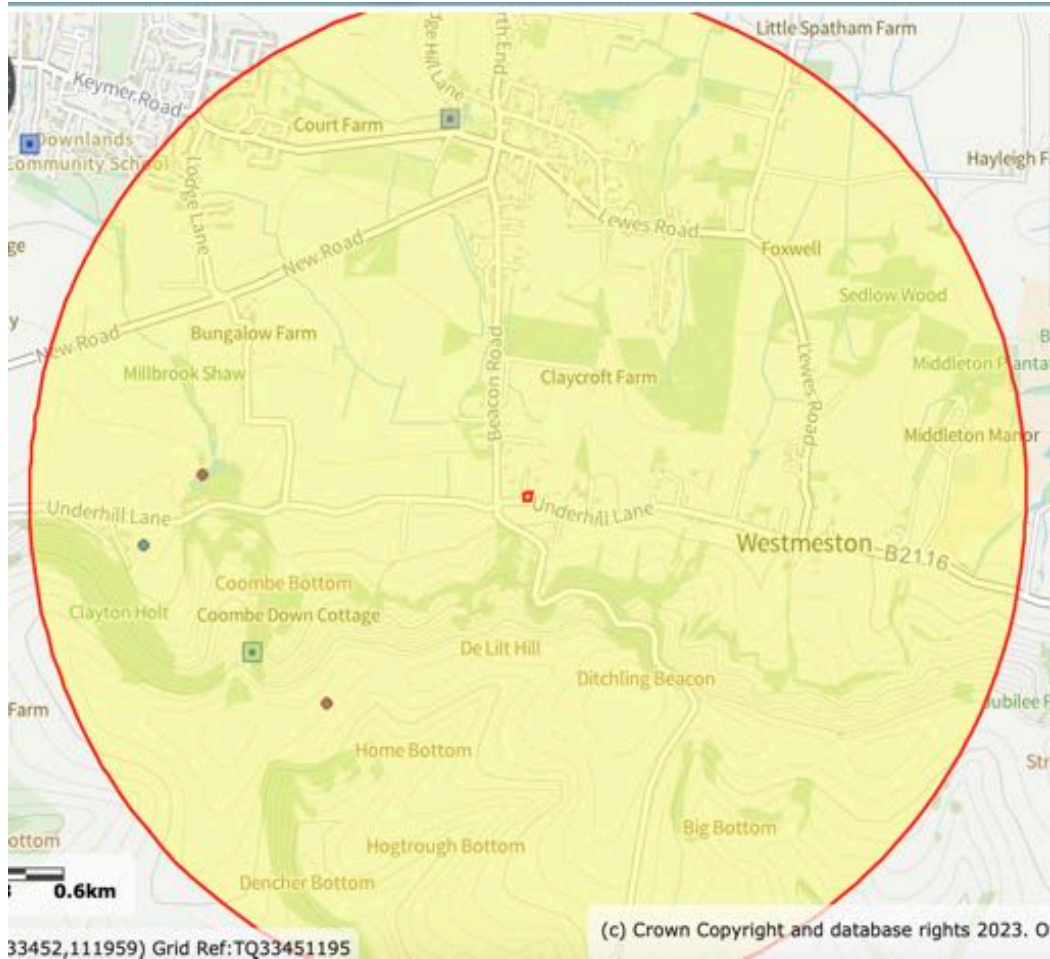
3.4 In terms of protected species; the nearest records for GCNs 1.14km south west in 2014, with an additional licence return in 2014, 1.3km to the west. Further GCN DNA was located approximately 1.6km west in 2019 and a GCN licence 2014-3189-EPS-MIT was granted in 2014 located 1.23km south west. The licences are shown in Figure 5 below.

Figure 5: Location of licence and licence returns within 2km of Tara. GCN licence is shown in light green square, and licence returns in coloured circles. Blue square is a granted bat licence.

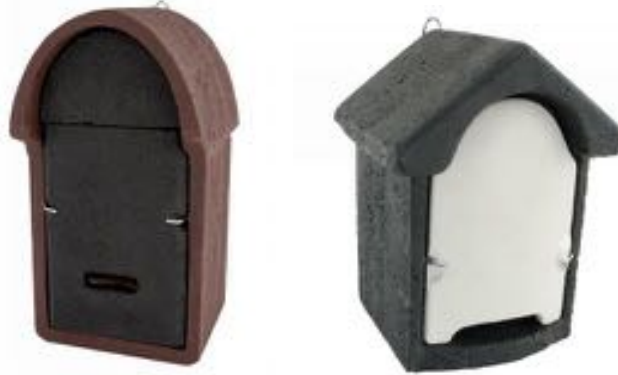
- 4.29 Additional roosting opportunities may be provided by hanging bat boxes on any of the mature trees. Recommended bat boxes include hardwearing woodcrete boxes, such as those shown in Figure 7 below, or similar.

Figure 7: Examples of recommended bat boxes to be installed within suitable mature trees on site – a CJ Wildlife woodstone box (left) and a Vivara Pro woodstone box (right).

- 4.30 Boxes should be installed at least 3m from the ground and on south and west facing aspects and away from artificial lighting.
- 4.31 Enhancements for bats could be incorporated within the design of the site. Sweet nectar and protein-rich pollen, especially night-scented flowers, are bait to encourage insects, a food source for bats. These species should be incorporated into the development where possible:
- Evenings primrose (*Oenothera biennis*)
 - Field poppies (*Papaver rhoeas*)
 - Knapweed (*Centaurea sp.*)
 - Night-scented stock (*Matthiola longipetala*)
 - Red campion (*Silene dioica*)
 - Honeysuckle (*Lonicera periclymenum*)
 - Sweet williams (*Dianthus barbatus*)
 - Angelica species
 - Wisteria (*Wisteria floribunda*)
 - Lavenders (*Lavandula sp.*)

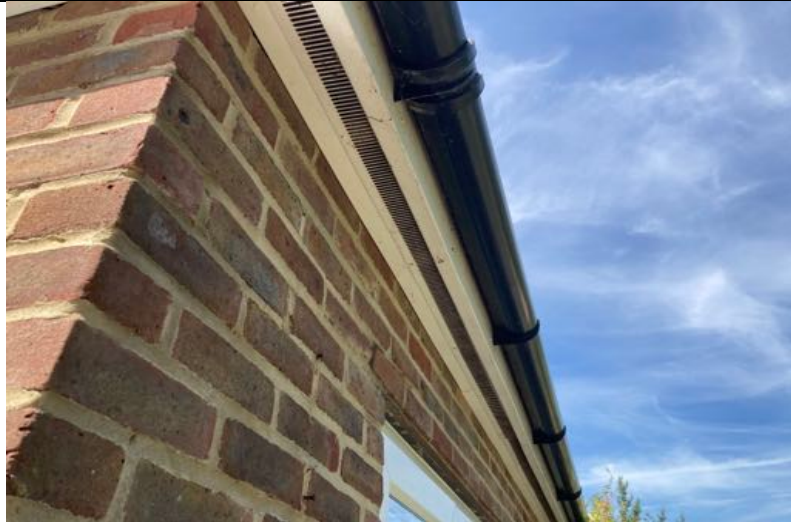
Photograph 4:
Another view of soffits around the new sections of the building

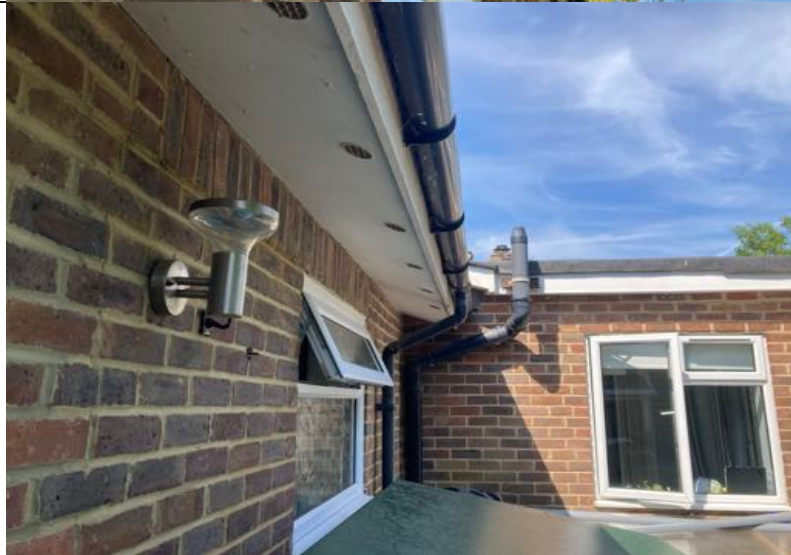
-
- 3.15 The soffits are a mixture of plastic and wooden. All of these are well sealed, with no cracks, loose sections, or missing sections. There is a section of flat roof and conservatory roofing to the rear. These features are also all well sealed.

Photograph 5:
The soffits to the rear of the building

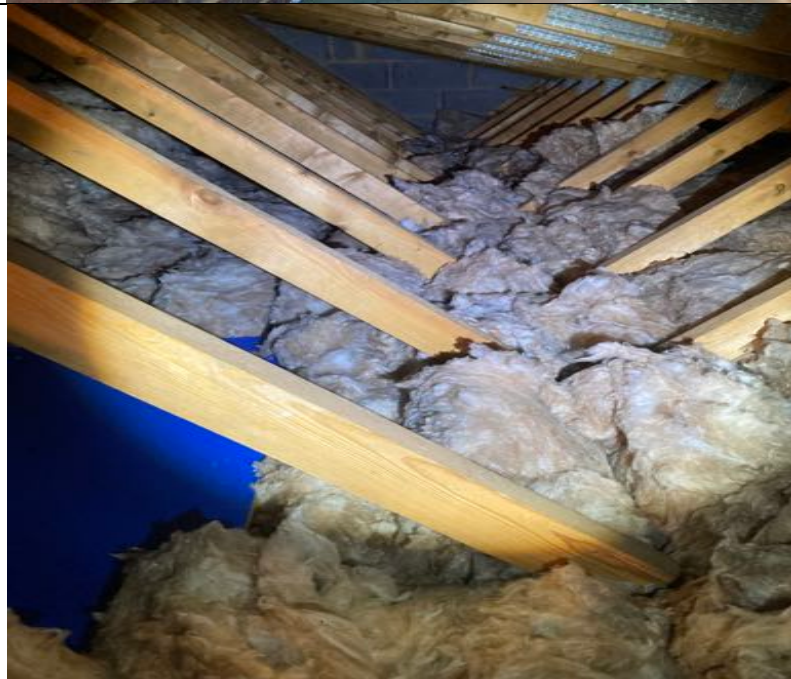
- 3.17 Each void supported breeze block walls, timber framed roof, bitumen felt internal lining, the floor of the void was thick with insulation. The central void is cramped, with a height of less than 1m and very cluttered. This void section was crawled through, and evidence of mouse and rat droppings were evident. No evidence of bat use was recorded across the whole of the void.

Photograph 6:
Inside the roof structure, the main void cramped and no evidence of roosting bats.

4.10 The house supported well sealed clay tiles and ridge tiles, well sealed soffits boards, and no holes, slipped or missing tiles were recorded. Internally the roof was cramped, and no evidence of bats was found. The lack of any evidence and the well sealed nature of the building, it was considered that the building has 'negligible' potential to support roosting bats and no further surveys are required.

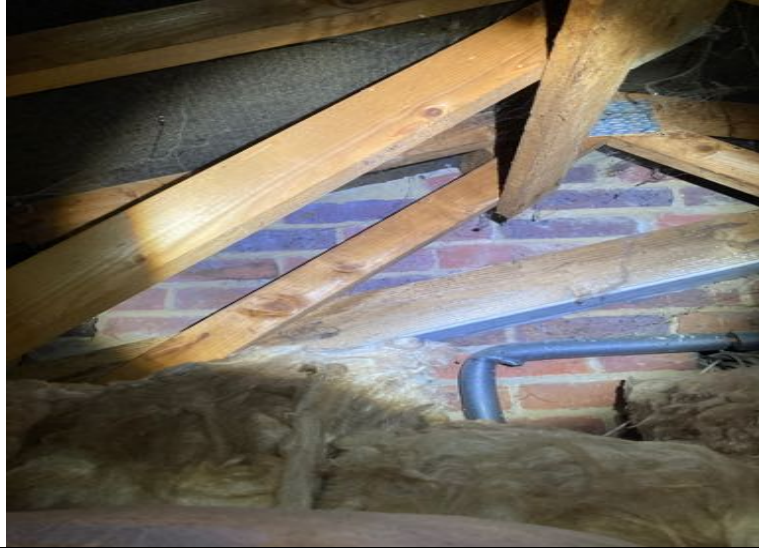
Photograph 7:
Another view of
the internal
environment.

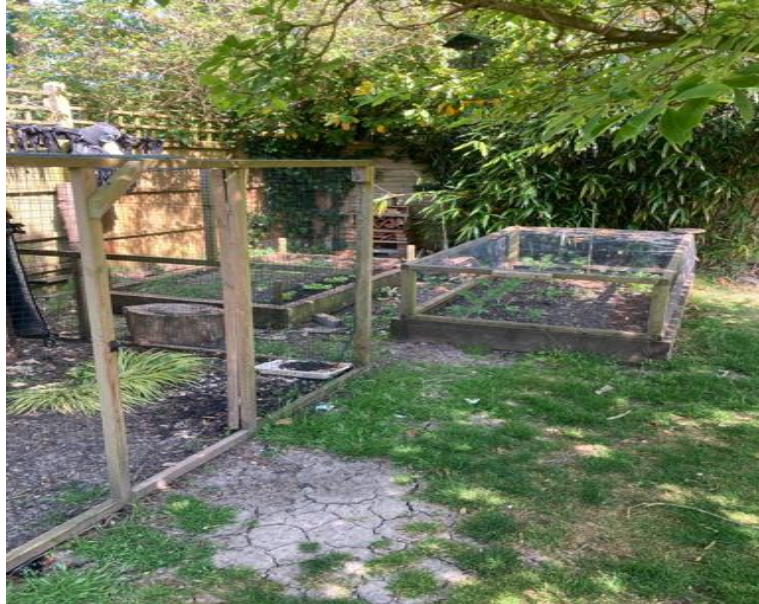
Photograph 8
The garden
habitats

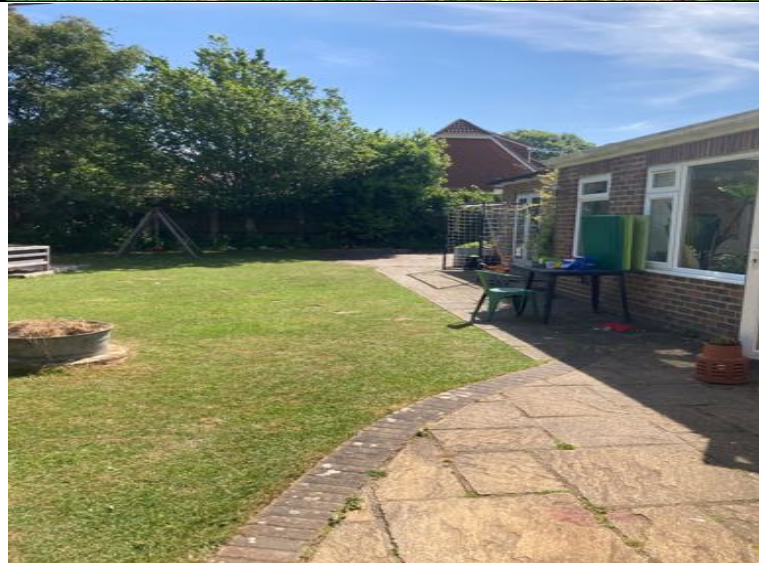
Photograph 9:
Overview of the
rear garden
