# CBA CHARLES BLAKE ASSOCIATES ARCHITECTURE

PROJECT: CONTINUED USE OF WESTERN ZONE AS TEMPORARY PAY & DISPLAY CAR PARK (FOR A

**DOCUMENT:** FLOOD RISK ASSESSMENT

**ISSUE**: 12/07/2023

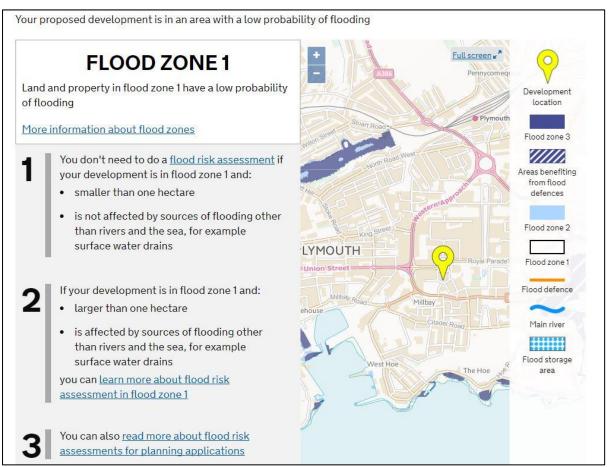
Fig 1. Flood Zone Extract

- 4.1 The site is located within Flood Zone 1. A flood risk assessment is not required if the site is smaller than one hectare and is not affected by sources of flooding other than rivers and the sea, for example surface water drains.
- 4.2 The site is finished in tarmacadam and laid to falls to a number of storm water gullies. This arrangement remains unchanged from the historical use of this area of site for car parking by Foot Anstey Sargent. Site Layout drawing 3513 41 Rev F indicates all gullies and approximate falls on site.
- 4.3 The existing storm water drainage provision functions perfectly well and the site drains successfully.
- 4.4 There were no objections raised to previous applications in terms of storm water drainage.
- 4.5 There is no history of flooding on the application site.
- 4.6 There is no change to the current storm water drainage provision.

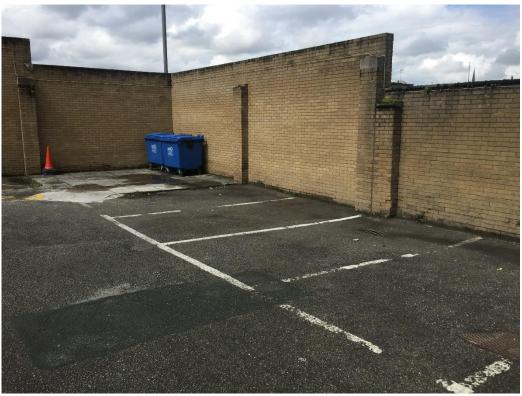
Fig 2. View into northwest corner (note: falls)

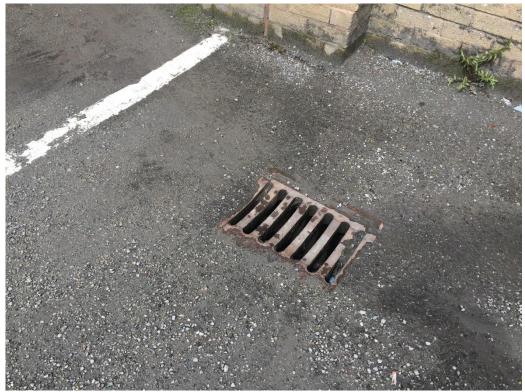
Fig 3. Storm water gulley in parking space no.3

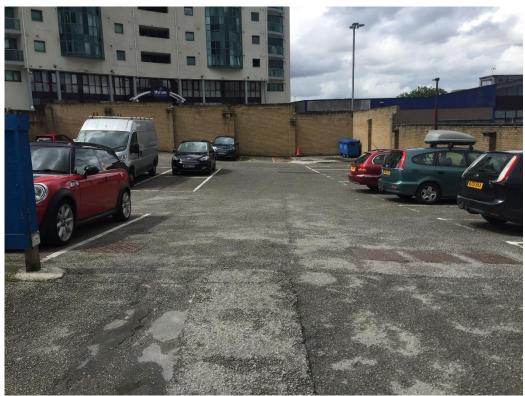
Fig 4. View west (note: falls)

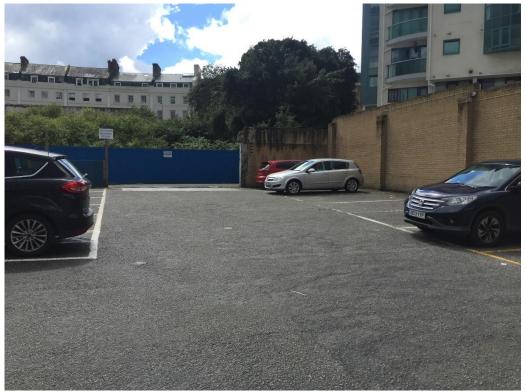
Fig 5. View south (note: falls)

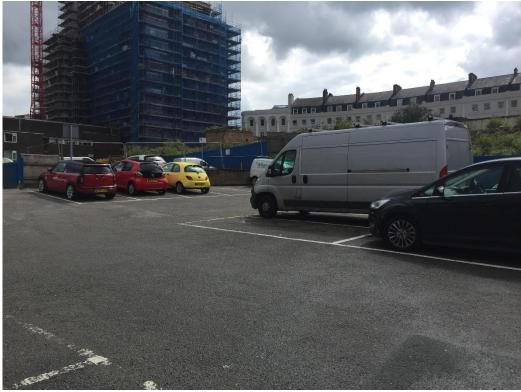
Fig 6. View southwest (note: falls)

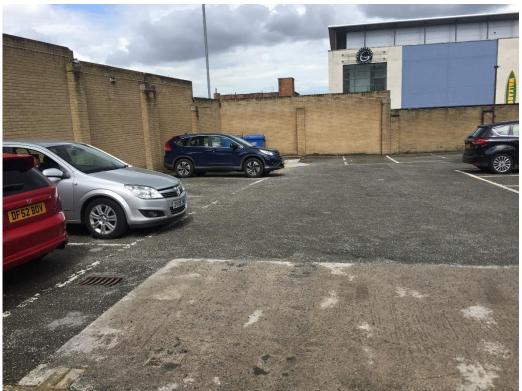
Fig 7. View north (note: gulley adjacent parking space no.19)
