# Meadow Environmental Consulting

## Phase I Environmental Assessment – Desk Study and Walkover Survey (LCRM Stage 1 Tier 1 Risk Assessment)

Site: Boundary Close, Minster on Sea, Isle of Sheppey, Kent ME12 3RG

PROJECT REFERENCE: 23-141/P1

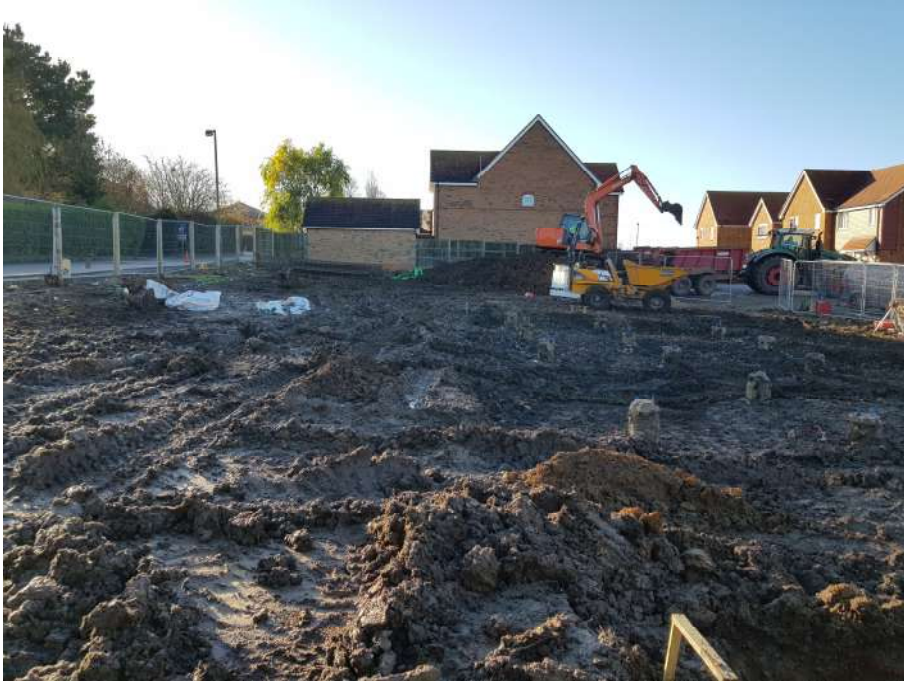
## PHOTOGRAPH 1

Looking south across the northeast area of the site that is proposed for plots 5 to 8. The central area will be occupied by the new dwellings.

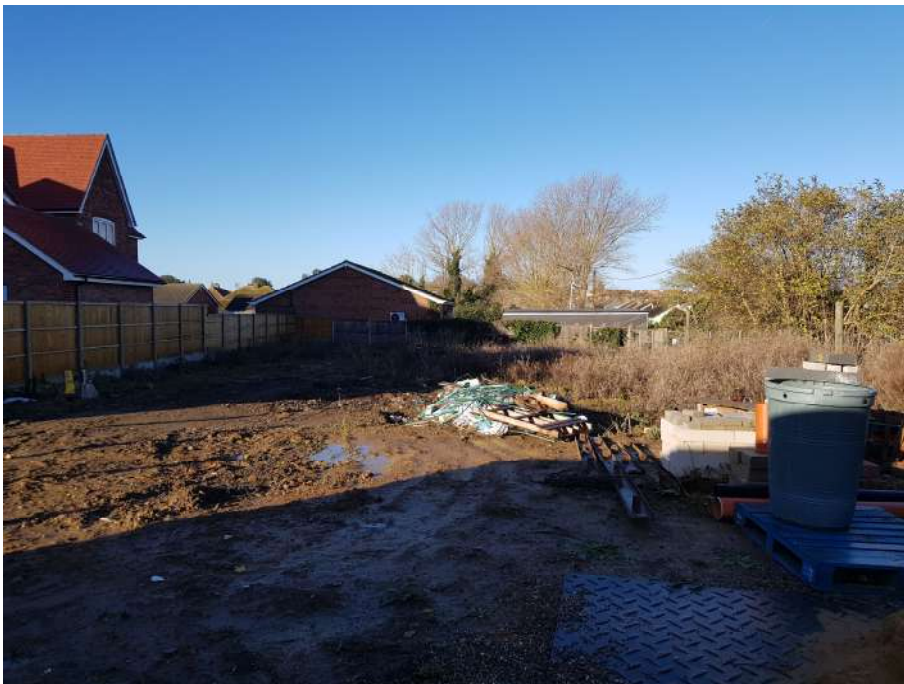
## PHOTOGRAPH 2

Looking west/northwest across the northwest area of the site at the area that is proposed for plot 4.

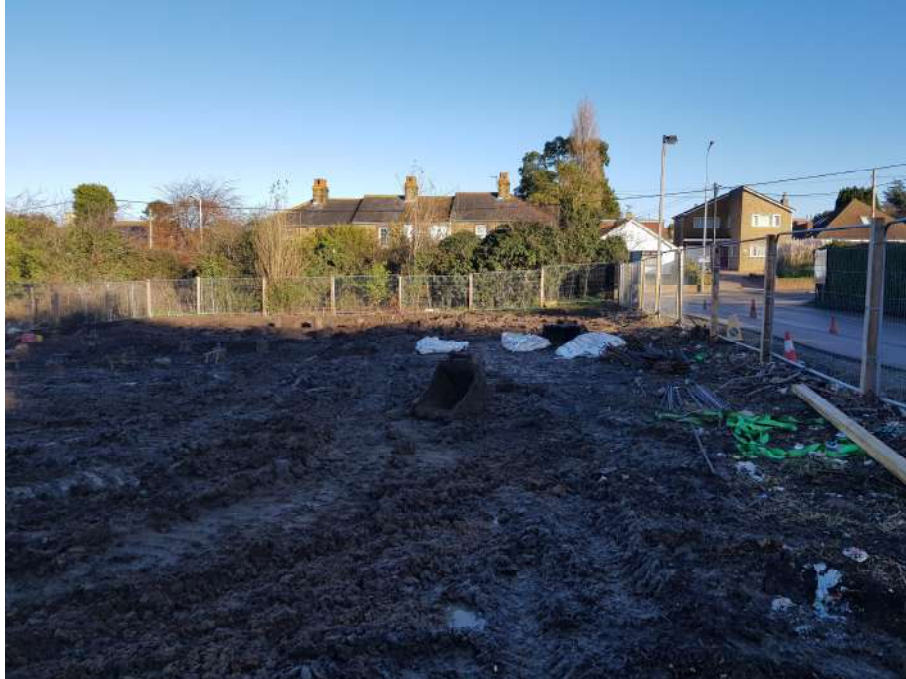
### PHOTOGRAPH 3

Looking north across the northeast area of the site at the east boundary that is proposed for plots 5 to 8. This area will mainly be the private gardens.

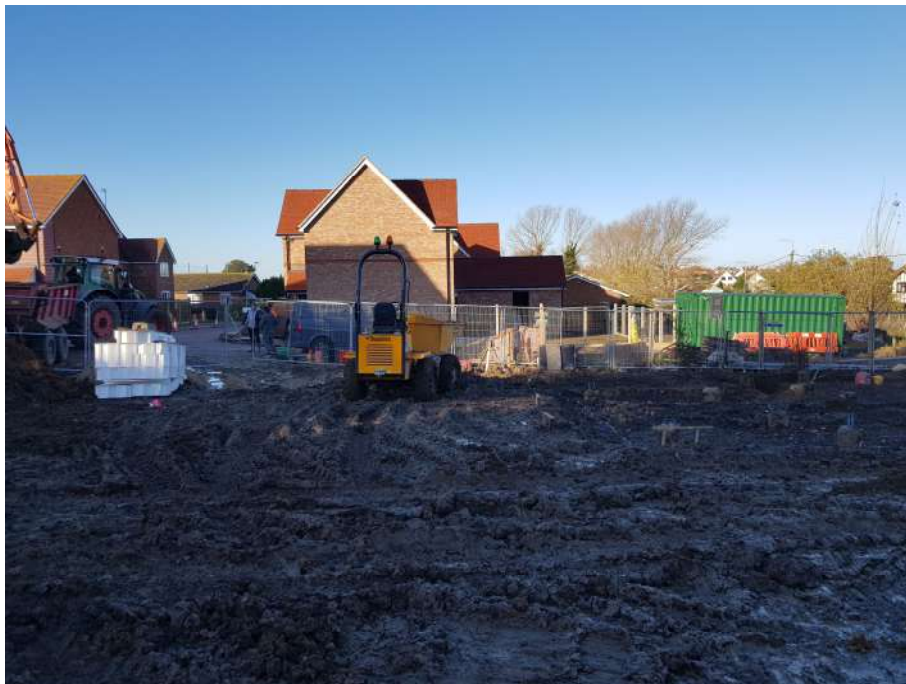
### PHOTOGRAPH 4

Looking west/northwest across the central area of the northeast area of the site that is proposed for plots 5 to 8. The unfinished plot 3 is in the background.

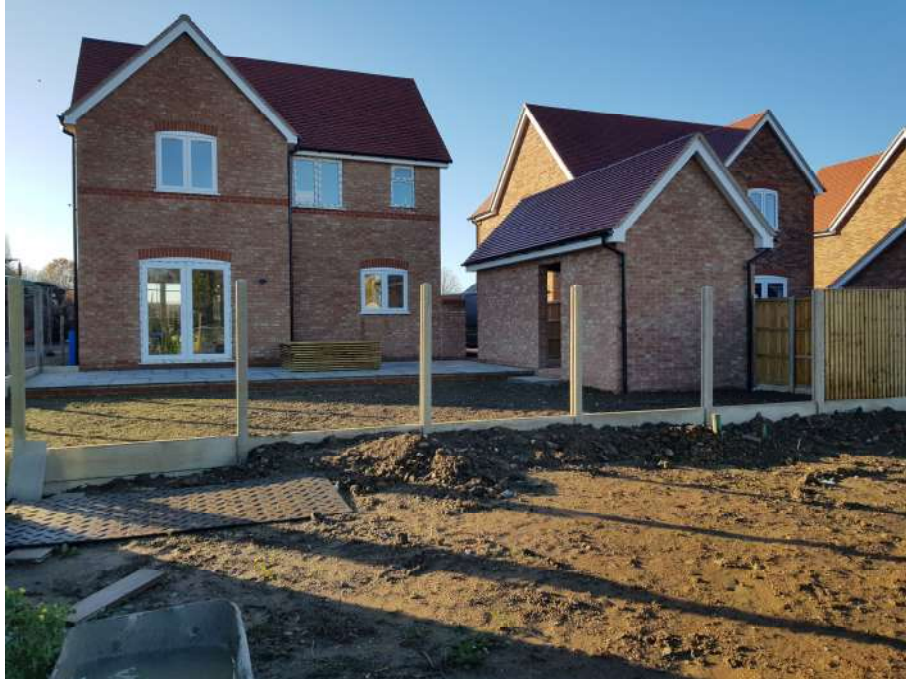
## PHOTOGRAPH 5

Looking southwest from the northeast area of the site at the incomplete plot 3. The adjacent occupied plot 2 is in the background.

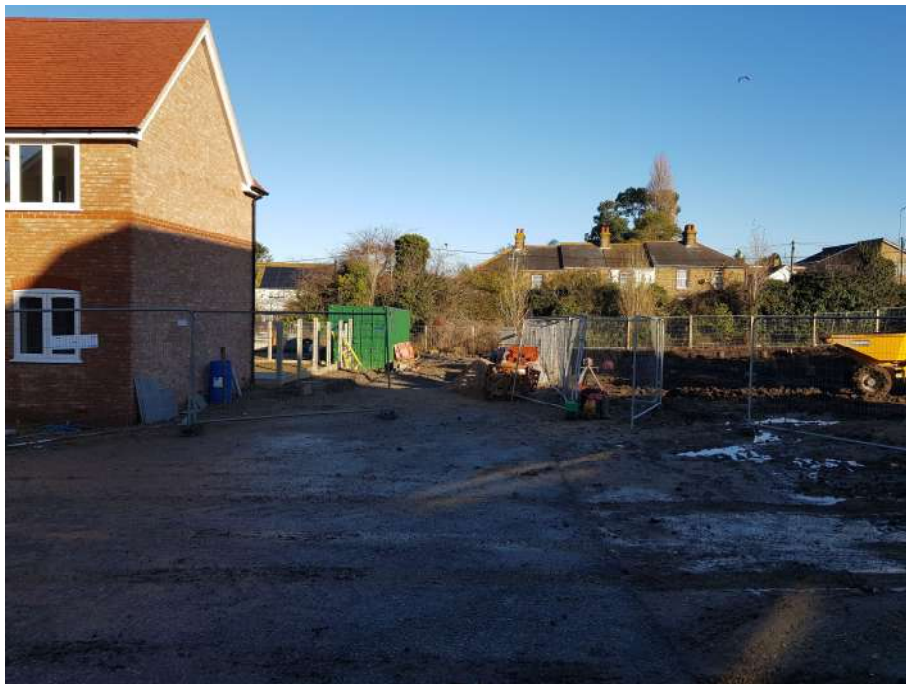
## PHOTOGRAPH 6

Looking north/northeast from the centre of the site at the location of the proposed access road to plot 4. The parking areas to plots 5 to 8 will be on the right and the unfinished plot 3 is on the left.

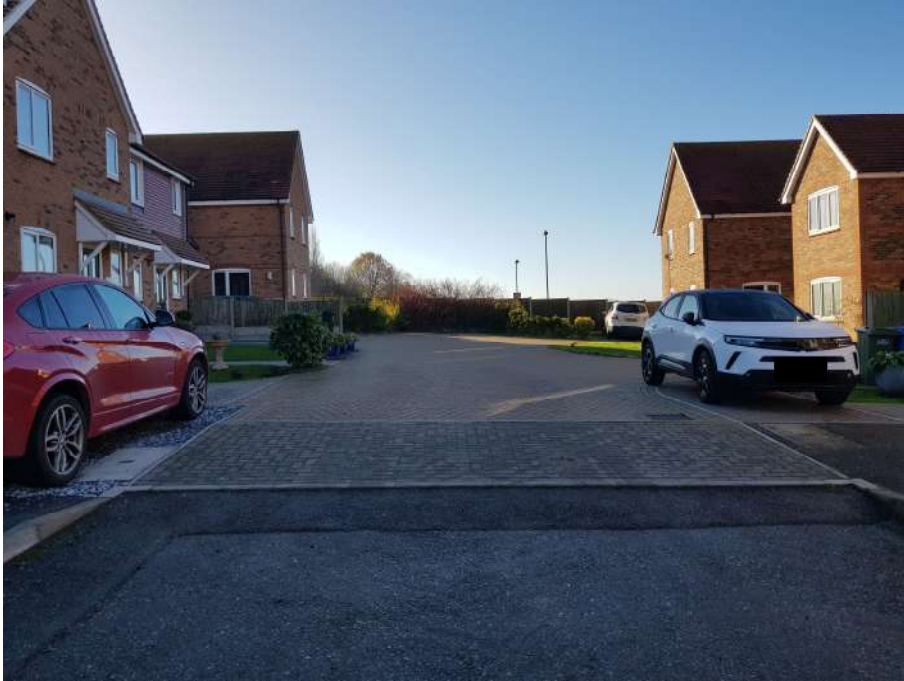
## PHOTOGRAPH 7

Looking south/southwest from the centre of the site showing the occupied plots in the south area of the site that were built between 2013 and 2015.

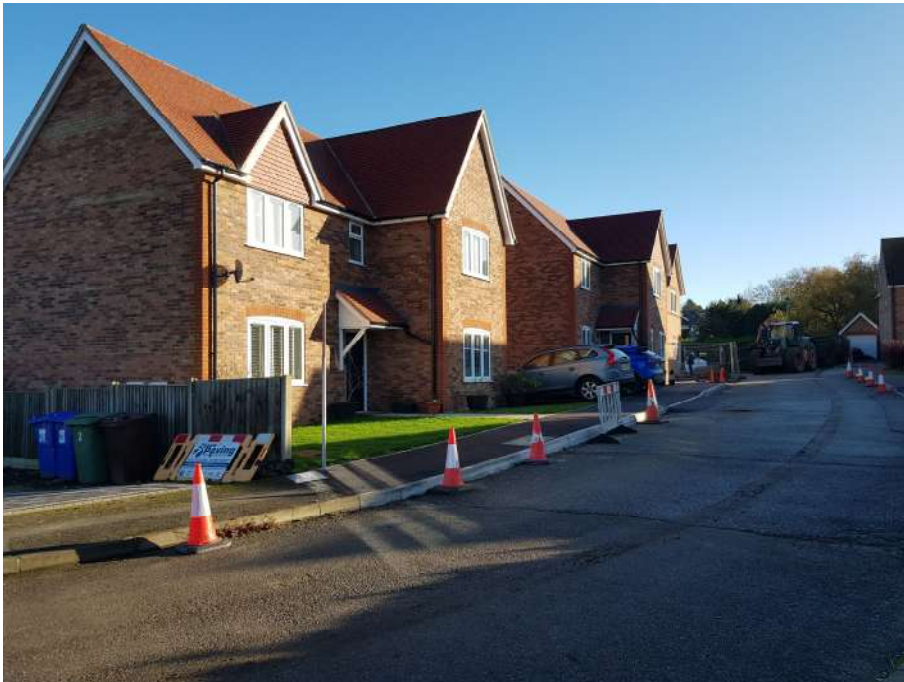
## PHOTOGRAPH 8

Looking east from the west boundary showing the occupied plots 1 and 2 with the unfinished plot 3 in the background.

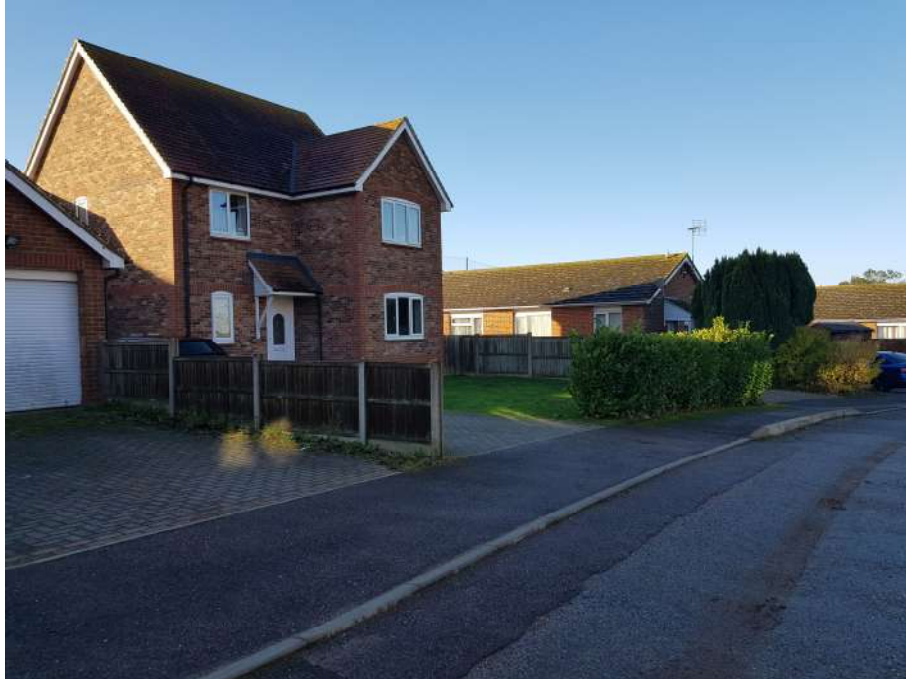
## PHOTOGRAPH 9

Looking west/southwest across part of the southwest area of the site showing the occupied plot 17 that was built between 2013 and 2015. The adjacent dwellings in Boundary Close and Echo Walk that were built in the 1980's are in the background.

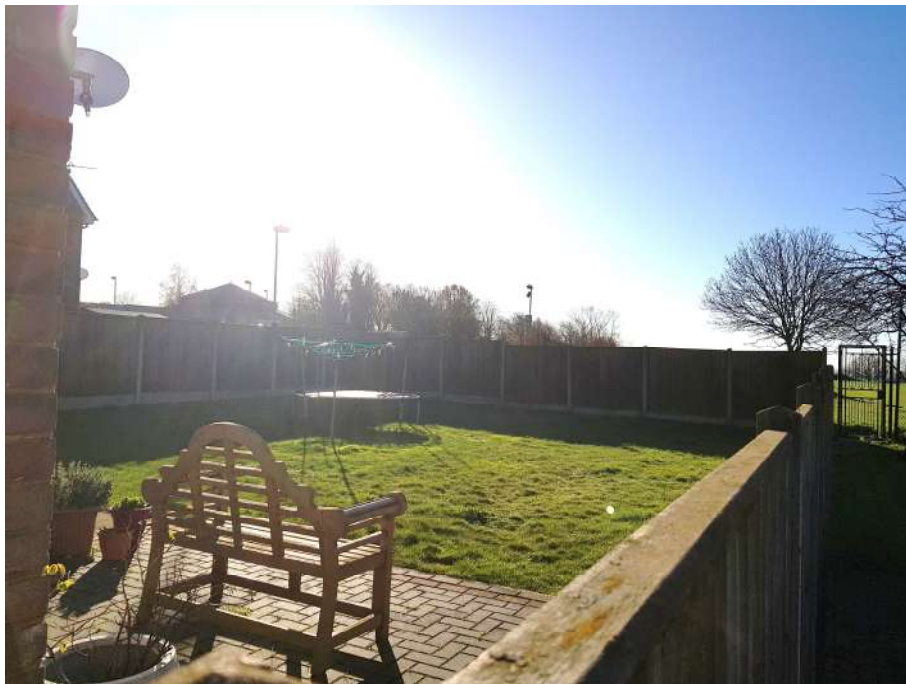
## PHOTOGRAPH 10

Looking southwest across the rear garden to plot 17. The adjacent recreation ground (Minster Cricket Club) is in the background beyond the gate.
