**BAT, BARN OWL &
NESTING BIRD SURVEY**

BARN 3

**[UPPER FARROWING HOUSE]
PENNYLAND FARM**

18th December 2023

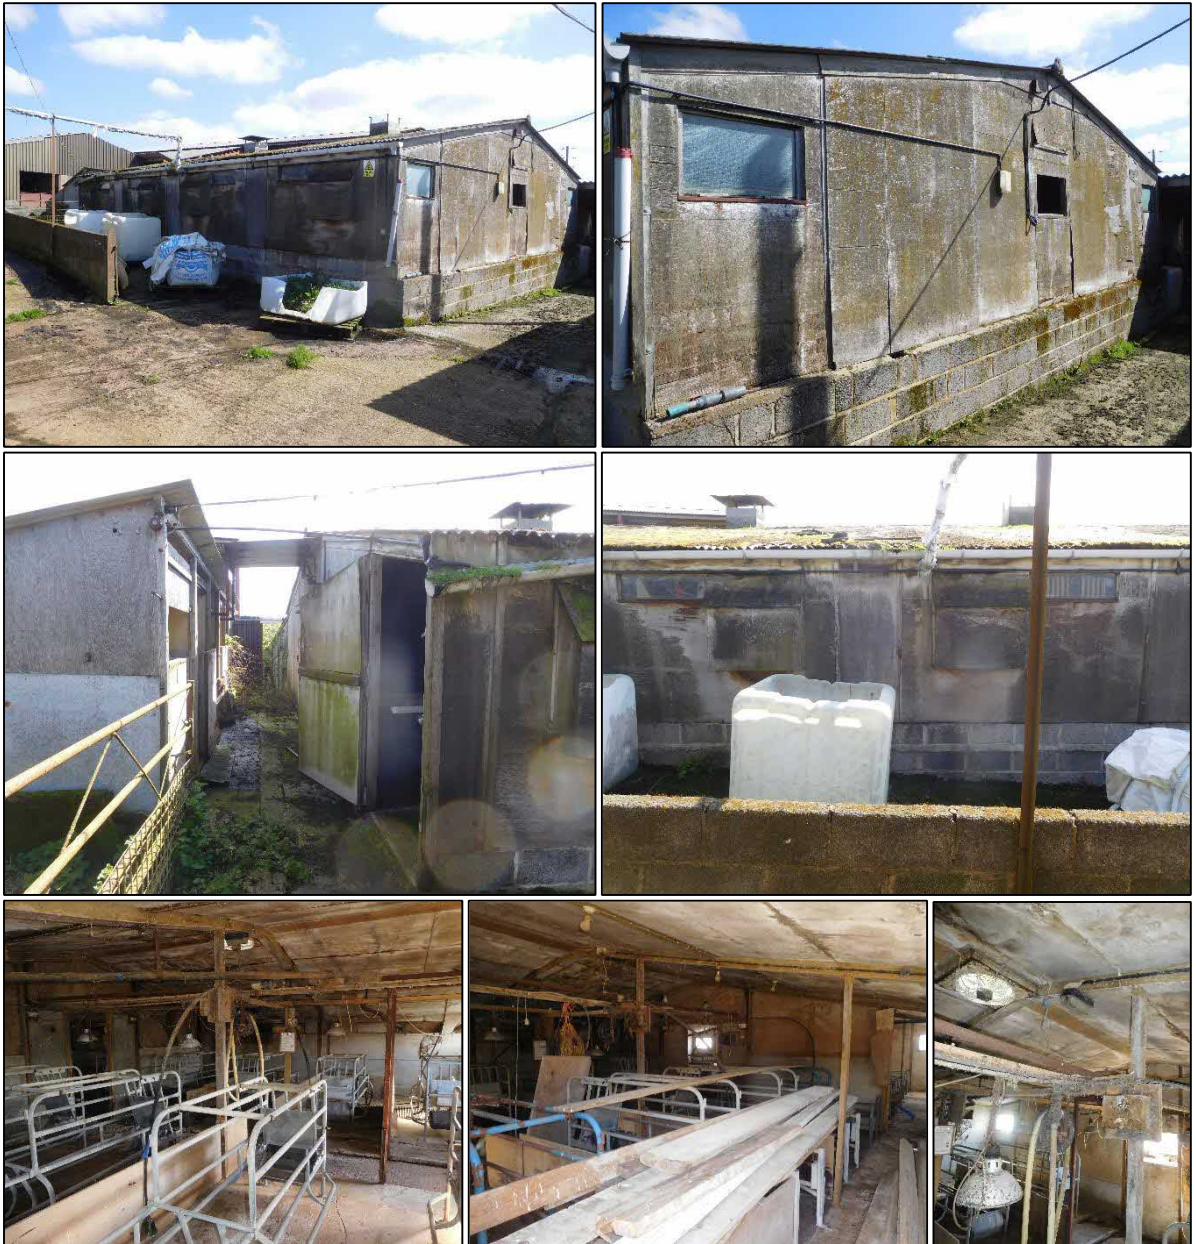
4.3.1 Barn 3 / Building B (Upper Farrowing House): *to be demolished and replaced*

Single-storey detached former pig-rearing unit built of plywood over concrete-block foundation walls. Pitched corrugated fibre-cement roof lied with asbestos sheets with no enclosed roof void. Drainage slurry channel beneath floors, covered with metal grid.

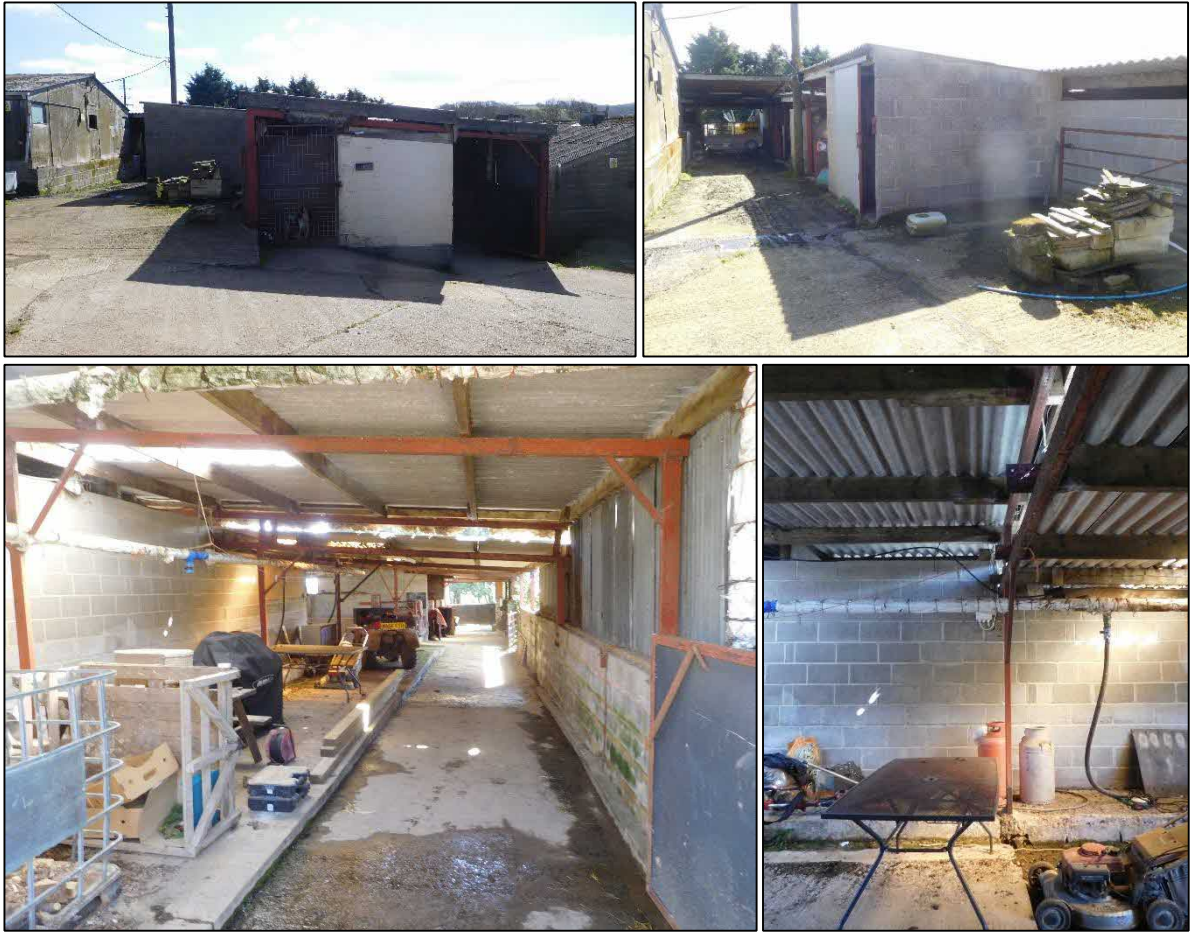
4.3.2 Building C: to be demolished

Single-storey concrete-block building with monopitch roof of unlined corrugated asbestos sheets and concrete floors. Kennel at west end with adjoining wood store / machinery store. Corrugated tin sheet wall along part of south side. Open ended at both ends (adjoining building includes stables at east end). Used for housing of sows, gilts & boars until c. 5 years ago.

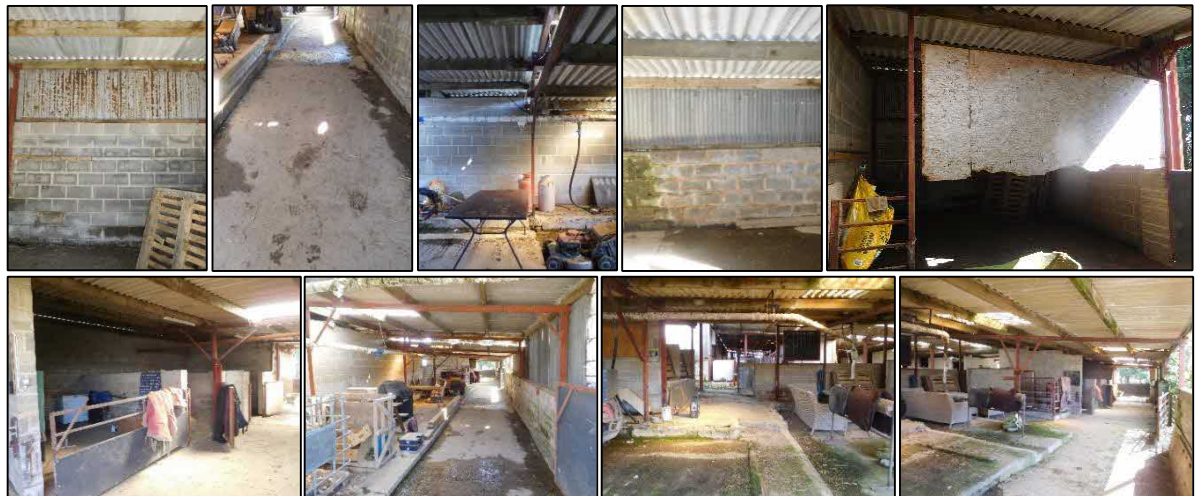
4.3.3 Building D: to be demolished

Continuation of above building with stables at far / east end. Used for housing of sows, gilts & boars until c. 5 years ago.

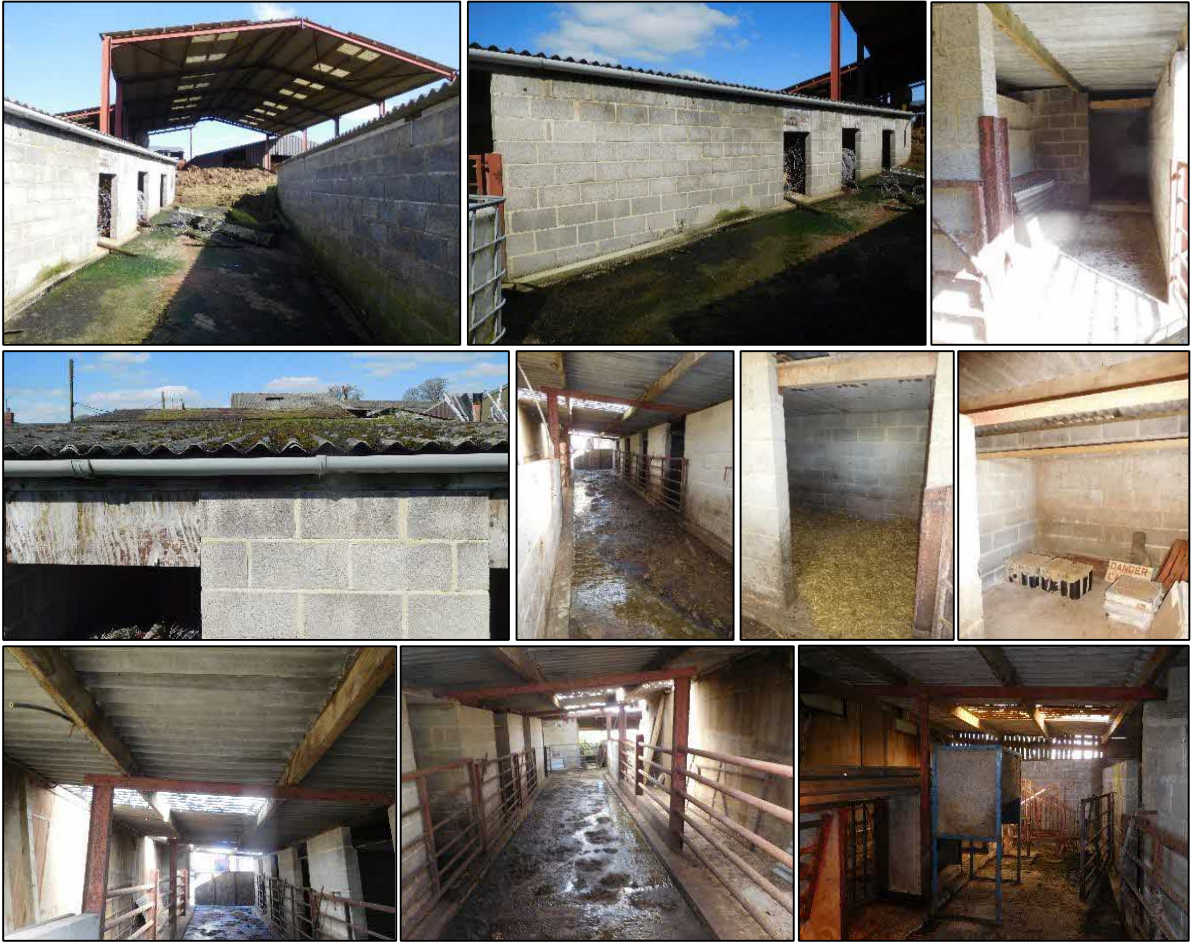
4.3.4 Building E: to be demolished

Single-storey concrete-block buildings with monopitch roof of unlined corrugated asbestos sheets and concrete floors. Used for housing of sows, gilts & boars until c. 5 years ago.

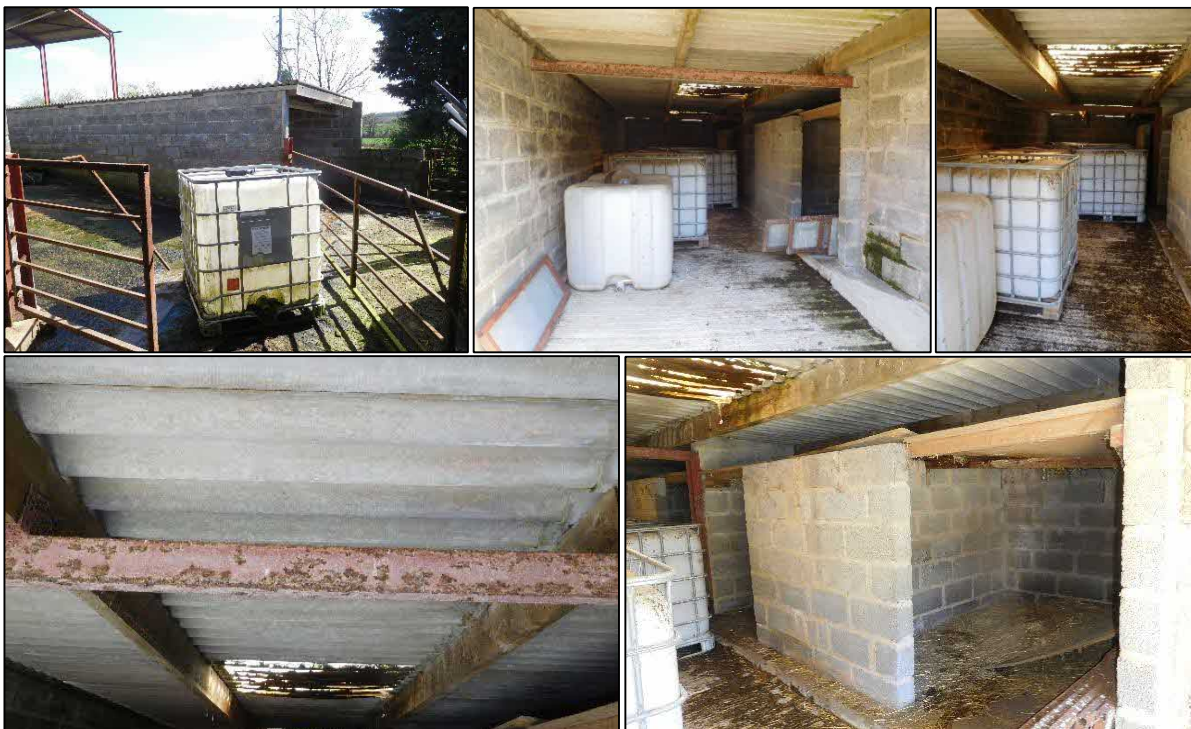
4.3.5 Building F: to be demolished

Detached single-storey concrete -block building with monopitch roof of unlined corrugated asbestos sheets and concrete floor. Used for housing of sows, gilts & boars until c. 5 years ago.

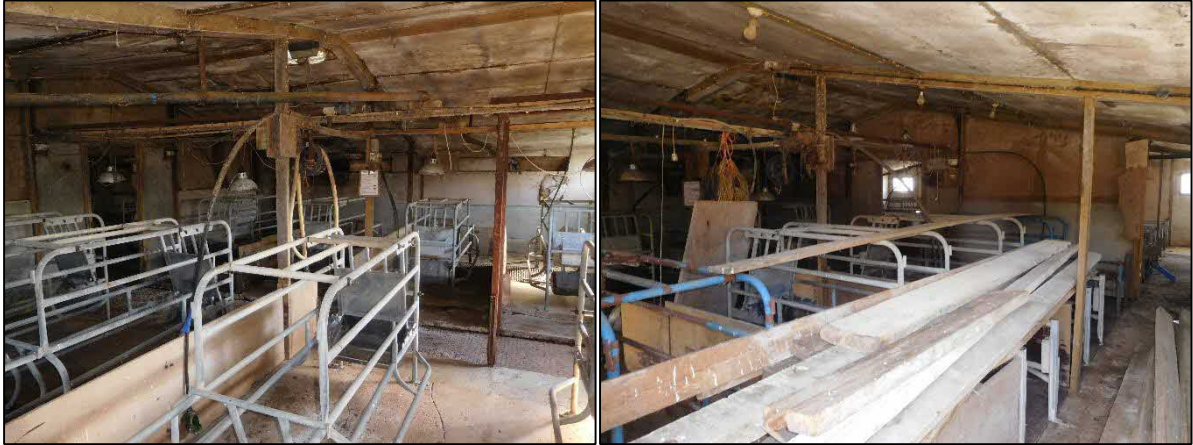
No **bats** or **signs of bats activity** (such as droppings and / or food fragments – beetle wing cases / moth wings) were found in the redundant farrowing building. There were no enclosed roof voids in the building.

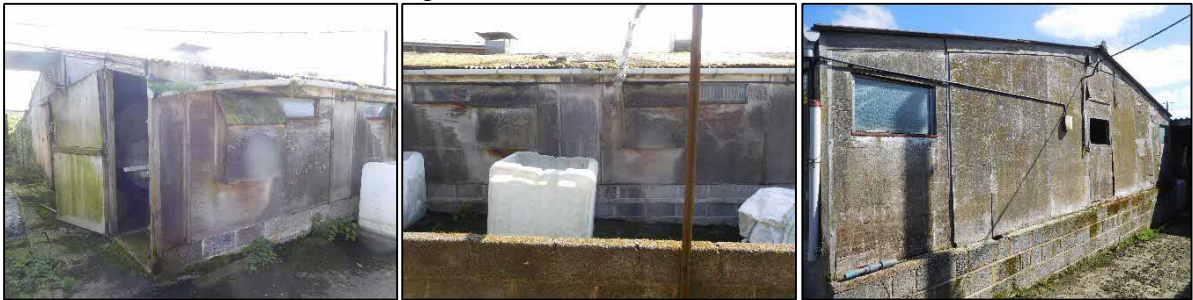
No potential roost locations for crevice-dwelling species (such as pipistrelles) were identified around the outside of the buildings.

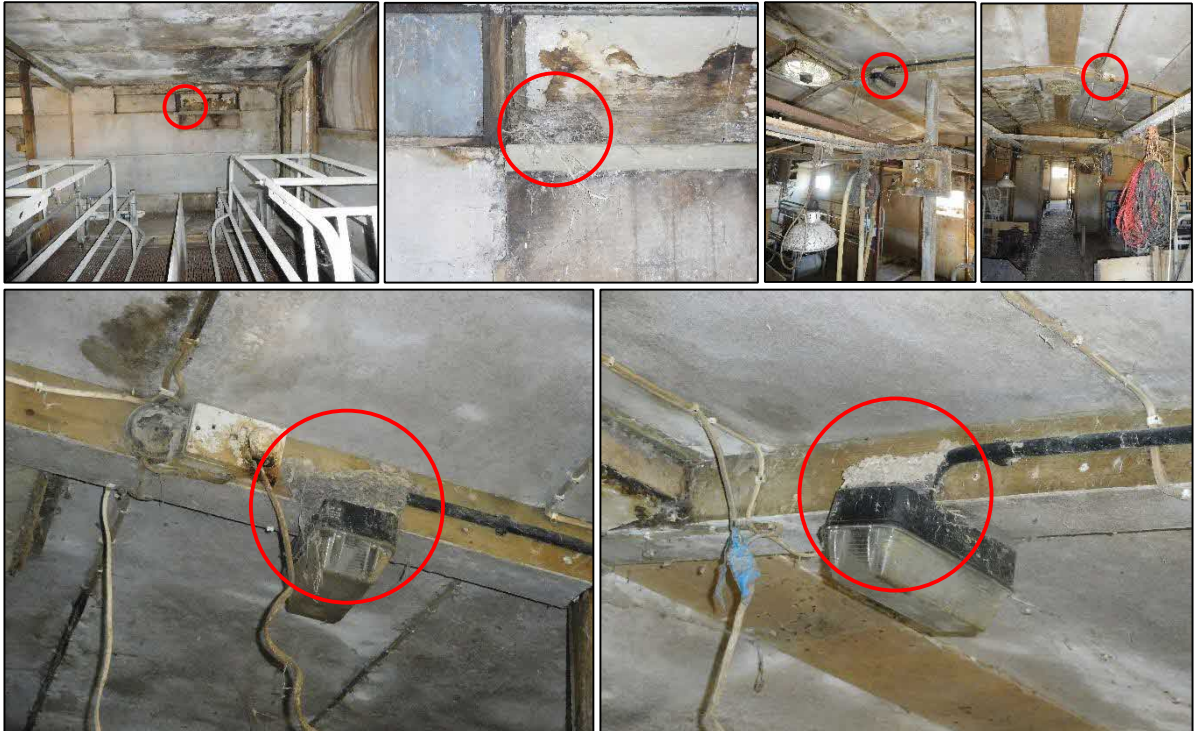
Three unoccupied nests were noted in the building – **2 x swallow** and **1 x blackbird / thrush**.

Without mitigation, there is a small risk that works associated with the proposed conversion of the redundant pig farrowing unit **could disturb nesting birds**.

Potentially disturbing works should be timed to avoid the nesting season – i.e. should be carried out between September and the end of February.

If potentially disturbing works are planned for anytime during the nesting season (March to late August) a **pre-works nesting bird survey** must be carried out immediately beforehand (i.e. within 24 hours) to confirm no nesting is taking place. If nesting is observed, then potentially disturbing works must be delayed until fledglings have left the nest.

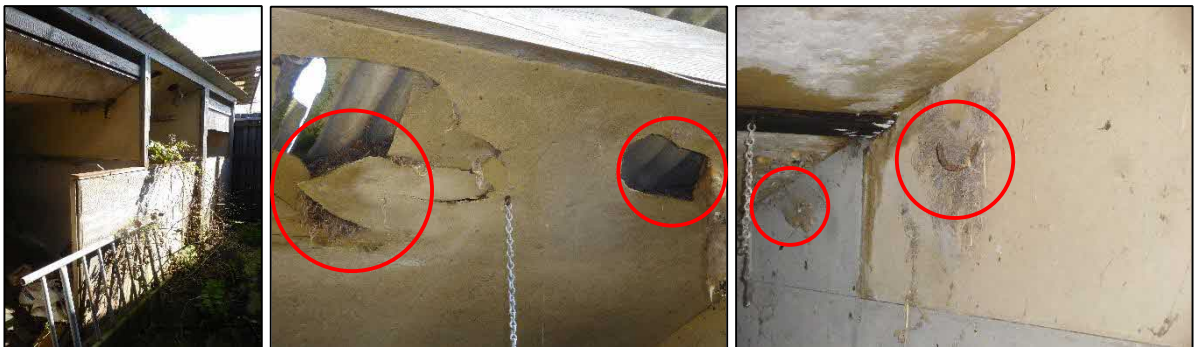
Two **swallow nest scars** and an **unidentified grass nest** were noted in the unoccupied pens at the north-east end of the building.

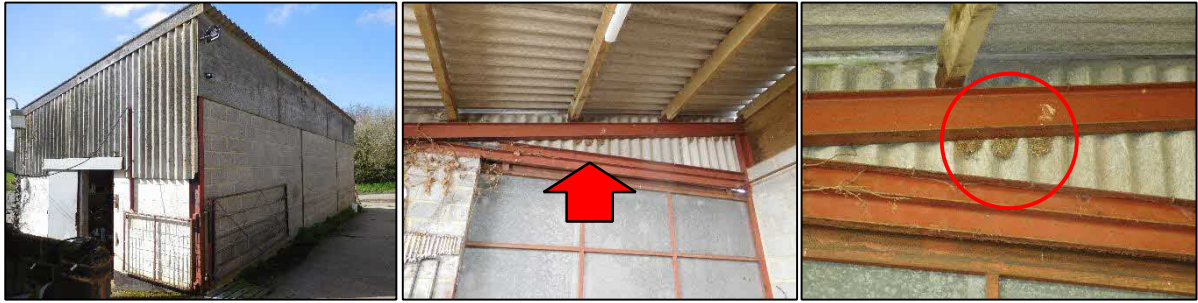
Evidence of nesting by **sparrows** was noted in other buildings on the farm.

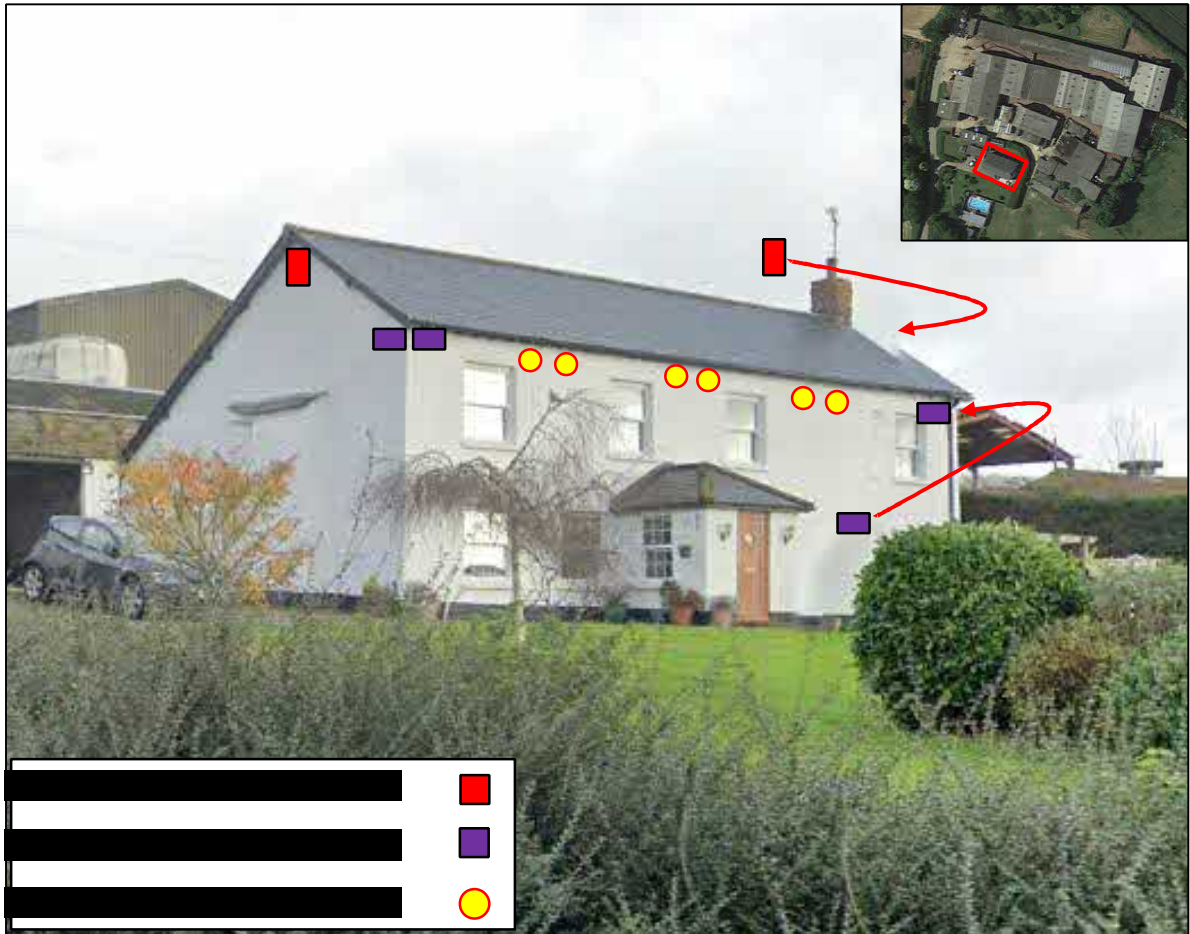
INDICATION OF POSSIBLE LOCATIONS FOR BAT BOXES AND BIRD BOXES ON THE HOUSE

2 x bat boxes - one at each gable end of house

4 x swift nest boxes at south-west and south-east corners of house

The house (to the south-west of the barn) – although not within the planning boundary - offers excellent opportunities for the installation of bird boxes (esp. house martin nest cups and swift nest boxes), which would increase the biodiversity gain on site (see page 24).

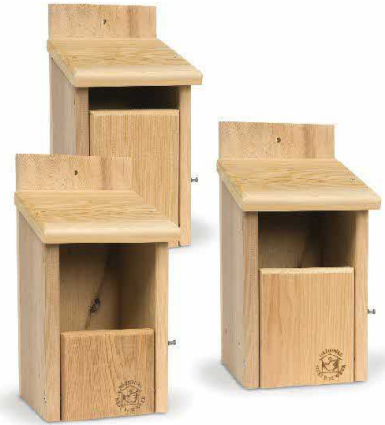
CedarPlus OpenFront Wooden Box

35mm opening for wrens / 75mm opening for robins

Materials: Durable 19mm thick Canadian cedar wood;

Dimensions: 318H x 156W x 175D mm; **Entrance:** 35mm / 75mm

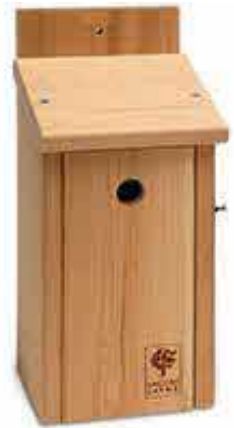
CedarPlus Modern Nest Box

An attractive, natural wooden bird box constructed from cedar for outstanding performance and maximum dependability.

19 and 25mm thickness Canadian cedar for excellent insulation and strength. The natural oils in cedar make this a long-lasting box which weathers attractively. Aluminium fixing nail will not damage tree and is safe when eventually felled. Hinged inspection door with rust-proof catch.

Dimensions 370 x 156 x 175 mm

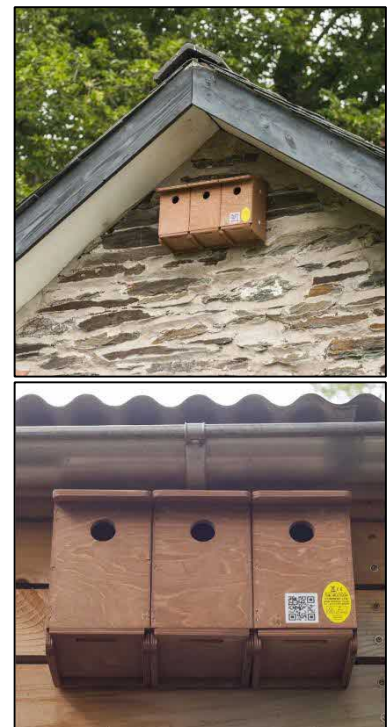
The **Sparrow Terrace** is the perfect way to provide much-needed nesting places for these endangered birds. The Terrace consists of three separate nest boxes which can be fitted next to each other in versatile ways, allowing these colonial birds to nest near to one another. The boxes have a 32mm entrance hole which is the perfect size for sparrows and are constructed from exterior grade FSC plywood, coated with a non-toxic, water-based preservative making it long-lasting and durable. The fixed roof allows fitting right up to the eaves, which is perfect for these birds, and the slide out floor allows inspection and cleaning whilst improving ventilation and drainage. The boxes can be hung to fit the shape of any building: horizontally or vertically, diagonally to fit gable eaves or A-shaped for a gable apex. The Terrace should be installed at least two to four metres off the ground making sure that there is a clear flight path to the nest. Boxes may also be sited directly under the eaves, but make sure that they are away from areas used by house martins. It is simple to add more compatible sparrow boxes later to suit your expanding colony (see images). Boxes can be put together using the plastic pegs provided. These are used to connect one box to the next and also to block off any holes in the sides. Boxes are fixed to the wall with two screws, one each in the left and right box.

Height: 240mm / Width: 376mm / Depth: 170mm / Weight: 2.2kg

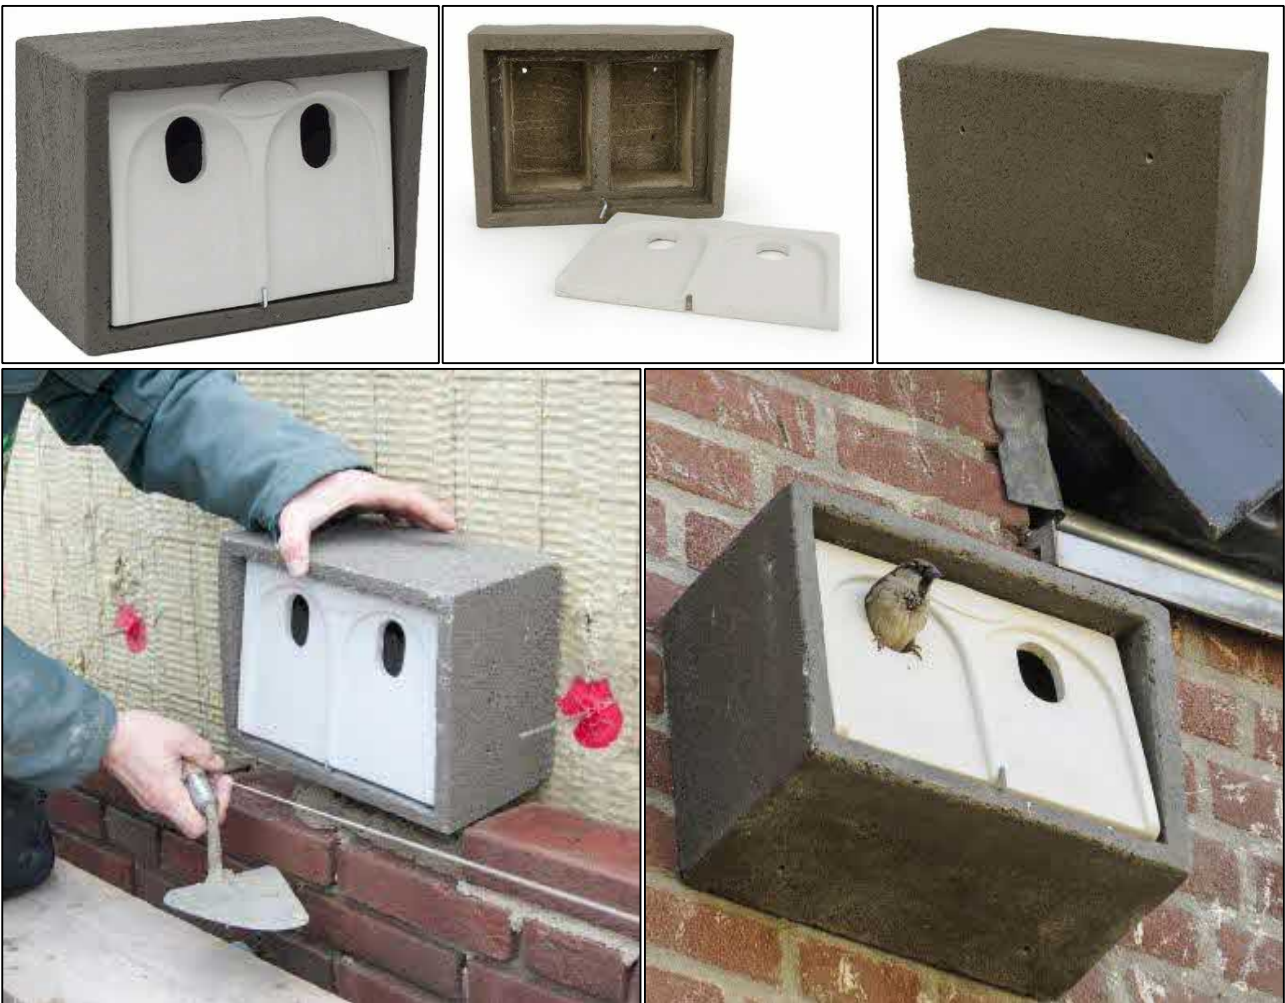
Vivara Pro Woodstone House Sparrow Nest Box

Single Chamber: Weight: 7.25kg / Depth 16cm x Height 29cm x Width 21cm

Double Chamber: Weight: 7.5kg / Dimensions: Depth 16cm x Height 29cm x Width 21cm

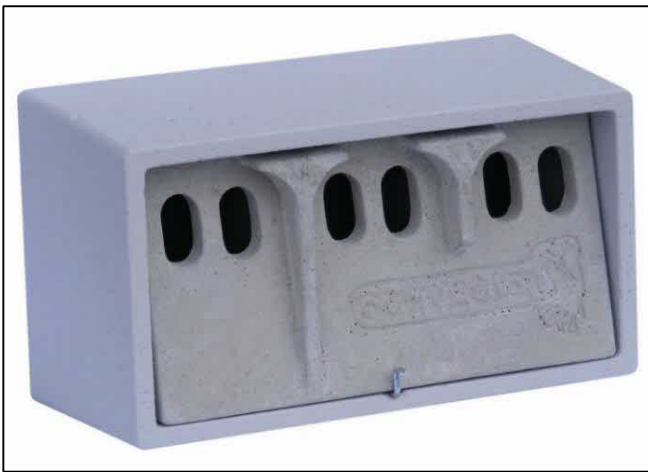
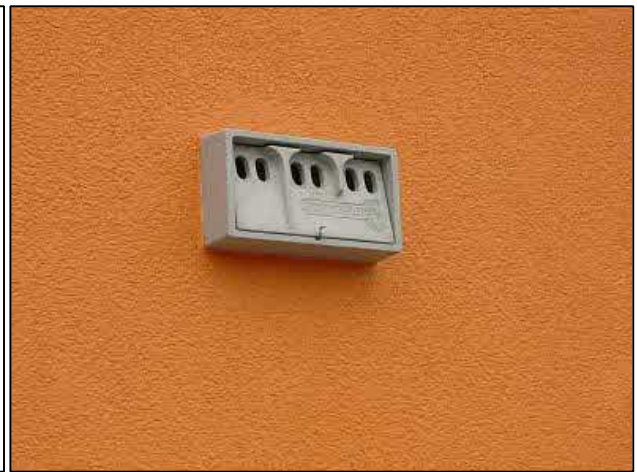
1SP Schwegler Sparrow Terrace

The Sparrow Terrace has been designed to help redress the balance of falling house sparrow numbers. The current UK population of 6 million pairs is half what it was in 1980 and this is thought to be due to habitat destruction and lack of suitable nesting spaces. Sparrows are social birds and like to nest in company. This terrace provides ideal nesting opportunities for three families. Made of Schwegler's revolutionary wood-concrete mix, this terrace is durable, breathable and will last many decades. It may also occasionally attract tits, redstarts and spotted flycatchers.

Brood chamber dimensions: Height: 16cm / Width: 10.5cm / Depth: 15cm

External dimensions: Height: 24.5cm / Width: 43cm / Depth: 20cm / Weight: 15kg

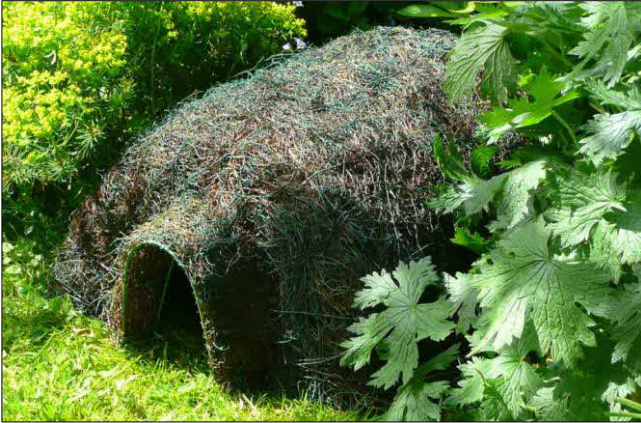
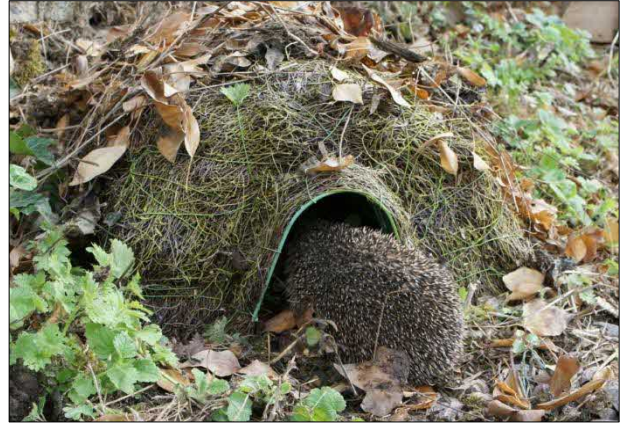
The **Hogitat Hedgehog Home** is designed to be an attractive natural home and safe retreat for hedgehogs. It features a sturdy, rust-proofed steel frame, a waterproofed roof with an attractive natural finish, and a predator defense tunnel. Specifically designed to blend into the garden setting, the Hogitat has an attractive natural appearance that will comfortably nestle into any garden environment. Siting: choose a quiet position out of the prevailing wind in an area with some nearby cover (areas of the garden with slugs - a natural food source).

Features: principally made of natural materials. Economic yet effective safe retreat for hedgehogs, or small mammals.

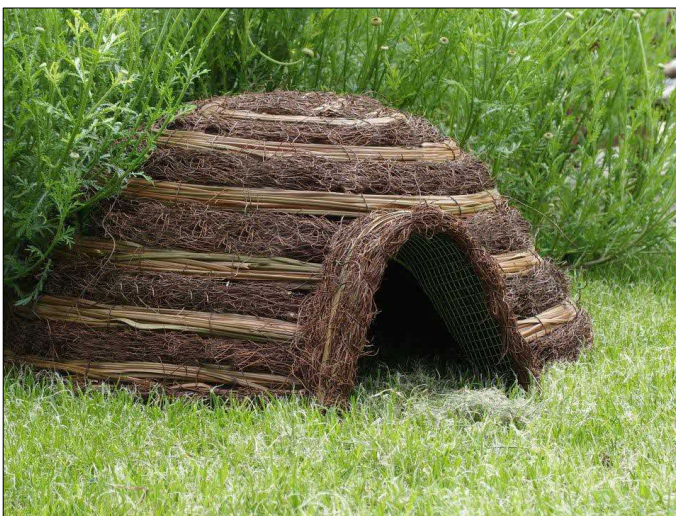
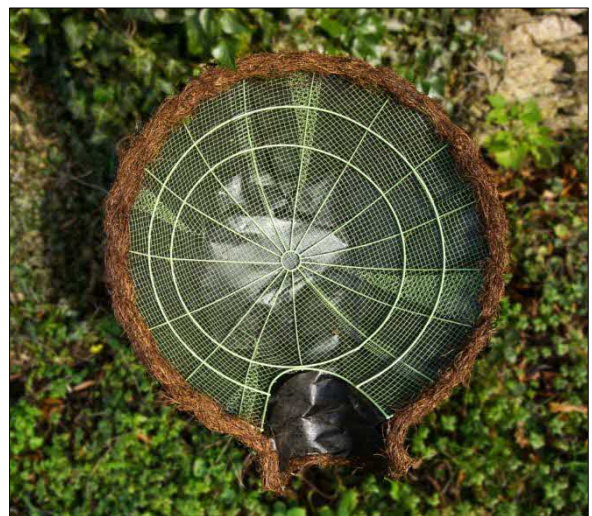
The wicker **Igloo Hedgehog Home** is designed to be an attractive home and a safe retreat for hedgehogs. It is constructed using a round painted steel frame with a water-proofed roof which is covered with a brush wood finish. It is designed to blend into the garden.

The igloo is spacious and can accommodate family groups and the entrance tunnel is designed to provide protection from predators such as badgers and dogs. The Igloo Hedgehog Home is predominately designed for shelter but may also be used during hibernation if additional garden waste is provided as cover.

Height: 22cm / Width: 59cm / Length: 53cm / Weight: 1.5kg
