**THE OLD MANOR HOUSE,
DONNINGTON, WEST SUSSEX**

**PRELIMINARY ECOLOGICAL
APPRAISAL & PRELIMINARY ROOST
ASSESSMENT**

A Report to: Hebden Design Studio

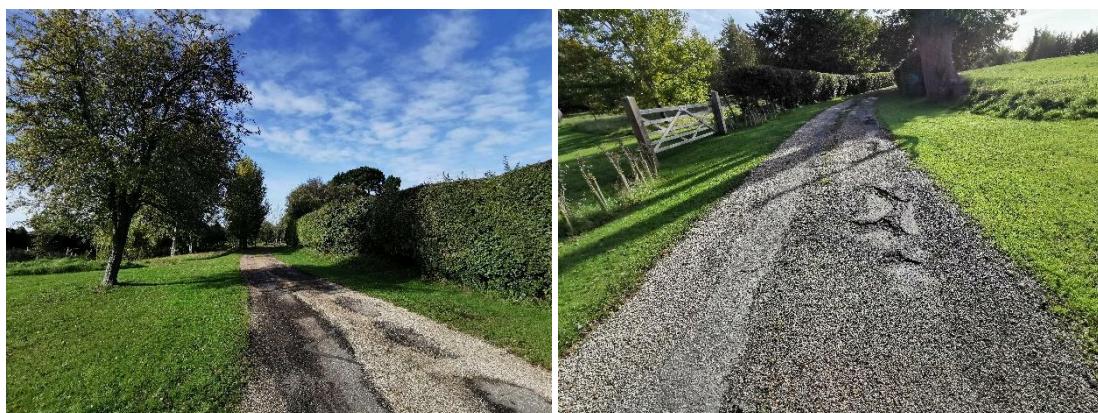
Figure 4. View of the access track

Areas of hardstanding on site are in the form of an access track off Selsey Road B2201 which is over 300m long and extends north-west to the main house and annex building (Figure 4). Other areas of hardstanding include the gravel courtyards to the front of the main house and the annex building (Figure 5). A tennis court is also present in the west of the site (Figure 6).

This habitat is considered to be of negligible ecological value.

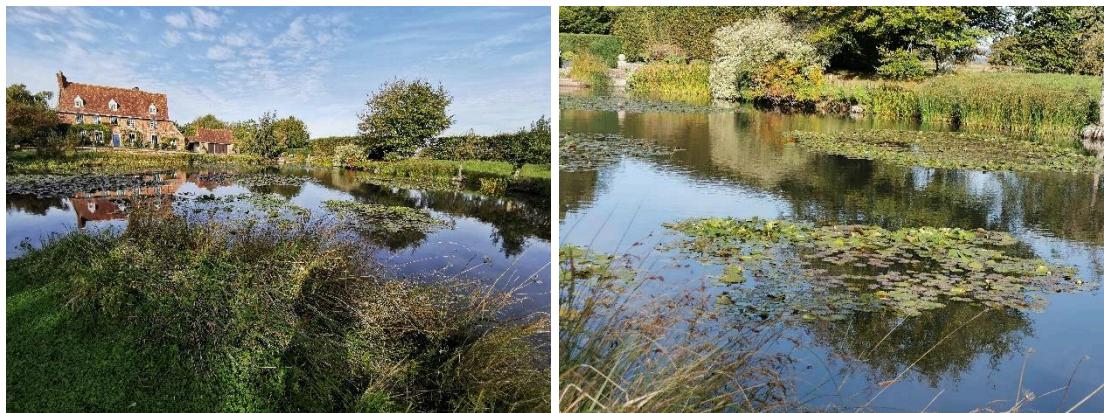
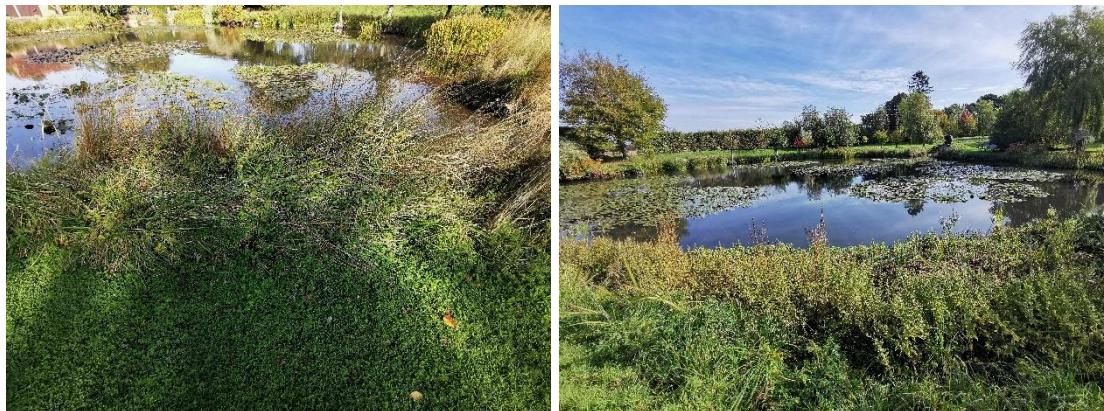
Figure 7. View of the lake on site

A large lake is located to the east of the Old Manor house (Figures 7 & 8). Approximately 50% of the lake is covered by water lilies *Nymphaeaceae*. The water quality is good. At the time of survey, a large population of ducks and a single coot *Fulica atra* were present within the lake. A large number of koi carp were also observed within the lake. A narrow strip of tall grass and herbs surround the lake, with species recorded including rush species *Juncus sp.*, common fleabane *Pulicaria dysenterica*, gypsywort *Lycopus europaeus*, yarrow *Achillea millefolium*, red clover *Trifolium pratense*, nettle *Urtica dioica*, bittersweet *Solanum dulcamara*, yellow flag *Iris pseudacorus* and some ornamental grass. Scrub and ornamental shrub are also scattered along the periphery of the lake.

This lake is considered to be of 'local' value.

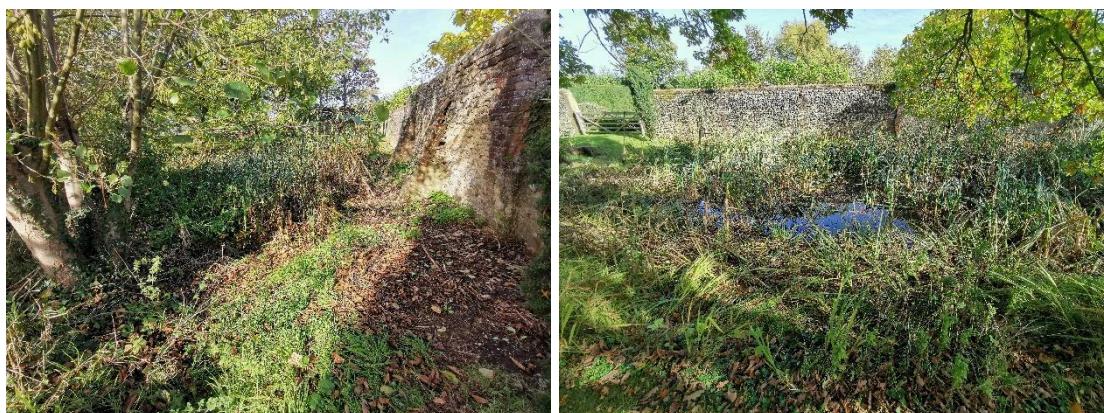
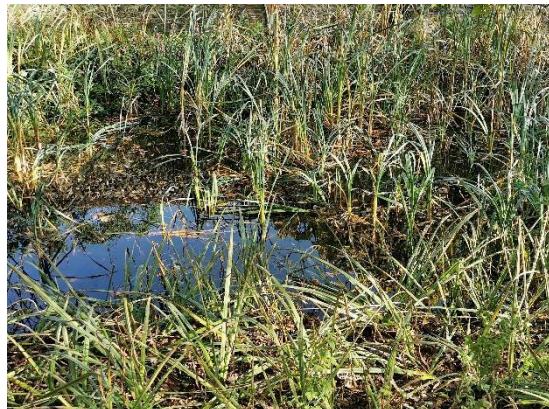
Figure 9. View of the pond in the west of the site

A relatively small pond is located to the south of the formal garden (Figures 9 & 10). The water in this pond is clear and considered to be of good quality. Bulrush *Typha Latifolia* is the dominant species within the pond, with only 20% of open water present. Soft rush *Juncus effusus* is also present in this area.

Ponds provide important habitats for a range of flora and faunal communities. The pond on site is of good quality and forms part of a networks of ditches and ponds in the wider landscape. Therefore, it is appointed a 'local' value.

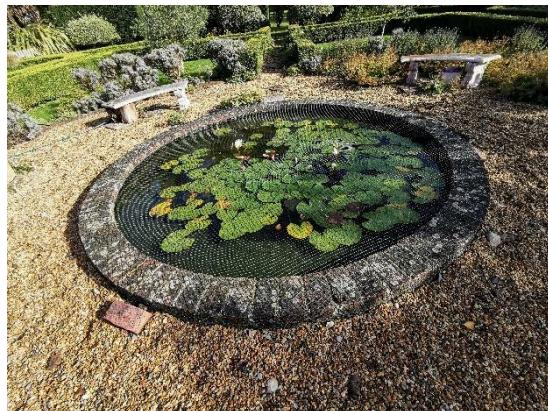
Figure 11. Man-made pond in the centre of the formal garden

A small, man-made, concrete pond covered by water lilies and a net on top is located in the centre of the formal garden (TN2) (Figure 11).

This pond is small in extent and surrounded by areas of hardstanding and managed shrubs. Therefore, it is considered to be of 'site' value only.

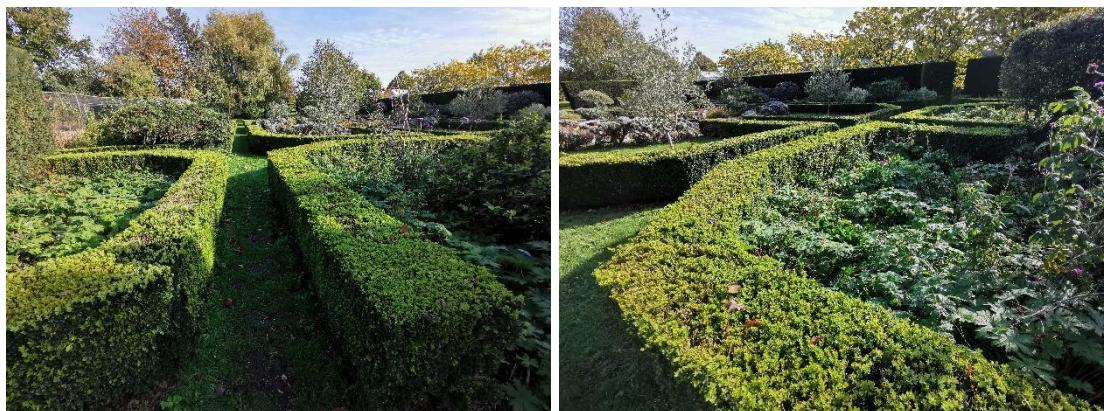
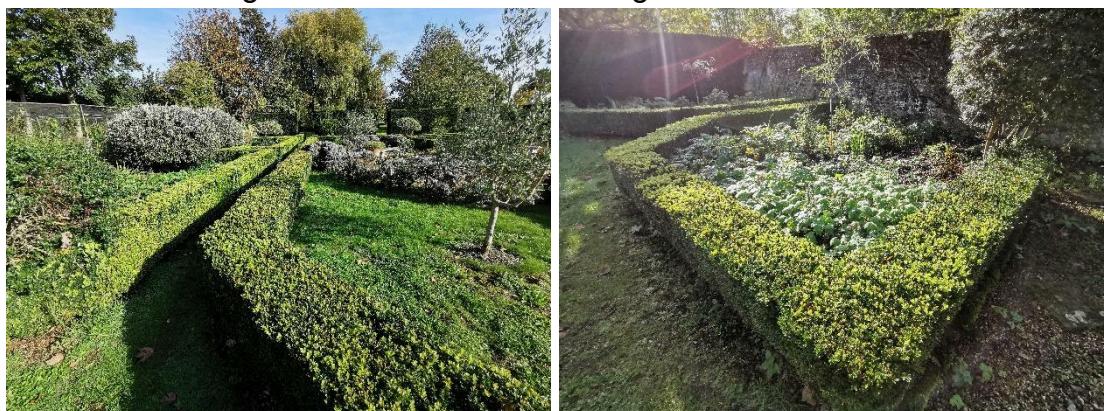
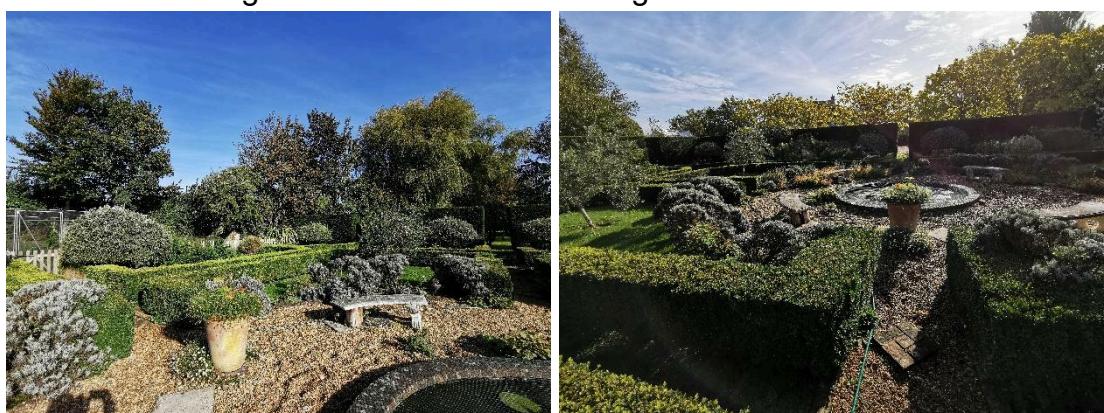
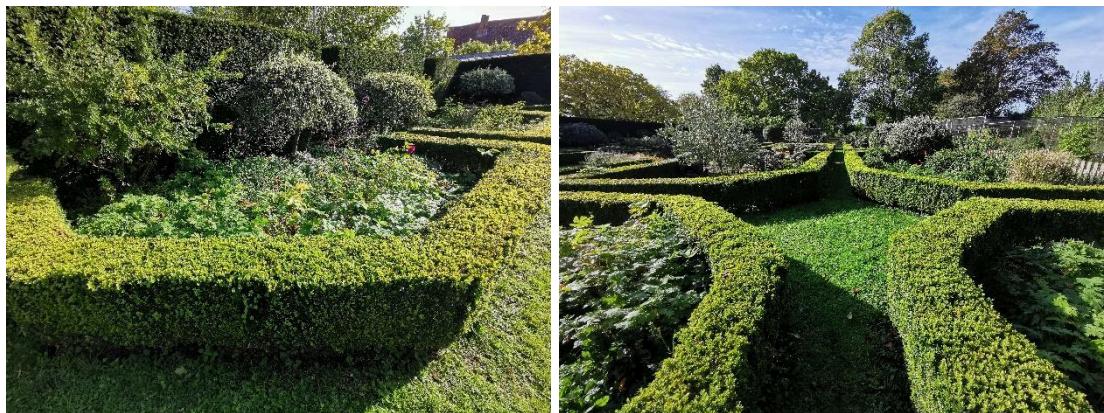
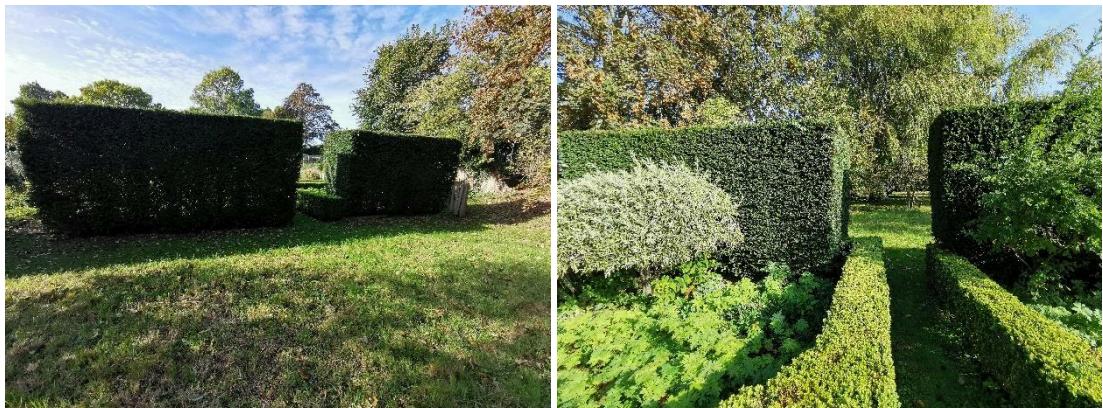
Figure 12. View of the formal garden in the west

A formal garden with a symmetrical layout is located in the west of the site (TN3) (Figures 12 – 16) and comprises low, box hedges *Buxus sp.* with ornamental shrubs and flowers and gravel/grass pathways. A small concrete pond is located in the centre of the formal garden (Figure 11). The shrubs and flowers recorded include vervain *Verbena sp.*, lavender *Lavendula sp.*, geranium species *Geranium sp.*, olive *Olea europaea*, moon daisy *Leucanthemum vulgare*, rosemary *Salvia rosmarinus*, aster *sp.*, hypericum species *Hypericum sp.*, Darwin's barberry *Berberis darwinii*, orpine *Hylotelephium telephium* and rose *Rosa sp.* The formal garden is enclosed by a managed yew *Taxus baccata* hedge,

approximately 2m tall, along the northern boundary and a brick wall along the southern boundary.

Whilst this habitat is of value to wildlife such as invertebrates, due to its management regime and mainly non-native nature, it is appointed a 'site' value.

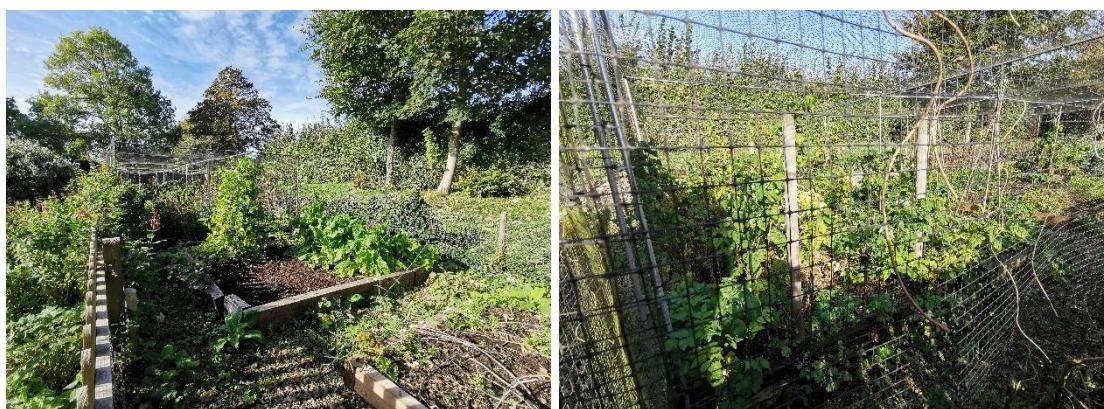
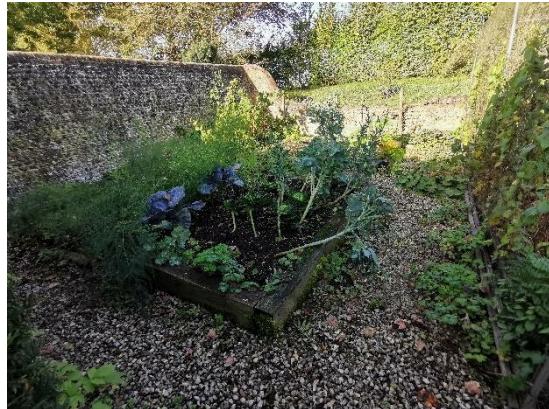
Figure 17. View of the vegetable patch in the west

A vegetable patch is located along the western boundary of the formal garden and at the time of survey contained tomatoes, raspberries, broad beans, runner beans, rhubarb and cabbage (Figures 17 & 18) (TN4). This habitat is of 'site' value.

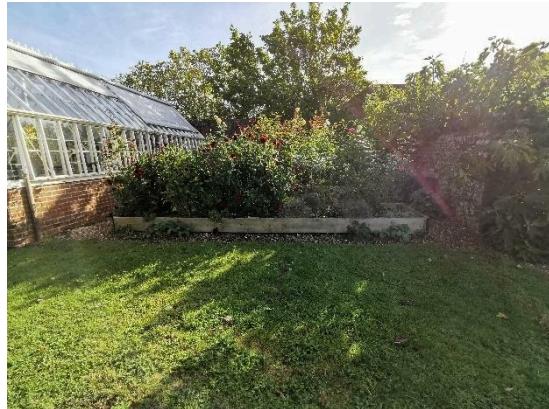
Figure 19. Flowerbed to the south of the greenhouse

A flowerbed, mainly dominated by roses, is located immediately to the south of the greenhouse on site (TN5) (Figure 19). This habitat is of 'site' value only.

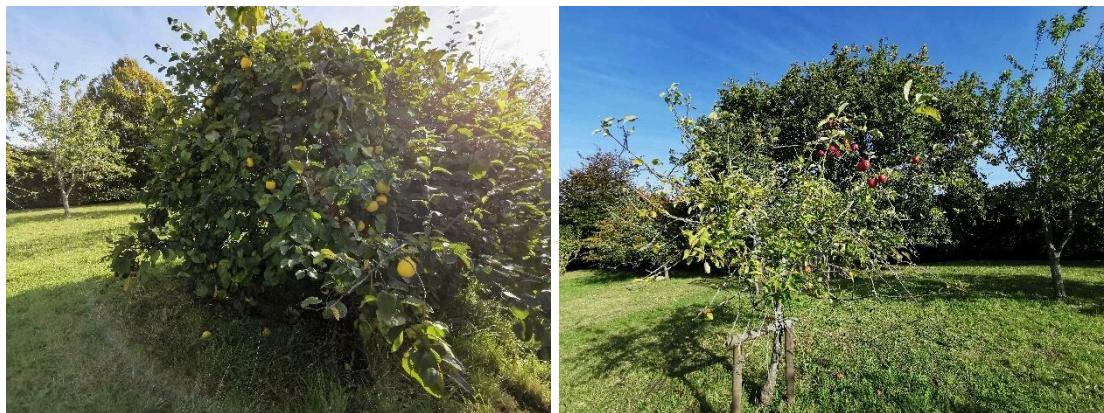
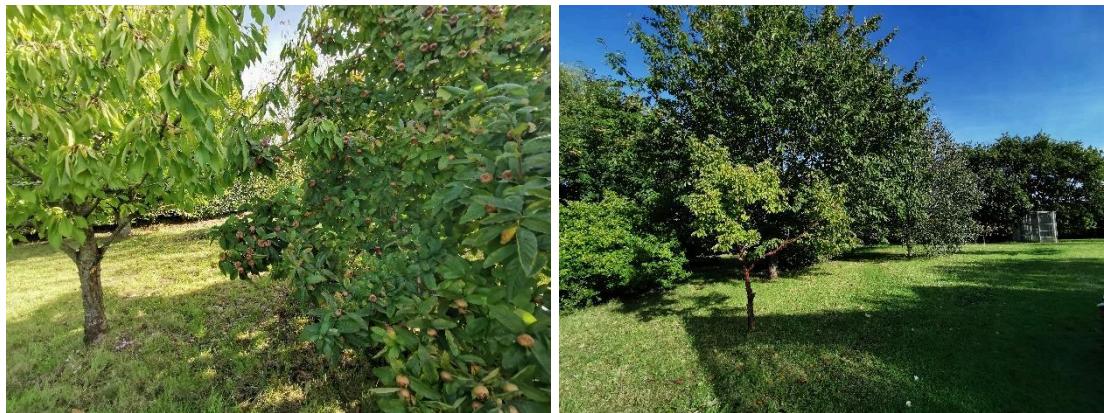
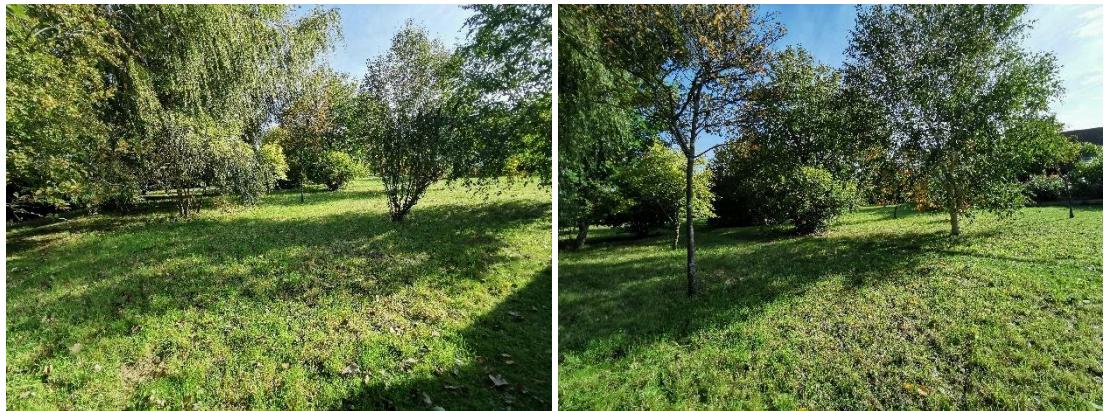
Figure 20. View of the orchard on site

An orchard is located in the north (TN6) (Figures 20 – 22). Fruit trees recorded in this habitat include early mature medlar *Mespilus germanica*, plum *Prunus* sp., mulberry *Morus* sp., pear *Pyrus* sp., cherry *Prunus* sp., different varieties of apple *Malus* sp. and quince *Cydonia oblonga*. The amenity grassland below the trees is managed and supports a short sward height. In addition to the fruit trees which are mainly located in the eastern half, other trees such as weeping willow *Salix babylonica*, sycamore *Acer pseudoplatanus*, silver birch *Betula pendula*, ash *Fraxinus excelsior*, oak *Quercus robur*, beech *Fagus sylvatica*, guelder rose *Viburnum opulus*, hawthorn *Crataegus monogyna*, broad-leaved cockspur thorn *Crataegus persimilis* and tulip tree *Liriodendron tulipifera* are present.

Whilst the orchard on site appears to be of recent origins and is limited in extent, orchards are a Priority Habitat and for that reason it is given a 'local' value.

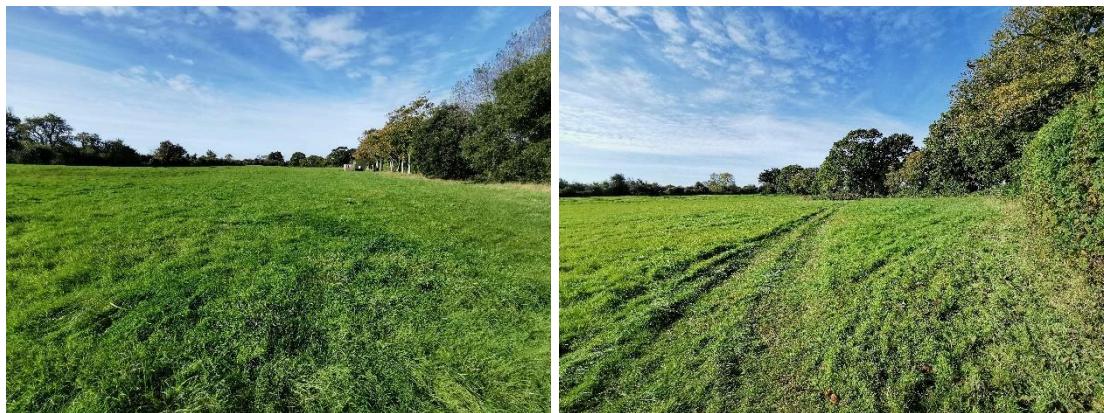
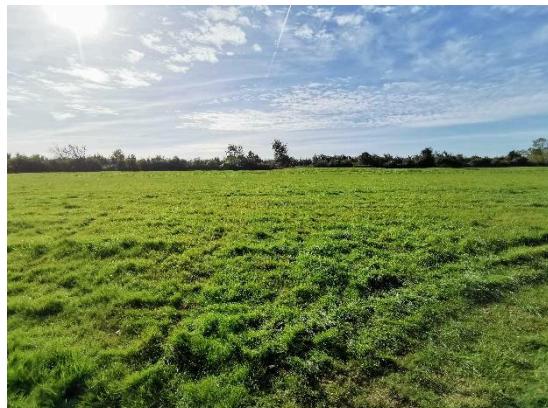
Figure 23. View of the semi-improved grass field in the west, looking west

The southern half of the site is covered by an irregular shaped field of semi-improved grassland (Figures 23 & 24). The sward height was relatively short at the time of survey (approximately 200mm high). The dominant grass is perennial ryegrass *Lolium perenne*, with fescue *Festuca sp.*, Yorkshire fog *Holcus lanatus*, cocksfoot *Dactylis glomerata*, nettle and dove's-foot crane's-bill *Geranium molle* also present.

This habitat is of low species diversity and due to its management regime, it is of low structural diversity as well. Semi-improved grassland is common locally and nationally and therefore this habitat is appointed a 'site' value only.

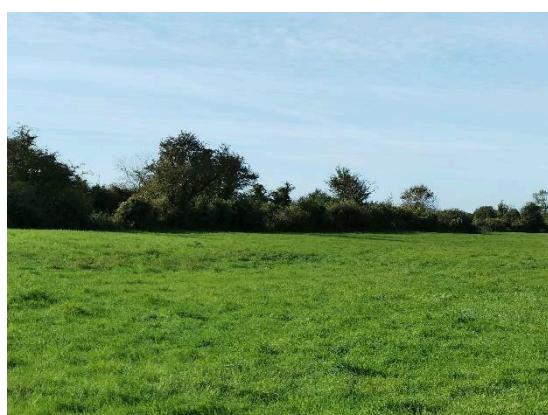
Figure 25. View of the scrub along the southern boundary of the site

A narrow strip of continuous scrub forms the southern boundary of the semi-improved grass field located in the southern half of the site (Figure 25). The dominant species recorded is bramble *Rubus fruticosus*, with other frequent species including hazel *Corylus avellana*, willow *Salix* sp., hawthorn and elder *Sambucus nigra*.

This habitat is common locally and could be easily created and therefore is considered to be of 'site' value.

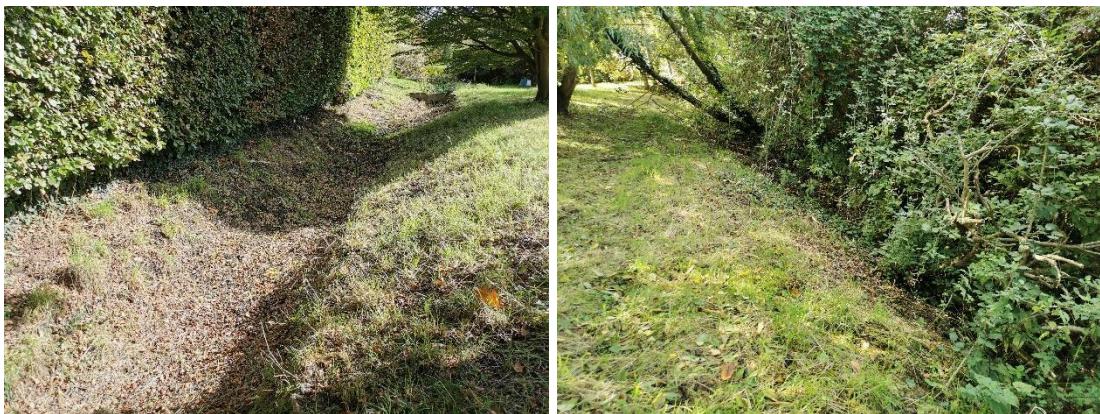
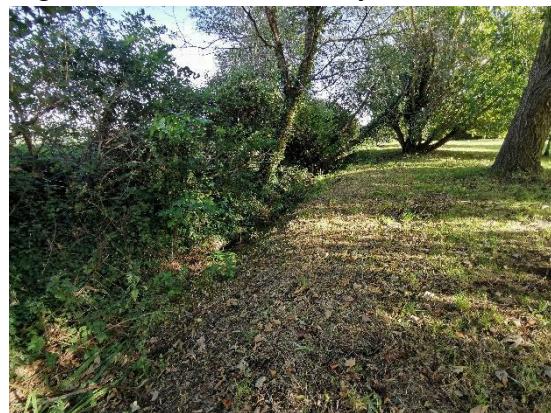
Figure 26. View of the dry ditch on site

Along the northern and western boundaries of the orchard is a ditch, which was dry at the time of survey (Figures 26 & 27). No marginal or in channel vegetation were present, with a single willow growing within the ditch. A dry drainage ditch is also present along the western boundary of the semi-improved grass field, with another drainage ditch along part of the southern boundary of the access track (dry at the time of survey).

Due to the lack of water within this feature, it is appointed a 'site' value only.

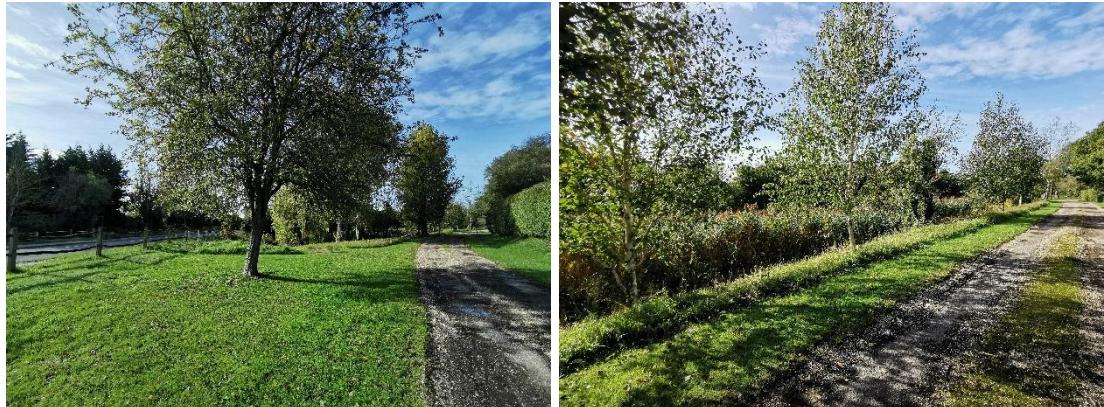
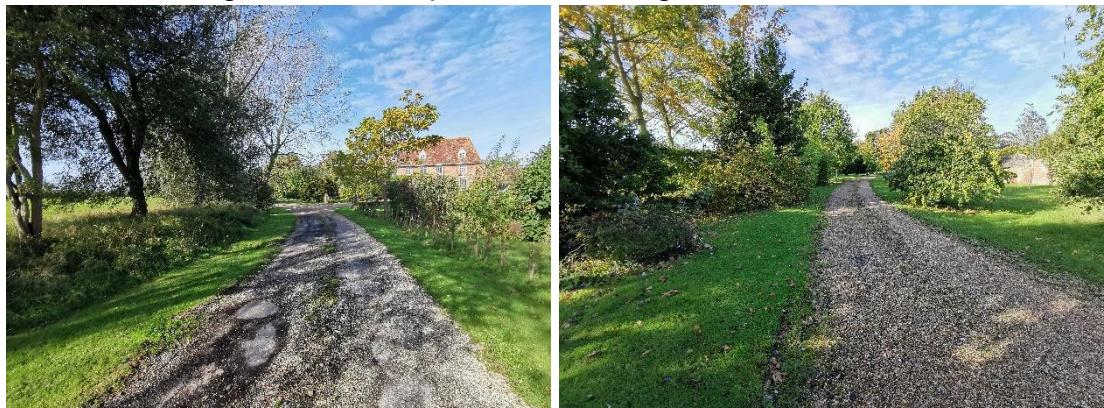
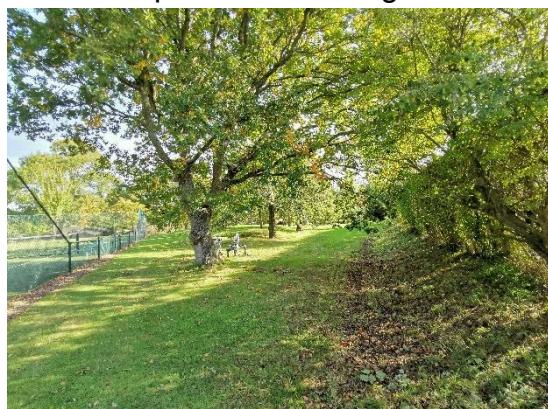
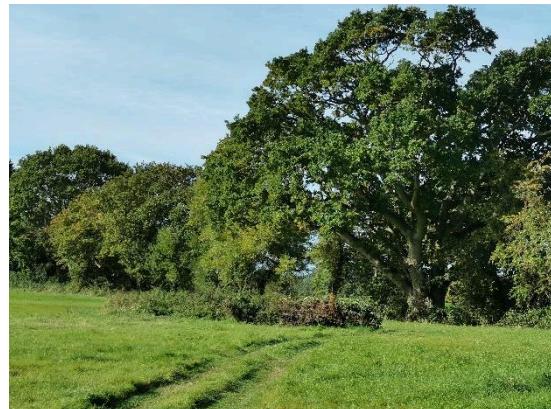
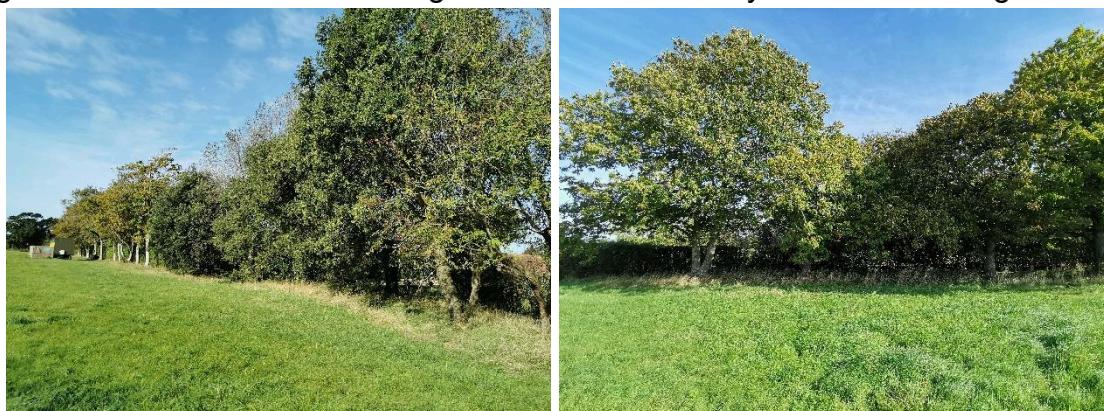
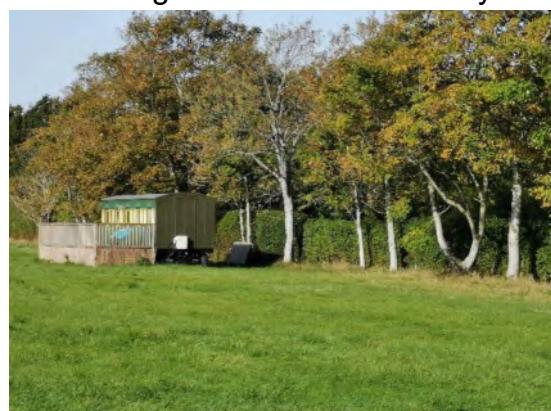
Trees are dotted along the southern boundary of the access track (Figures 28 & 29), in addition to a number of trees to the west of the tennis court (Figure 30). The western boundary of the semi-improved grass field is also lined with mature and semi-mature trees

such as oak, field maple *Acer campestre*, hawthorn, willow and hazel (Figure 31). Another line of trees is located along the northern boundary of the semi-improved grass field, with the species recorded including semi-mature white poplar *Populus alba*, holm oak *Quercus ilex*, sycamore, hawthorn and sweet chestnut *Castanea sativa* (Figures 32 - 34).

The treelines and group of trees on site provide suitable habitat for a wide range of protected and notable species. Furthermore, due to the semi-mature and mature nature of some of these trees, their large number and connectivity to the wider landscape, they are considered to be of high ecological value. Therefore, scattered trees on site are appointed a 'local' value.

- Σ Any trees required to be cleared to facilitate the development should be replaced with native trees. Recommended species to be used in the soft landscaping scheme include rowan *Sorbus aucuparia*, crab apple *Malus sylvestris*, cherry *Prunus avium*, yew, oak, common lime *Tilia × europaea*, horse chestnut *Aesculus hippocastanum* and beech.
- Σ Should any areas of amenity grassland be lost, it is recommended that a wildflower meadow seedmix such as Emorsgate EM1 is used to replace this habitat, which is of higher biodiversity value to standard lawn seed mixtures.
- Σ A selection of bird and bat boxes are recommended to be installed on the mature trees on site.

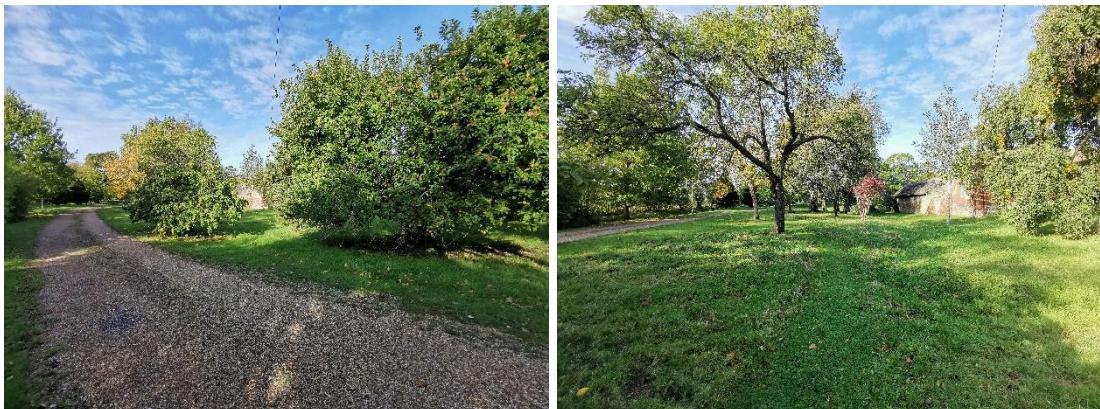
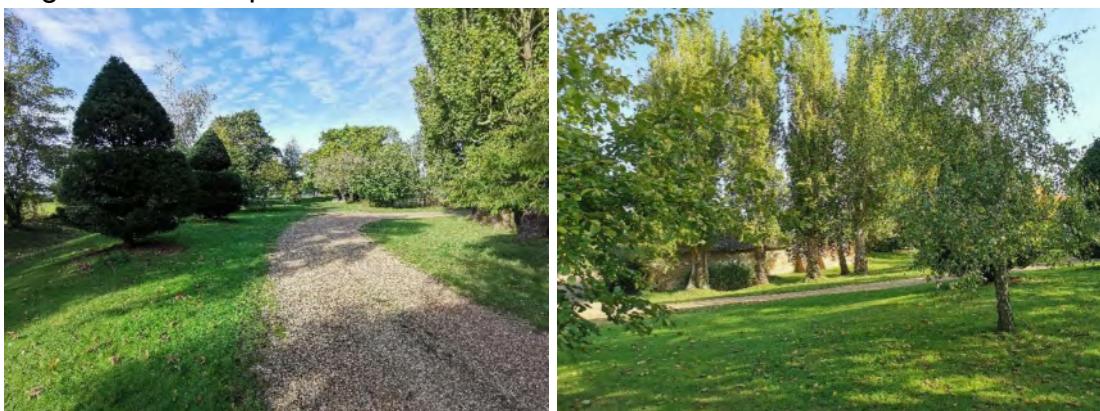
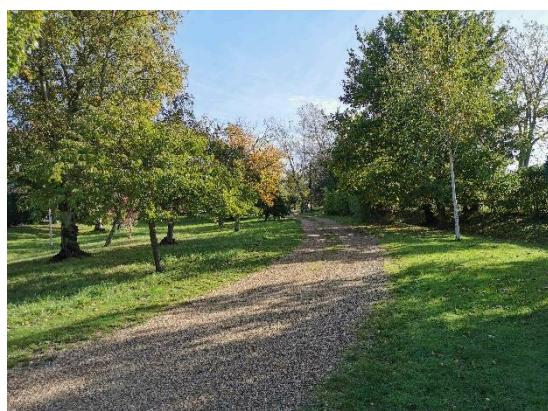
Figure 35. Example of trees to the south of the Old Manor House and annex

Another group of trees is located to the south of the Old Manor House, Annex and the formal garden and comprises quince, mature Lombardy poplar *Populus nigra*, cherry, silver birch and apple (Figures 35 – 37).

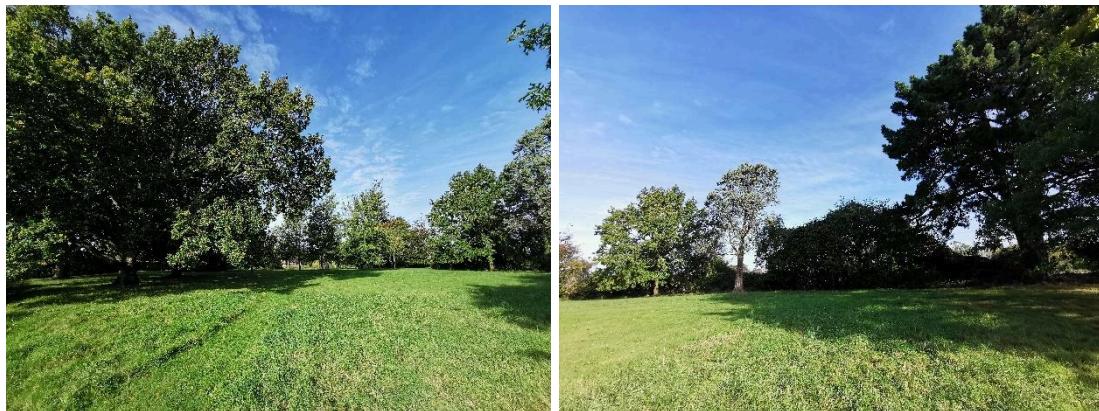
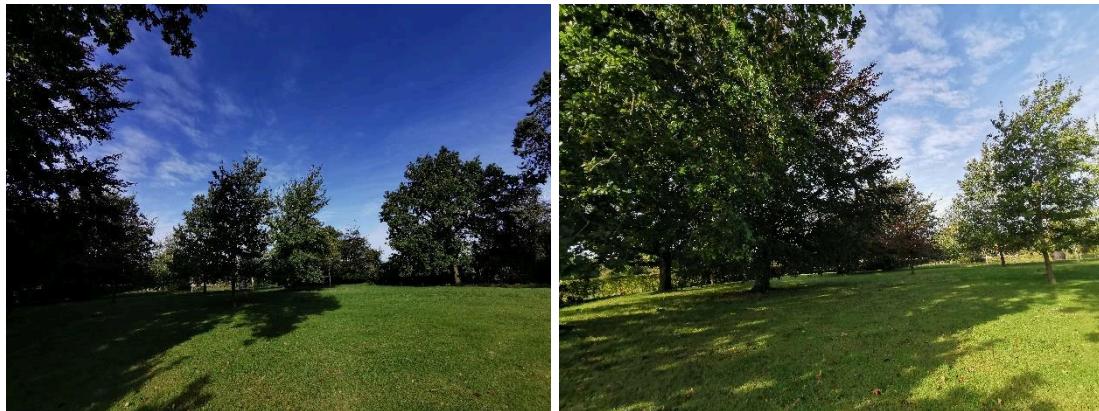
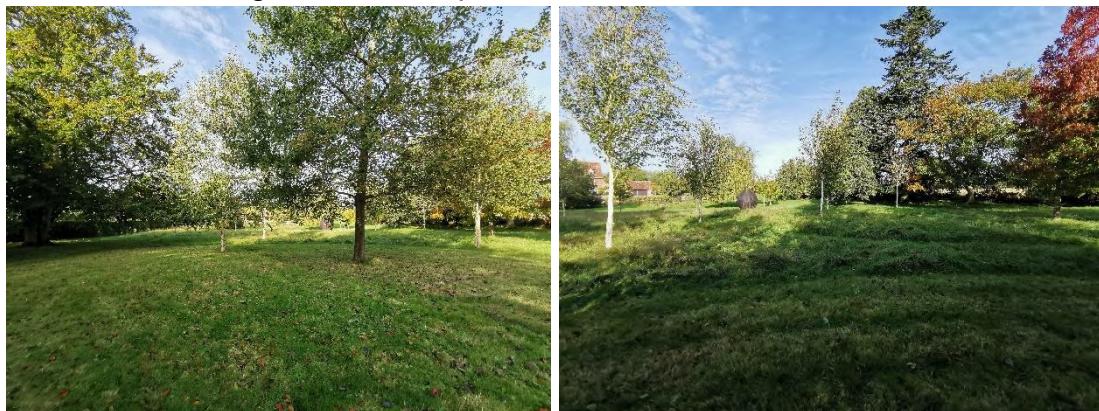
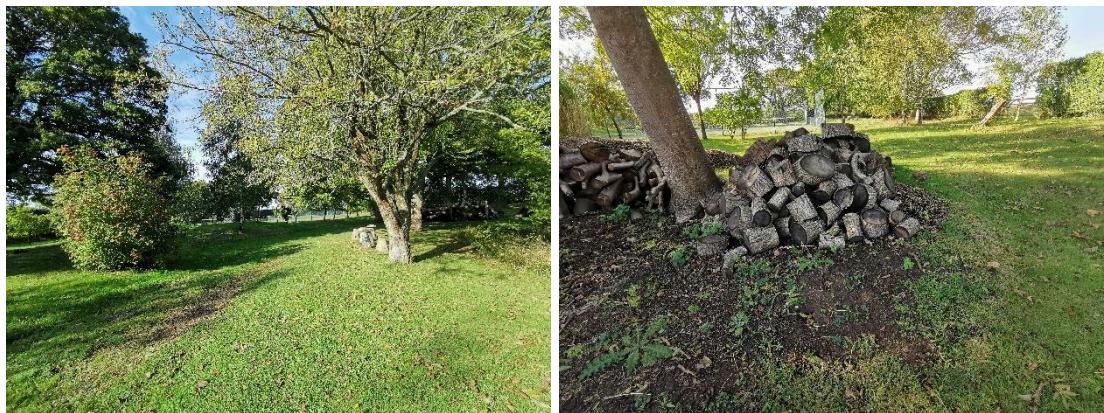
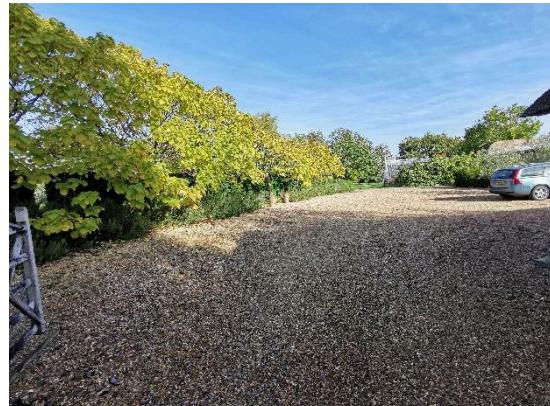
In the eastern part of the site is another area of parkland, with the trees present including weeping willow, copper beech *Fagus sylvatica f. purpurea*, beech, oak, silver birch, holm oak, alder *Alnus glutinosa* and pine *Pinus sp.* (Figures 38 - 40). Another group of trees scattered within areas of managed amenity grassland is located to the east of the tennis court and comprises olive trees, oak, silver birch, topiary yew *Taxus baccata*, beech, ash,

guelder rose, alder, field maple and cherry (Figure 41). A line of ornamental trees is also present along the western boundary of the annex's courtyard (Figure 42).

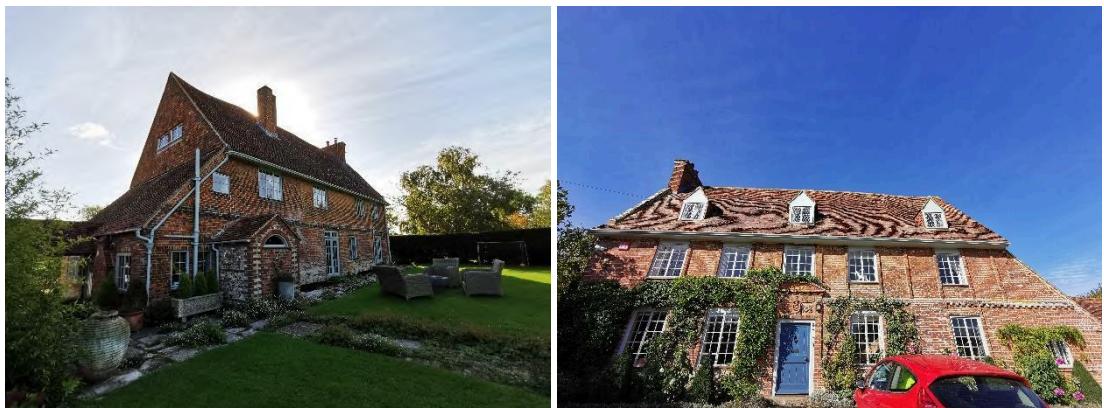
The main house on site is a large, two-storey brick building with a pitched roof covered by clay tiles, dating back to the 17th century (Figure 54). A lean-to extension adjoins the northern elevation (Figure 55). The eastern roof supports three dormers, with the sides covered by hanging tiles (Figure 56). The northern gable-end is covered by hanging tiles (Figure 57). Presence of minor gaps behind the hanging tiles could not be ruled out. The roof tiles are generally in a good state of repair; however, gaps under some of the roof tiles is present (Figures 58 – 60). The ridge tiles appear to be in a good condition. A window is present in the northern gable-end, with two windows in the southern gable-end. The southern gable-end is in a good state of repair (Figure 61). A brick chimney is present in the western elevation, along with another chimney within the southern gable-end. The lead flashing around the base of the chimneys appears to be tightly sealed (Figures 62 & 63). Soffits are tightly sealed with no gaps present along the eaves (Figures 64 & 65).

Figure 54. View of the eastern (right) and western (left) elevations of the Old Manor House

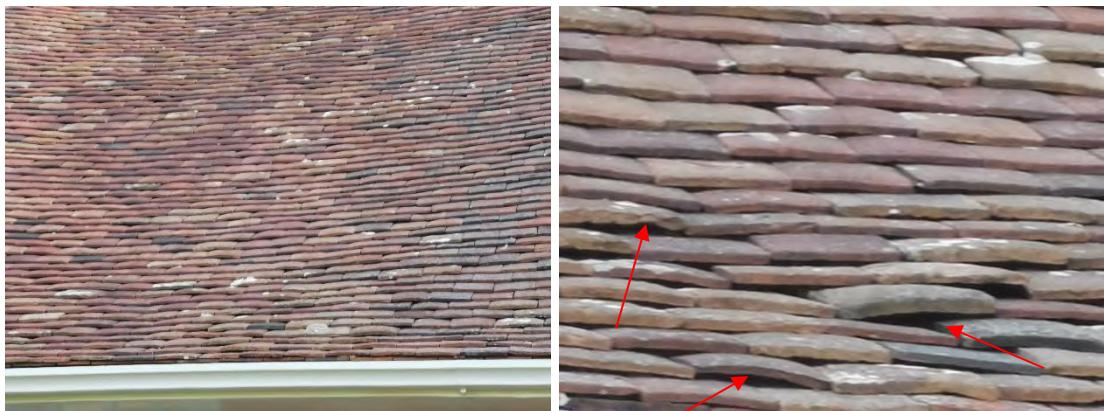
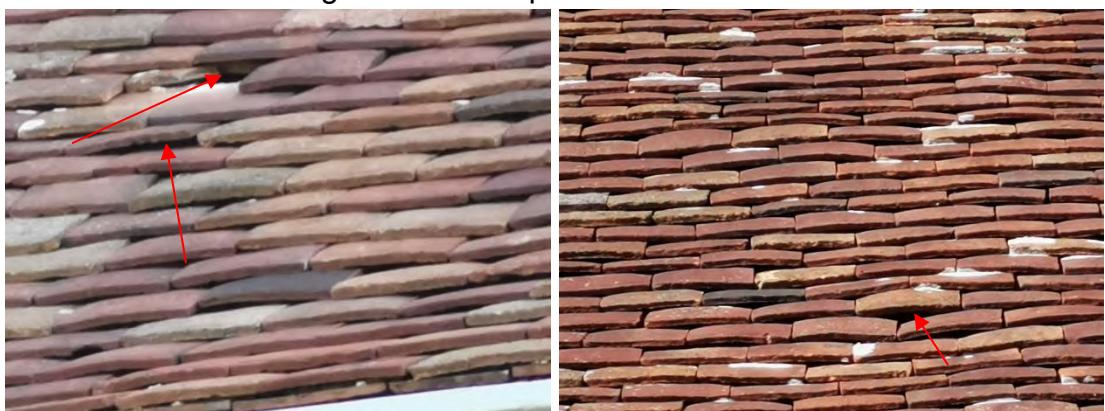
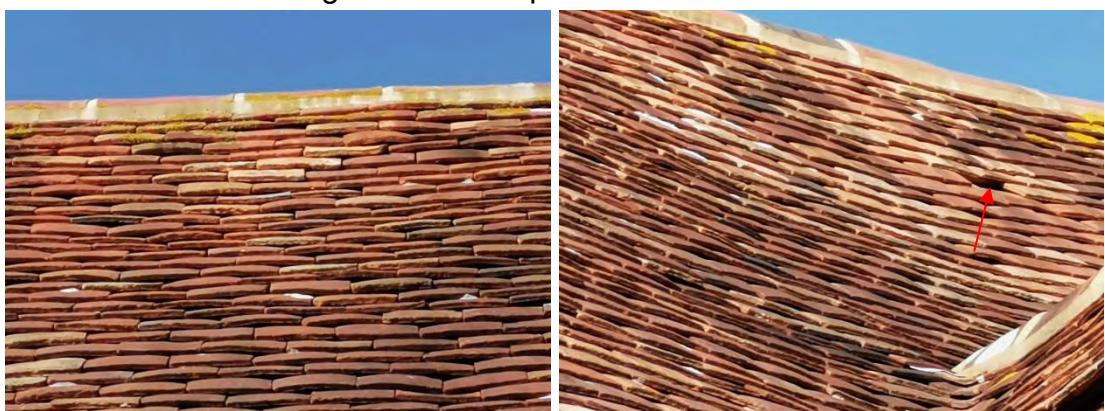
Figure 58. Example of lifted roof tiles

Figure 59. Example of lifted roof tiles

Figure 60. Example of lifted roof tiles

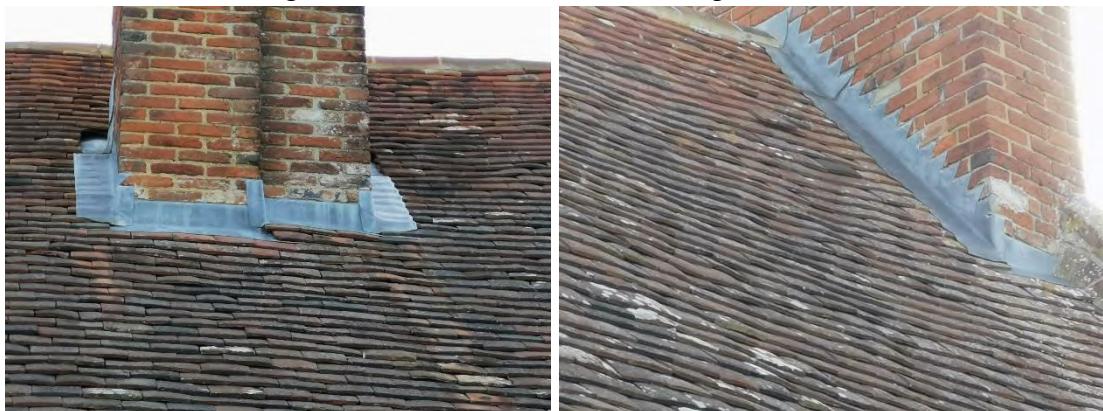
Figure 62. View of the lead flashing around the base of the chimney

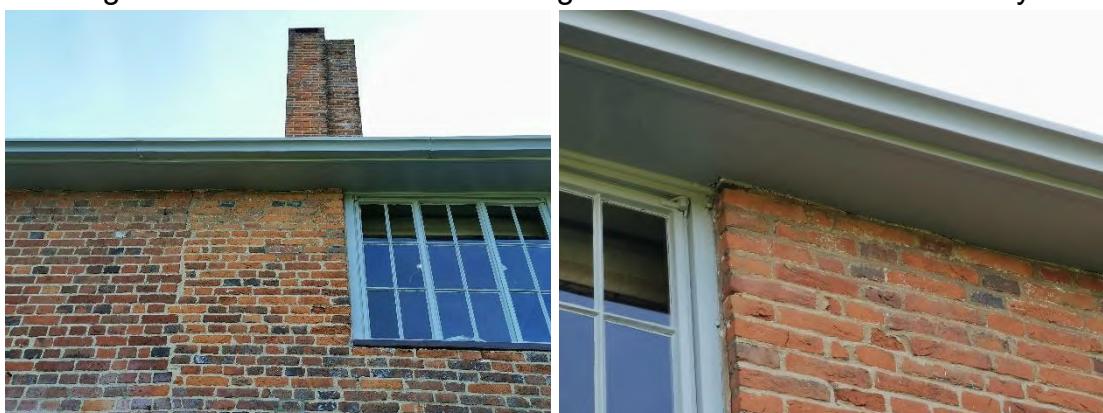
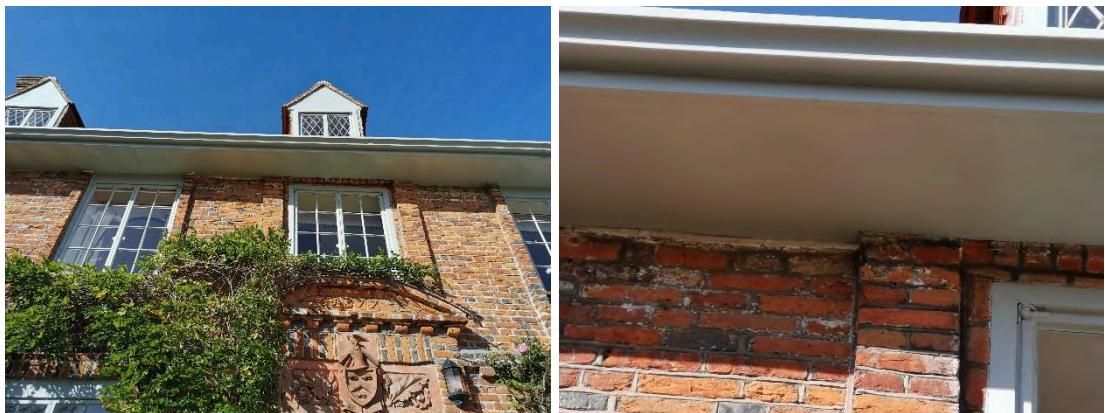
Figure 64. View of the tightly fitted soffit

Figure 65. View of the tightly fitted soffit

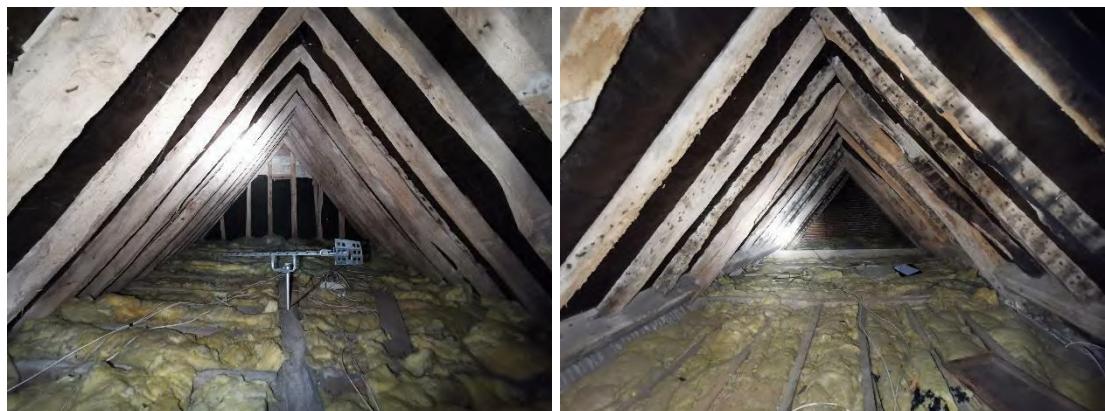
Internally, a single roof void, approximately 13m long is present (Figures 66 & 67). The apex to floor height is approximately 1.5m. The floor is insulated. Roofing felt is present between the rafters and the roof tiles. The roofing felt is in a good condition with no tears or cuts present (Figure 68). No ridge beam is present (Figure 69). One of the gable-ends is brick with the other one covered by roofing felt and vertical beams.

Figure 66. Internal view of the loft void

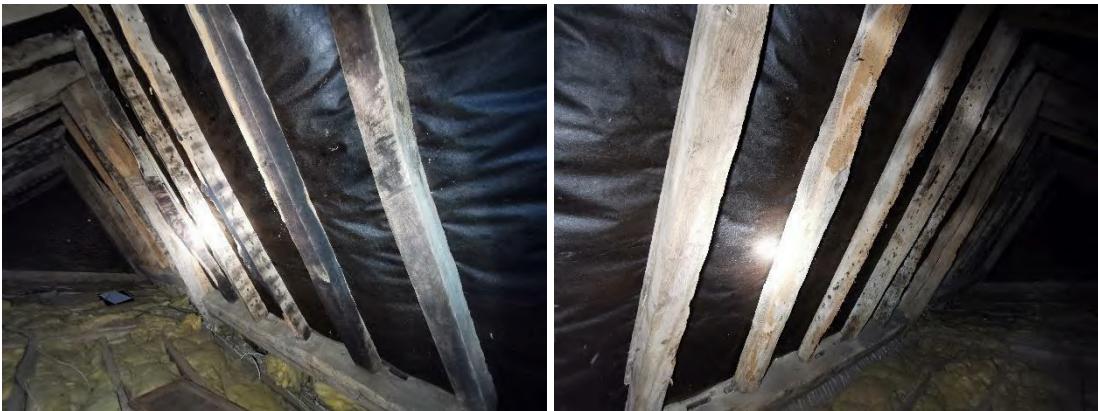
Figure 68. View of the roofing felt

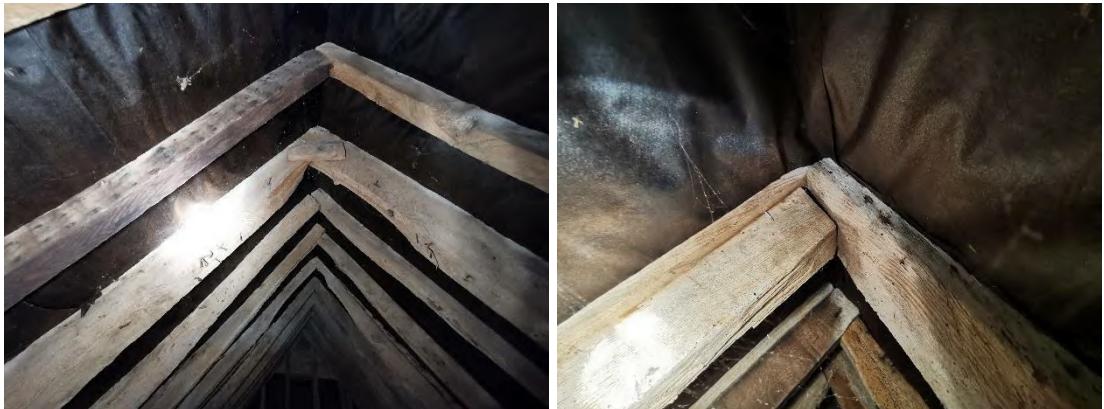
Figure 69. No ridge beam present

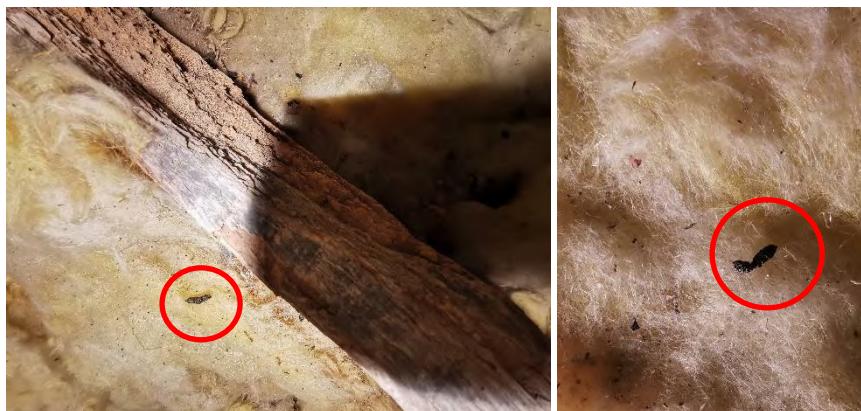
Evidence of bats in the form of three droppings was found during the internal inspection of the loft void (Figure 70). Rodent droppings were also recorded on the loft floor.

Figure 70. Bat droppings found in the loft space

The main house and the garage are considered to be of high potential to roosting bats. Therefore, any works to these buildings has the potential to disturb or kill/injure bats and result in the loss/damage of a roosting location, if present. As such, a recommendation is made in Section 7.

The main dwelling and garage on site have been identified as having high potential to support roosting bats. Bat Surveys: Good Practice Guidelines published by the Bat Conservation Trust (Collins, 2016) recommends that for structures with high bat roosting potential three dusk emergence/dawn re-entry surveys are undertaken during the bat active season to determine the presence or absence of roosting bats. The peak bat survey season extends from May to August.

If a roost is discovered during these surveys, a Natural England European Protected Species licence may be required to enable the proposals. The licence application process will include the submission of a method statement detailing the current status of bats on site and how the favourable conservation status of the bat population will be maintained. Prior to a licence being issued, planning permission must be granted and relevant conditions relating to protected species must be discharged.
