**THE OLD MANOR HOUSE,
DONNINGTON, WEST SUSSEX**

**PRELIMINARY ECOLOGICAL
APPRAISAL & PRELIMINARY ROOST
ASSESSMENT**

A Report to: Hebden Design Studio

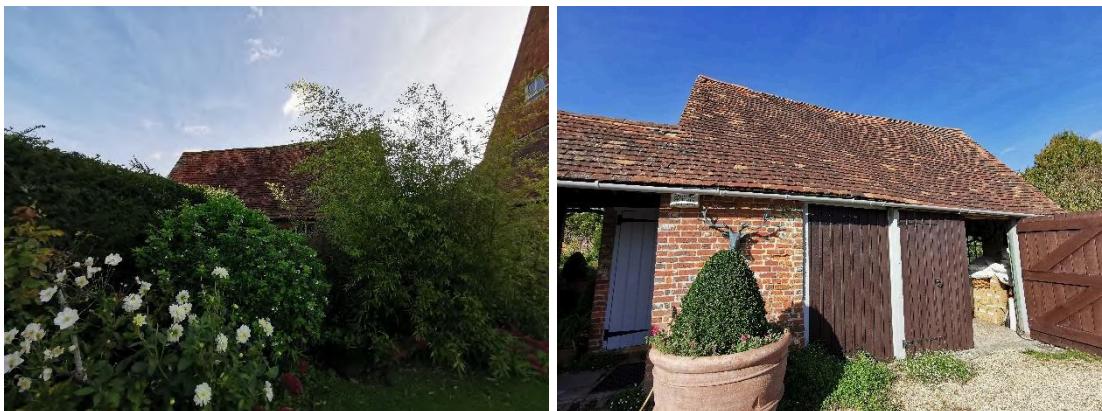
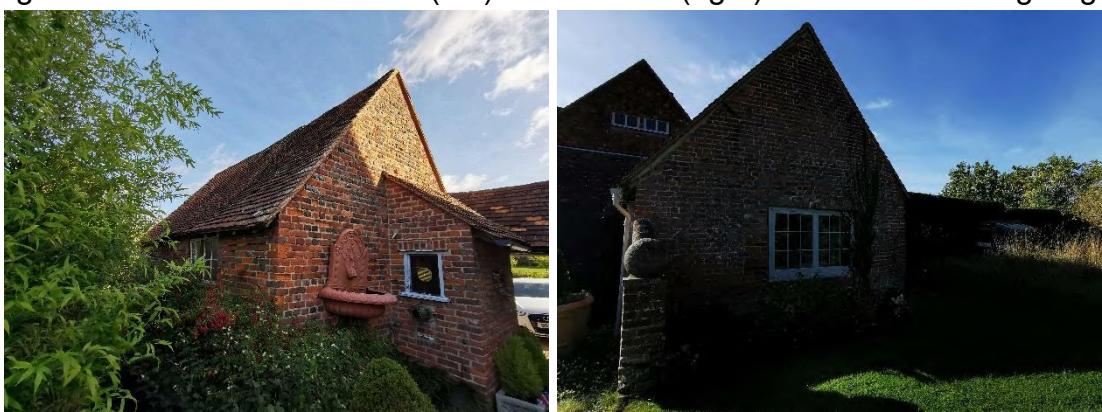
A detached garage is linked to the main house via a covered walkway (Figures 71 & 72). The garage supports a pitched roof, covered by clay tiles. The front elevation contains two wooden doors. The roof is in a relatively poor state of repair and contains a number of missing and lifted roof tiles, providing access into the void or potential roost features (Figures 73 - 76). Some of the ridge tiles are also missing (Figure 76). The brick gable-ends are in a good condition and tightly sealed.

Figure 71. View of the western (left) and eastern (right) elevations of the garage

Figure 72. View of the southern gable-end and the western elevation (left) and northern (right) elevation of the garage

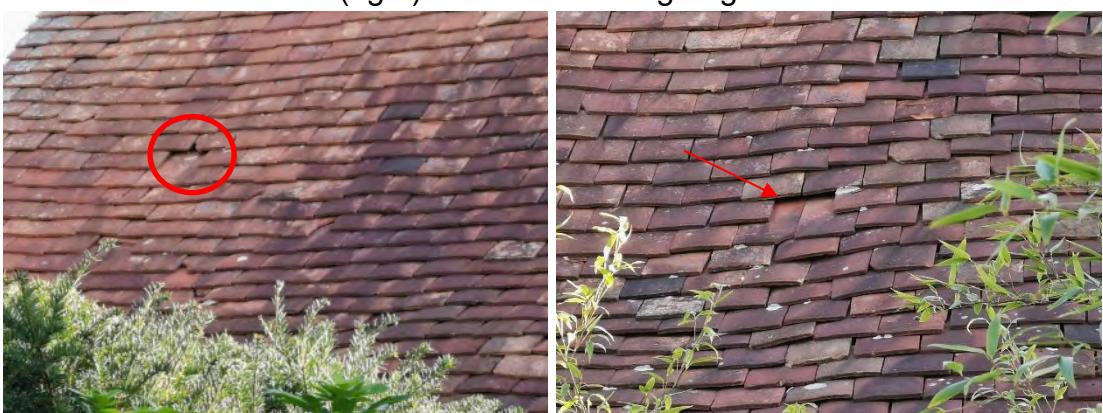
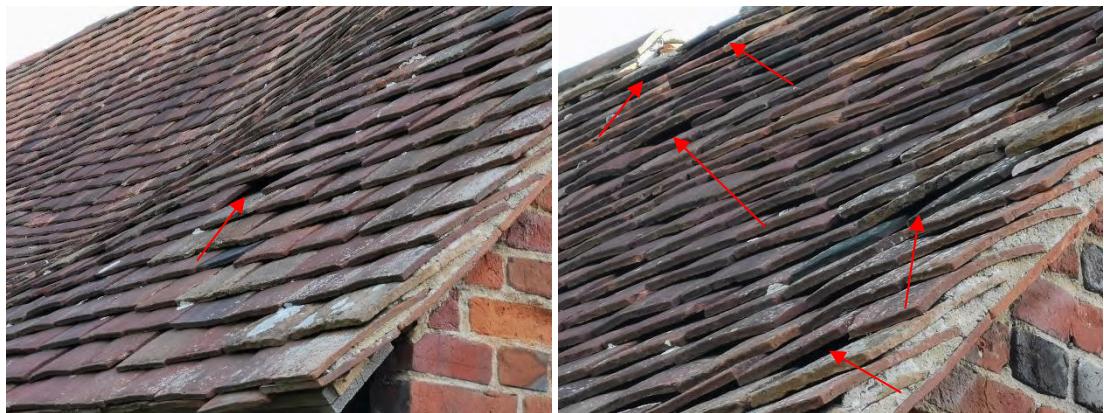
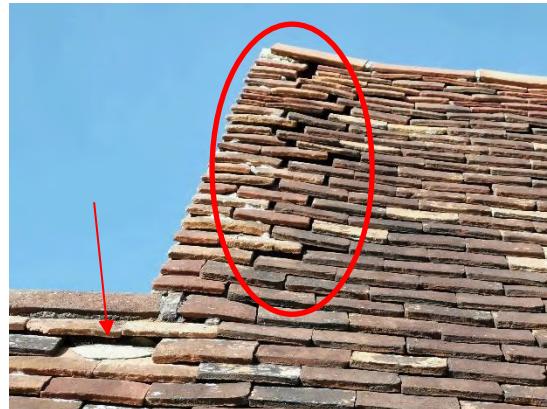
Figure 73. Example of missing and lifted roof tiles

Figure 74. Example of missing and lifted roof tiles

Figure 75. Example of missing and lifted roof tiles

No evidence of bats in the form of droppings, feeding remains, urine staining, etc. was found during the external and internal inspection of the garage. Overall, the garage is considered to be of high potential to roosting bats.

The main dwelling and garage on site have been identified as having high potential to support roosting bats. Bat Surveys: Good Practice Guidelines published by the Bat Conservation Trust (Collins, 2016) recommends that for structures with high bat roosting potential three dusk emergence/dawn re-entry surveys are undertaken during the bat active season to determine the presence or absence of roosting bats. The peak bat survey season extends from May to August.

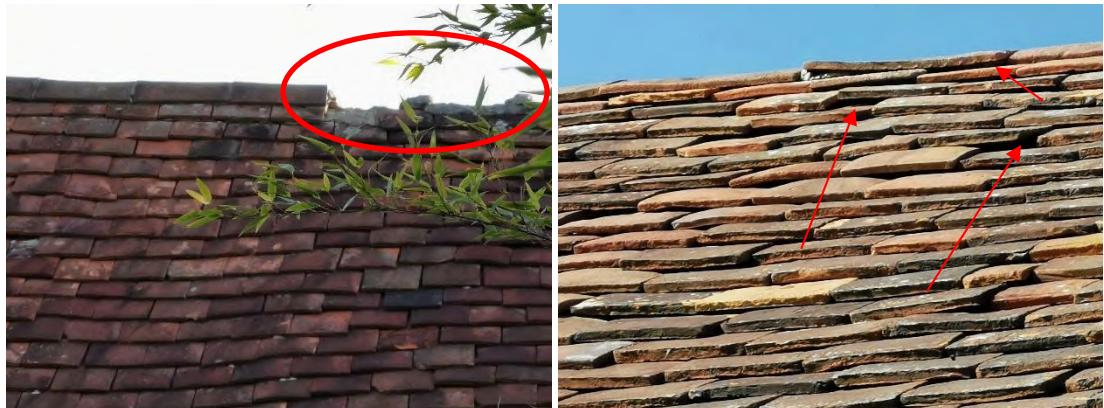
Figure 76. Missing ridge tile and lifted roof tiles

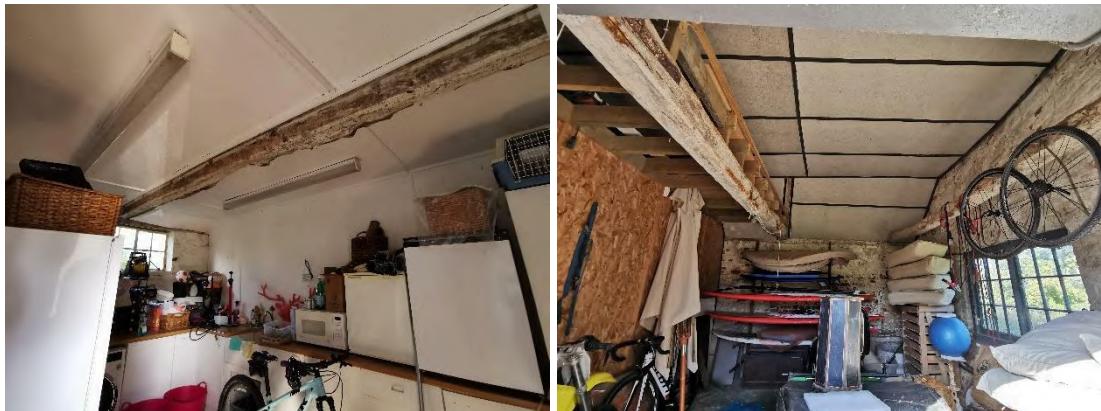
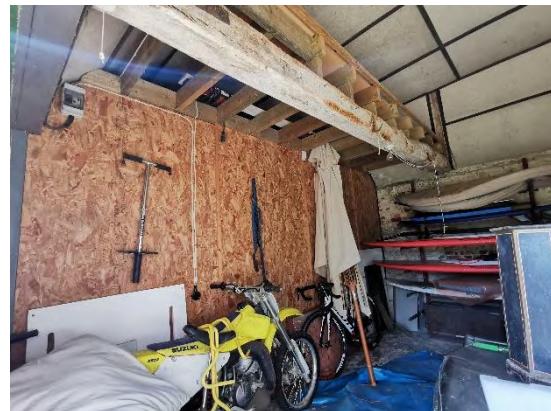
Internally, there is a loft void present; however, no hatch is present and therefore this space could not be inspected (Figures 77 & 78).

Figure 77. Internal view of the garage

Figure 78. Internal view of the garage

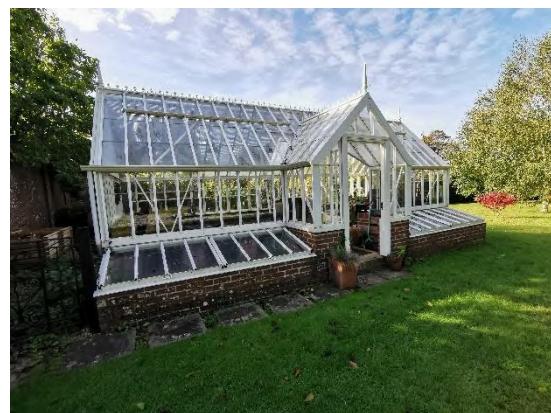
The greenhouse is considered to be of negligible potential to roosting bats (Figure 79).

Figure 79. View of the greenhouse

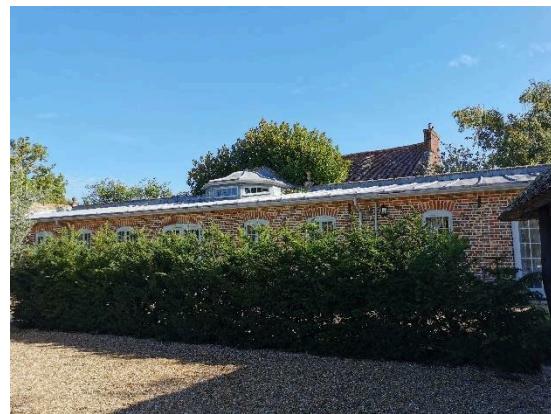
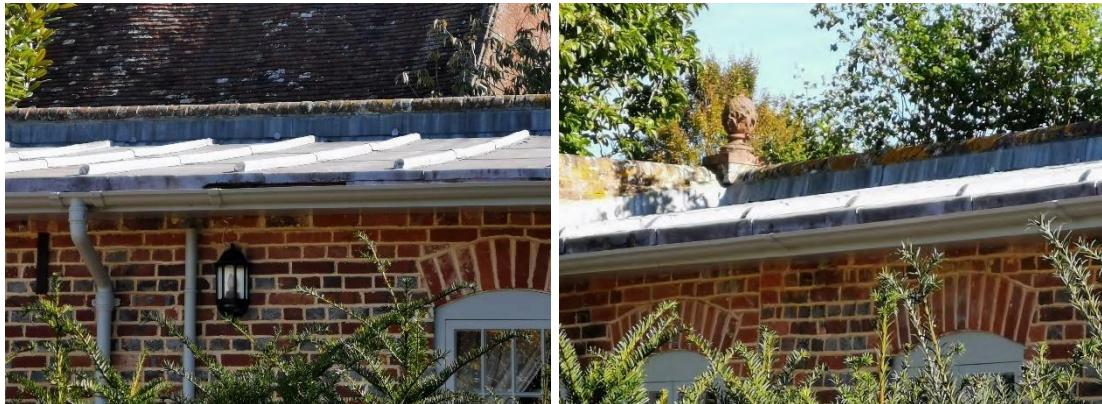
The annex is a long (approximately 25m long), single storey brick building with a sloping lead roof (Figure 80). It is understood that no roof void is present. The brickwork and the lead roof appeared to be in a good condition and well-sealed (Figures 81 & 82) and therefore this building lacks any potential roost features for bats. The soffits are also tightly fitted. As such, the annex is considered to be of negligible potential to bats.

Figure 80. View of the western elevation of the annex

Figure 81. View of the lead roof

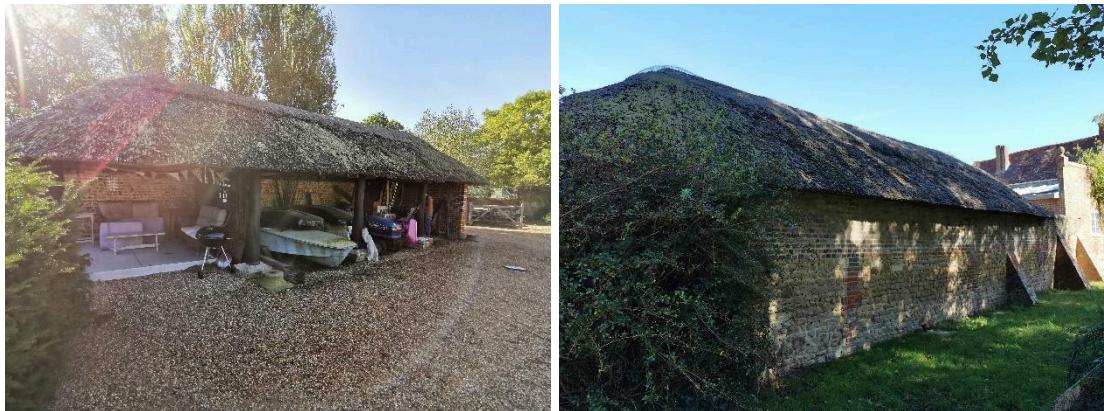
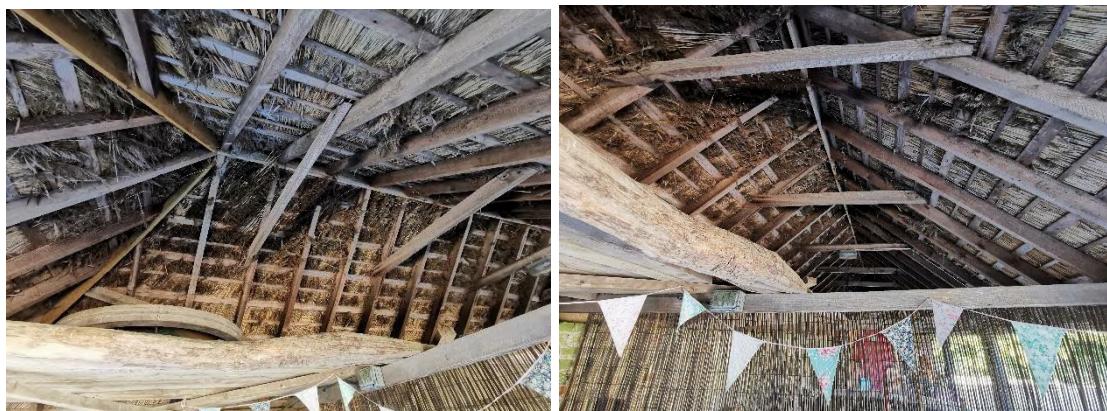
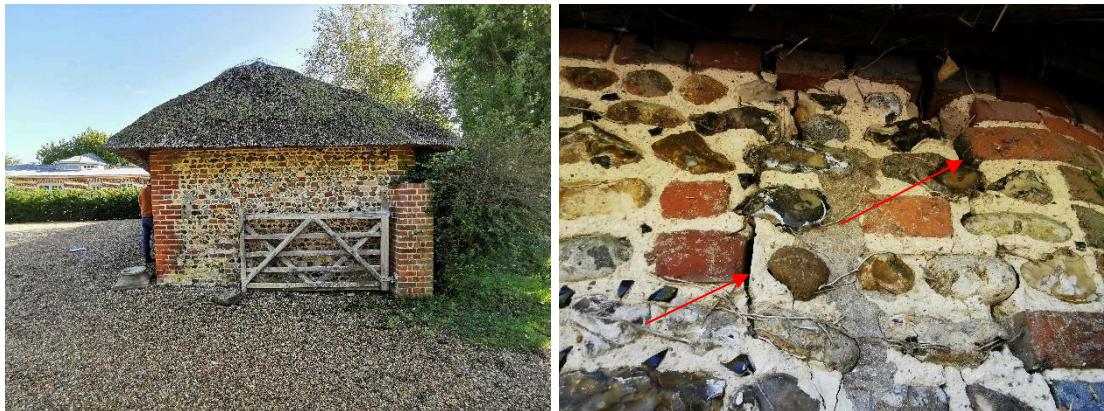
The carport is an open fronted structure with flint and brick walls and a thatched roof, used for storage (Figure 83). Internally, the straw/reed is fitted directly onto the beams and rafters (Figure 85). This structure is exposed to the elements. The western wall supports two cracks (Figure 86). These shallow features were inspected with the aid of an endoscope and no evidence of roosting bats was found. Similarly, there are no potential roost features identified between the rafters/beams and the straw/reed. No evidence of roosting bats was recorded during the external and internal inspection of this structure. The building is therefore considered to be of negligible potential to roosting bats.

Figure 83. View of the southern (right) and northern elevations (right) of the thatched carport

Figure 85. View of the roof of the thatched carport

Figure 86. View of the western wall of the thatched carport

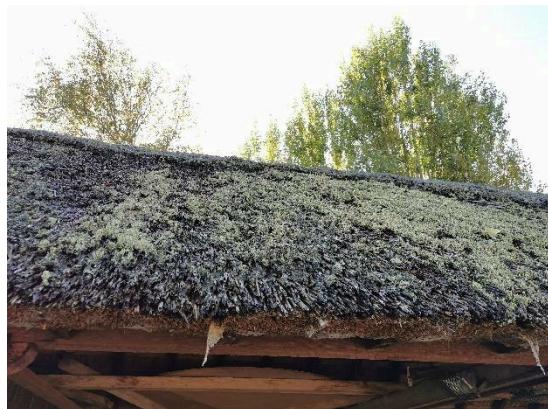
Figure 84. View of the of the thatched roof of the carport

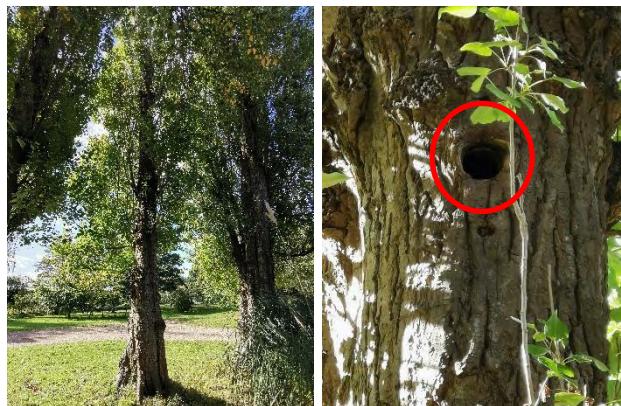
Figure 87. Lombardy poplar tree with low bat potential (woodpecker hole) – south of the thatched carport

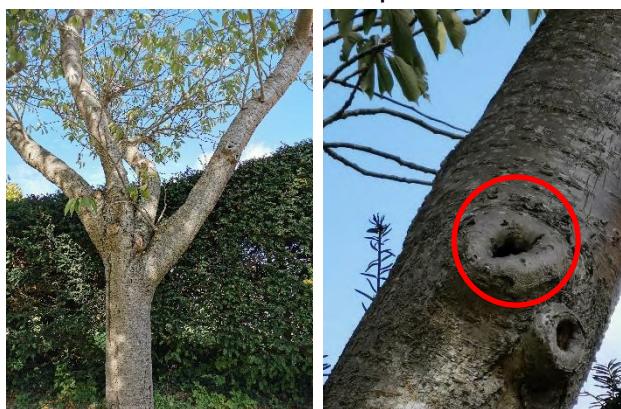
All trees on site were subject to a ground level roost assessment. This visual assessment of the trees aimed to determine the presence of any potential roost features within the trees. Examples of potential roost features include cankers, hazard beams, natural holes (e.g. knot holes), loose bark and woodpecker holes. A small number of trees were identified to support potential roost features for bats which are shown in the Phase I Habitat Map (TN8) (Figures 87 - 96).

Figure 88. Cherry tree to the south of the Old Manor House with a knothole (low bat potential)

- Σ Any trees required to be cleared to facilitate the development should be replaced with native trees. Recommended species to be used in the soft landscaping scheme include rowan *Sorbus aucuparia*, crab apple *Malus sylvestris*, cherry *Prunus avium*, yew, oak, common lime *Tilia × europaea*, horse chestnut *Aesculus hippocastanum* and beech.
- Σ Should any areas of amenity grassland be lost, it is recommended that a wildflower meadow seedmix such as Emorsgate EM1 is used to replace this habitat, which is of higher biodiversity value to standard lawn seed mixtures.
- Σ A selection of bird and bat boxes are recommended to be installed on the mature trees on site.

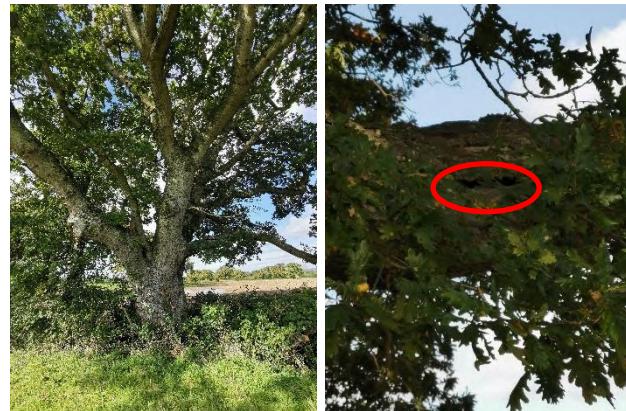
Figure 89. Oak tree along the western boundary of the southern grass field with a large cavity in the limb – moderate bat potential

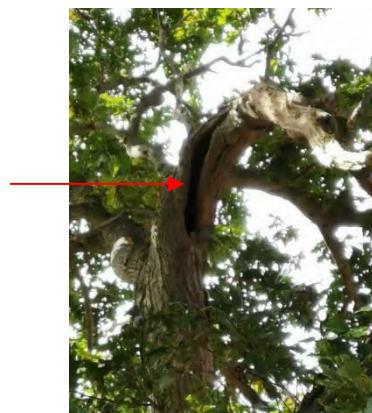
Figure 90. Another oak tree along the western boundary of the southern grass field with a large cavity in the limb – moderate bat potential

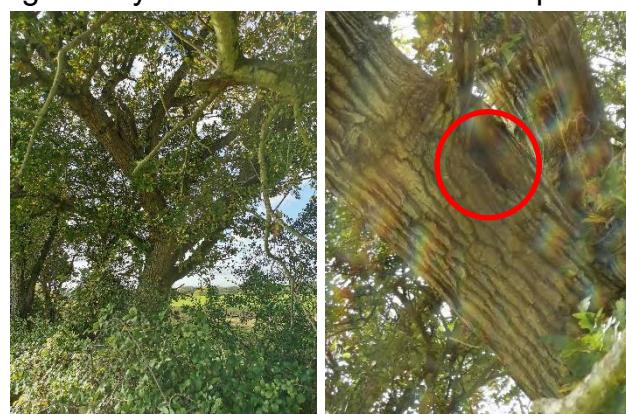
Figure 91. Another oak tree along the western boundary of the southern grass field with a cavity in the limb – moderate bat potential

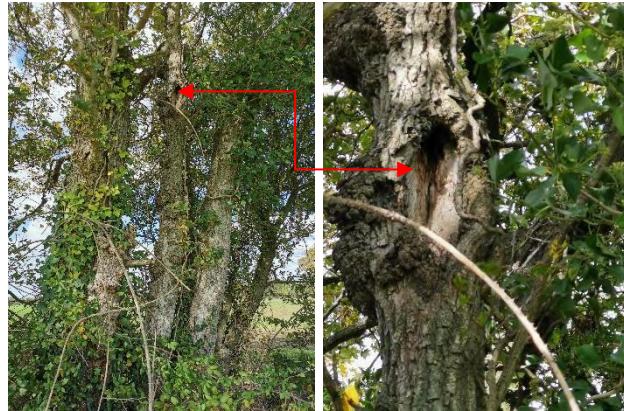
Figure 92. Another oak tree along the western boundary of the southern grass field with a wound – moderate bat potential

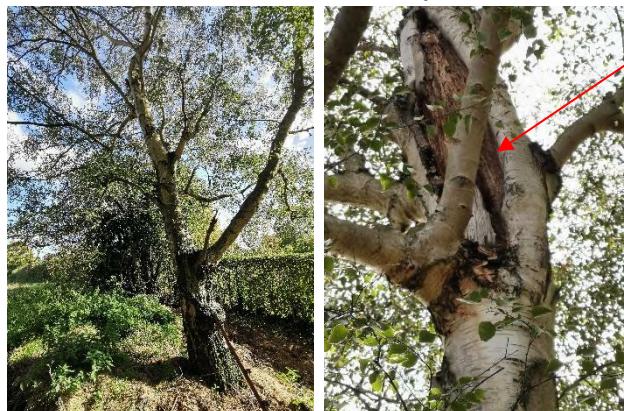
Figure 93. Silver birch tree in the corner of the eastern-most field with a cavity – moderate potential for bats

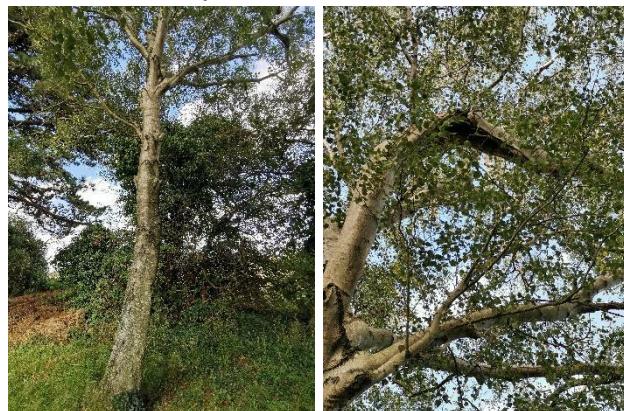
Figure 94. Another silver birch in the corner of the eastern-most field with a hazard beam – low potential for bats

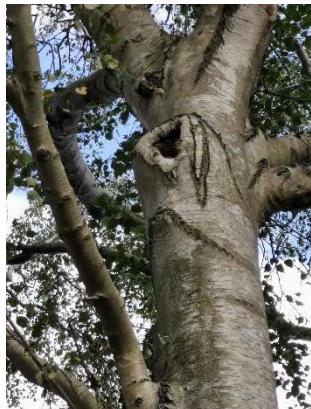
Figure 95. Another silver birch in the corner of the eastern-most field with a knothole – low potential for bats
