Flood Map - Slice A

Westgate, DARTFORD, DA1 2DF

Report Reference:	Client:	TPS Ltd
7666TA	Project:	Orchard Street, Dartford

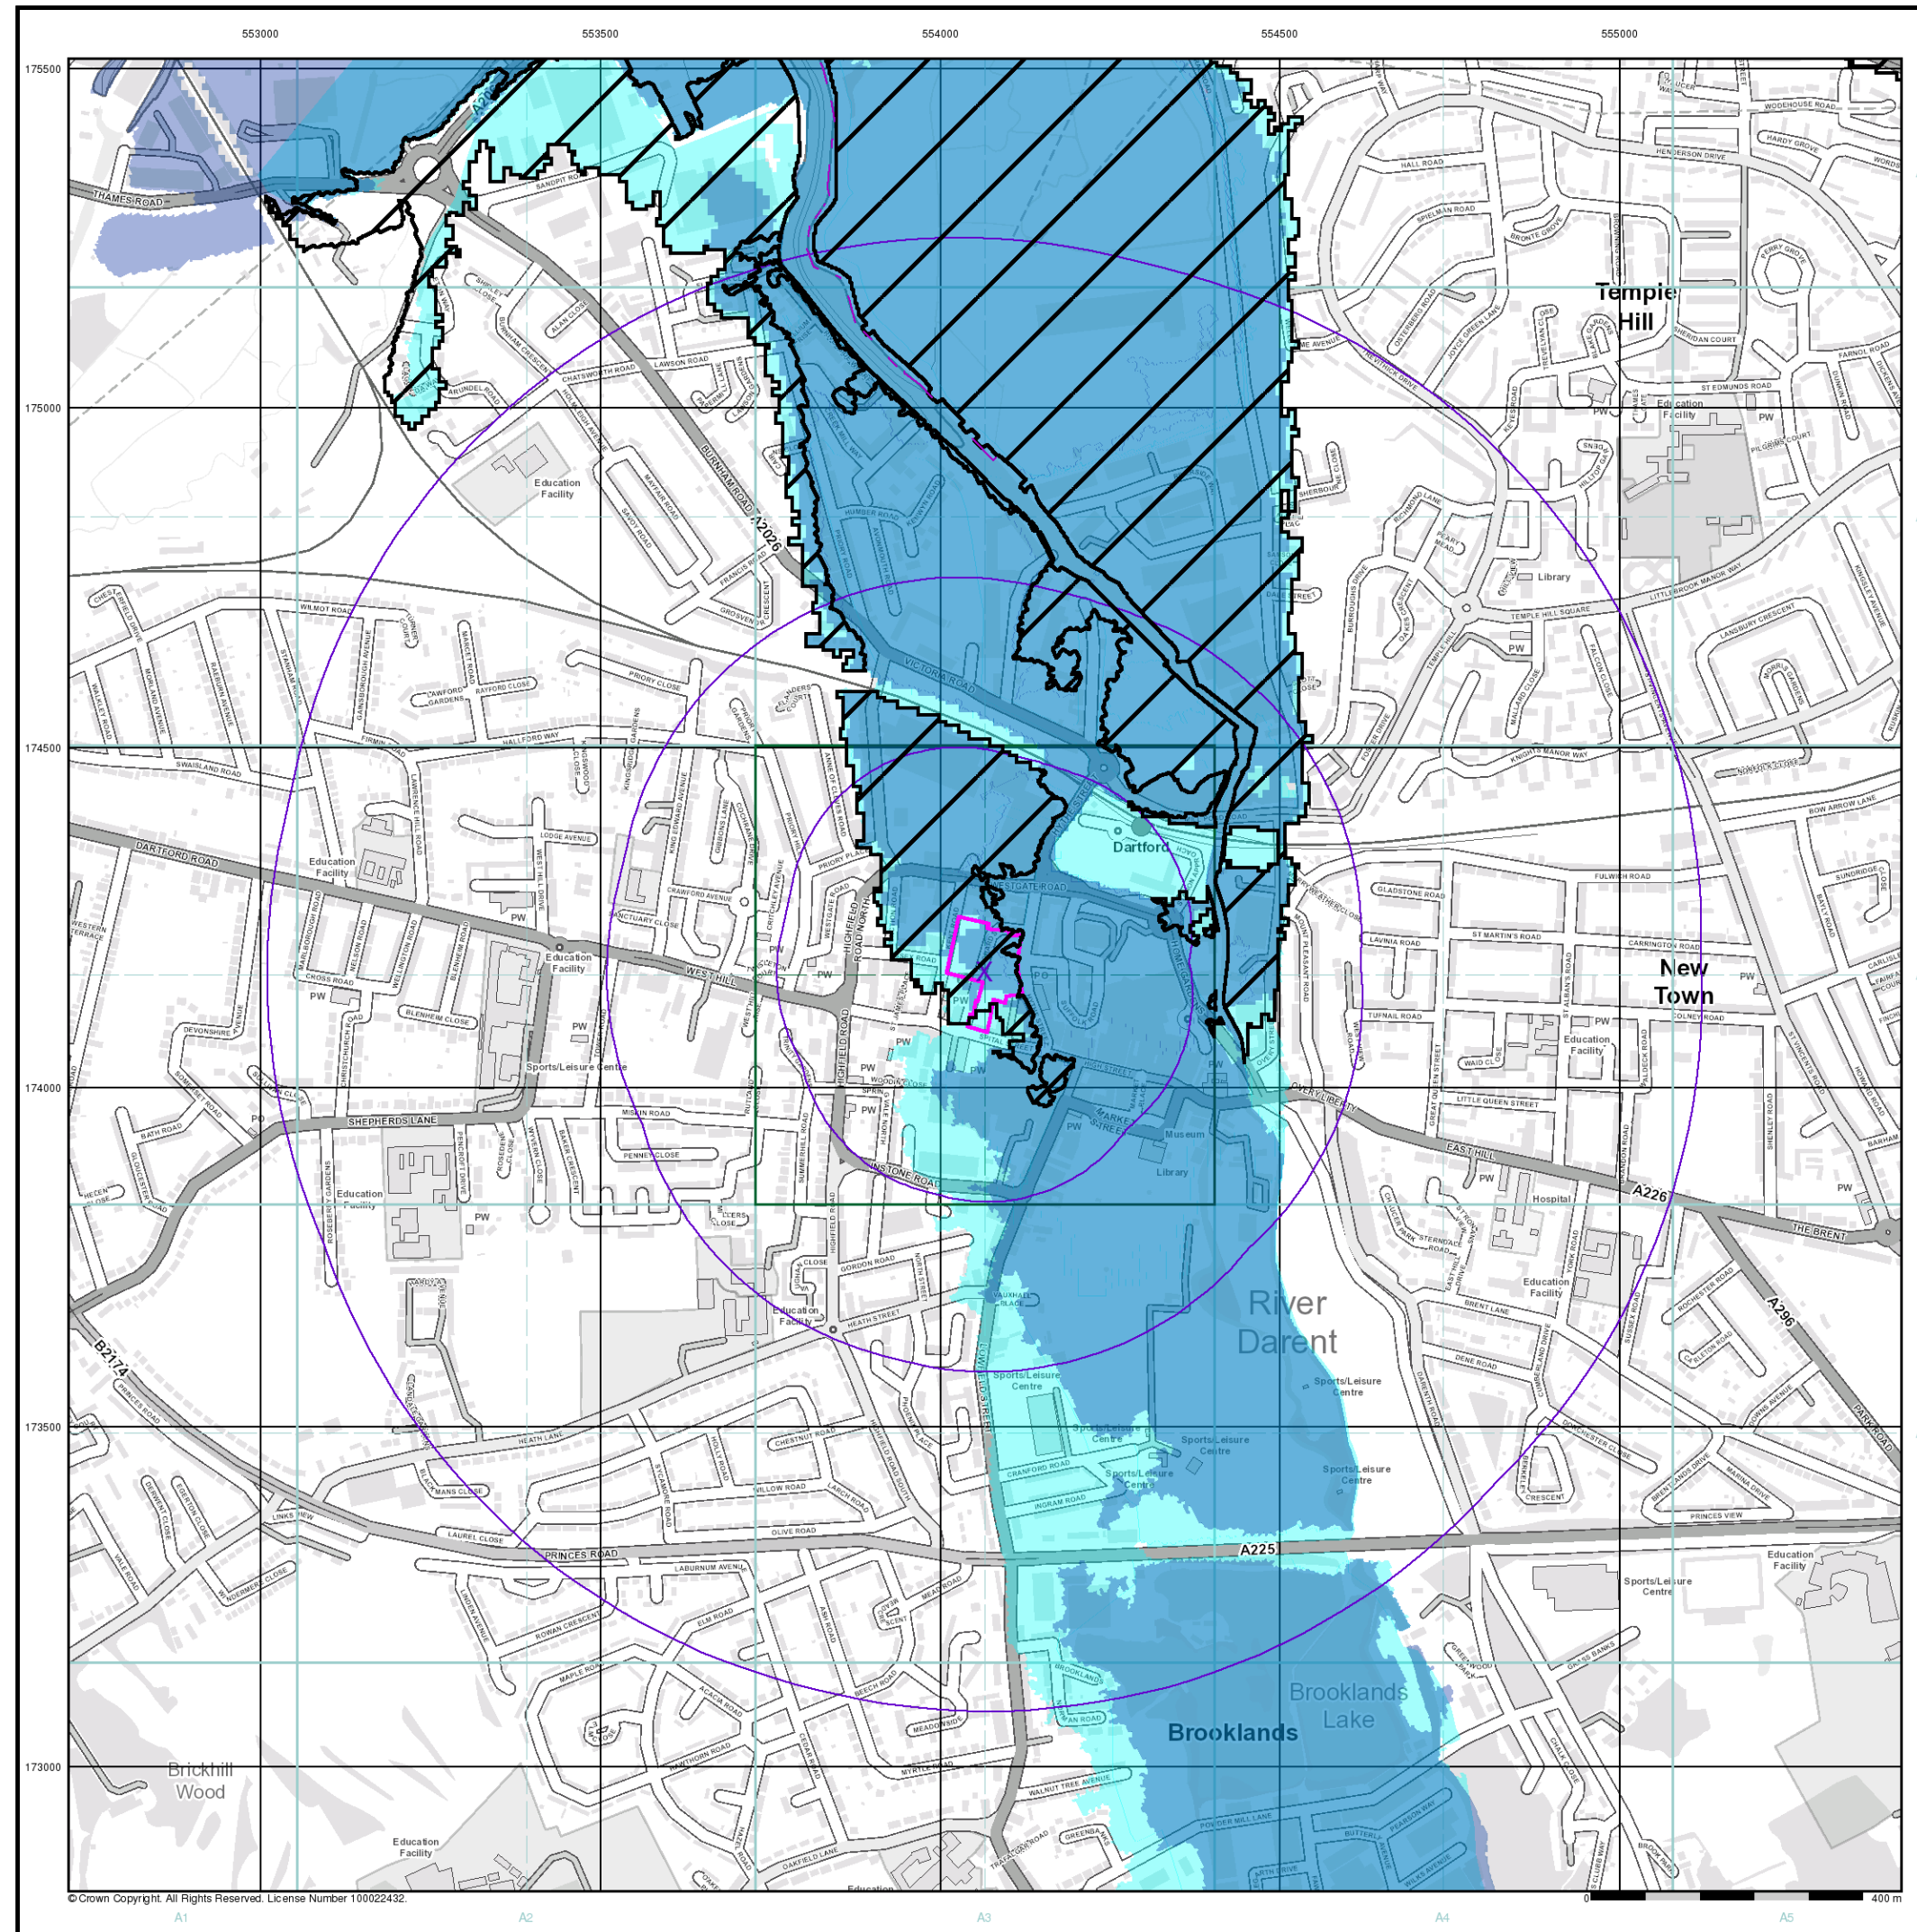
- Extreme Flooding from Rivers or Sea without Defences (Zone 2)
- Flooding from Rivers or Sea without Defences (Zone 3)
- Area Benefiting from Flood Defence
- Flood Water Storage Areas
- Flood Defence

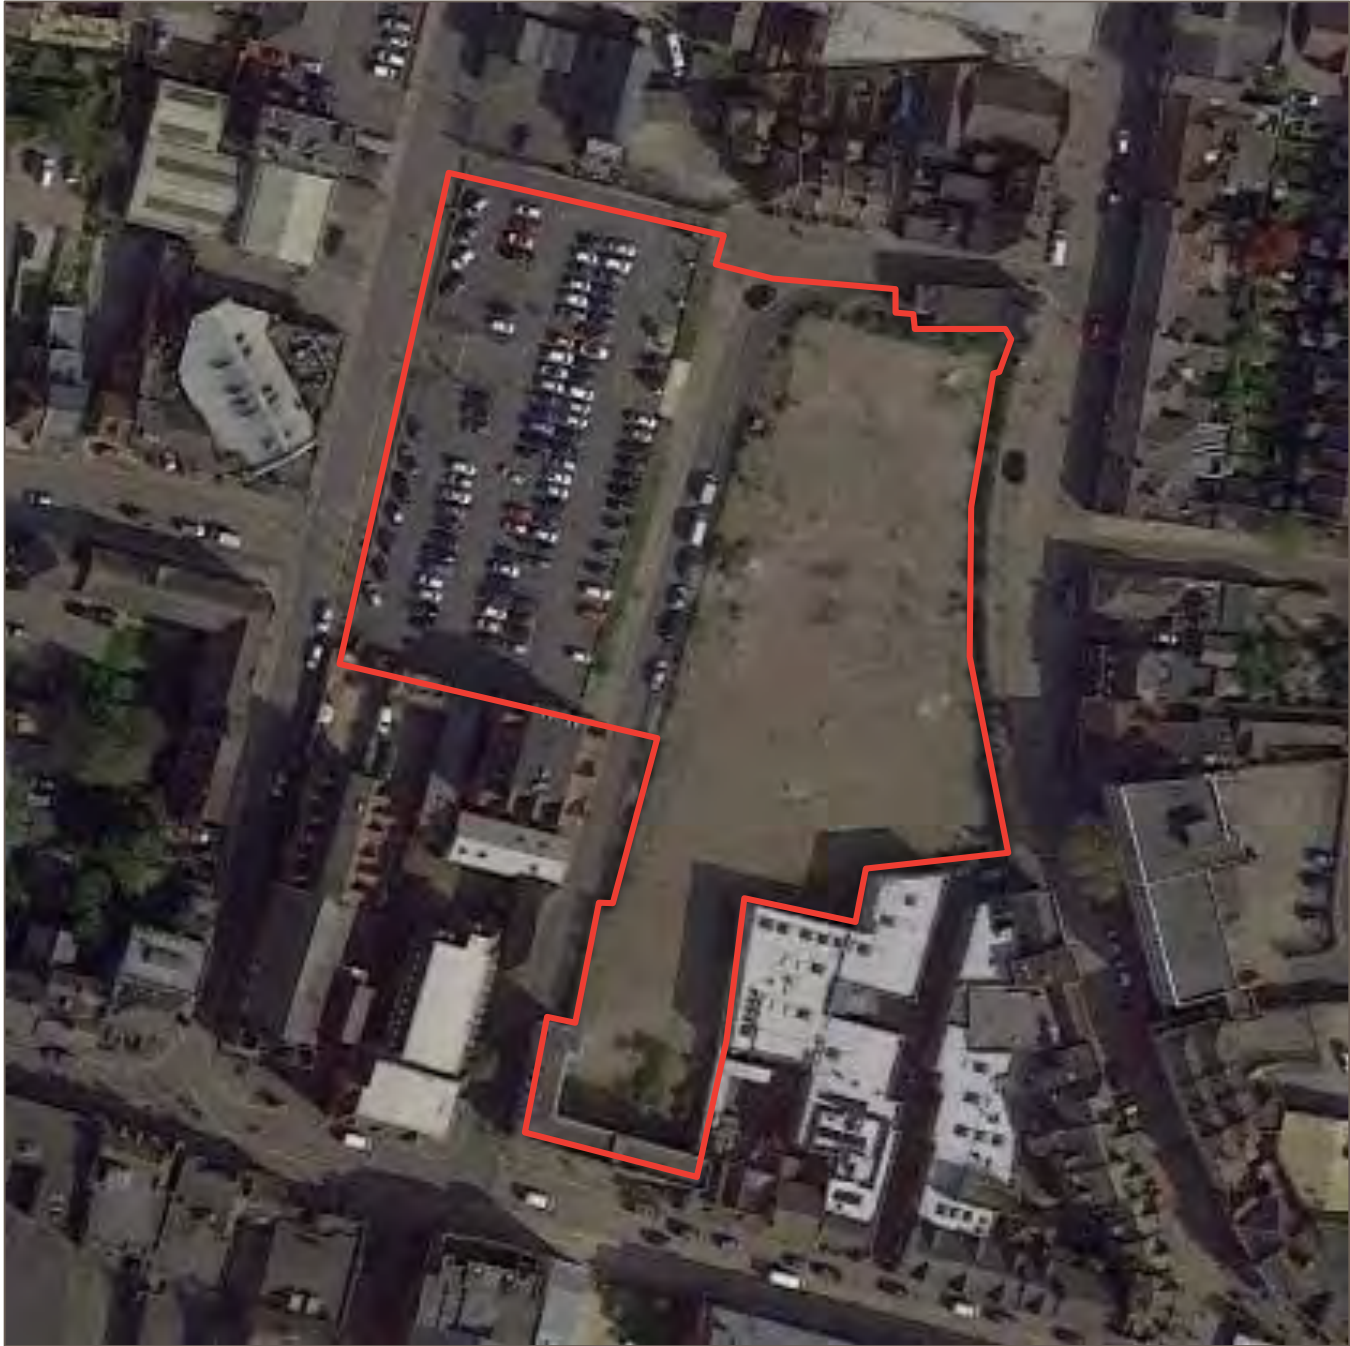
Approximate site boundary

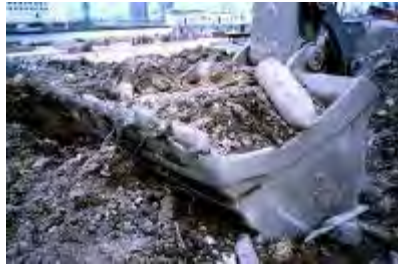
Bomb Weight: 40-54kg (110-119lb)
Explosive Weight: c25kg (55lb)
Fuze Type: Impact fuze/electro- mechanical time delay fuze
Bomb Dimensions: 1,090 x 280mm (42.9 x 11.0in)
Body Diameter: 200mm (7.87in)
Use: Against lightly damageable materials, hangars, railway rolling stock, ammunition depots, light bridges and buildings up to three stories.
Remarks: The smallest and most common conventional German bomb. Nearly 70% of bombs dropped on the UK were 50kg.

50kg bomb, London Docklands

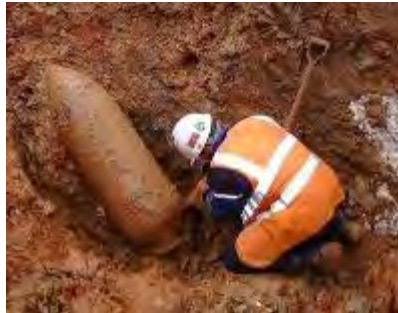
Bomb weight: 245-256kg (540-564lb)
Explosive weight: 125-130kg (276-287lb)
Fuze type: Electrical impact/mechanical time delay fuze.
Bomb dimensions: 1640 x 512mm (64.57 x 20.16in)
Body diameter: 368mm (14.5in)
Use: Against railway installations, embankments, flyovers, underpasses, large buildings and below-ground installations.

250kg bomb, Hawkinge

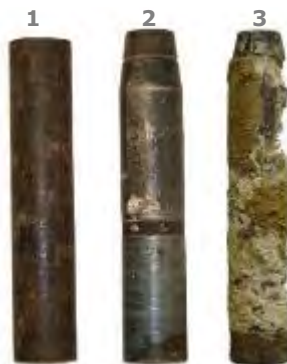
Bomb weight: 1.0 and 1.3kg (2.2 and 2.87lb)
Filling: 680gm (1.3lb) Thermite
Fuze type: Impact fuze
Bomb dimensions: 350 x 50mm (13.8 x 1.97in)
Body diameter: 50mm (1.97in)
Use: As incendiary – dropped in clusters against towns and industrial complexes
Remarks: Jettisoned from air-dropped containers. Magnesium alloy case. Sometimes fitted with high explosive charge

1. Scaffold pipe
2. Incendiary 1kg bomb
3. Incendiary bomb recently found on site in UK
