Purpose of Issue  
PLAND LBC APPLICATION

Project Log Store Roof, Chimneys, Retaining Wall and Field Shelter at Villa Farmhouse, Main Road, Aust, Bristol  
Client Mr & Mrs Sheasby  
Title Elevations as Proposed

Drawing No. SHS3335.83-

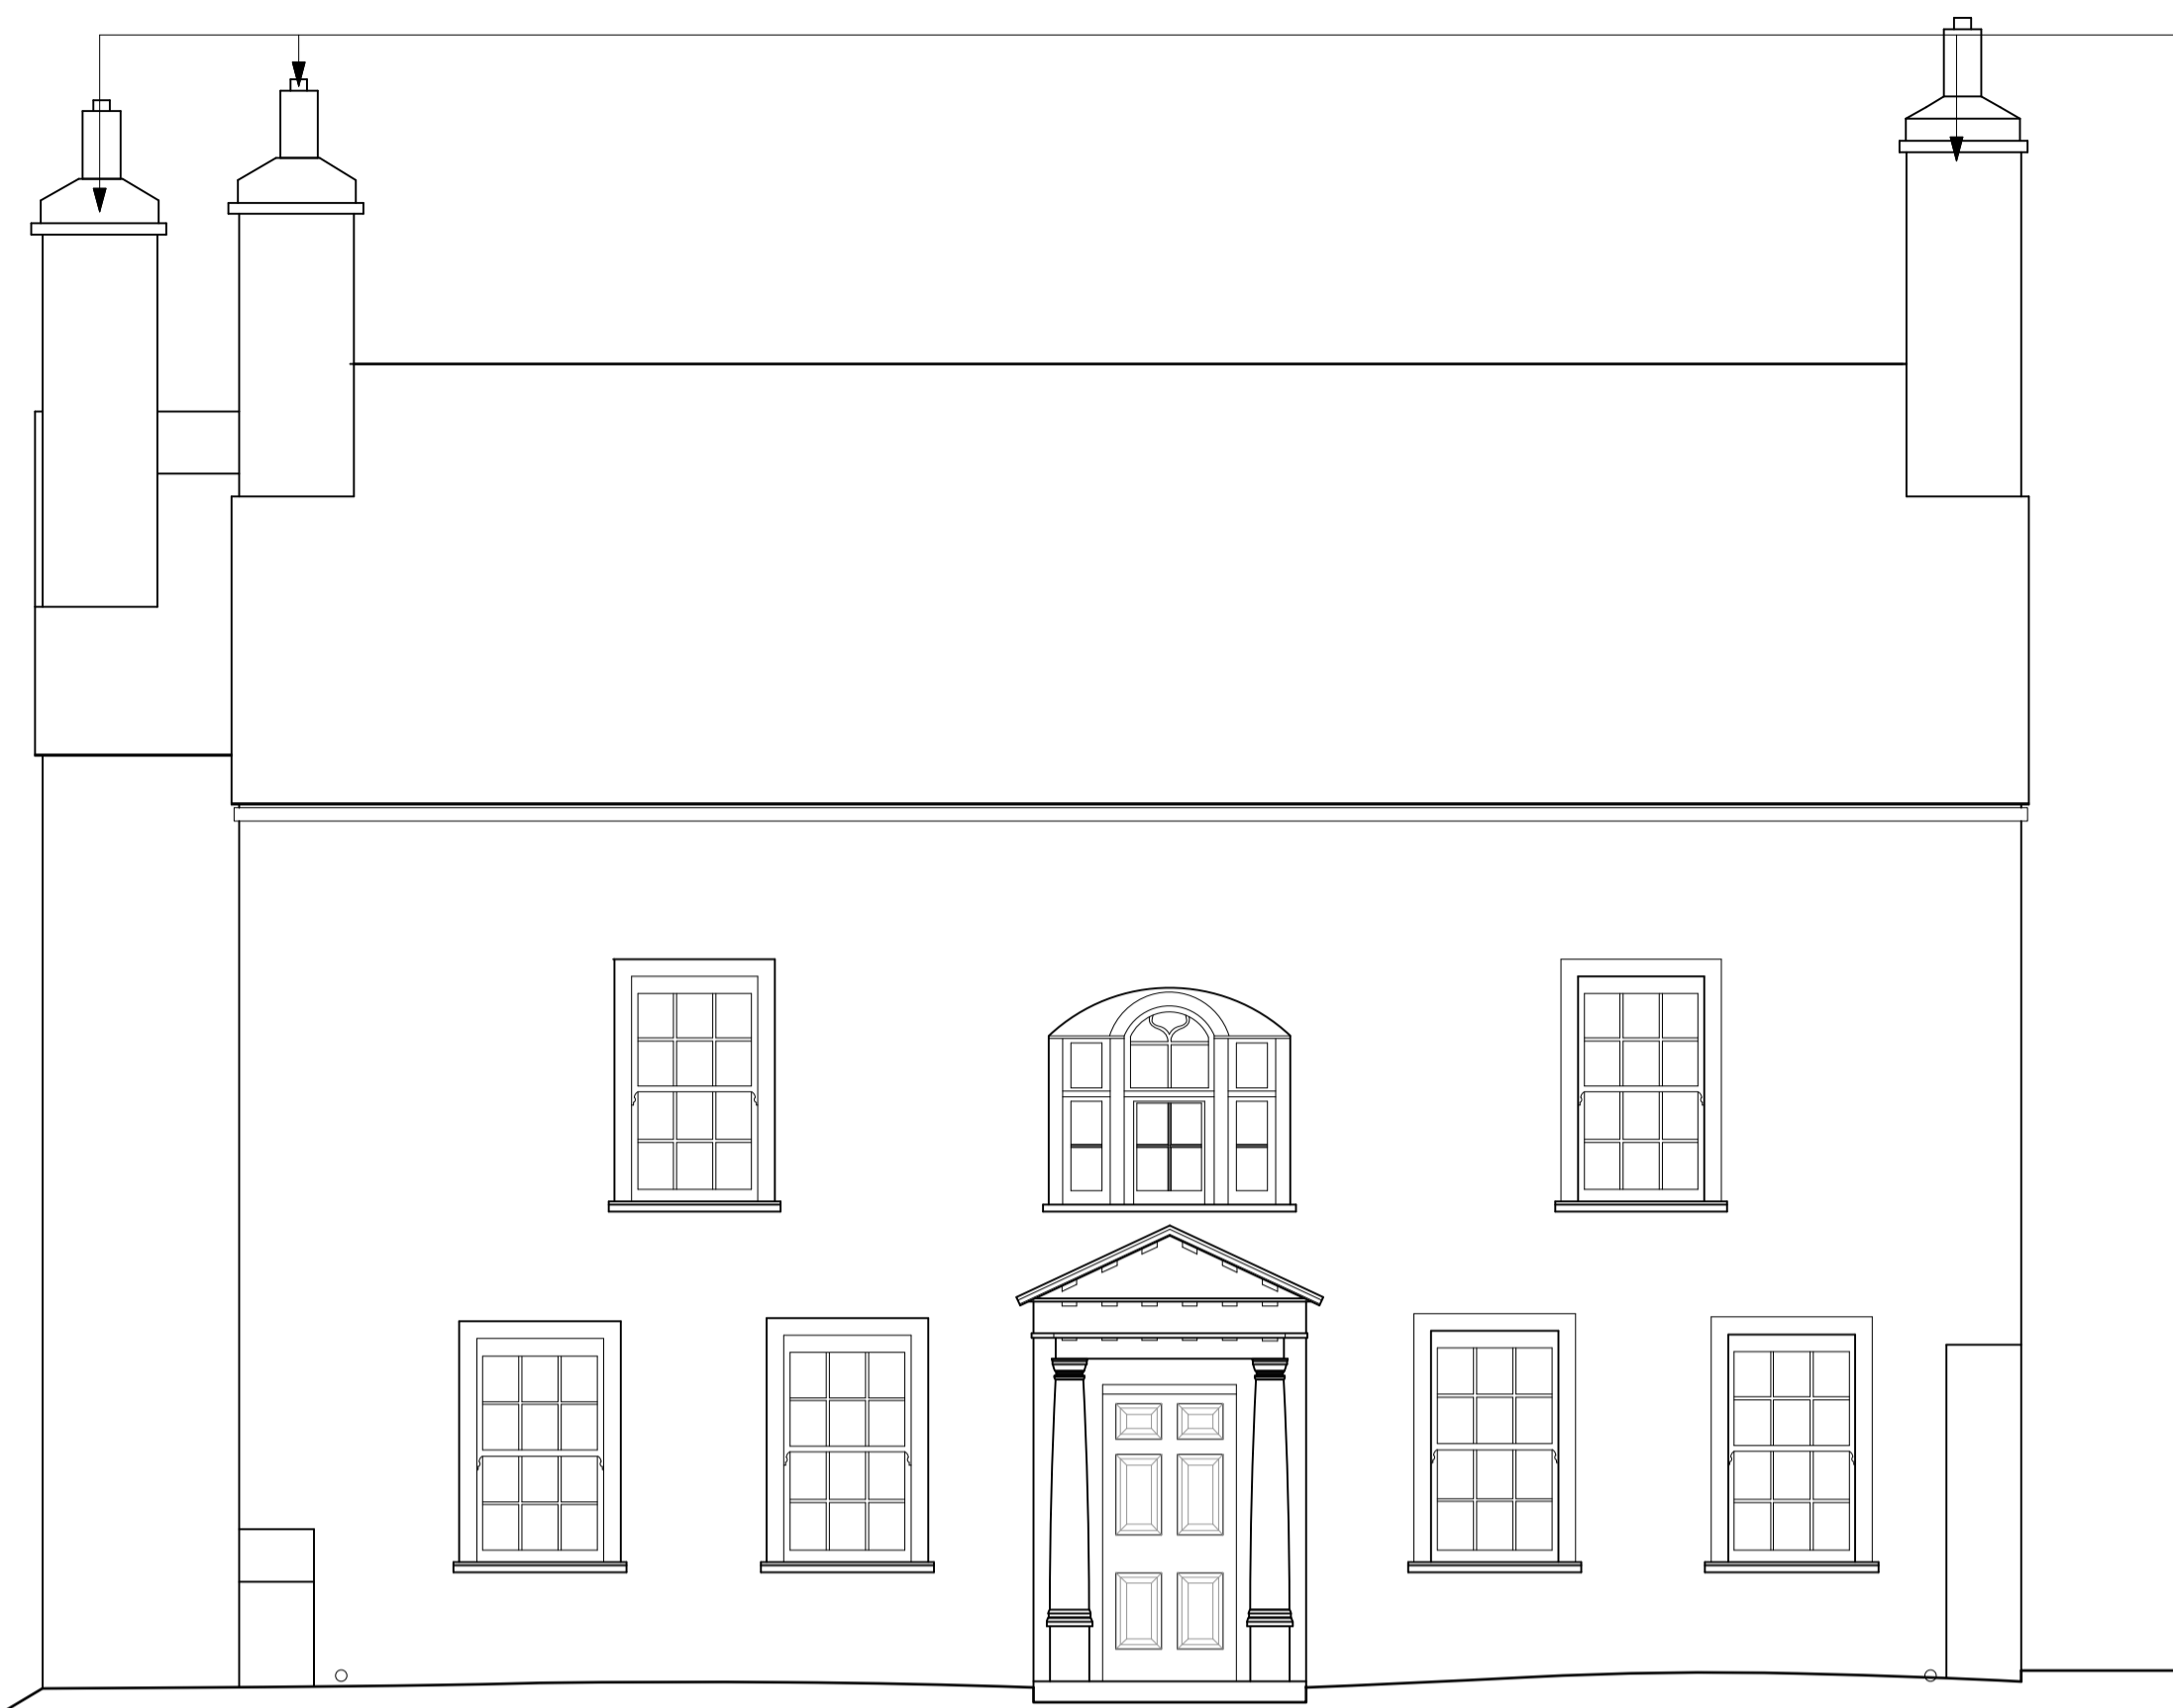
**FRONT ELEVATION**

The chimneys with cement render in poor condition. During repair work to remove modern cement render the brickwork was found to be in a very poor condition and unsafe. Re-built in brick to match. See Photo 1 below.

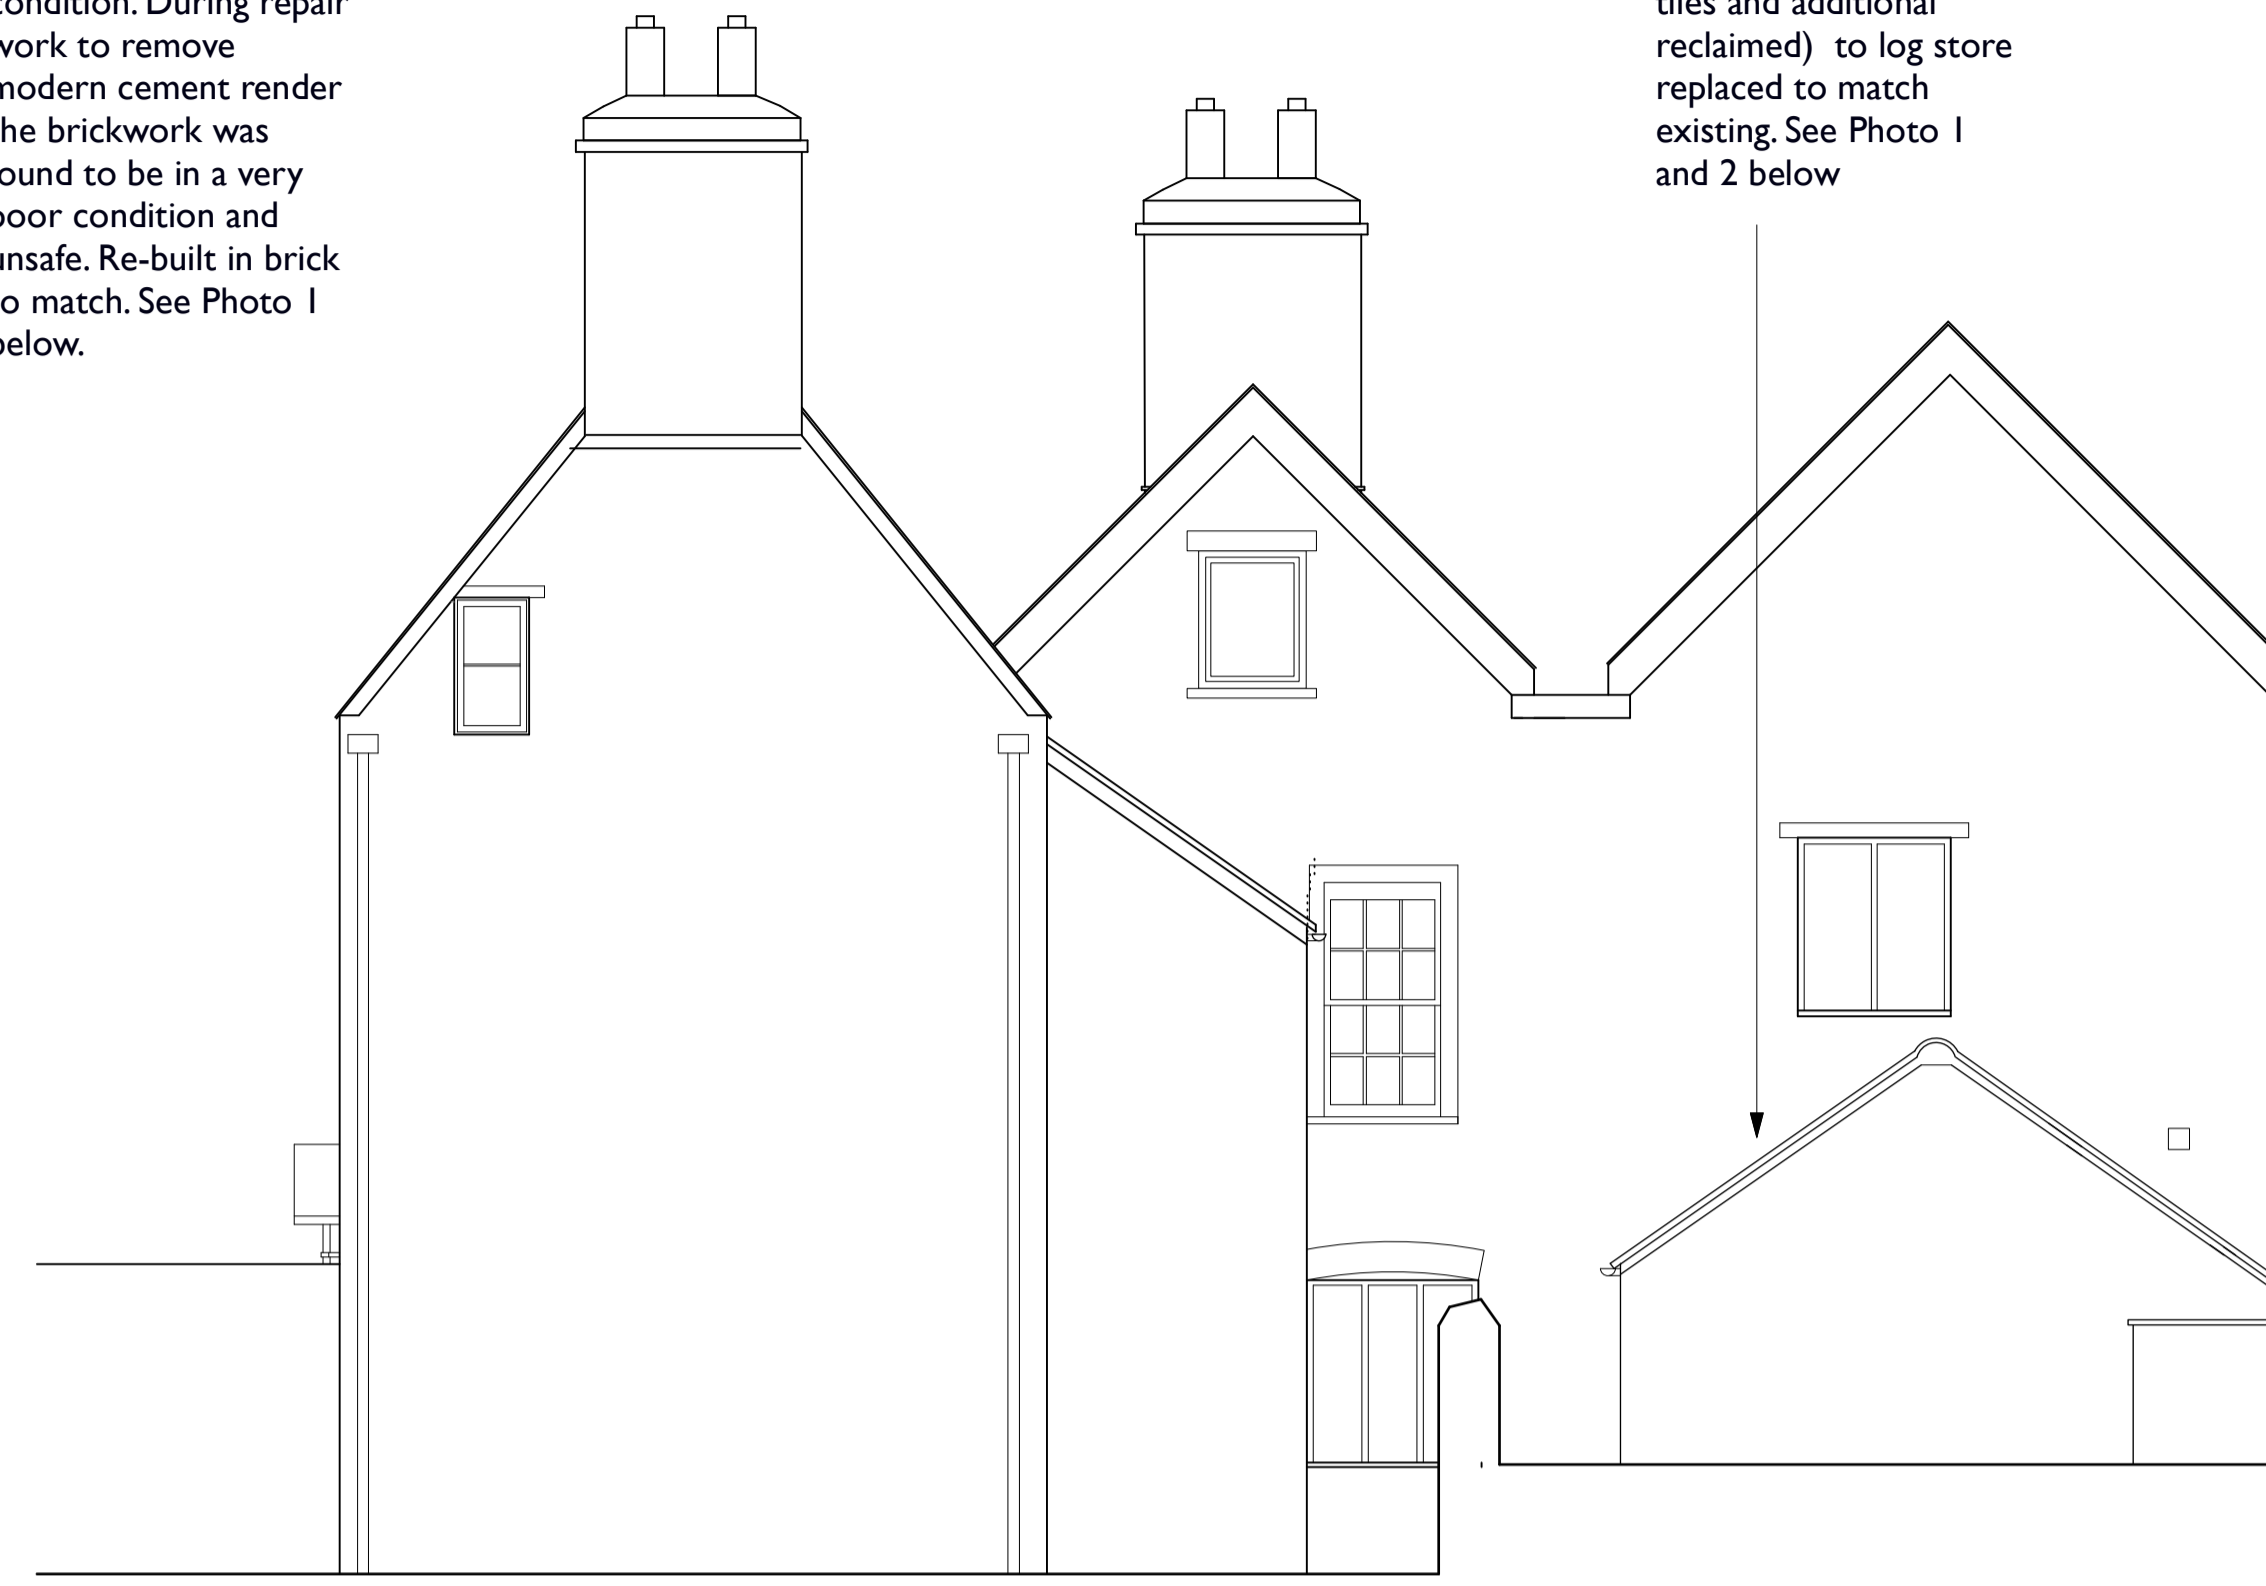
**SOUTH ELEVATION**

Roof structure and roof finish (re-use existing tiles and additional reclaimed) to log store replaced to match existing. See Photo 1 and 2 below

New rubble stone retaining wall to match existing walls. Max height 1.17m

The proposed retaining wall does not harm the significance of the listed building or its setting. It sits comfortably with the high boundary wall and the scale of house

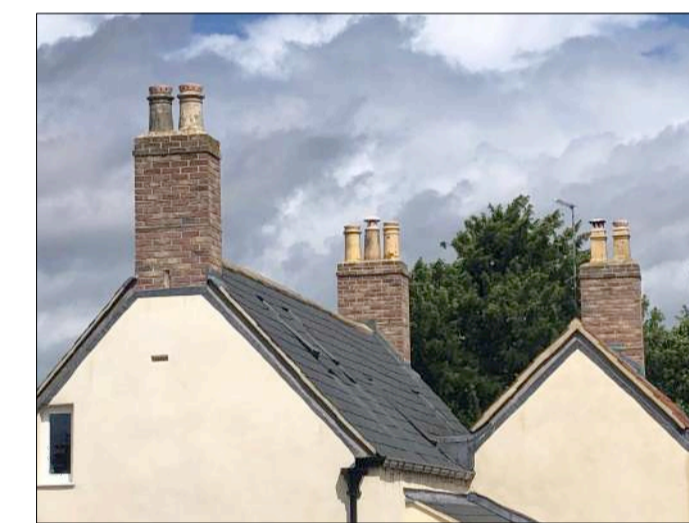
**PHOTO 1:**  
3no. RE-BUILT CHIMNEYS IN BRICK TO MATCH ORIGINAL DESIGN AND WITH RECLAIMED POTS

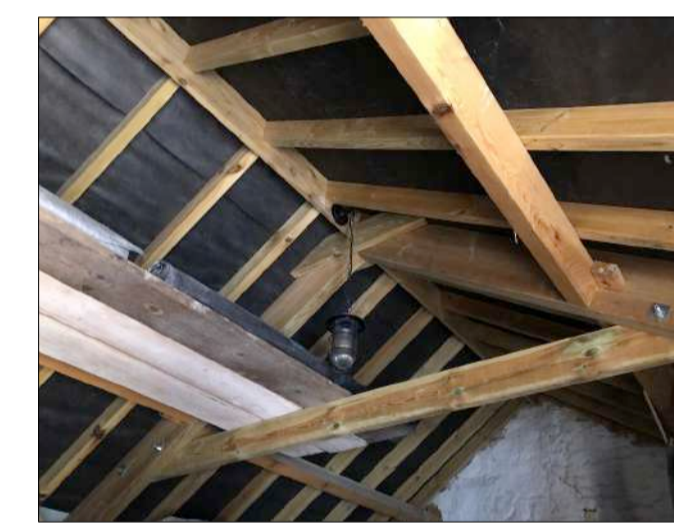
**PHOTO 2:** LOG STORE RE-INSTATED ROOF STRUCTURE

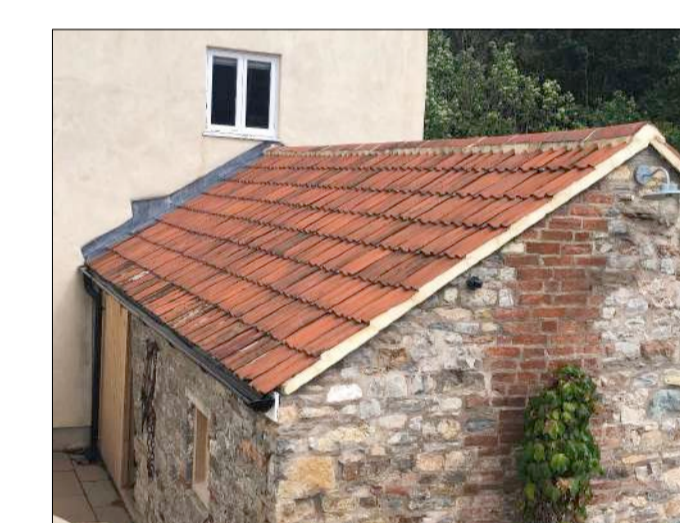
**PHOTO 3:** LOG STORE RE-INSTATED ROOF FINISH Existing tiles re-used, additional tiles are reclaimed tiles to match
