Re: Land at Former Victoria Garage, Scotland Street, Ellsemere

This letter summarises our investigation of the ground surrounding 2No. below ground fuel tanks associated with the former petrol filling station of Victoria Garage, Scotland Street, Ellesmere. The site is in the early stages of development of 8 No. residential houses by Mere Holdings (Ellesmere) Ltd. A site investigation of the site was undertaken by Georisk Management Ltd. on behalf of Landfind (Services) Ltd. in 2023 referenced below, and is to be read in conjunction with this letter.

SITE PLAN

Drawing No.	8224 / 01	Rev.	-
-------------	------------------	------	---

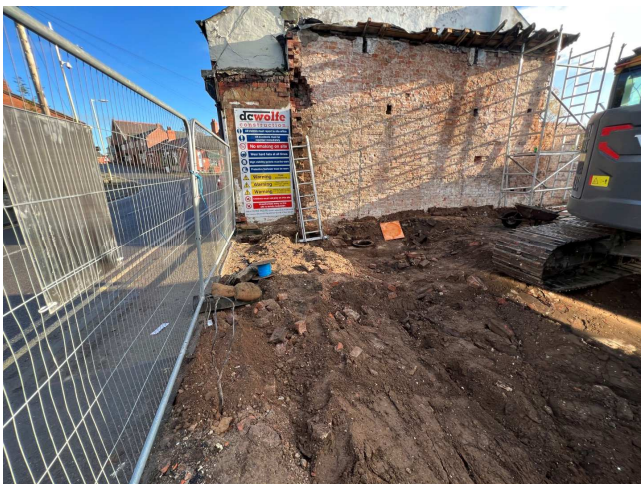
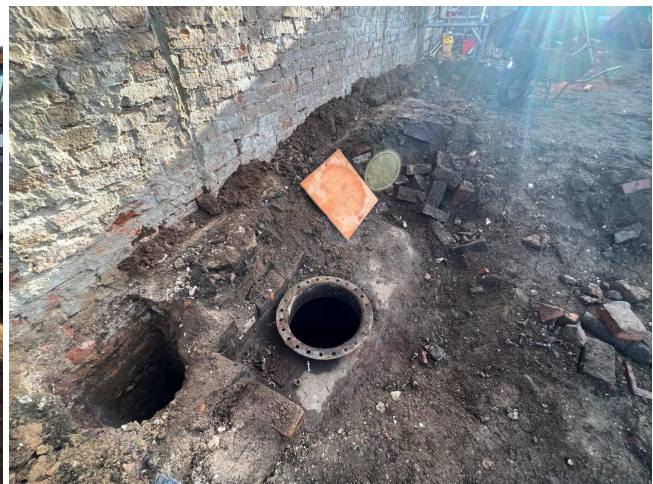
Both tanks are referenced 'Tank 1' and 'Tank 2' on the Site Plan showing their locations respective of the former garage building now demolished and the overall site. Whilst Tank 1 was removed it can be noted that Tank 2 was situated on the site boundary close to the adjacent and formerly adjoining terraced residential property. Mere Holdings (Ellesmere) Ltd decided that due to the close proximity of the tank to the adjacent foundation, removing it would undermine and put at risk the integrity of the adjacent property and that it should remain in-situ providing no contamination was encountered and that it was filled with concrete. Leaving it in situ would not impact any proposed plots given its location within the verge of the proposed access road into the new development. The tank was emptied, cleaned and degassed and Coopers would therefore trial pit adjacent to it to log and analyse the surrounding ground to assess contamination and vapour risk. The tank shown in the photographs below was observed to be within a metre of the adjacent property and surface. Its depth to its base was circa 1.5m deep.

Photographs 1 and 2: Showing the presence of 'Tank 2' in relation to the adjacent property.

The enclosed OTIS Ltd Works Completion Note lists Tank 2 as having been emptied, cleaned, degassed and filled with concrete on 1st December 2023 removing any void present in the ground. Mere Holdings (Ellesmere) Ltd also provided Coopers with OTIS's Degas Certificate confirming the tanks were degassed prior to filling and/or removed, as well as the Hazardous Waste Regulations Consignment Note and Controlled Waste Transfer Notes of the tank washings, and a Controlled Waste Transfer Note for the disposal of Tank 1 which are enclosed below.

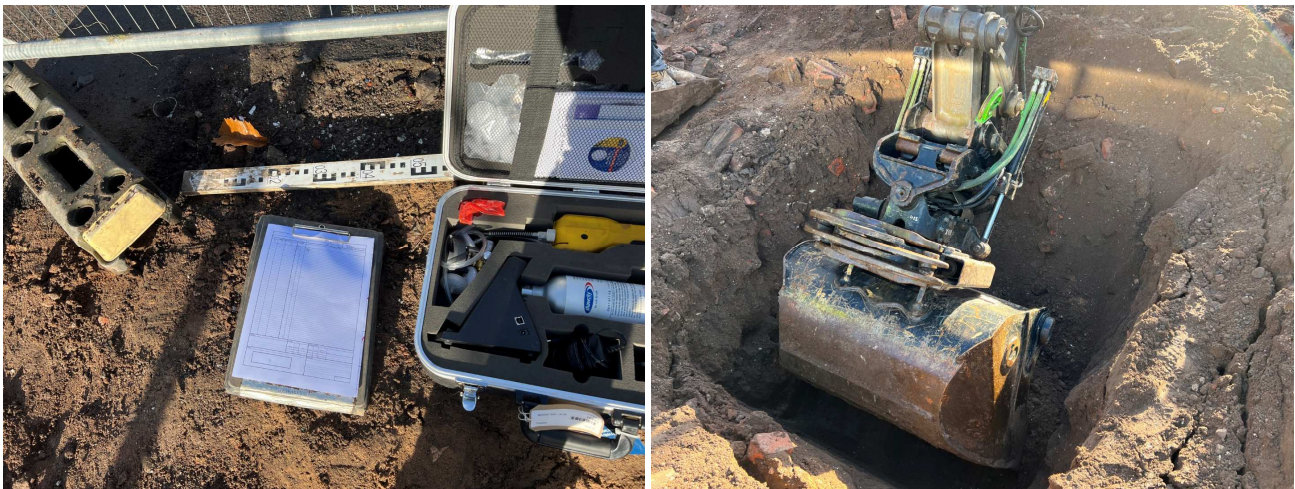
At the time of Coopers' attendance Tank 1 had just been removed with the excavation loosely backfilled with site arisings to meet health and safety requirements. Coopers supervised the re-excitation of the tank location logging it as trial pit TP01. The base of the excavation and tank location was identified at 1.5m, depth, overlying a natural sand strata. No visual or olfactory signs of contamination was observed in the ground adjacent beneath the former tank or on the sides of the excavation. Coopers monitored the samples and excavation using a Photo Ionisation Detector (PID) which would detect any presence of volatiles within the samples not able to be detected by the engineer. The instrument was used to monitor background levels initially and also test the air space within the remaining tank (Tank 2). Background levels were 0ppm whereas the air within the tank quickly increased to in excess of 100ppm and continued to increase demonstrating the instrument was working and that volatiles remained in the tank. Testing of recovered samples from TP01 read 0ppm throughout.

A sample of the sand at the base at 1.8m and 4 No. from each of the sides at 1.6m depth of trial pit TP01 were issued to DETS for analysis of speciated Total Petroleum Hydrocarbons (TPHs). All samples returned mostly showing less than detectable concentrations of all carbon ranges, with very low concentrations of the C16-21 and C21-35 aromatic range, supplementing the PID reading taken during logging. It can therefore be concluded the ground surrounding the former tank location is free from any contamination associated with any fuel leakages from the tank or historical garage activities, with no risk from contamination or vapours to groundwater or the adjacent residents or future residents of the development.

Photographs 3 and 4: Showing the PID equipment used for detecting vapours and the progressive excavation of trial pit TP01 within the location of Tank 1.

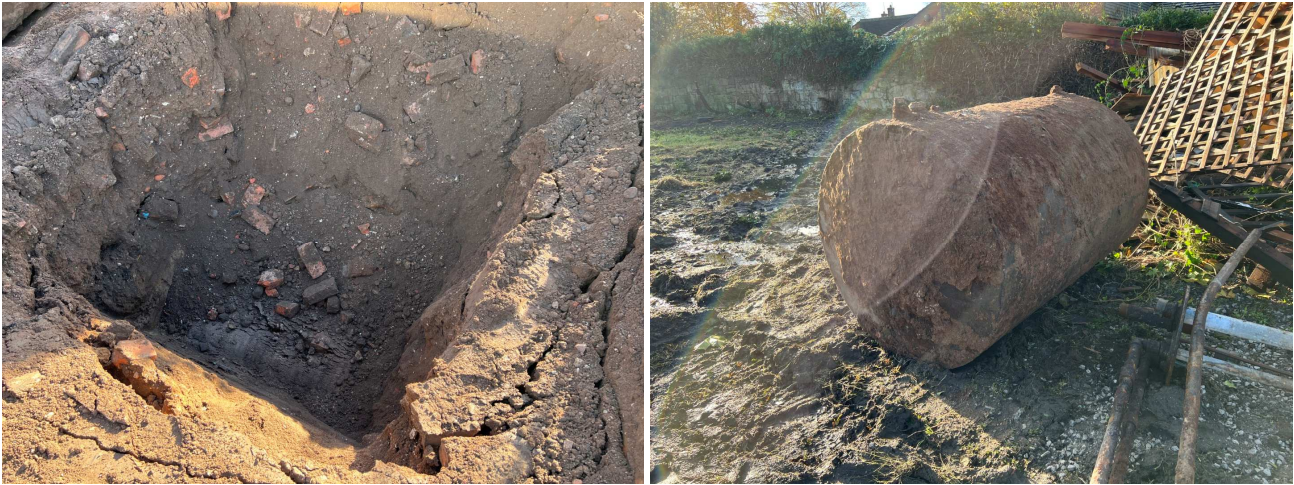
Photographs 5 and 6: Showing trial pit TP01 and the recovered Tank1 ready for disposal.

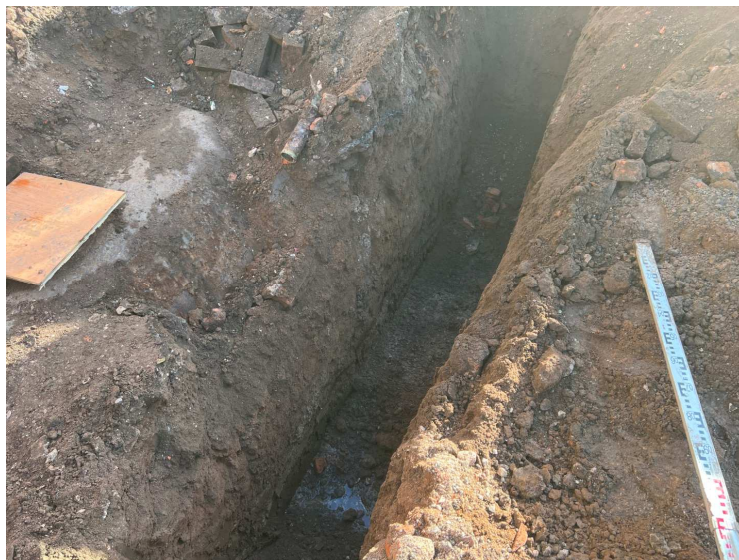
Coopers excavated trial pit TP02 adjacent to the tank, logging a made ground sand to 1.2m depth, which was underlain by a natural thin clay overlying sand. No visual or olfactory signs of contamination were observed in the ground adjacent the tank. As with Tank 1 and TP01 Coopers monitored the samples and excavation using a PID instrument which would detect any presence of volatiles within the samples not able to be detected by the engineer. Testing of recovered samples from TP02 read 0ppm throughout.

4 No. samples representing each strata logged within trial pit TP02 were issued to DETS for analysis of speciated Total Petroleum Hydrocarbons (TPHs). All samples returned showing less than detectable concentrations of carbon ranges, supplementing the PID reading taken during logging.

Photograph 7: Showing trial pit TP02 being excavated adjacent to Tank 2 which is left of the photograph.

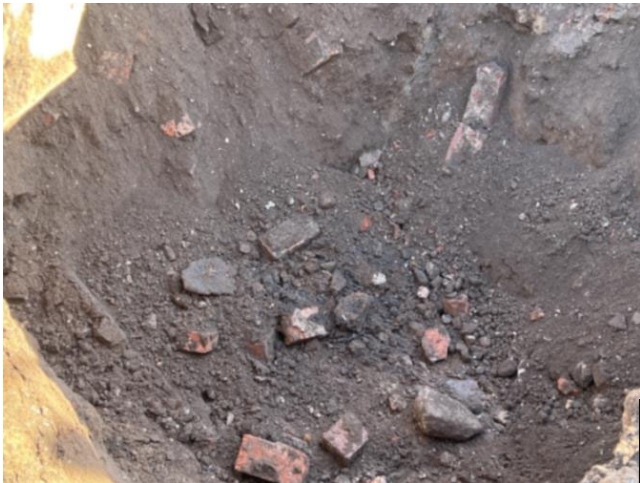
Depth (m)	Sample / Tests	Water Depth (m)	Field Records	Level (mOD)	Depth (m) (Thickness)	Description	Legend	Water
1.60	JV		PID reading at 1.60m = 0.00ppm		(1.50)	MADEGROUND. Dark brown, silty, gravelly, fine to coarse SAND. Gravel is sub-angular to sub-rounded, fine to coarse of various lithologies including brick and concrete (backfill material). *Assumed as loose.

1.80	JV		PID reading at 1.80m = 0.00ppm		(0.40)	Brown, slightly gravelly, silty, fine to medium SAND. Gravel is sub-angular to sub-rounded, fine to coarse of various lithologies. *Assumed as loose to medium dense.

1.90	Complete at 1.90m

Location CAT scanned prior to excavation.
 Spalling from sides of trial pit.
 No groundwater encountered during excavation.
 *Based upon trenchside stability characteristics.
 Please note that discolouration of photographs may occur when viewed on screen as a PDF, or when printed as a hard copy.
 Trial pit completed following removal of fuel tank.
 Trial pit completed for contamination purposes. No visual or olfactory evidence of contamination during excavation.
 During excavation background PID reading of 0.00ppm.
 Trial pits shown on Coopers Drawing No. 8224/01
 Backfilled with arisings upon completion.

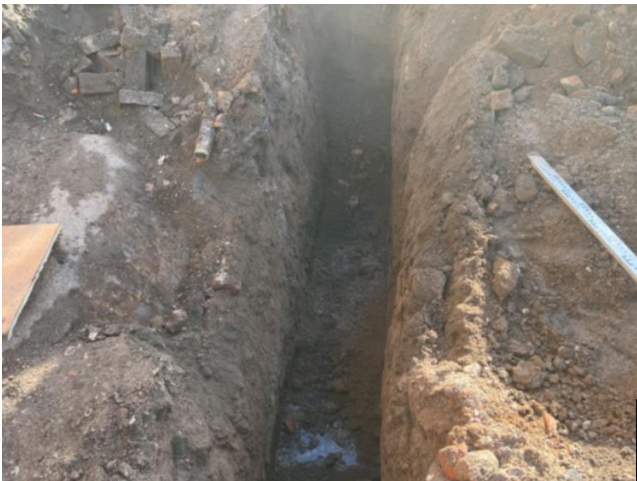
0.50	JV		PID reading at 0.50m = 0.00ppm		0.50 (0.70)	MADEGROUND. Orangish brown, slightly silty, fine to medium SAND with rare, fine gravel. *Assumed as loose to medium dense.

1.60	JV		PID reading at 1.60m = 0.00ppm		1.50 (0.40)	Greyish brown, slightly gravelly, silty, fine to medium SAND. Gravel is sub-angular to sub-rounded, fine to coarse of various lithologies. *Assumed as loose to medium dense.

Slight seepage at base(1) at 1.90m.		1.90	Complete at 1.90m		∇1

Location CAT scanned prior to excavation.
 Sides stable during excavation.
 Slight seepage at base of trial pit.
 *Based upon trenchside stability characteristics.
 **Spurious shear vane, sample breaking apart during testing.
 Shear vane SV-6 used. Medium vane.
 Please note that discolouration of photographs may occur when viewed on screen as a PDF, or when printed as a hard copy.
 Trial pit completed alongside insitu fuel tank.
 Trial pit completed for contamination purposes. No visual or olfactory evidence of contamination during excavation.
 During excavation background PID reading of 0.00ppm.
 Trial pits shown on Coopers Drawing No. 8224/01
 Backfilled with arisings upon completion.
