Preliminary Roost &  
Nest Assessment

Marae Barn  
Bagg Lane  
St. Germans  
Saltash  
PL12 5PB

August 2023

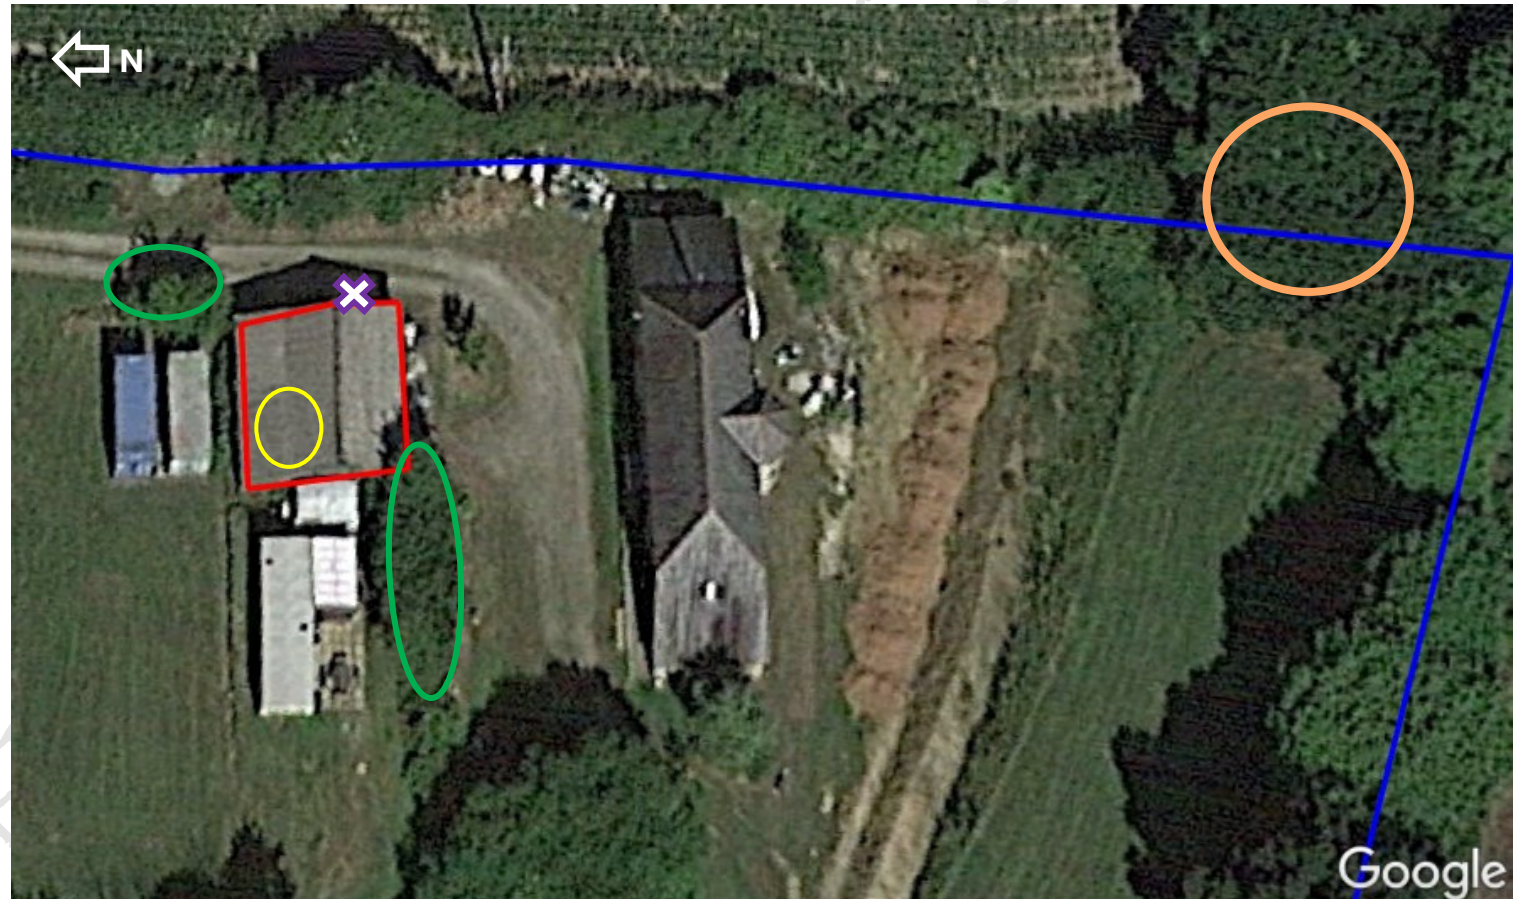
Locations are approx. and not to scale.	
Site boundary	
Dwelling surveyed	
Location of bird nesting	
Hawthorns

Proposed Mitigation & Enhancement	
Swallow cup on north or eastern aspect	
Protection of root protection area of hawthorn trees.	
Owl box

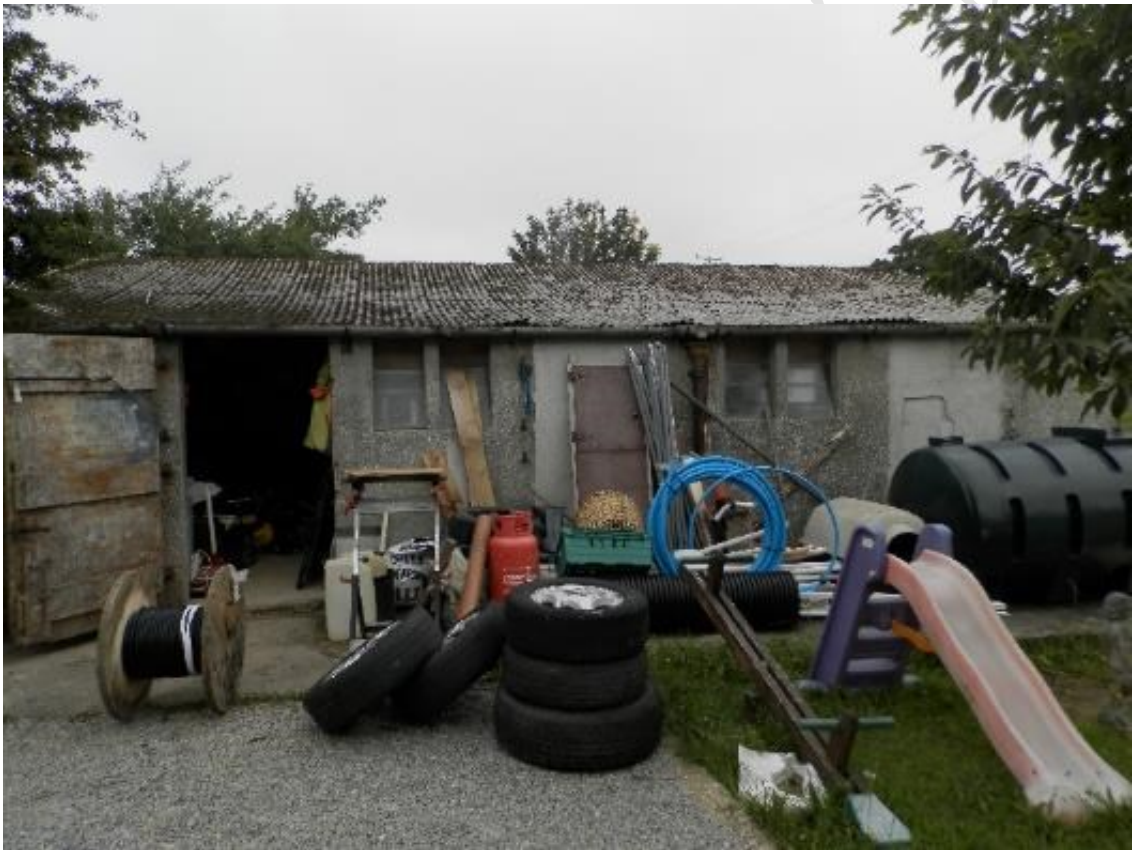
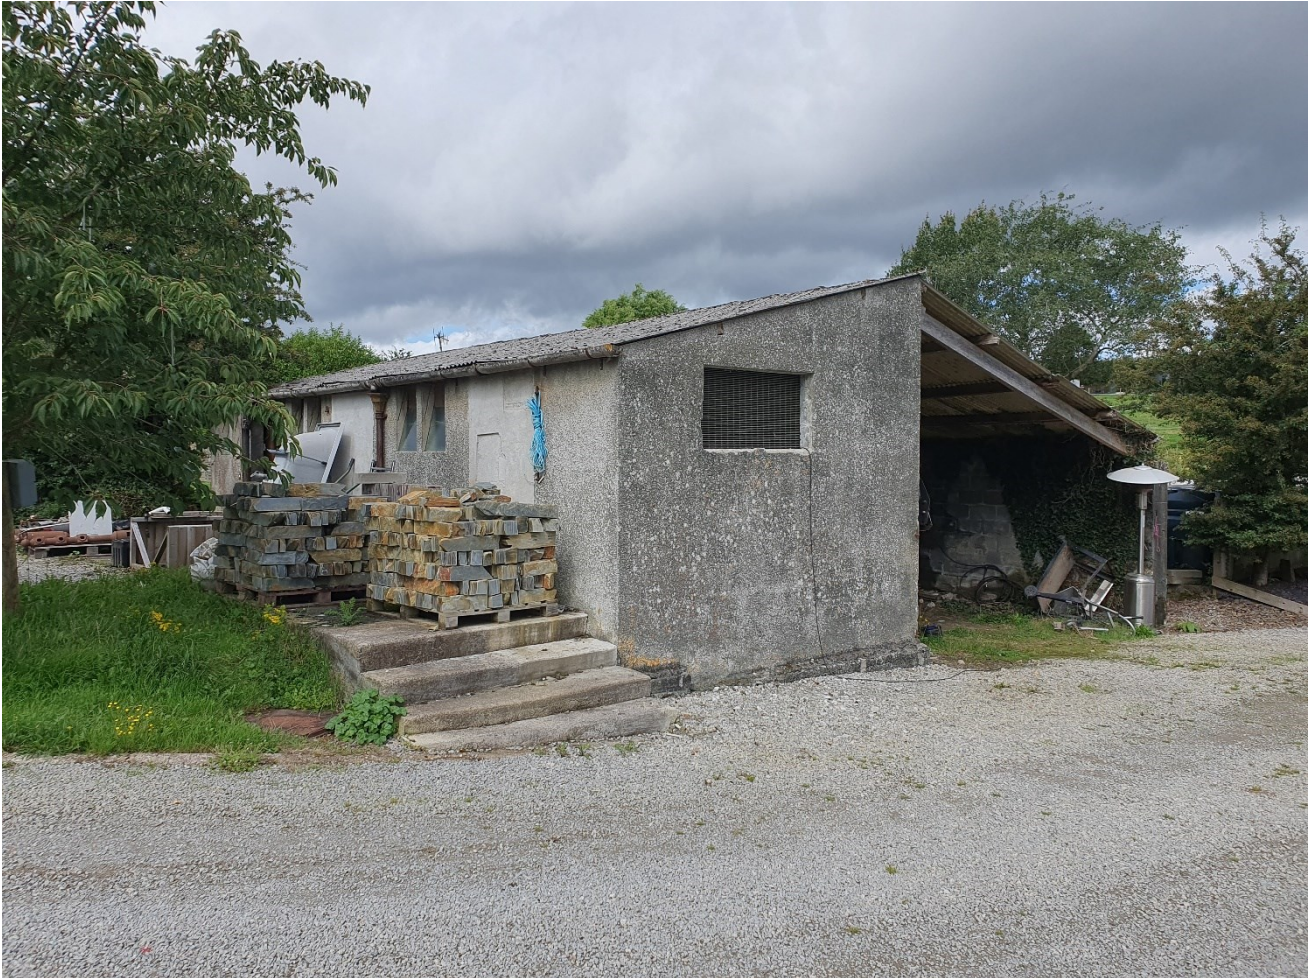
**Image from 2020**

The barn is constructed of block with render (no cavity). The pitched roof is constructed of corrugated asbestos sheeting. There is no loft void and no lining.

No evidence of bats was recorded within the barn. The barn is in two sections: The northern half is open on one side making it bright and open to the elements which make it unsuitable for bat roosting. However, there is a Swallows nest being actively used in the beams of the roof. The southern half is closed and secure and is kept locked making ingress difficult. Additionally, due to the construction materials the temperatures within will fluctuate making it unsuitable for roosting.

This structure offers negligible roosting features.

Potential nesting features exist: - A Swallows nest which was actively being used was recorded up in the beams of the northern part of the barn.

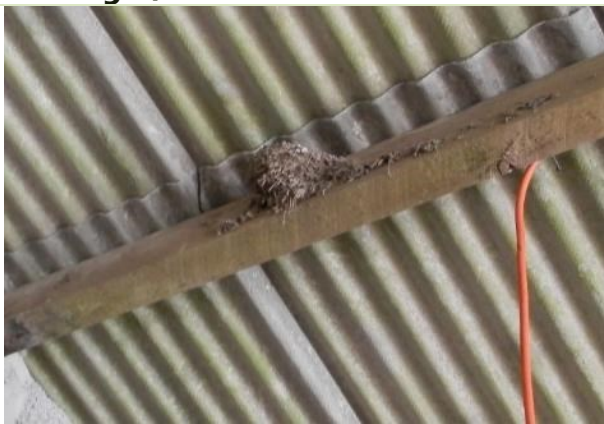
The Swallows nest recorded in the northern half of the barn. Not present in 2023

- To mitigate this loss, provide: 1 x swallow cup provision to be erected on the northern or eastern aspect of the new structure.

- Development cannot begin until all bird nests are no longer in use. As such, any work will have to take place outside of the current breeding season: from September to February (approximately).

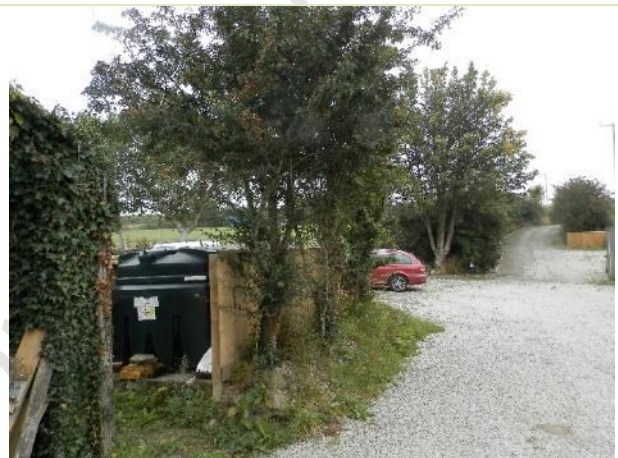
A view of the Hawthorns north of the barn.

- Further habitats: The client proposes to retain the hawthorn trees which are in the vicinity of the barn. These trees are still fairly young, and it would not be a requirement to retain them. It is therefore recommended that the client observe root protection areas of these trees to avoid damage and avoids the use of heavy machinery within the area of the trees, avoids storage of chemicals or materials or the lighting of fires near to these trees in order to protect them appropriately. .

The Root Protection Area (RPA) of individual standard trees can be put in place. RPAs are calculated as an area equivalent to a circle with a radius 12 times the stem diameter of the tree. RPAs are capped at 707m<sup>2</sup>, represented by circle with a radius of 15 metres where the tree is at the centre.

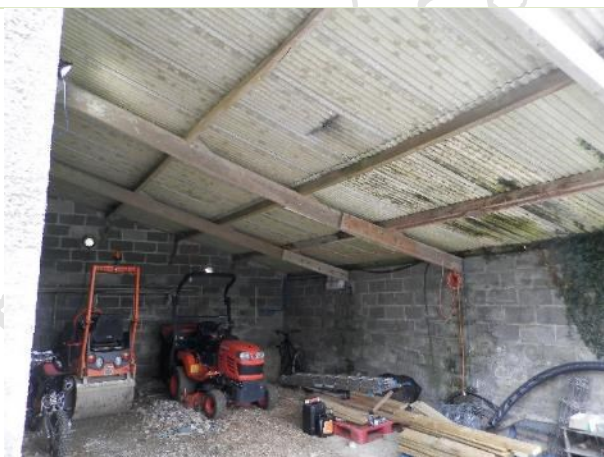
View of the northern half of the barn showing how bright the structure is during the day.

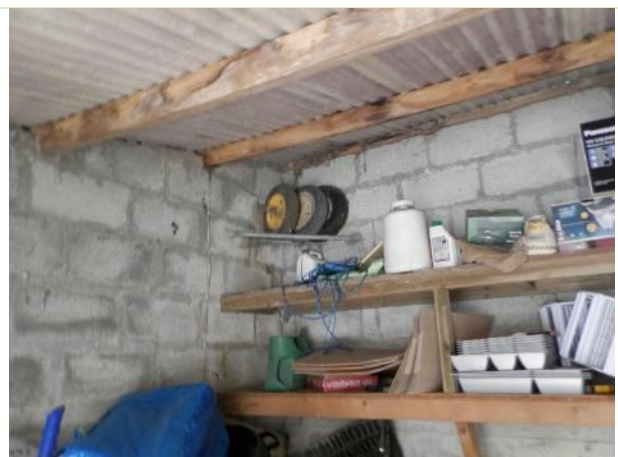
View of the interior of the southern half of the barn, frequently used, bright, showing the intact pointing, and the intact roof.

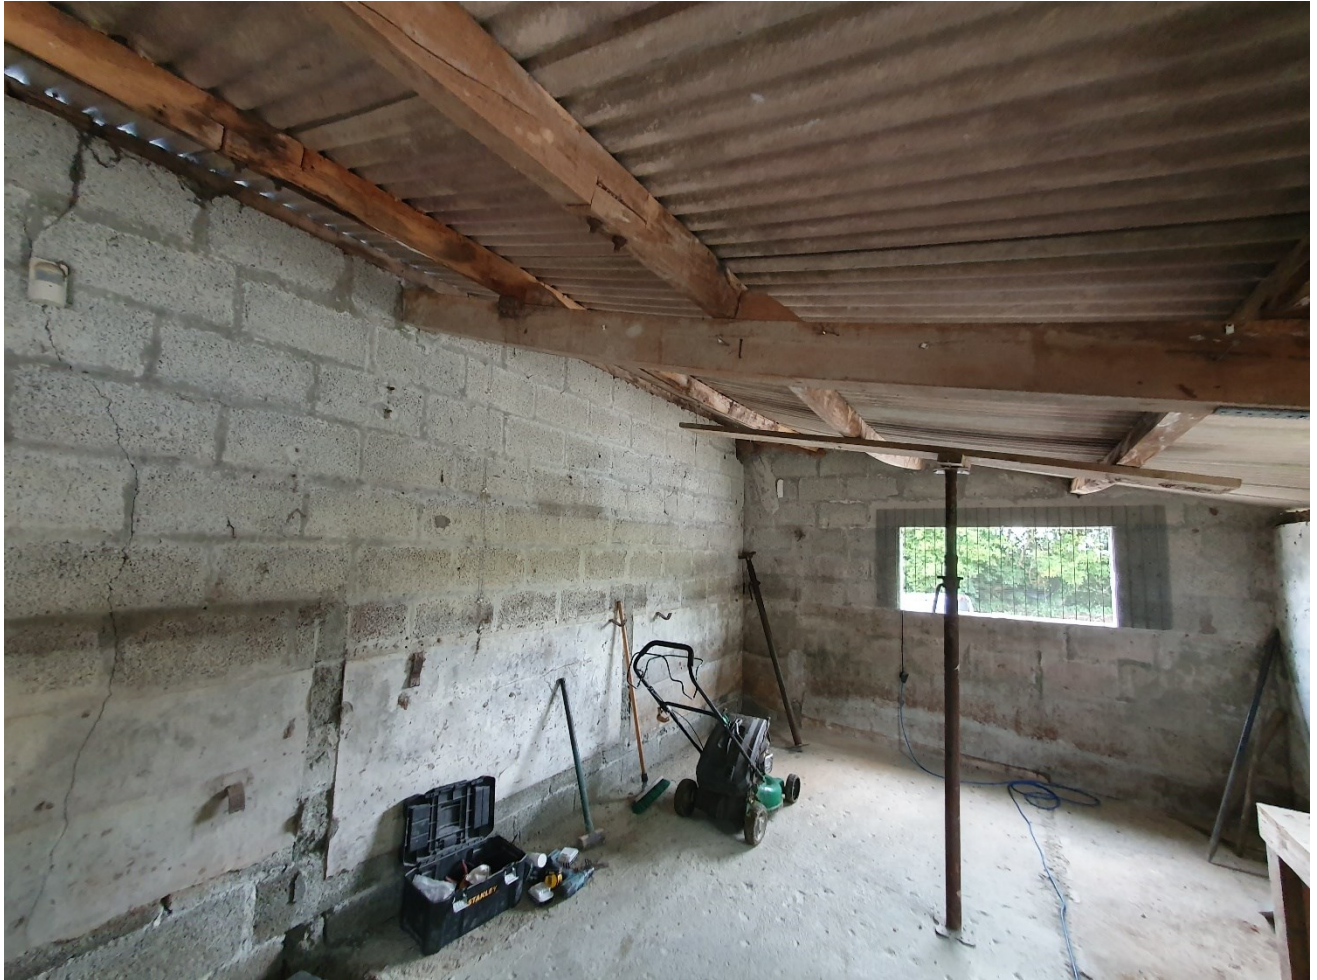
Image from 2023 – essentially the same as 2020
