JOB		Moor Hall Farm					
DRAWING		Proposed Roof Plan					
DRAWING NUMBER		1324 P 023					
scale	1:50	A2	date: Apr 23				
drawn	FW/VMN						
Revisions		<table border="1"> <tr> <td>A</td> <td>B</td> </tr> <tr> <td> </td> <td> </td> </tr> </table>		A	B		
A	B

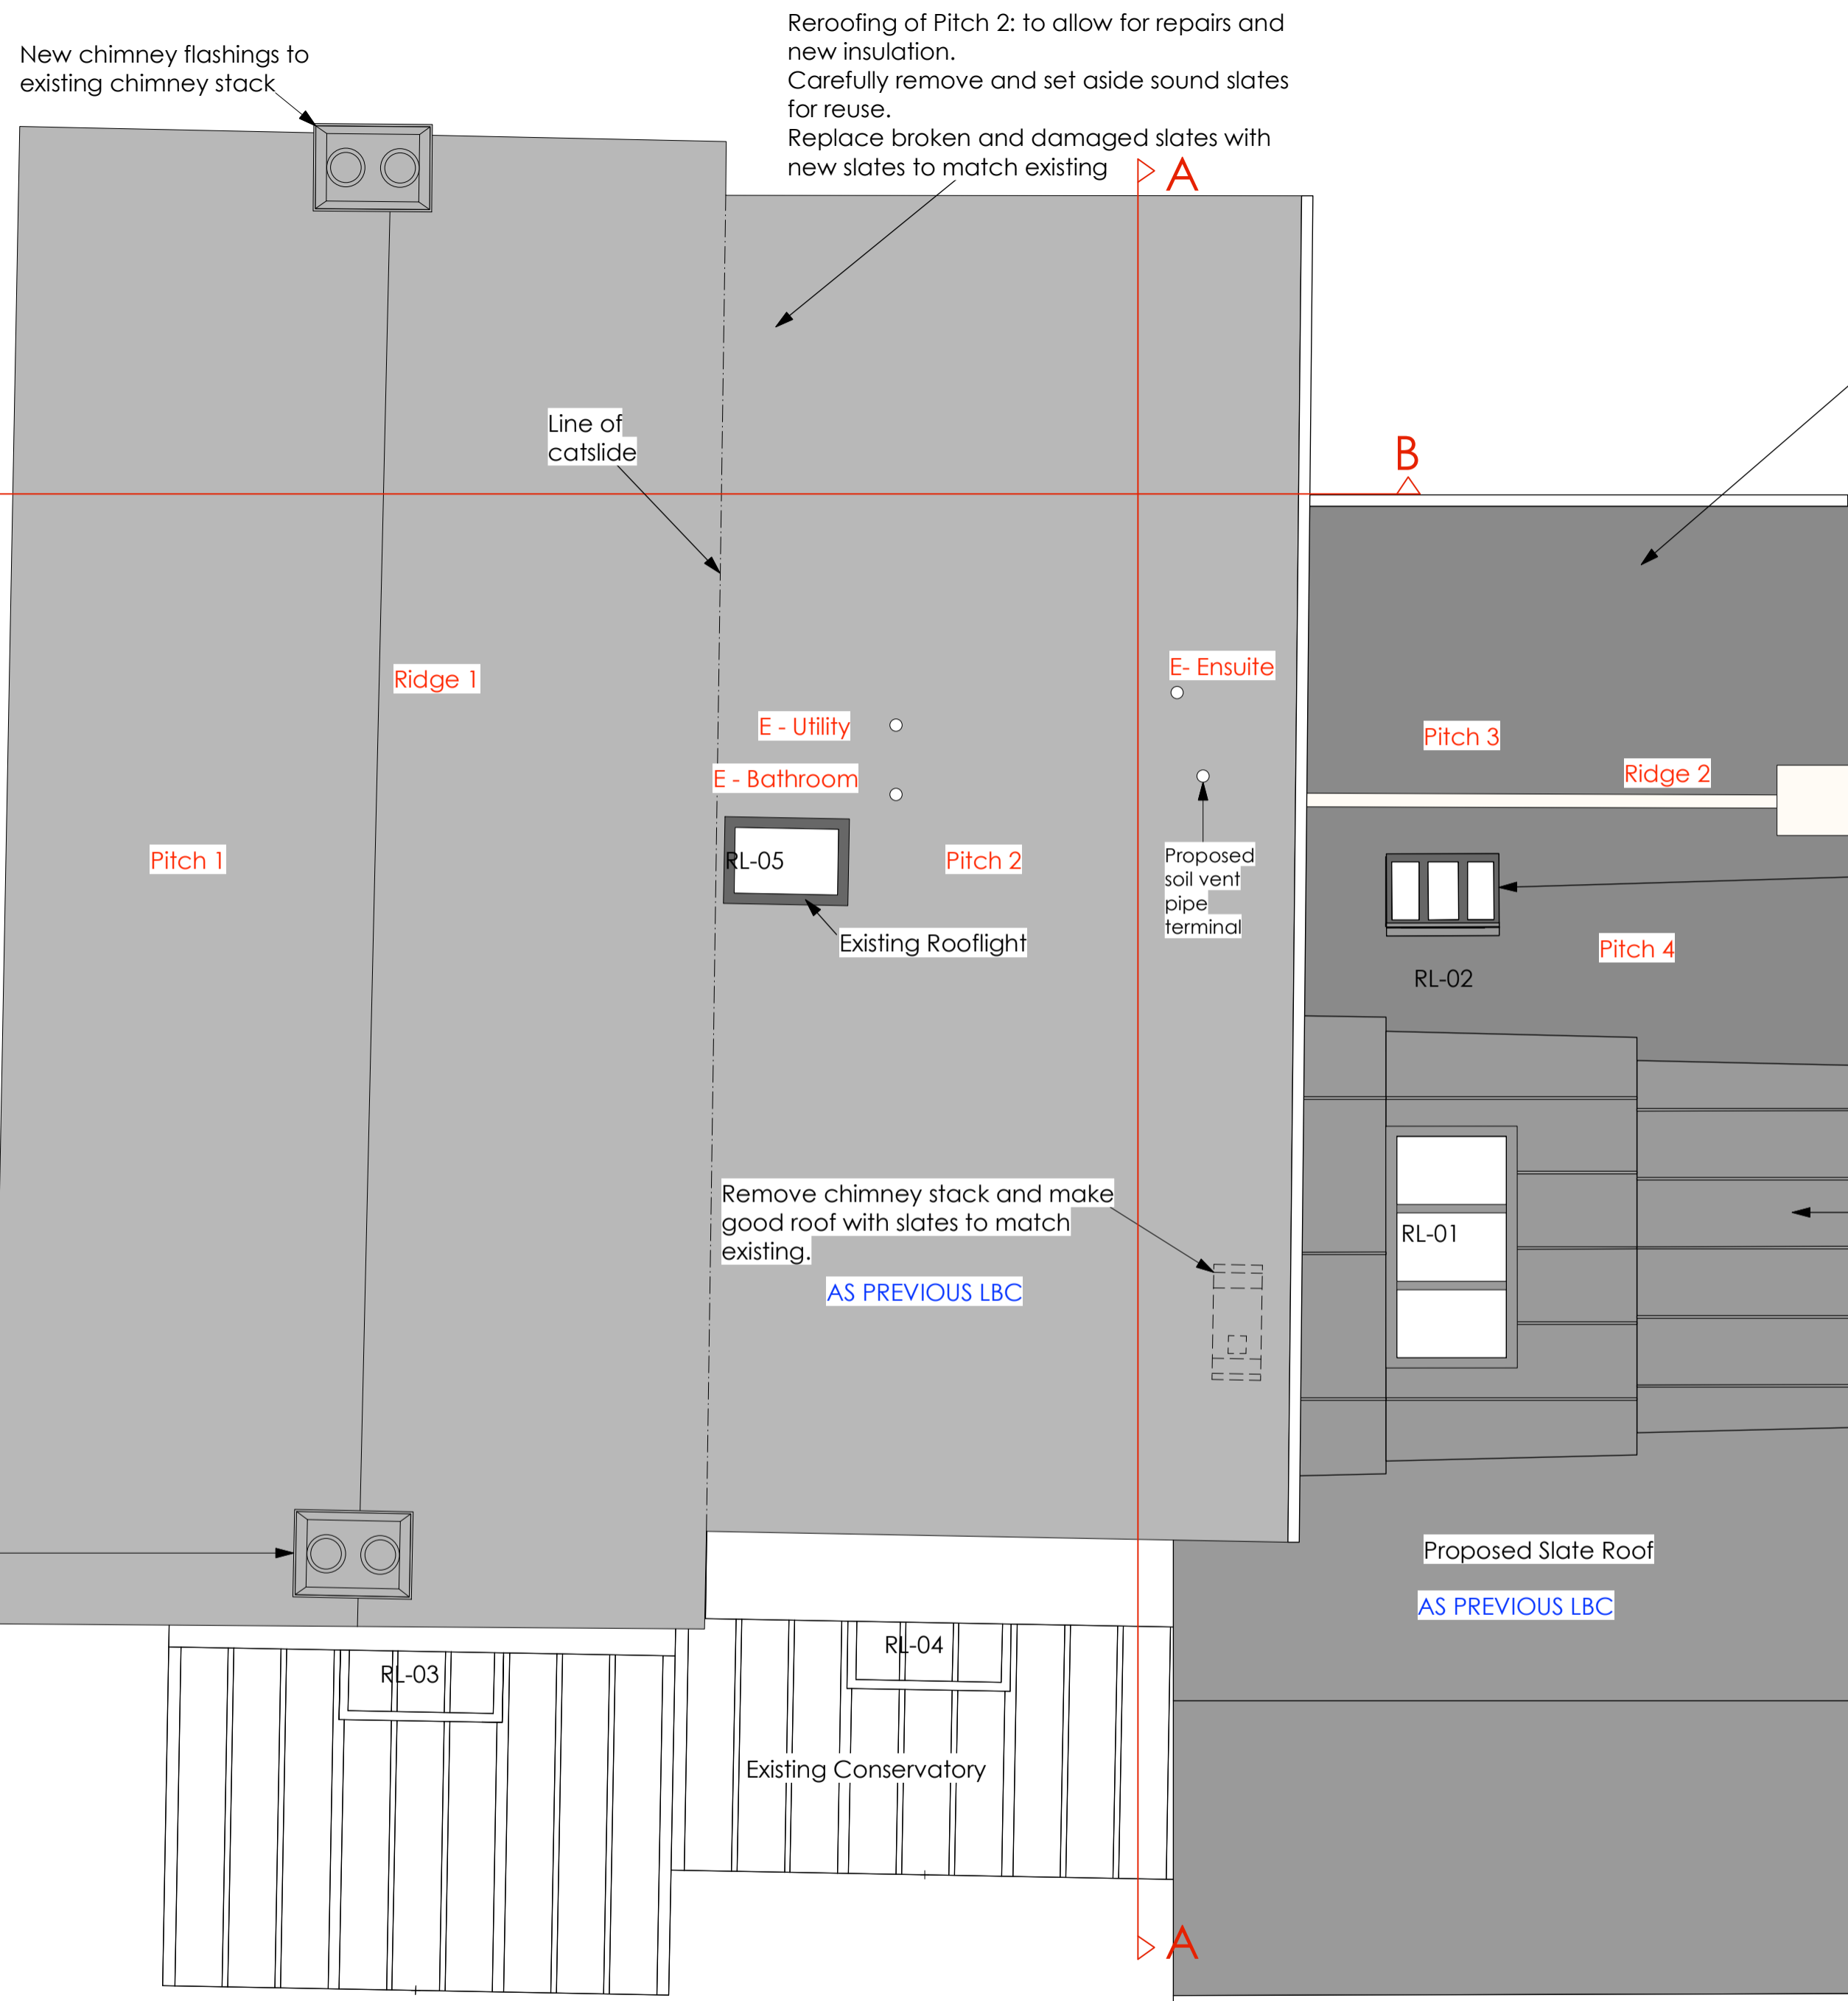
Reroofing of Pitch 1.  
Existing configuration of roof covering is not original.

Carefully remove and set aside sound slates for reuse (suspected nail sick roof). Check condition of battens and existing felt and replace as necessary to suit a like-for-like gauge. Refix set aside slates and replace damaged slates with new slates to match existing.

NOTE: Existing verge slates are inadequate and only half sized to be replaced with one-and-a-half sized verge slates.

Ridges 1 & 2  
Carefully remove existing ridge tiles. Rebed on completion of re-slating, replacing any damaged ridge tiles to match existing.

Lead repairs  
Check condition of existing flashings around chimneys and replace as necessary if defective or inadequate (cover looks deficient from low level)

Replace rotten fascias and soffits as necessary in species and profile to match existing.  
NOTE: Maintain bat access into the roof space as identified by the Ecologist if the relevant soffit needs replacing.
