## **Existing North East Elevation**

2 MILL WALK, WHEATHAMPSTEAD, HERTFORDSHIRE, AL4 8DT

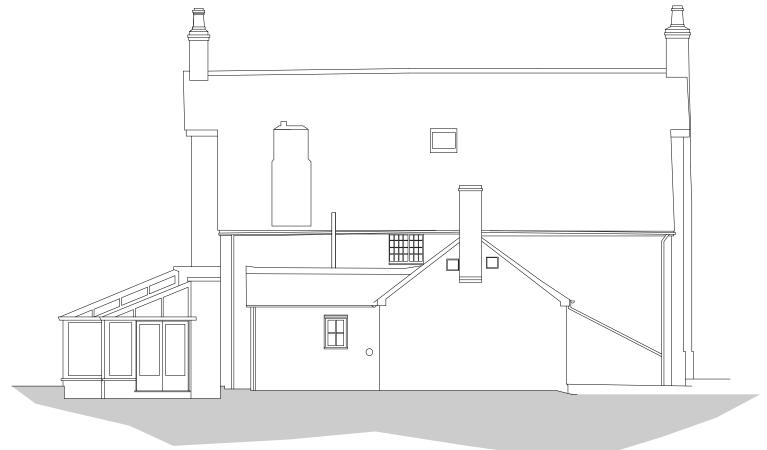
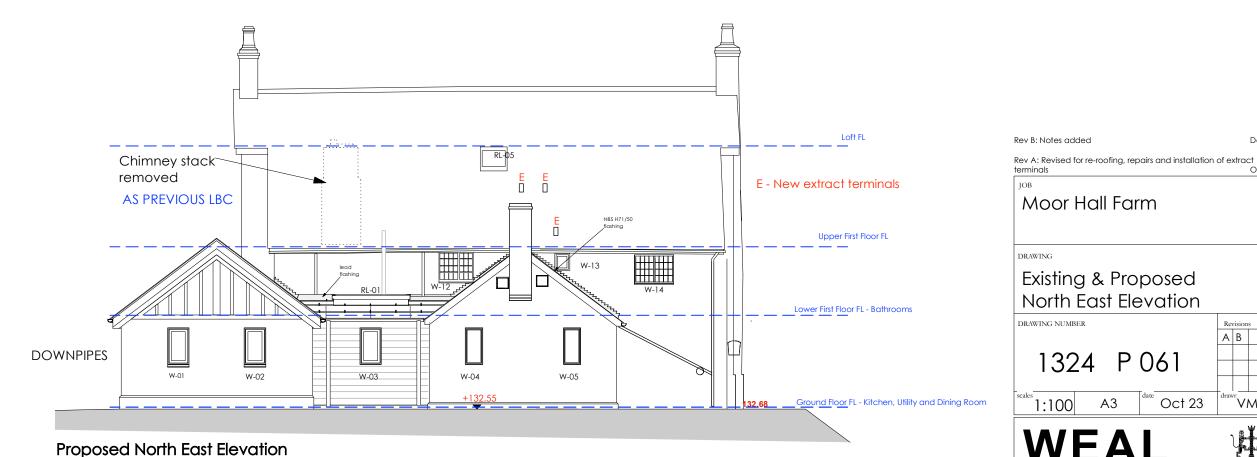
5m Replace rotten fascias and soffits as necessary in species and profile to match existing. NOTE: Maintain bat access into the roof space as identified by the Ecologist if the relevant soffit needs replacing. 5m
