Ravenscourt Park Hospital

Phase 1 Preliminary Risk Assessment

Curtins Ref: 082182-CUR-XX-XX-T-GE-001

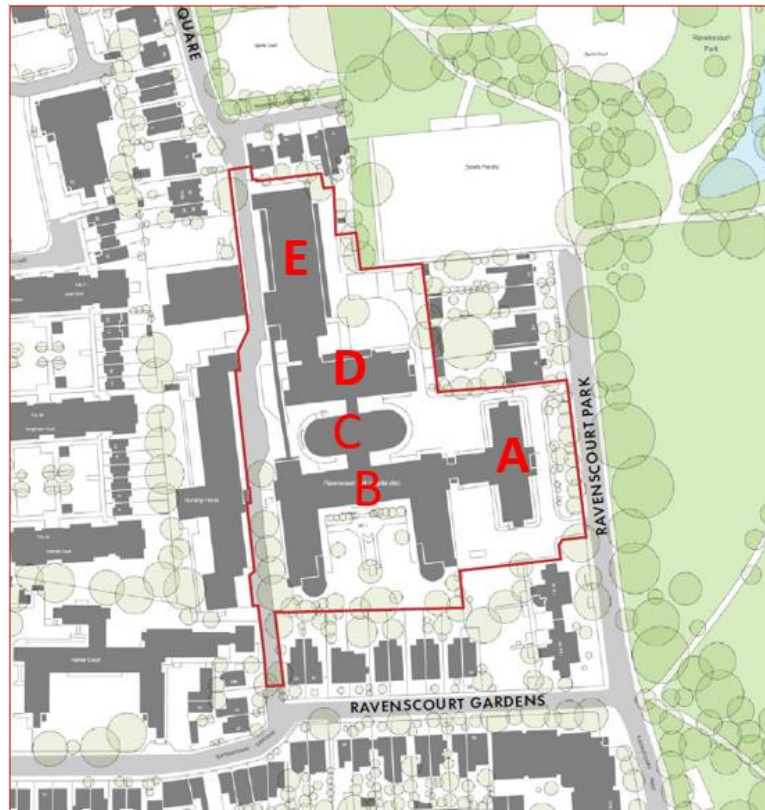
Figure 2.1 Site Location (TT Group, 2023) – Blocks demarcated in red

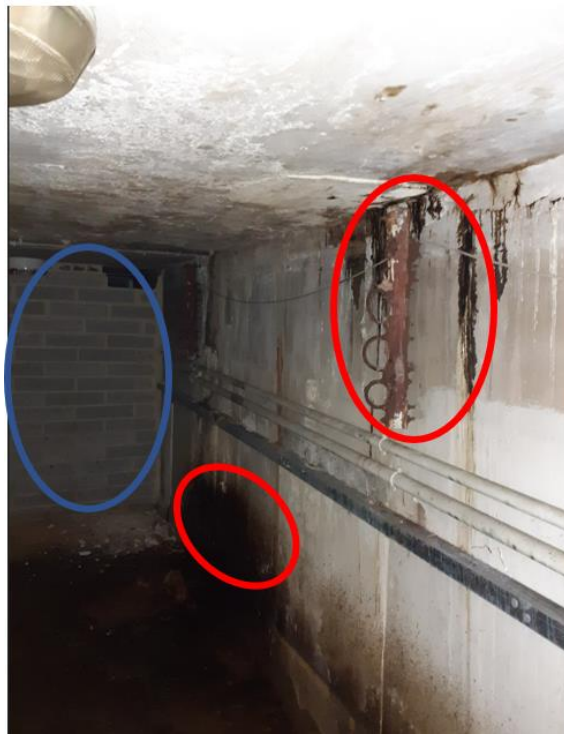
As part of the site walkover, suspected heating oil was noted to be leaking into the service tunnel on the west adjacent to the western boundary, as presented in Figure 2.2a and b. Hydrocarbon odours and staining were recorded associated with the staining and viscous fluid noted. It is anticipated that the potential source of heating oil is associated with the off-site energy centre. The service tunnel was 'bricked up' to the western boundary as highlighted in Figure 2.2a and it was estimated that the leakage/staining was recorded circa 3m inside the site boundary.

Figure 2.2a Service tunnel with suspected heating oil/kerosene (hydrocarbons)- blue highlights anticipated site boundary and red highlights areas of leakage.

- **Source 4:** Mobile Phase – Leakages of fuel-based contaminants including suspected heating oil identified during site walkover leaking into service tunnel potentially through existing subsurface infrastructure (service tunnels, existing utilities etc.)/granular superficial deposit potentially originating from off-site energy centre west of the site. The Council records highlight that oil tanks were installed at the energy centre in the 1970s.

S4 (off-site): Mobile Phase – Leakages of fuel-based contaminants originating from off-site energy centre west of the site	P5: Horizontal migration of mobile phase contaminants through the granular superficial deposits – followed by inhalation of vapours	R1: Residents, Site Staff, Visitors and Trespassers	Medium Chronic health risk	Likely During the site walkover within service tunnels along the western boundary, leakages of fuel-based contaminants anticipated to be heating oil/kerosene were identified. These are considered to originate from off-site energy centre to the west of the development site. Typically heating oil/kerosene comprise longer chain hydrocarbons and therefore not generally associated with an inhalation of vapour risk. However further investigation and testing along the western boundary is required to confirm this. Based on the current understanding, there is a potential likely risk of fuel based hydrocarbons migrating onto site and presenting a potential inhalation of vapours risk to future site users. It is recommended that a GQRA is undertaken to further determine the risk.	Moderate	GQRA as part of a ground investigation

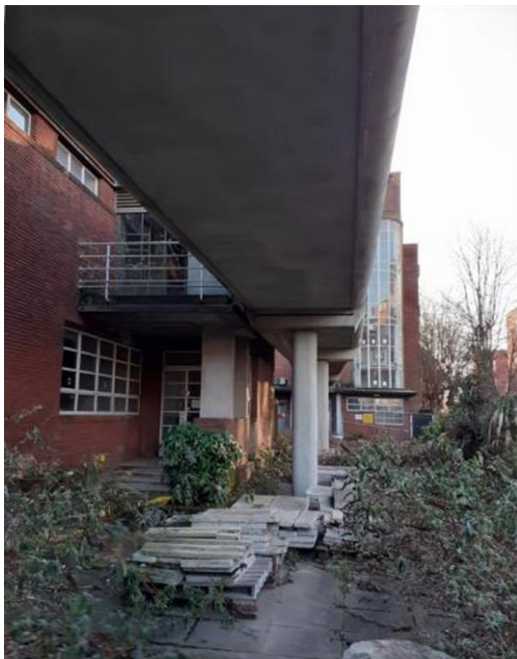
Photo No: 9

Orientation: South	
Notes: Link corridor between Block B and E on western boundary

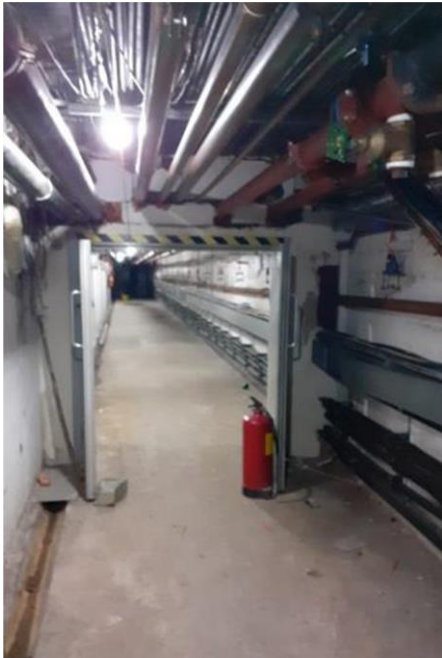
Photo No: 11

Orientation: -	
Notes: On-site service tunnels
