ARBORICULTURAL IMPACT ASSESSMENT

Bushloe House, Wigston

Macc Group

220804 22018 AIA V1b

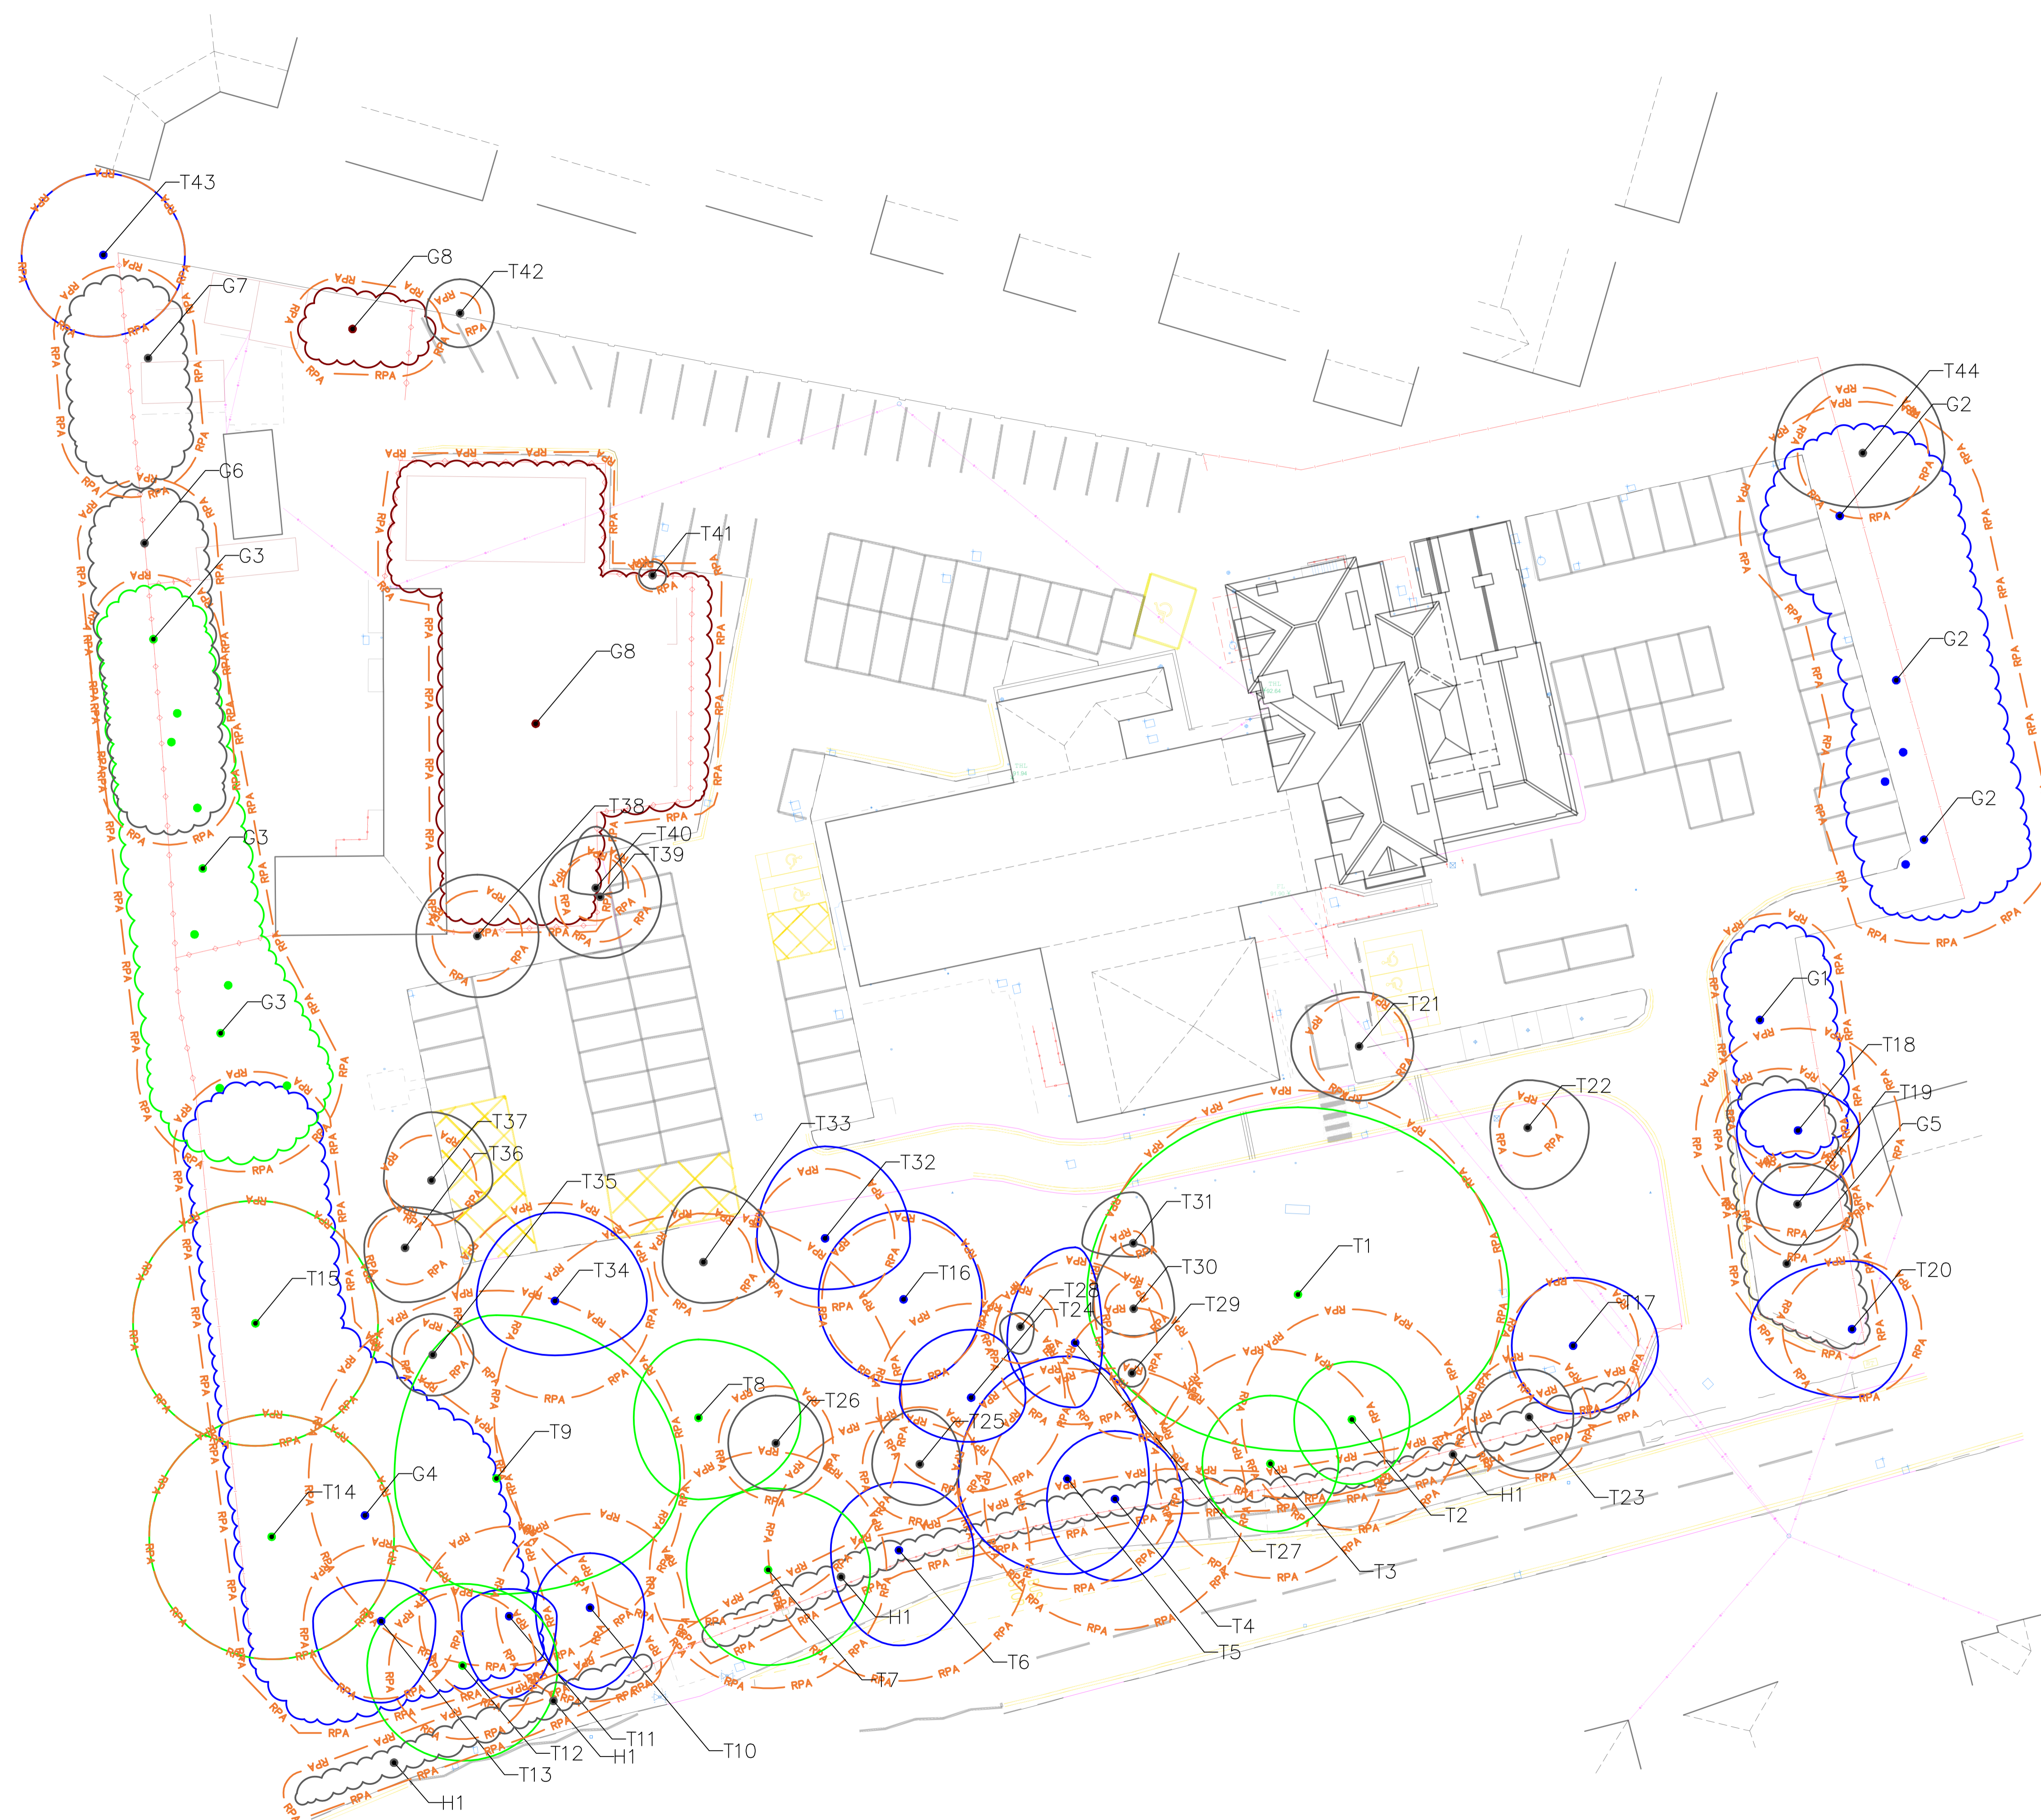
Some tree locations are based on aerial imagery and measurements taken onsite. As such tree locations must not be taken as exact.

This TCP is created as a design tool and does not make an assessment of the impacts or subsequent effects of the Proposed Development to trees. Therefore, the TCP must not be submitted solely to inform the planning application. An Arboricultural Impact Assessment or similar report will be required to inform the planning application which this TCP may form part of.

- 4.2.5 The location of each tree and their associated constraints including canopy spread and Root Protection Areas (RPAs) with and without the Proposed Development are illustrated on plan numbers OE-001 and OE-002 both at Appendix 4.

- 6.1.1 The distribution of tree canopy cover on and within influencing distance of the Site is illustrated on the Tree Constraints Plan (OE-001) at Appendix 4.

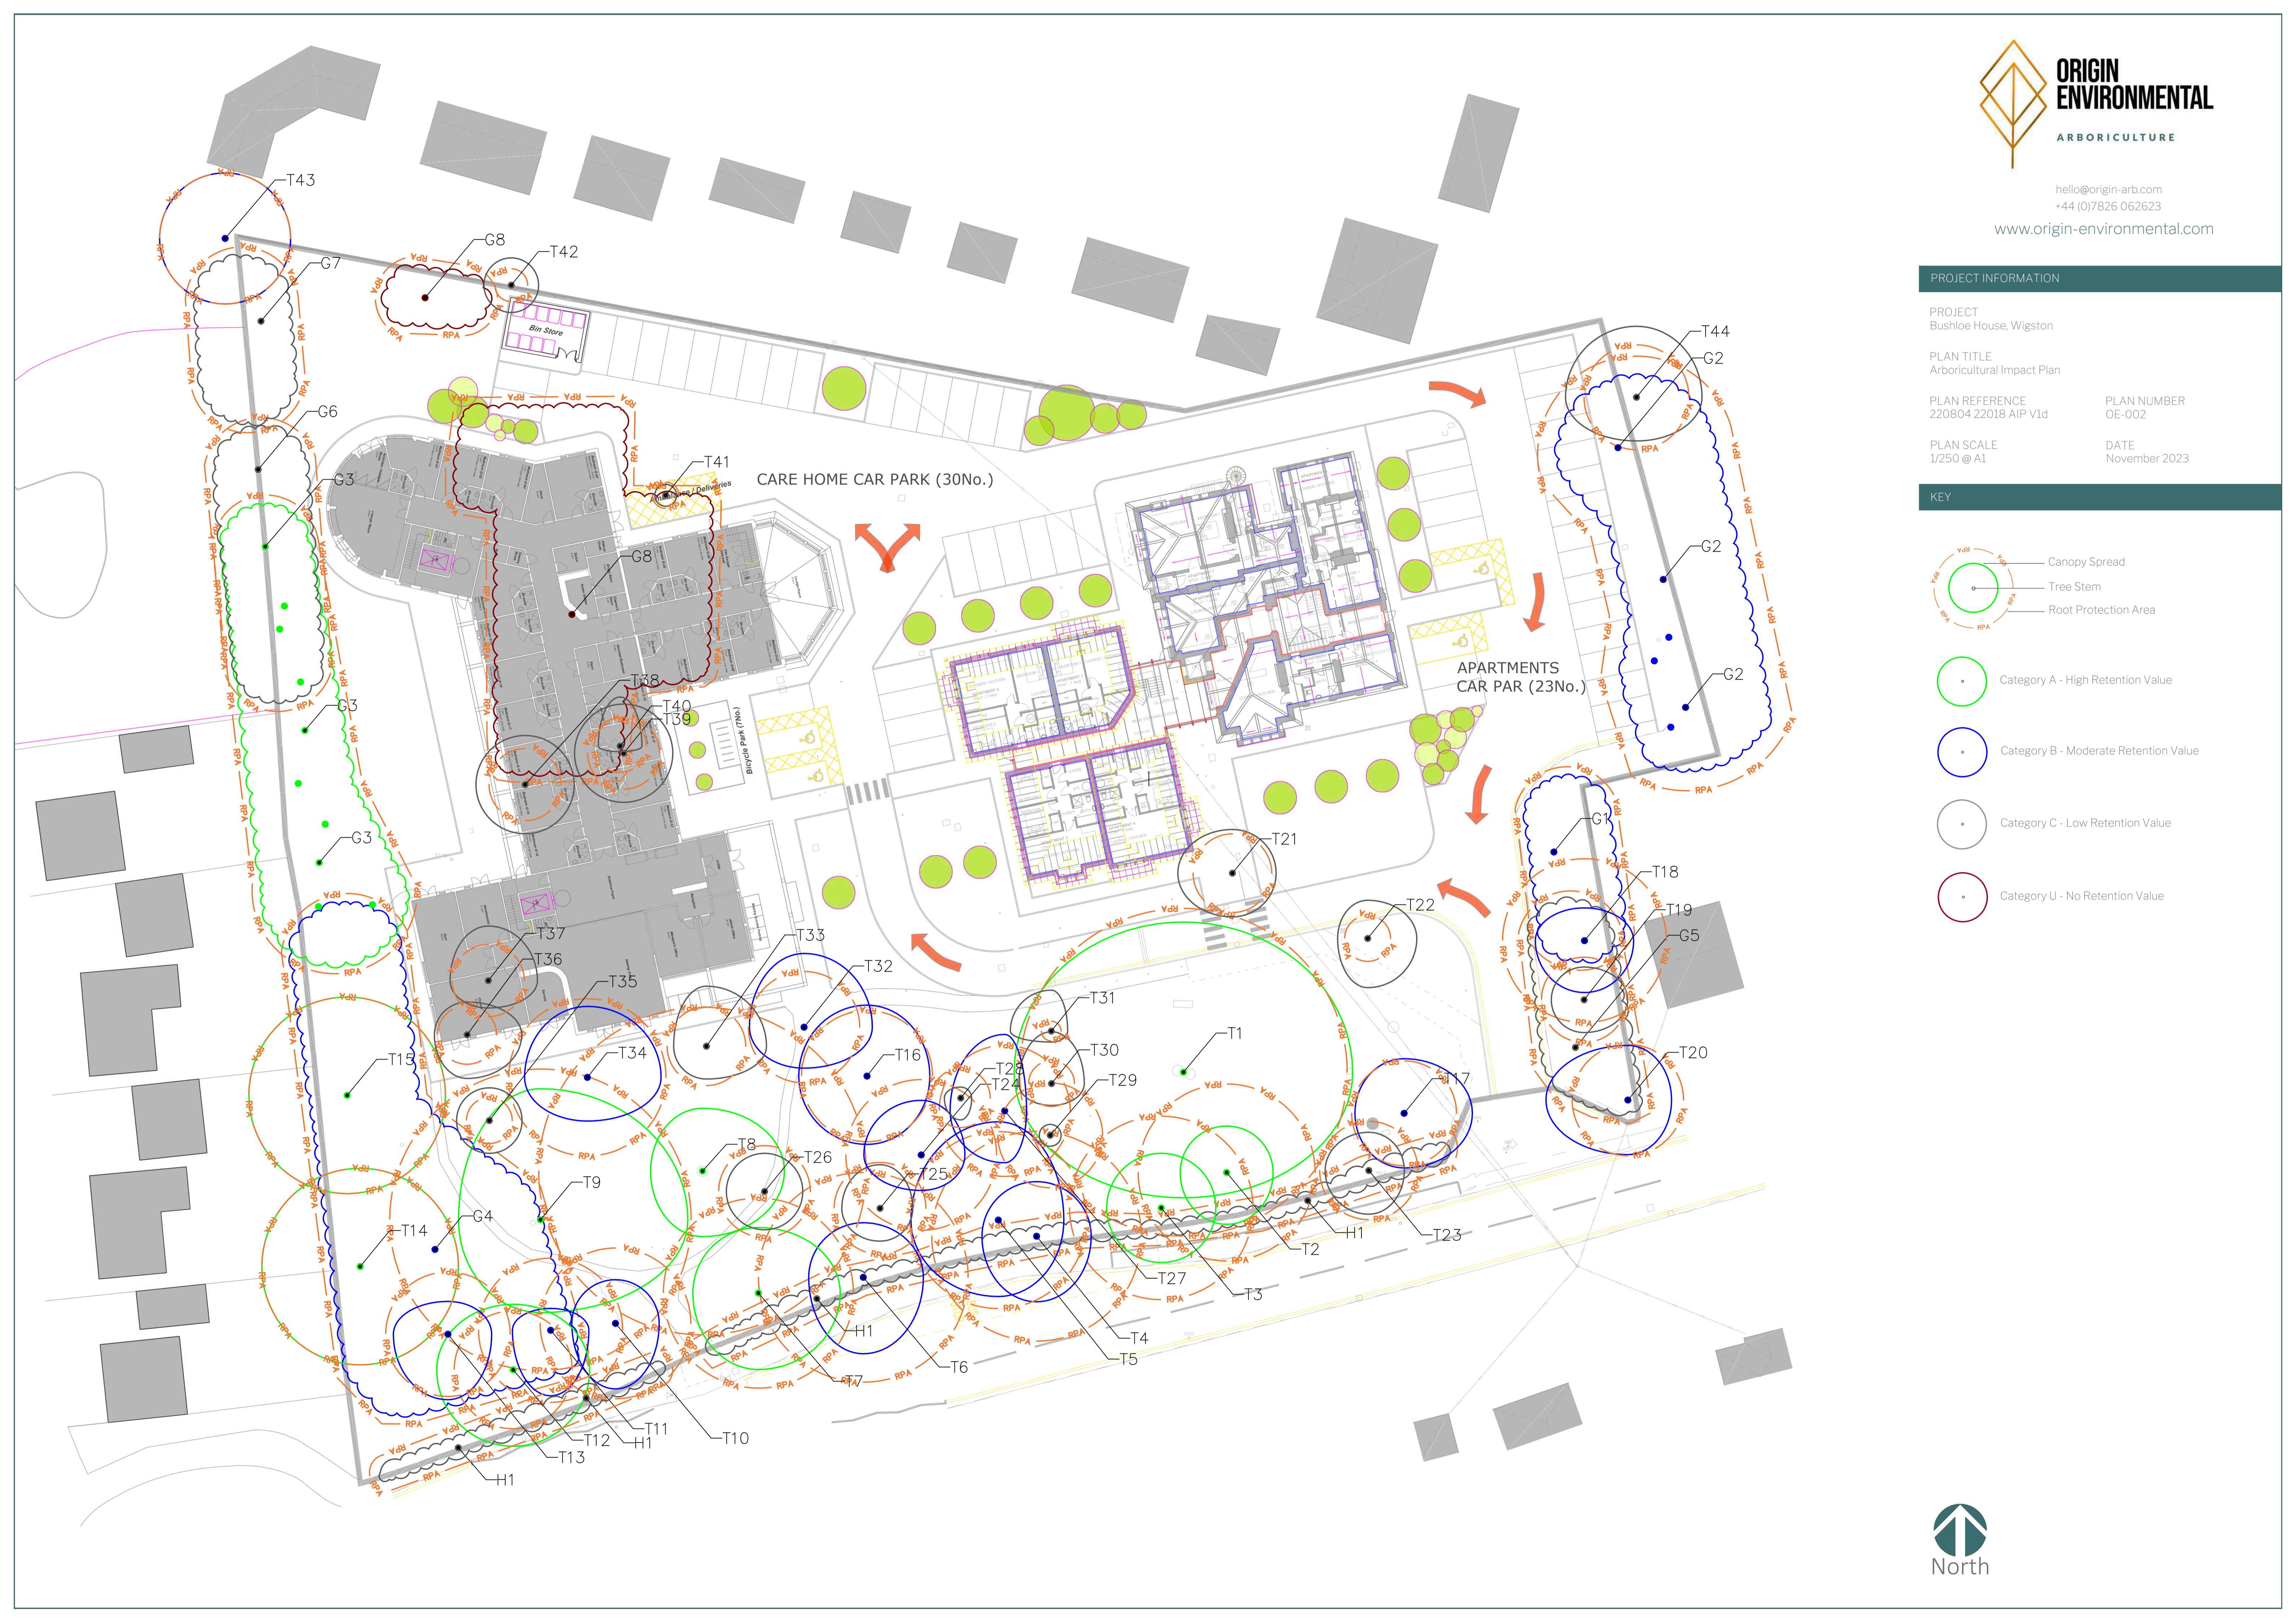
Trees to be *removed* for Development

- 5.1.1 To implement the Proposed Development there will be a requirement to remove 9no. individual trees and 1no. group of trees. These include 2no. category B, 7no. category C and 1no. category U retention value.
- 5.1.2 A breakdown of the proposed tree removal/relocations are outlined in the table below. Full specification of tree removal is provided within the complete Tree Schedule at Appendix 3. All trees which are directly or indirectly impacted upon by the Proposed Development, are illustrated on plan OE-002 at Appendix 4.

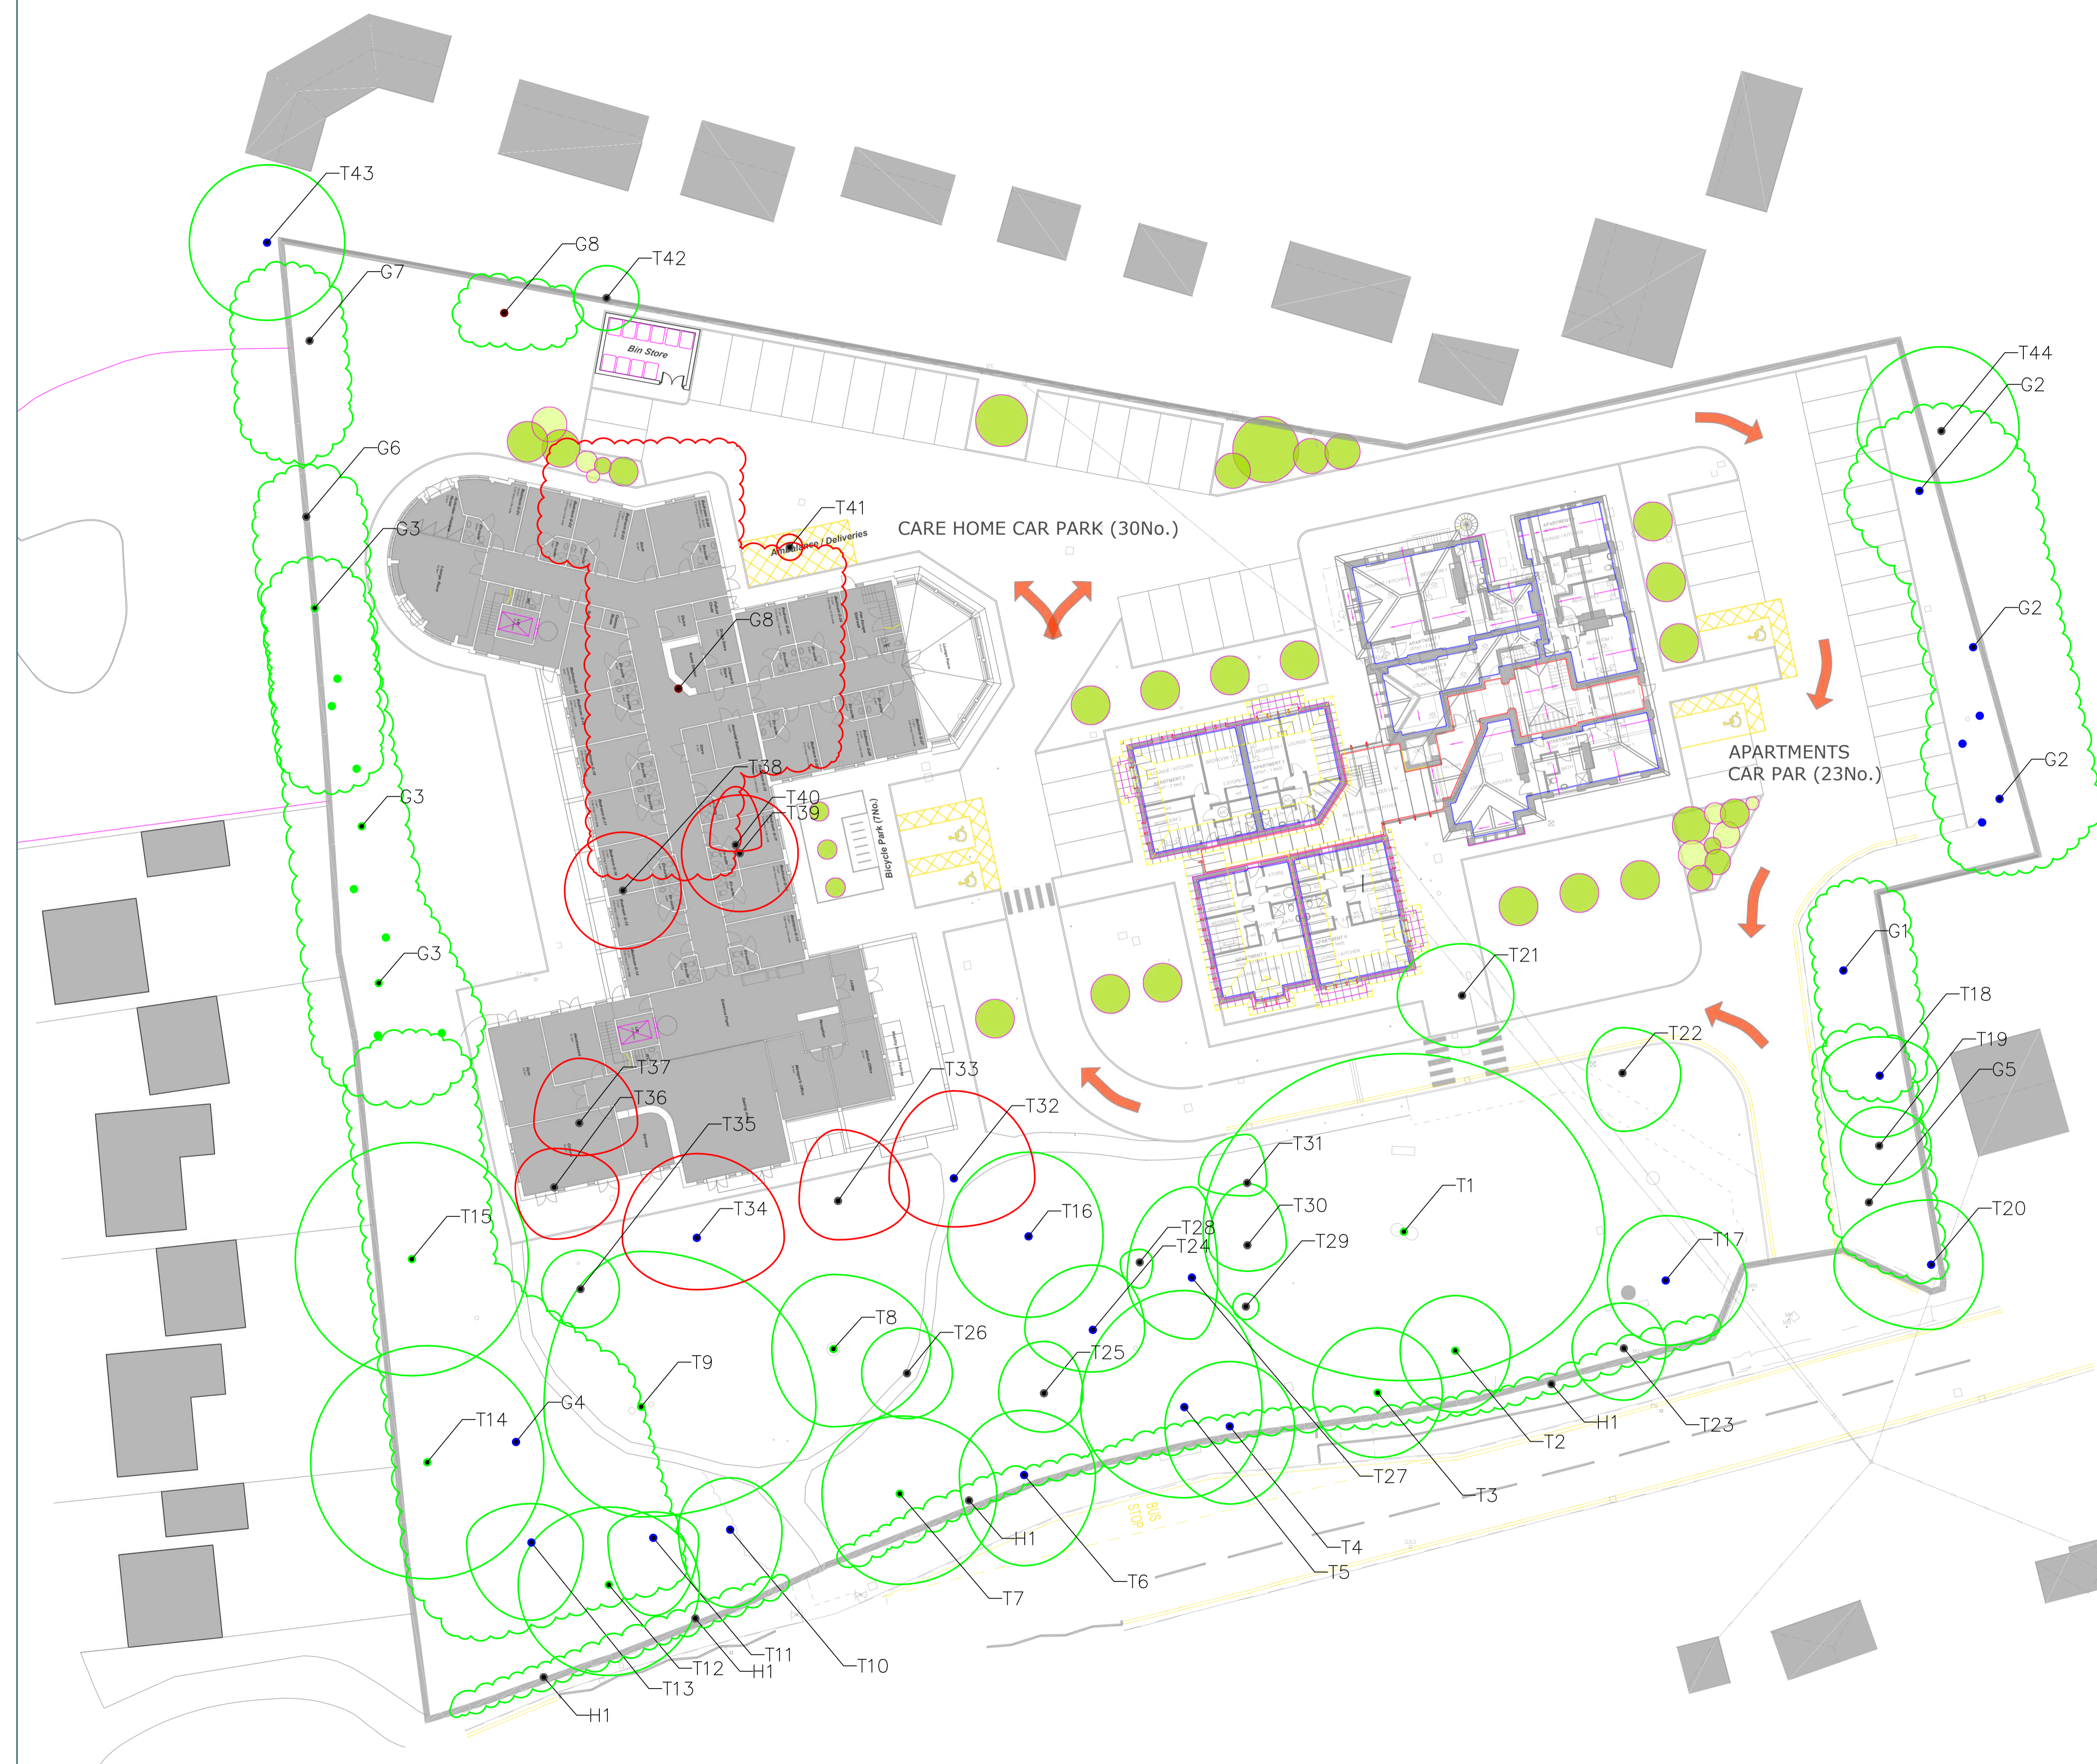
Construction Exclusion Zone

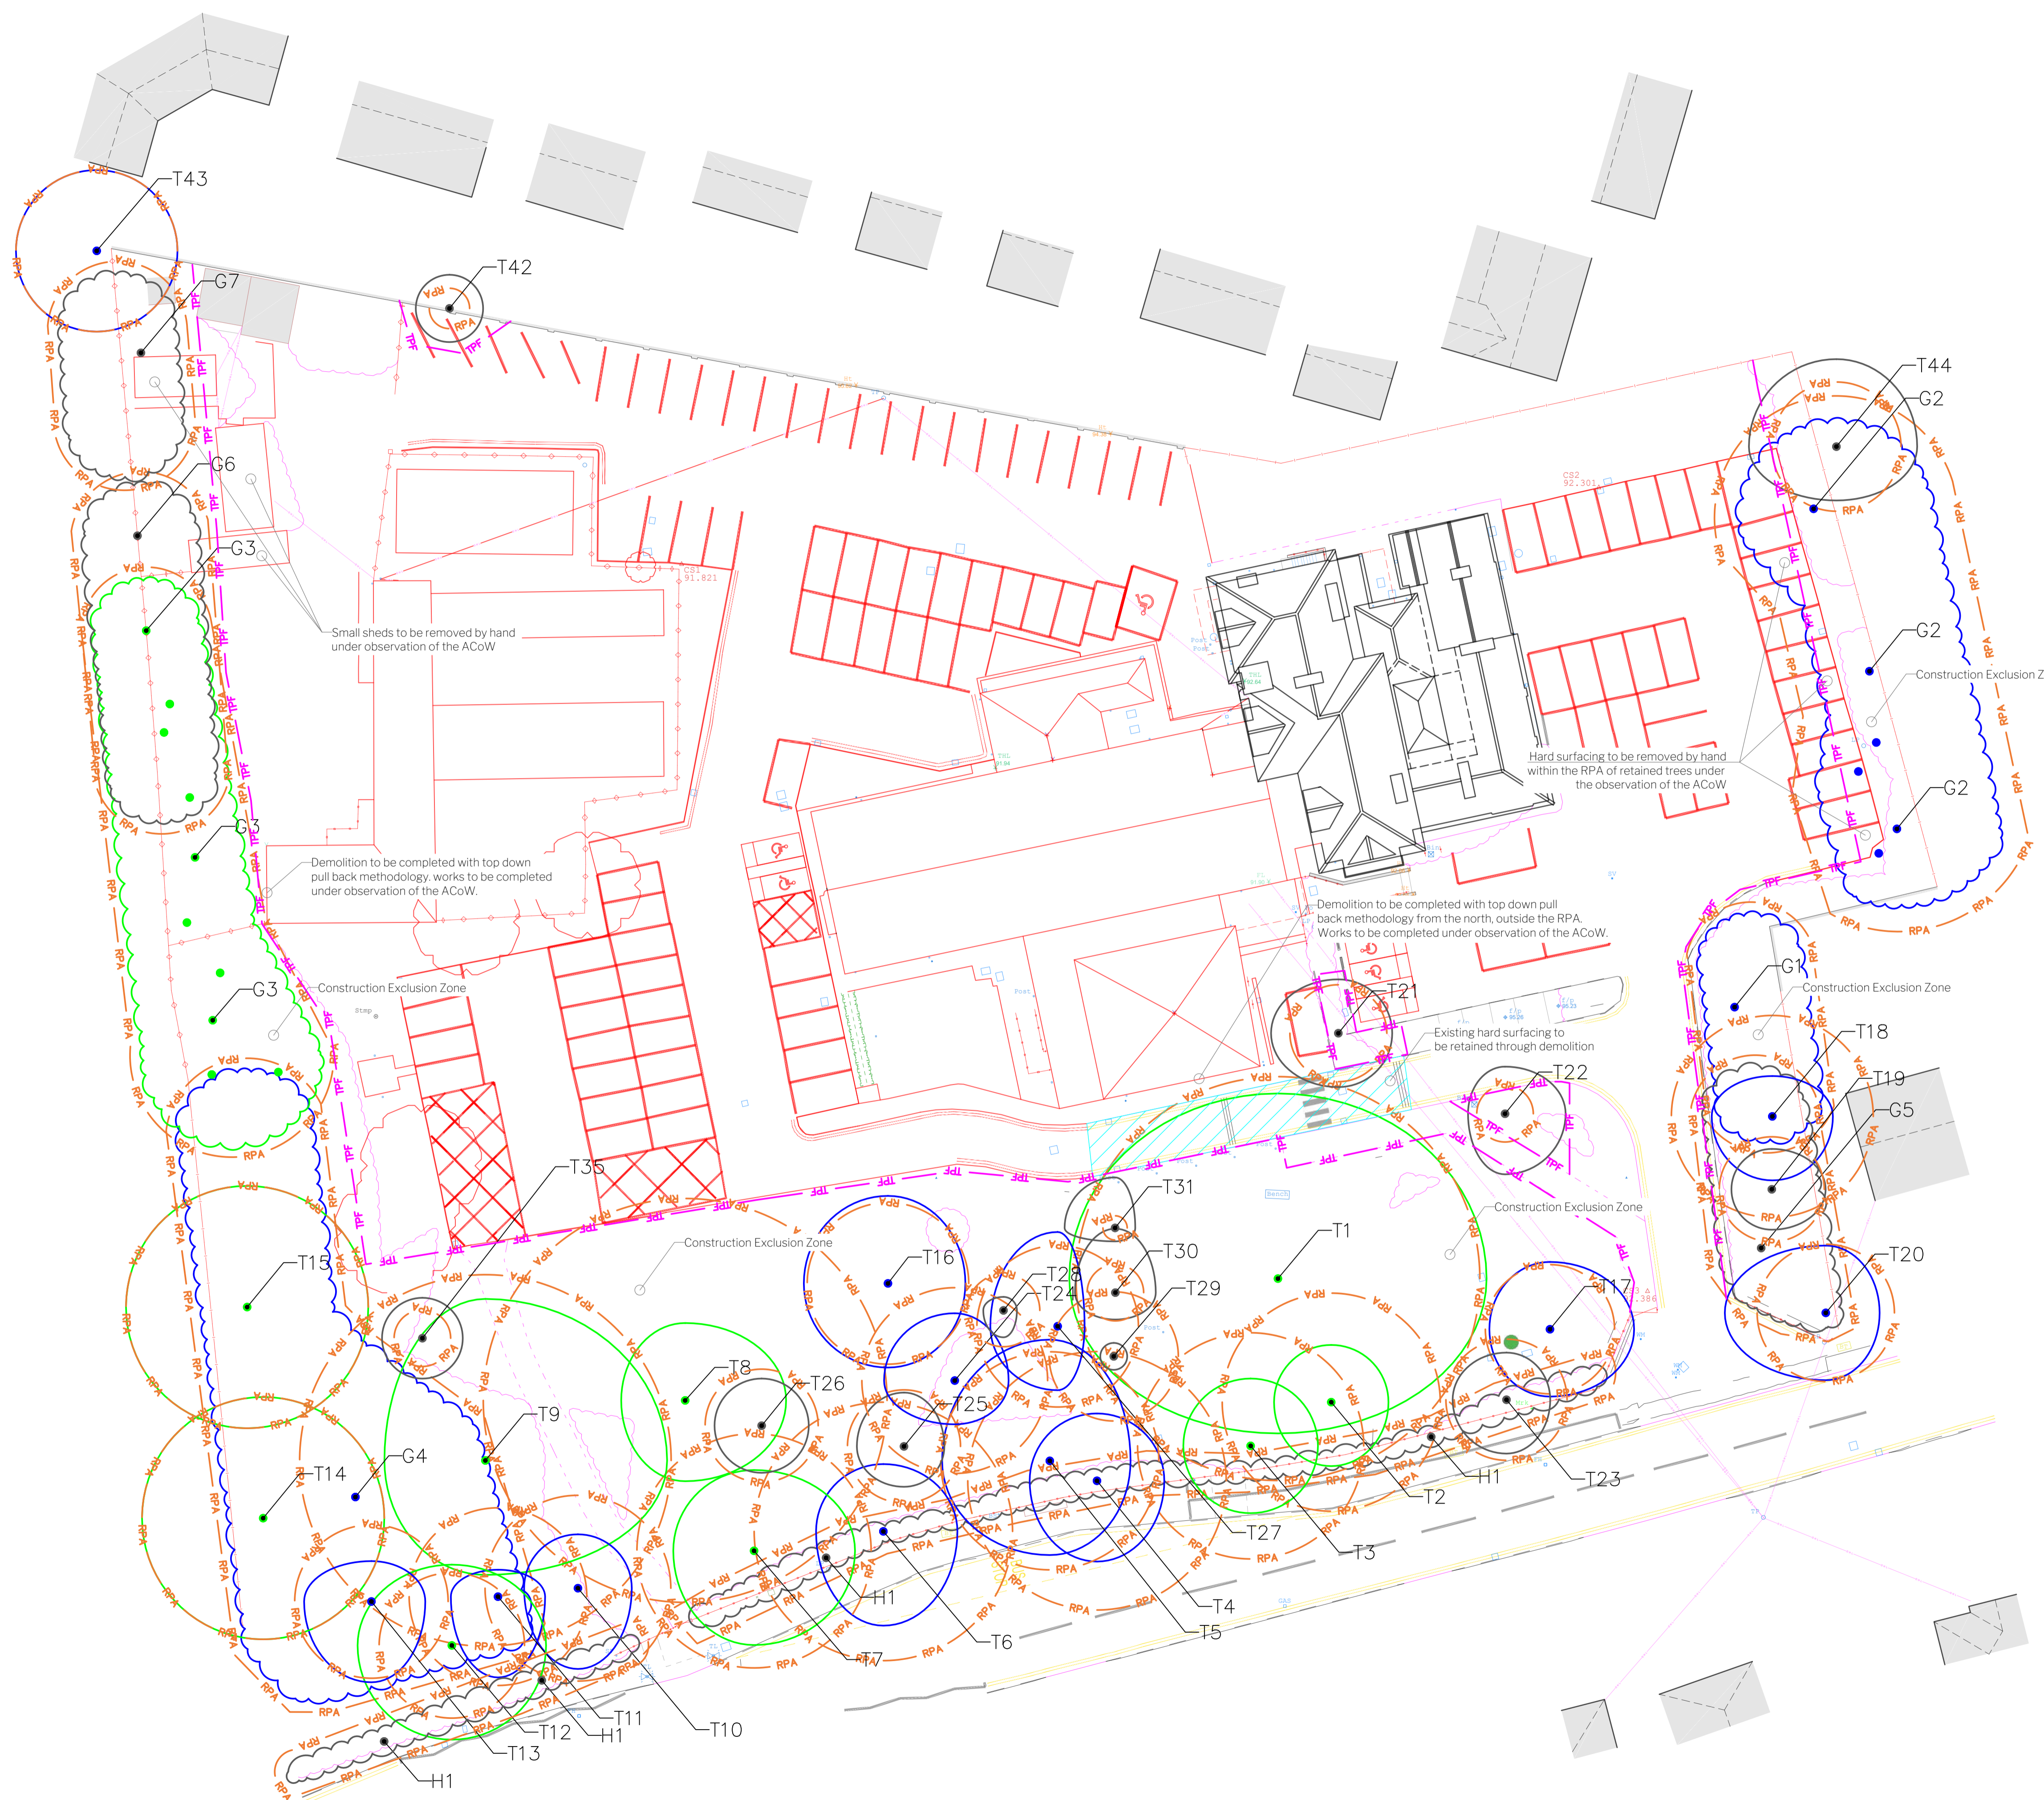
100mm Clean Woodchip Spread Across the RPA

- 7.2.4 The Greenfix Geoweb will be 75mm in depth and installed above the existing ground level. This will reduce the likelihood of ground compaction and ensure good infiltration to the ground for rainwater run-off within the RPA.

- 7.2.15 The Greenfix Geoweb will be 150mm in depth and installed above the existing ground level. This will reduce the likelihood of ground compaction and ensure good infiltration to the ground for

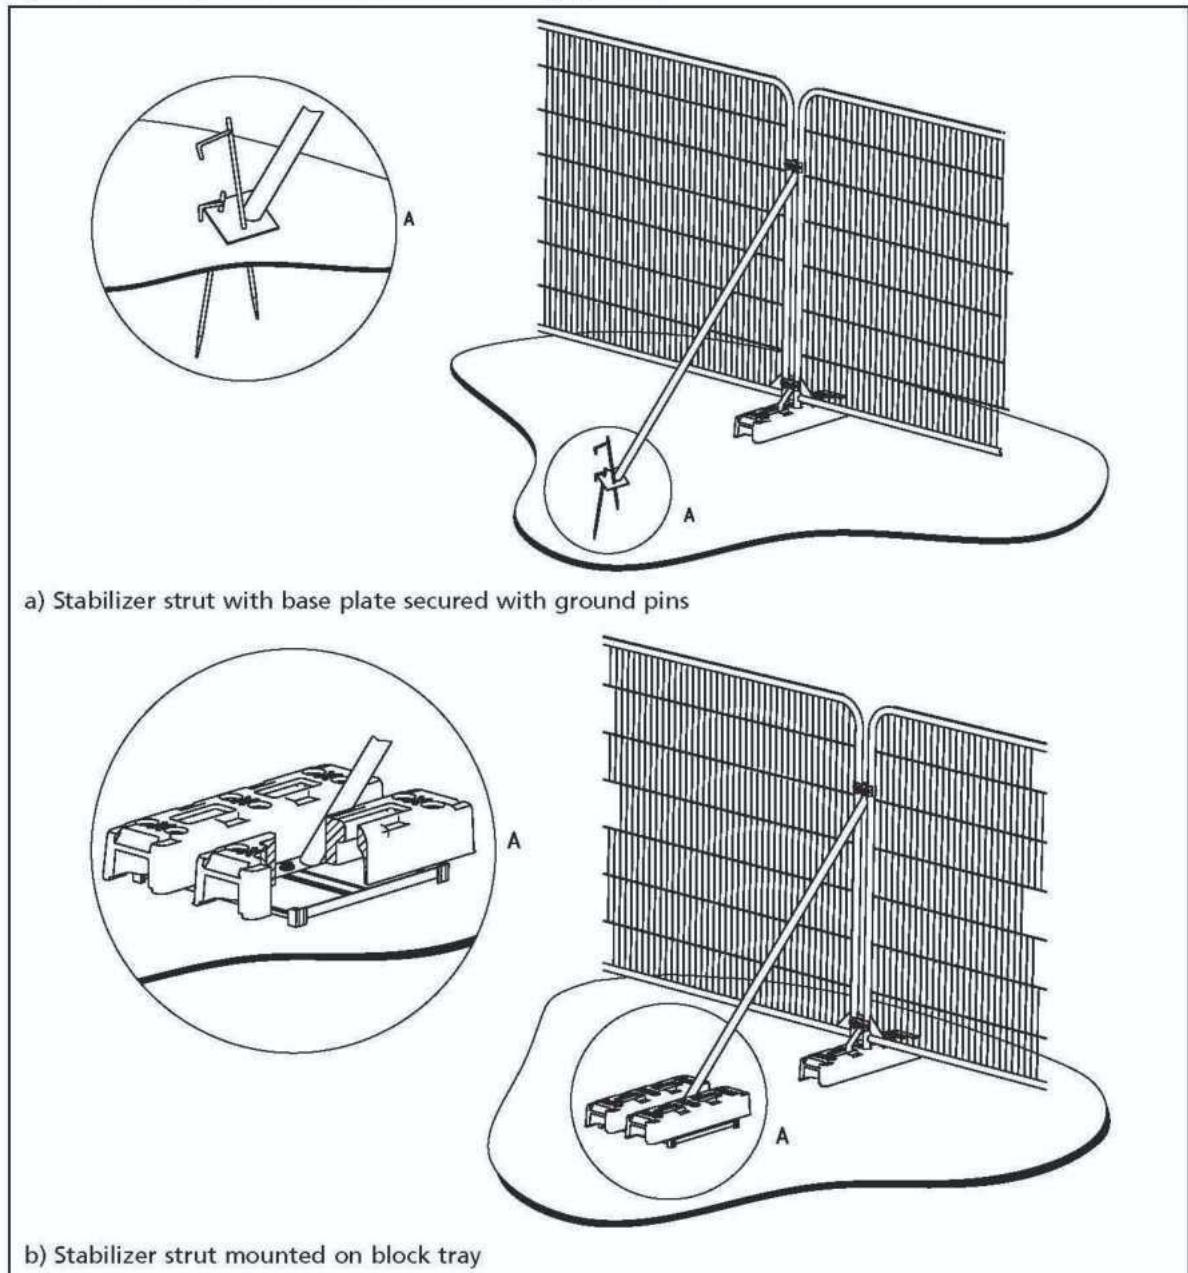
Figure 3 Examples of above-ground stabilizing systems
