RESULTS OF FURTHER BAT SURVEY WORK

**KENYN PEDER, BOUNDER TREATH,
COVERACK, CORNWALL**

May and July 2023

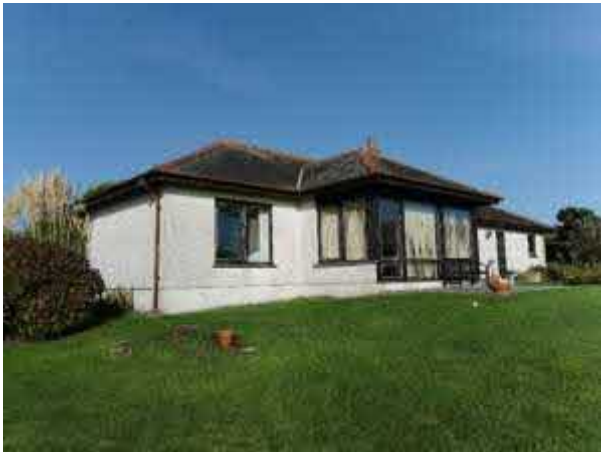
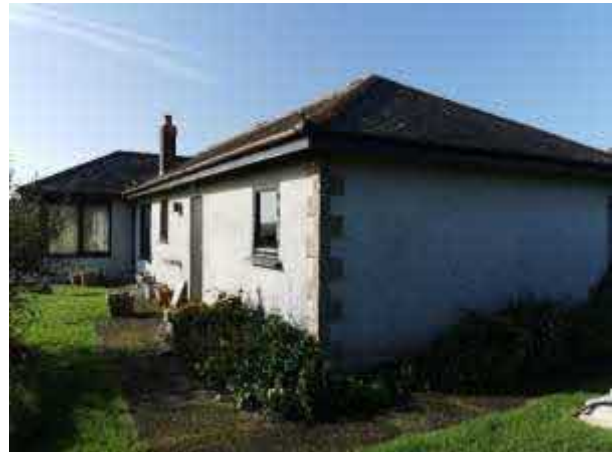
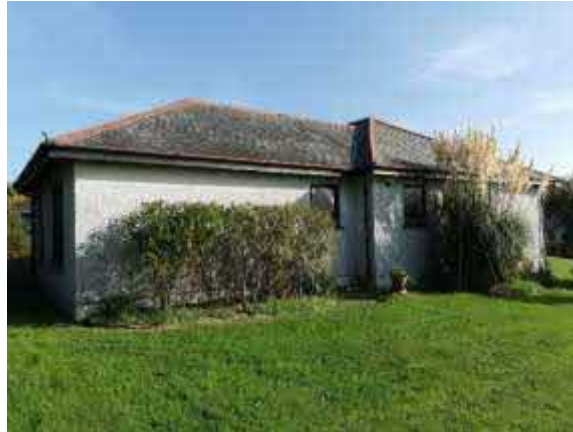
The building subject to this survey is a detached L-shaped bungalow set in the centre of a large garden with a projecting extension to the south east and a double garage built onto its north eastern end. The building is built from rendered blockwork and has a hip ended slate covered roof with clay ridge tiles, see photos 1, 2 and 3.

Photo 1. Showing the house from the south west

Photo 2. Showing the house from the south east

Photo 3. Showing the house from the west

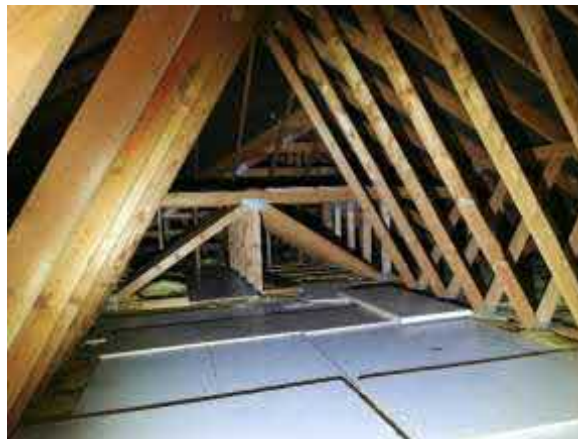
Internally there is a single L shaped roof space over the building which is partially divided into more open and more cluttered sections by heavy cross braced trusses, see photo 4. There is a second roof space over the garage which is partially portioned off from the main roof void, this roof void is very cluttered with crossing timbers. The roof voids are open from the floor of the roof void to the underside of the roof which is lined with bitumen felt.

Photo 4. Showing the roof void over the main part of the building

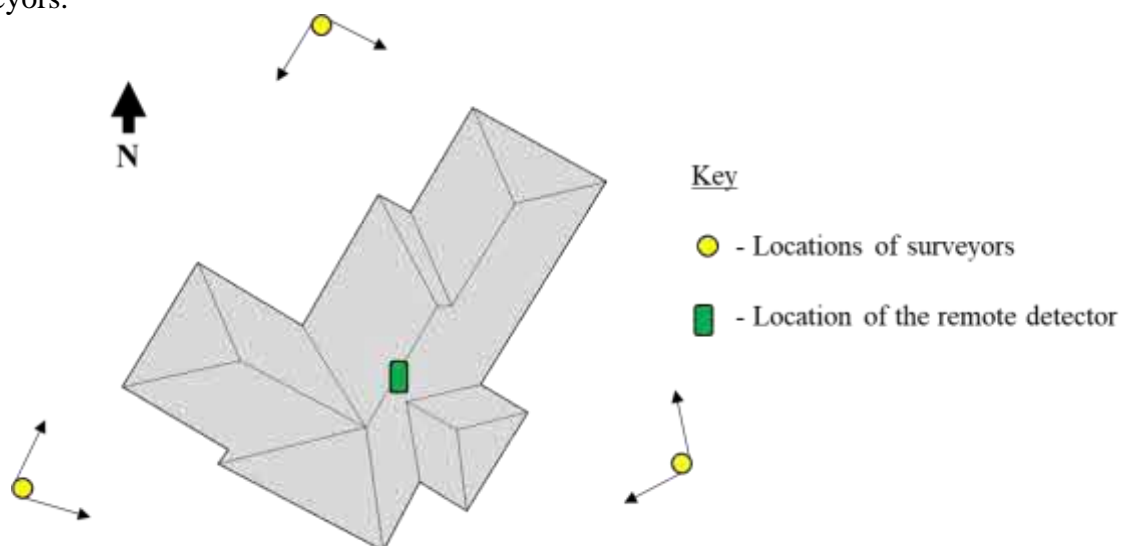
On 30th May 2023, Matthew Thurlow, James Walker and Felicity Thurlow were positioned around the outside of the house so that all aspects could be watched, see Figure 2. for the locations of the surveyors.

Figure 2. The locations of the surveyors during the emergence surveys and the remote detector

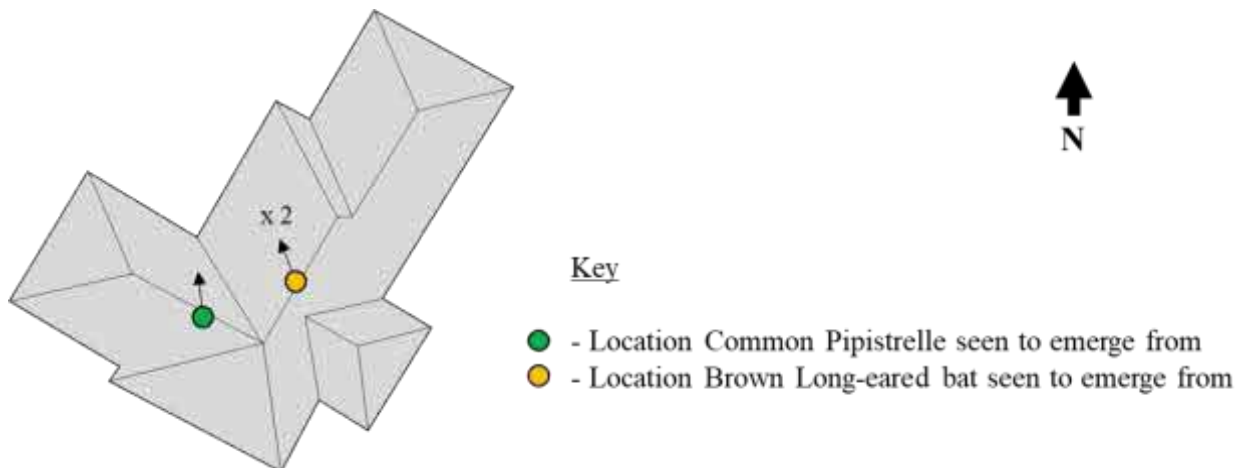
The first bat activity was recorded was from Common Pipistrelle which was seen to emerge from the eastern-most vented ridge tile of the north-west hipped roof at 21:39. At 22:20 and 22:31 single Brown Long-eared bats were seen to emerge from the vented ridge tiles on the southwest facing dormer.

A single Common Pipistrelle and two Brown Long-eared bat were seen to emerge from this building during this survey, see Figure 3.

Figure 3. Summary of the location's bats were seen to emerge from during the 1st emergence survey

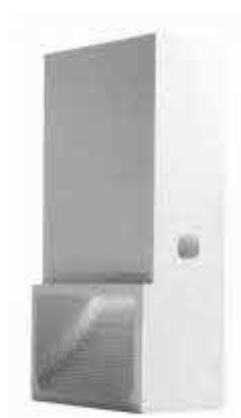
Figure 5. Showing a Green & Blue Bat Blocks

As the proposed works will result in all the existing roosting sites being destroyed replacement roosting sites will need to be installed into the extended building to ensure the conservation status of bats on the site is maintained. This should take the form of building three integrated bat boxes (we would recommend using Green & Blue Bat Blocks) into the new building (away from windows). One should be built into south eastern elevation, one into the south western elevations and the last into a north facing elevation, see figure 5.
