BAT, BARN OWL AND NESTING BIRD SURVEY

**KENYN PEDER, BOUNDER TREATH,
COVERACK, CORNWALL**

October 2022

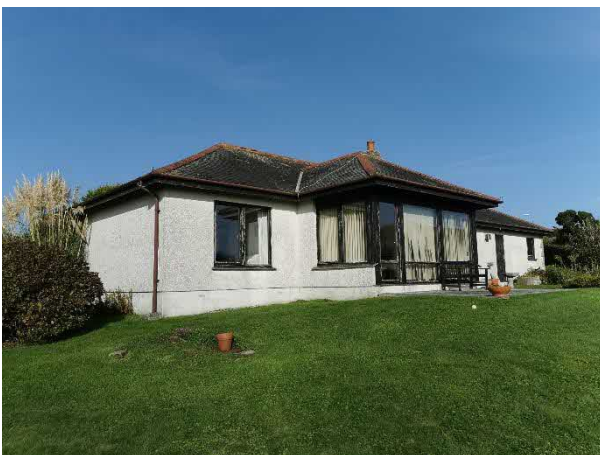
The building subject to this survey is a detached L-shaped bungalow set in the centre of a large garden with a projecting extension to the south east and a double garage built onto its north eastern end. The building is built from rendered blockwork and has a hip ended slate covered roof with clay ridge tiles, see photos 1, 2 and 3.

Photo 1. Showing the house from the south west

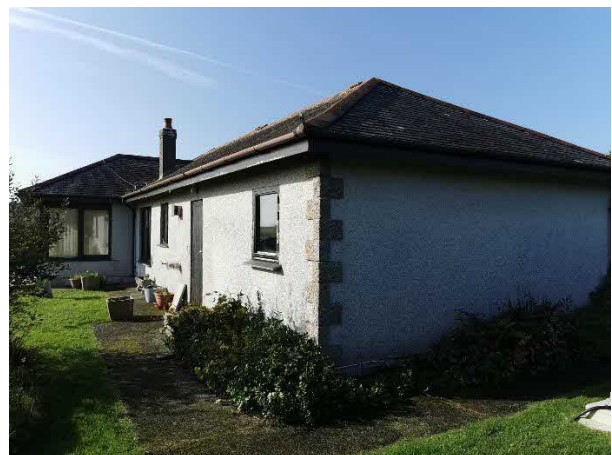
Photo 2. Showing the house from the south east

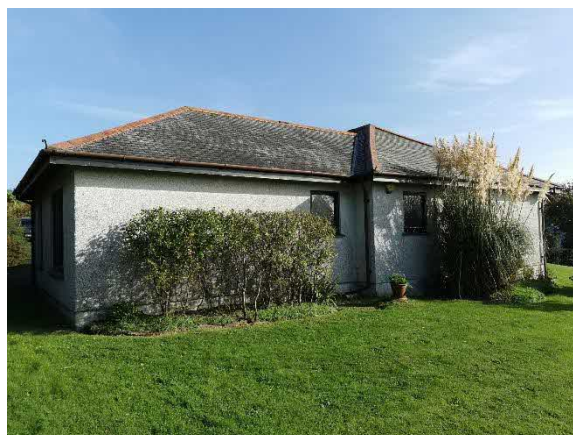
Photo 3. Showing the house from the west

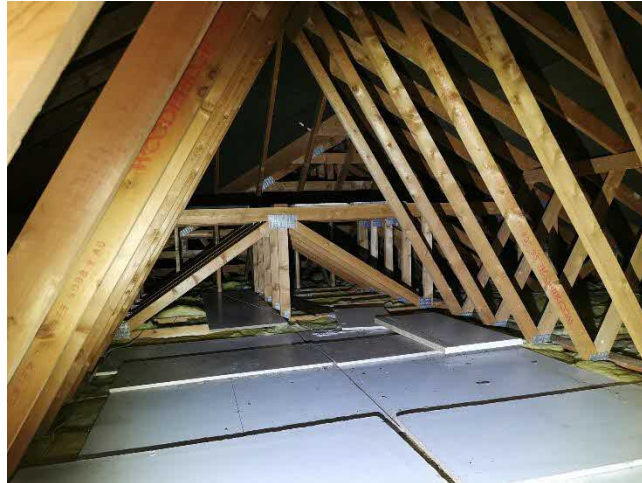
Internally there is a single L shaped roof space over the building which is partially divided into more open and more cluttered sections by heavy cross braced trusses, see photo 4. There is a second roof space over the garage which is partially portioned off from the main roof void, this roof void is very cluttered with crossing timbers. The roof voids are open from the floor of the roof void to the underside of the roof which is lined with bitumen felt.

Photo 4. Showing the roof void over the main part of the building
