Bat Building Inspection Report

6 Benett Avenue, Hove

December 2023

Project no.	Project
11639	6 Benett Avenue, Hove

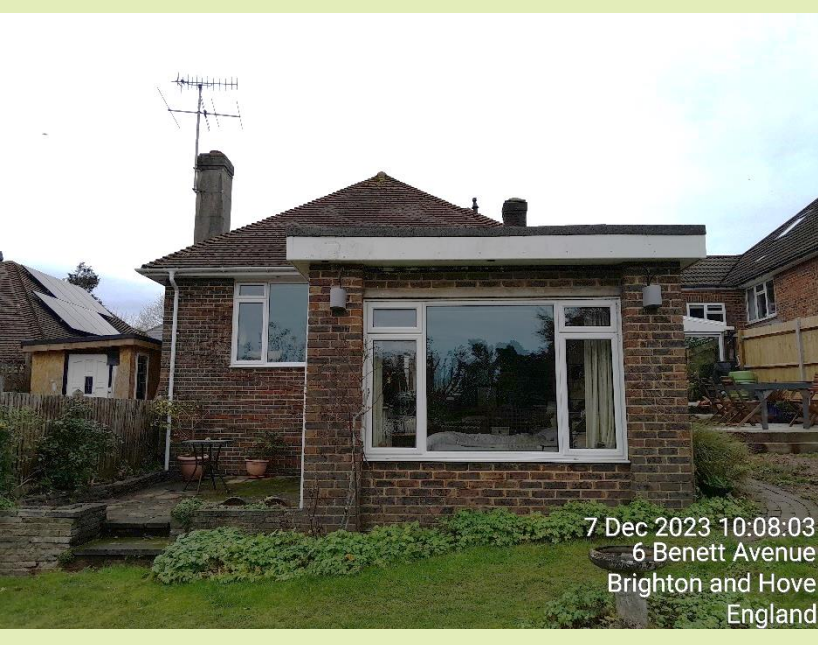
Photograph Number and Feature	Photograph of Feature
1. Showing back of building.

- 3.3 The building was noted to be currently a residential home in the urban area of Hove. One streetlight was present within 20m of the front of the building. Outdoor lights were present at the back of the building (See Appendix A, Photographs 1-2).

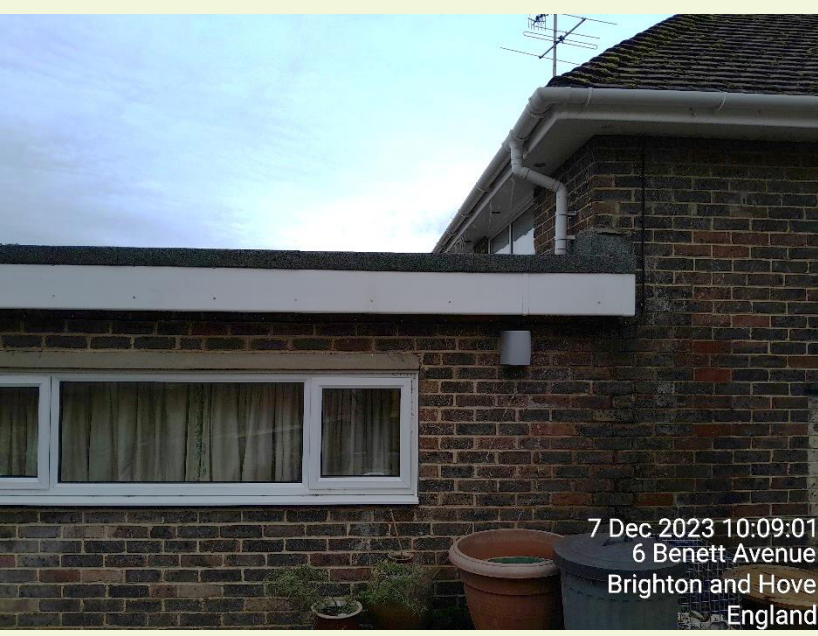
<p>7 Dec 2023 10:08:03 6 Benett Avenue Brighton and Hove England</p>
2. Previous extension at the back of the building. Roofing felt and brick. Main building tiles and brick. No gaps or access points seen.

- 3.7 Gaps between downpipe and wall were also inspected. The pipes were a considerable distance away from the wall (See Appendix A, Photograph 2). There were multiple mesh ventilation holes noted under the eaves of the building. Each one was inspected. None were noted to be missing or broken (See Appendix A, Photograph 3).

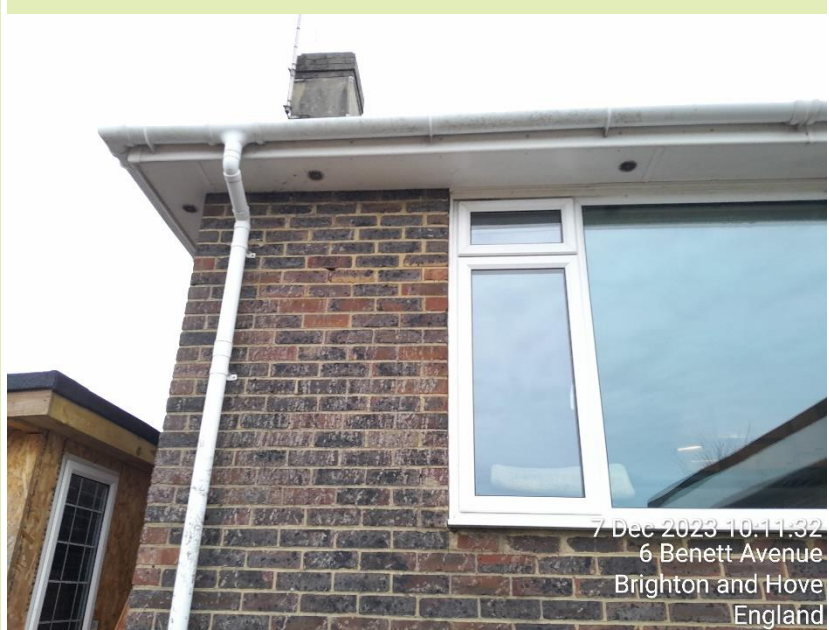
- 3. Mesh ventilation holes noted.

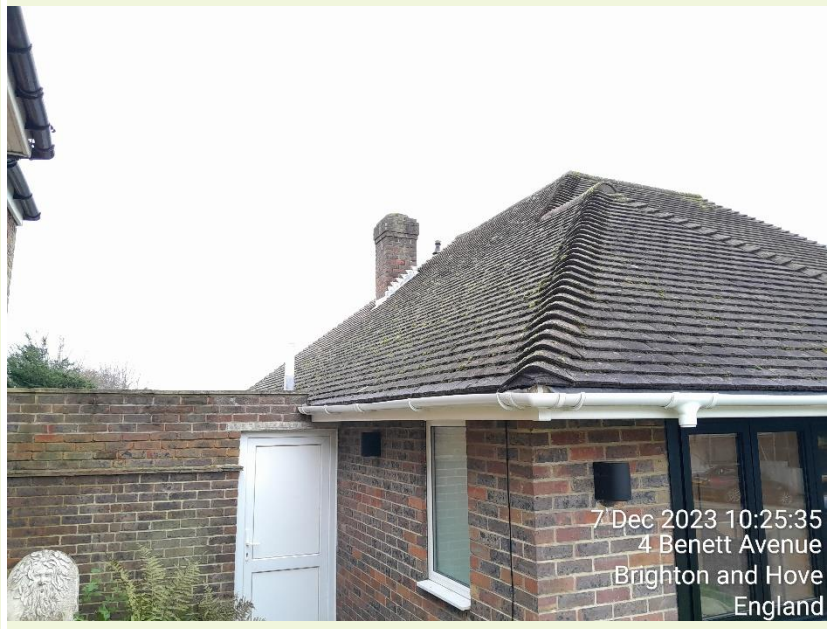
- 4. Front of the building where Lead flashing can be seen and external lights.

- 3.5 Lead flashing surrounding the chimney appeared to be flush and with no signs of egress noted (See Appendix A, Photograph 4).
- 3.6 No potential access points were seen when assessing the external structure. Tiles were flush against each other. No tiles appeared to be damaged or missing. No gaps in the roofing felt were noted. Bricks appeared to be in good condition with no cracks noted.

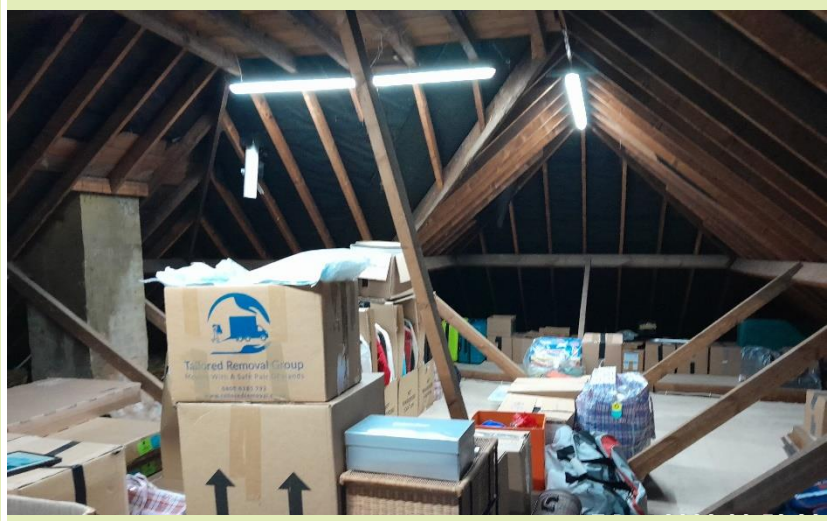
7. Inside roof spacing.
Note frequent use by residents for storage and lights fixed.

- 3.12 The roof space was open with access to all corners and areas.
- 3.13 The roof space appeared to be used frequently for storage (See Appendix A Photograph 7).

- 3.14 No evidence of bat specimen, droppings, urine stains, feeding remains, or odour were noted. Ridge beams and other beams appeared intact and in good stable condition with no evidence of scratch marks or use by bats were noted. Spider webs were present scattered throughout the space. Ridge and hip beams were flush and clean with no evidence of use by bats noted. Roof lining was in good condition with no marks or rips noted (See appendix A, Photographs 7-9).

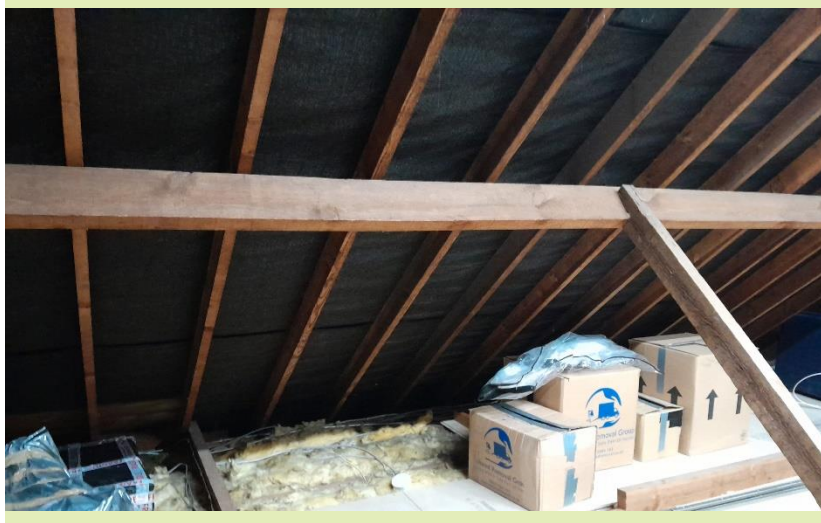
9. Wood in good condition, storage noted and insulation.
