REPORT NUMBER: 8062,GI,RMS,RMS,PC,HS,08-01-24,V1

SITE: Rishangles Hall, Eye Road, Rishangles, IP23 7LA

Remediation Area Plan – 6405,RMS,VA/001/Rev0

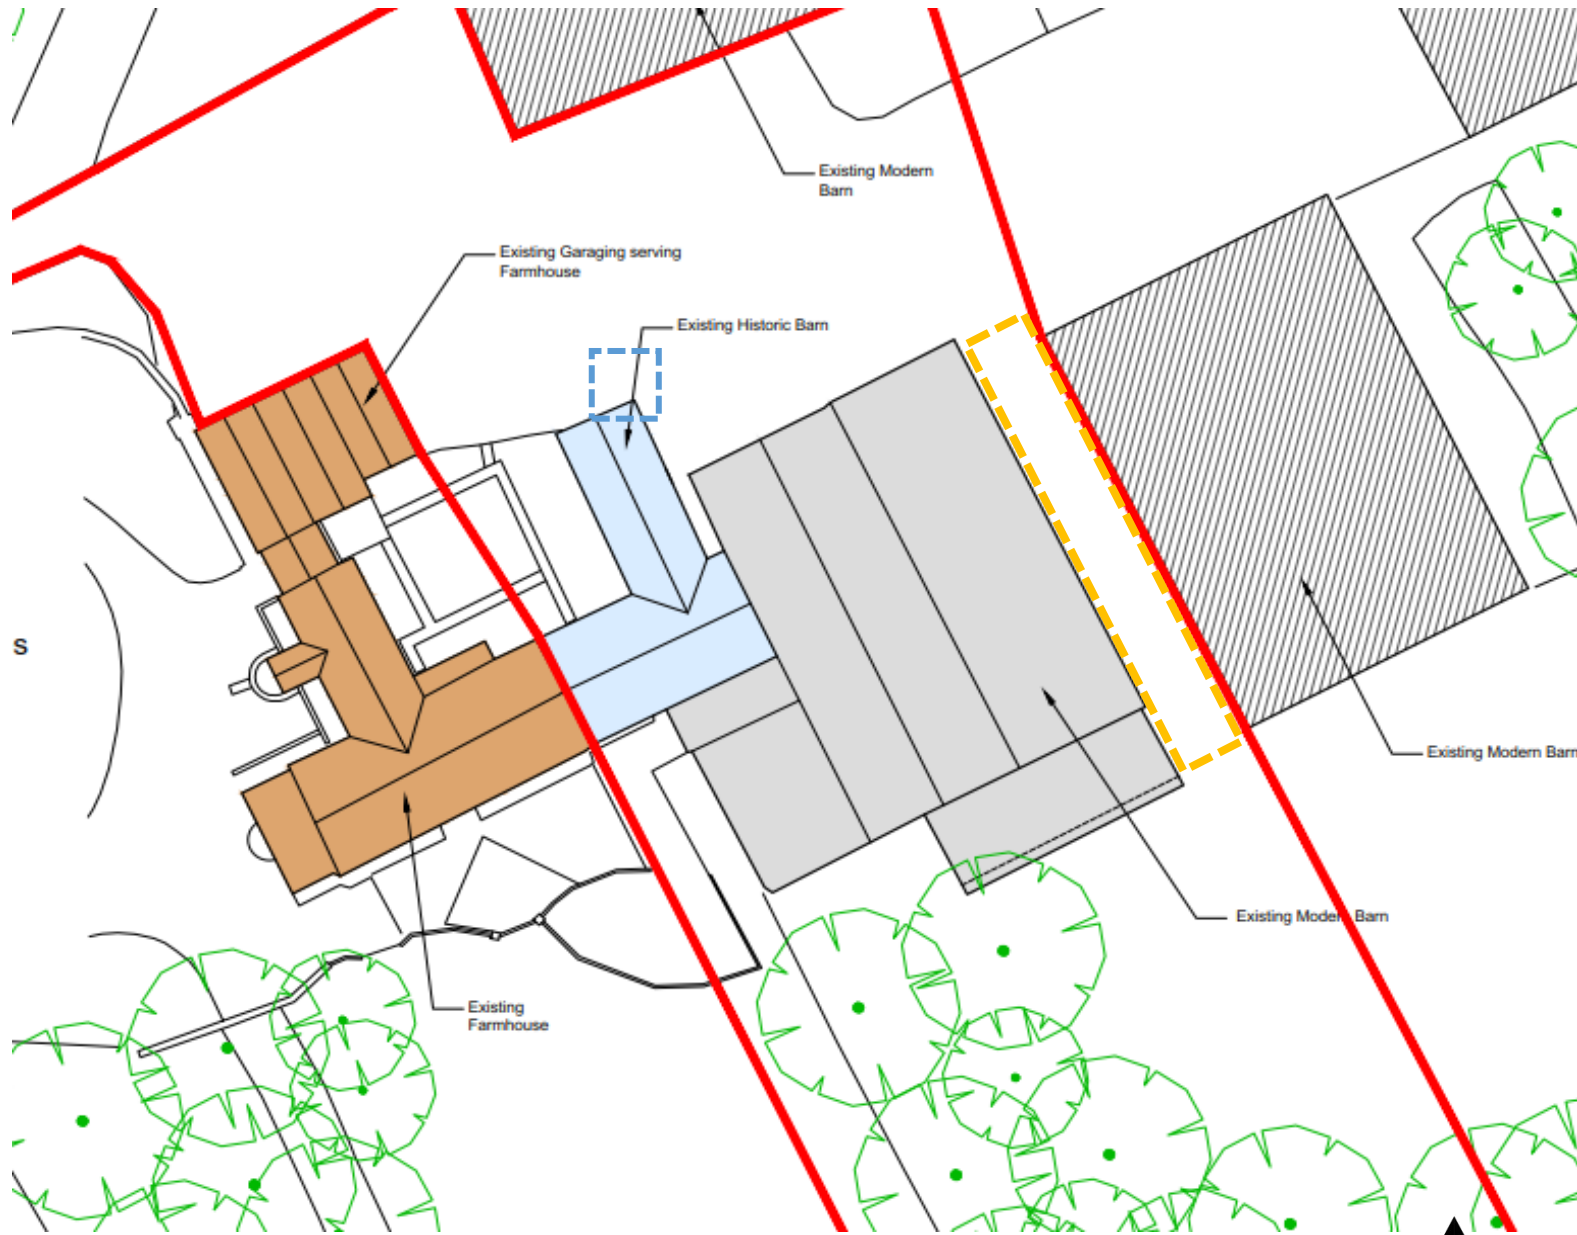
3x3m Cover System
-

Asbestos Grid Picking Area

Proposed Remediation Plan

Loose asbestos fibres were not recorded at concentrations above the screening criteria, however the presence of bound asbestos fragments and the potential for disturbance via vehicle movement along the track is a risk that should be addressed via visual screening/picking of ACM fragments, and if necessary (see discussion below)*, below the concrete slab around WS10. The process for this is detailed below:

- This approach comprises creation of a “soil cover system” via:
 - (i) removal of existing Made Ground to 600mm below finished ground level from a 3m x 3m* square centred on WS09; and
